Root Cause Analysis and Correction of Single Metal Contact Open-Induced Scan Chain Failure in 90nm node VLSI

Chao-Cheng Ting^{ab*}, Ya-Chi, Liu^c, Hsuan-Hsien Chen^a, Chung-Ching Tsa^a and Liwen Shih^d

^a*Division of IC Technology, Faraday Technology Corporation, No.5, Li-Hsin Rd III, Hsin Chu Science park, Hsin Chu , Taiwan 300, R.O.C*

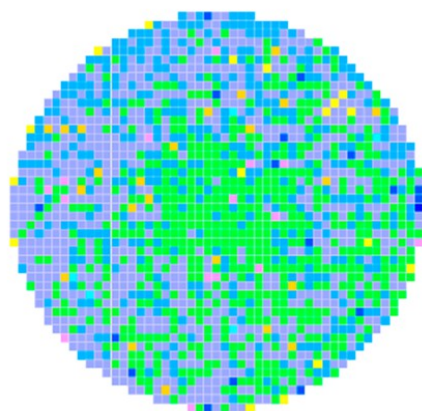
A 90 nm node VLSI based on standard performance process suffered significant low yield of approximately 34%. The failing wafer map is shown in Figure 1. With reference to Figure 1, the two top failures are identified as scan chain test and ATPG (Automatic Test Pattern Generation) test. Since the scan chain failure dominates, this paper studies the cause and corrective action to recover the scan chain failure.

34(%)	Pass die rate
40(%)	Fail rate of scan test
22(%)	Fail rate of ATPG test

Figure 1. The failing wafer map. (Green) Passing dies. (Purple) Dies failing scan chain. (Blue) Dies failing ATPG test.

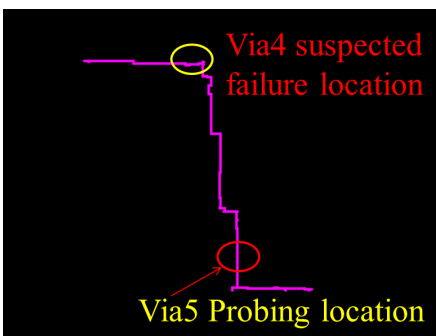
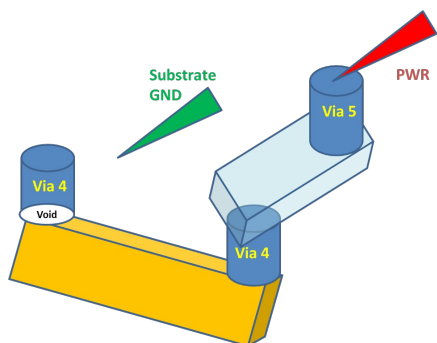
First, scan diagnosis was performed to localize the suspected failure net as shown in Figure 2 (top). Based on the scan diagnosis result, the sample was polished to expose via 5 for probing. As shown in Figure 2 (bottom), the power was supplied to via 5 and the ground was applied to the substrate for further EBAC analysis.

Figure 2. The scan diagnosis indicating the suspected failure loop (top) and the illustration of probing for EBAC imaging (bottom).

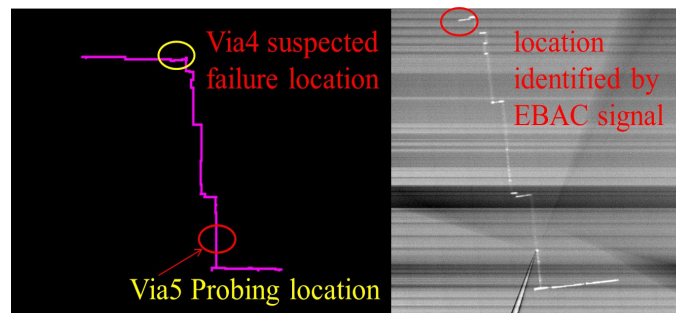
EBAC technique was performed on that suspected trace to identify the failure location. Figure 3 shows the EBAC image indicating the failure location to be around via 4 as shown by the disconnected metal trace after via 4 as compared to the scan diagnosis suspected net; this technique provides a quick way to assess the suspected failing net without physically inspecting the entire net which can be time-consuming.

Figure 3. The scan diagnosis result of failure trace (left) and the EBAC image (right).

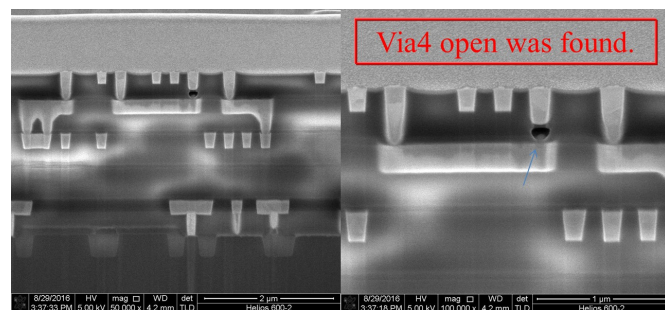
Figure 4 shows the SEM image of the FIB cross section revealing a sub-surface void at the bottom of via 4, which is of the nature as reported by Richard L., et al [3]. In addition, there is no deformed via as compared to the adjacent ones. This indicates that the open failure does not belong to the via etch or former lithography process. In order to uncover the actual cause of the open failure, we performed EDX element analysis. As shown in Figure 5(c) and (f), the extra carbon and oxygen signals were discovered at the bottom of the metal contact. Based on the above information and the presence of silicon signal, as shown in Figure 5(b), we reasonably assumed that the Si, O and C signals come from silicate polymer as it cannot be removed by wet solvent cleaning as depicted in Figure 6.

Figure 4. SEM overview image of the FIB cross section (left) and the high magnification SEM image indicating via 4 open (right).

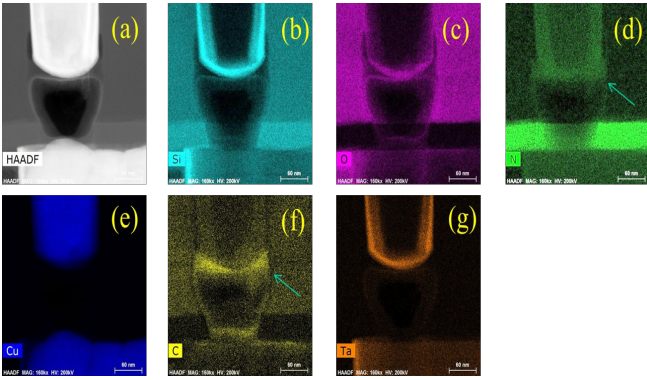
Figure 5. TEM and EDX mapping image. (a) The HAADF (High Angle Annular. Dark Field) TEM image. (b) The EDX mapping of Si (light blue). (c) The EDX mapping of O (pink). (d) The EDX mapping of N (green). (e) The EDX mapping of Cu (dark blue). (f) The EDX mapping of C (yellow). (g) The EDX mapping of Ta (brown).

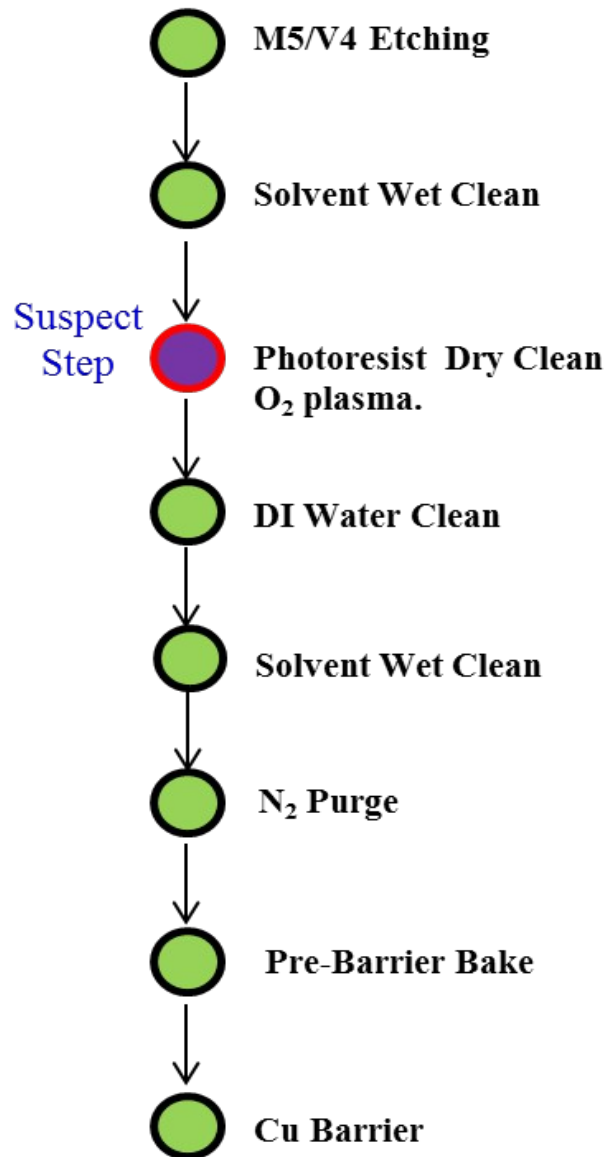
A partition check analysis was conducted using defect performance inspection at each process step. It was found that the failure likely occur in the steps after the first solvent clean, as indicated in Figure 6. Based on this insight, we postulate that the formation of silicate polymer was due to the reaction of the silicon and photoresist radicals generated during the plasma dry clean process, as indicated by the red spot in Figure 6. This is because unlike the organic compounds (photoresist), the silicate polymer cannot be easily removed during the wet clean. Also, based on Figure 6, the solvent may remain in the silicate polymer and outgas during the pre-barrier baking process, which can lead to poor copper adhesion in the following electrochemical plating process (Koh, L. T., et al argued the carbon containment may affect the bottom fill up ability and He, Q. Y et al noted the residual carbon contamination will increase the occurrences of copper void during the ECP. [4,-6]). To substantiate our hypothesis, we devised a revised fabrication flow with ultra-dilute hydrogen fluoride (UDHF) clean and N₂ purge to replace the dry clean and second solvent clean to avoid radical recombination and solvent outgassing during pre-barrier bake respectively.

Figure 6. The fabrication flow and the suspected photoresist O₂ plasma dry clean step.

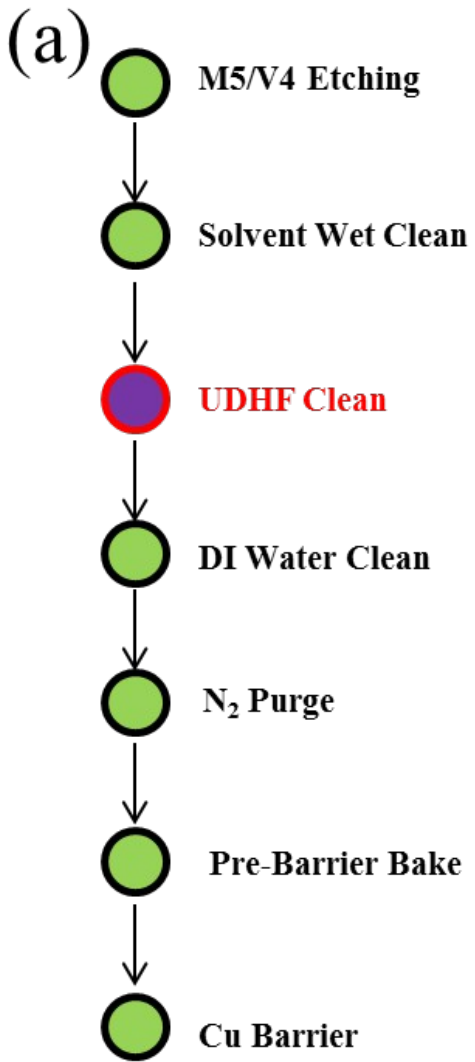
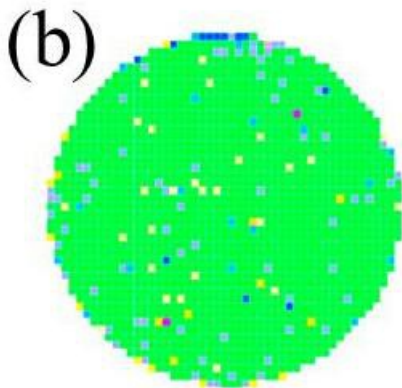
Figure 7. (a) The revised fabrication flow. (b) The test result of the revised flow. (Green) Passing dies on all test items.

As shown in Figure 7(a), the UDHF clean was applied just after the solvent clean and before the DI wafer flush to ensure the total removal of the expected silicate polymer. The scan chain fail rate was significantly reduced with the revised fabrication flow. The wafermap with the improved yield is presented in Figure 7(b). The yield improvement from approximately 34% to 90% as a result of the corrective action directly supports our assumption on the formation of silicate polymer.

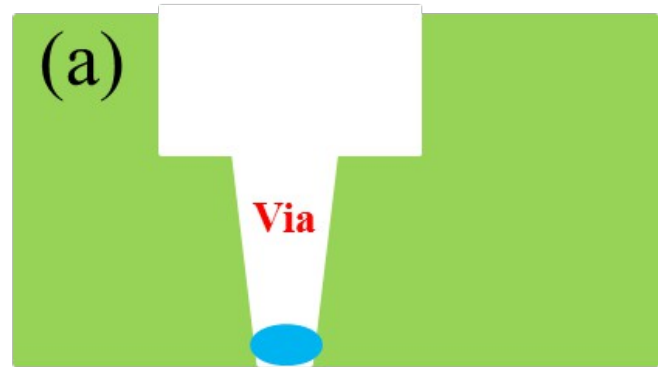
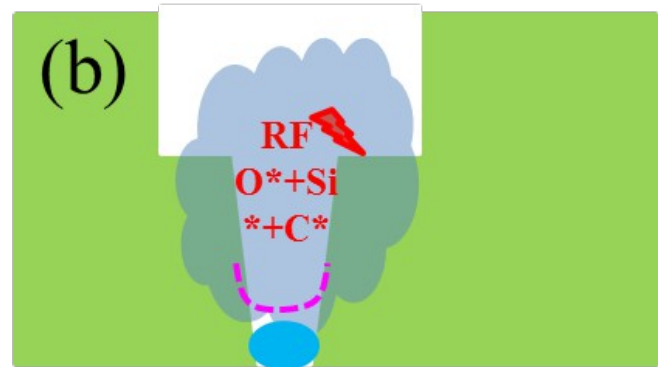
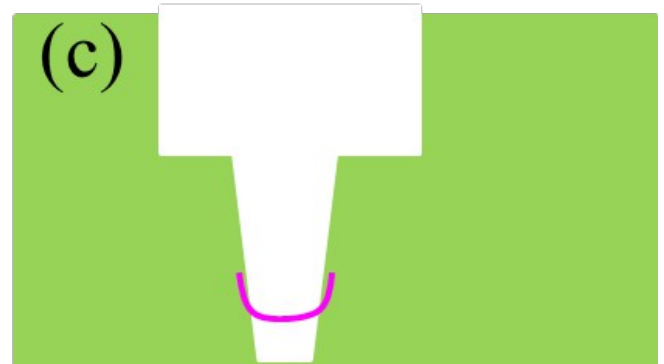
For a complete understanding on the failure mechanism, Figure 8 illustrates the formation of silicate polymer in three stages. First, after the etching process, the photoresist and solvent residue that remain at the bottom of via are hard to be completely removed by the wet clean process. Second, the O₂

plasma dry clean is capable of ionizing the photoresist and solvent residue, leading to the formation of Si, C and O radicals. Third, after the plasma dry clean, the Si, C and O radicals recombined to form silicate polymer which give rise to C, Si, O signals in the EDX images. Finally, the unwanted silicate polymer along with the solvent residue evaporate during the later pre-barrier baking process leading to a poor adhesion in electrochemical plating process. This explains the subsequent copper void.

Figure 8. The schematic of the failure mechanism. (a) solvent and photo-resist residue (carbonaceous compound) adhere to the via bottom. (b) The O₂ plasma dry clean generate O, Si and C radicals. (c) The unwanted silicate polymer is formed at the via bottom based on the O, Si and C radical recombination.
