# Copper alloys deterioration due to anthropogenic action

A. Duran\*, J.L. Pérez-Rodríguez\*, L.K. Herrera\*, M.C. Jiménez-de-Haro\*, M.D. Robador\*, A. Justo\*, J.M. Blanes\* and J.C. Pérez-Ferrer\*

### 1.1. The Pardon Gateway of the Mosque-Cathedral of Cordoba

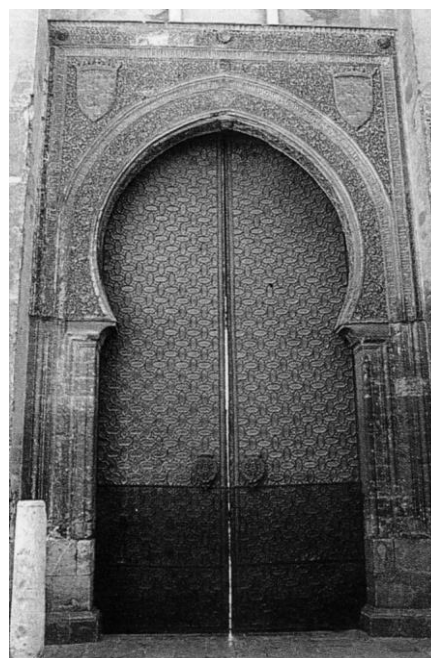
**Figure 1.** Pardon gateway of Mosque-Cathedral of Cordoba.

The gateway was rebuilt in 1739. The leaves were in a good conservation state until the middle of the XX century, when a sudden alteration began after being subjected to a cleaning process. The alloys and the rivet used to fix the plaques presented a high degree of oxidation. This deterioration was attributed to a wrong cleaning procedure with an inappropriate product, and it was necessary to stop the deterioration process as well as to eliminate the corrosion products.

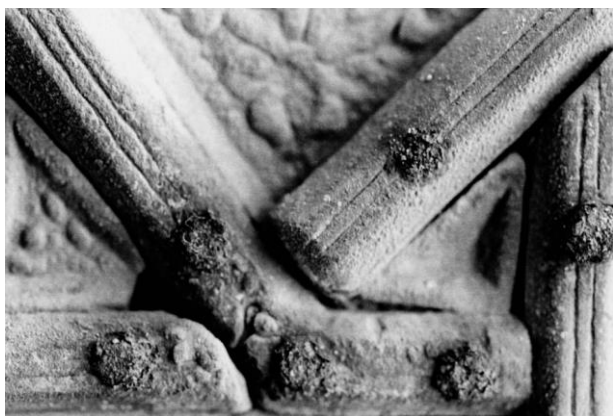
- Sample 1 was taken from the reverse of left leaf, on sheets that surround the internal edge of the leaf.
- Sample 2 was taken from a separated fragment of a moulding.
- Sample 3 was taken from right leaf, located similarly to sample 1.
- Sample 4 is a powder taken from a caisson in the right leaf showing severe corrosion.
- Sample 5 is a powder taken from a rivet (Fig. 2).
- Sample 6 is a separated fragment (nail) from the top of the door. (Fig. 3).

**Figure 2.** Details of the rivets.

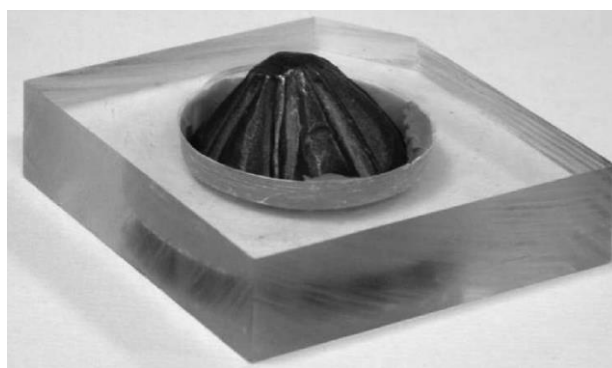
**Figure 3.** Separated fragment (nail) from the top of the door.

The chemical analysis carried out directly in the fragment of the sample 6 after cleaning still shows the presence of Cl, together with Cu, Sn, Pb, Fe and small amounts of Zn, showing the difficulty to remove ion chlorine.

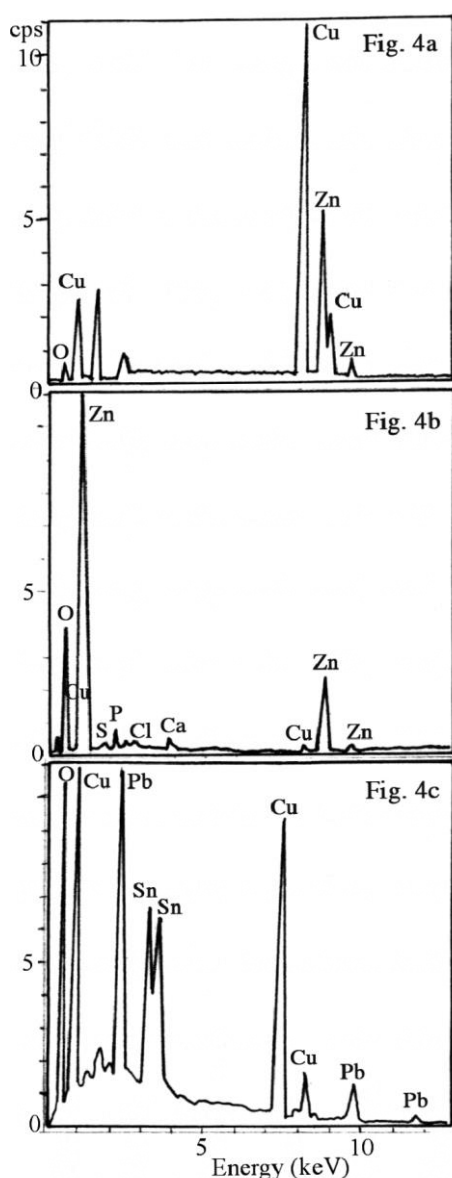
In a first step, the alloys used in the leaves construction were characterized. The elemental analysis of sample 1 shows that the original material is constituted by copper and zinc (Fig. 4 a)). Punctual chemical analysis in this sample shows the presence of Zn (Fig.4 b)). The x-ray diffraction patterns of this sample support the presence of copper zinc alpha brass (figure not shown). The chemical composition and phases found for sample 3 are similar to those present in sample 1. These results confirm that these materials are constituted by copper zinc alpha brass. This alloy is present in a small part of the leaves, mainly in the edges.

The elemental analysis of sample 2 shows the presence of Cu, Sn and Pb (Fig.4 c)). A similar composition was found for sample 6 accompanied by Fe and small amounts of Zn. The X-ray diffraction patterns of this sample show that it is constituted

**Figure 4.** Elemental analysis of sample 1. (a) general and b) punctual); and sample 2 (c) general).

Also, punctual elemental analysis in samples 1 and 3 shows the presence of Zn and O (Fig.4 b)). This finding may be attributed to formation of ZnO (zincite). When zinc is exposed out-doors initially form zinc oxides<sup>[14]</sup> that may be transformed into a basic zinc compound. It is possible that ZnO identified in this sample resulted from the corrosion of freshly exposed zinc. This phase has not been detected by X-ray diffraction.

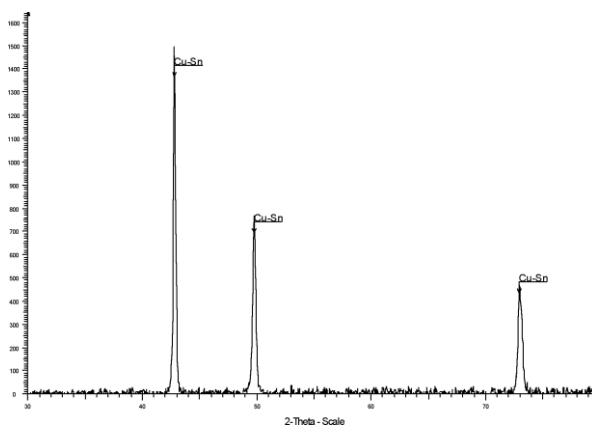
by copper-tin alpha brass (Fig. 5). The x-ray diffraction patterns of this last sample has been carried out on the sample after cleaning by restaurators using a Göbel accessory that allow the direct study of irregularly shaped samples avoiding to obtain any powdered sample from the pieces, that it was not permitted by restaurators due to high artistic value of this piece. In figure 3 it is shown the montage used to obtain the x-ray diagram of these samples.

**Figure 5.** XRD patterns of unaltered material of sample 6 (Cu-Sn).

These results show that these samples are constituted by bronze as main component in the leaves of the gateway. The presence of lead is due to the manufacturing process frequently used (bronze cast) in the past.

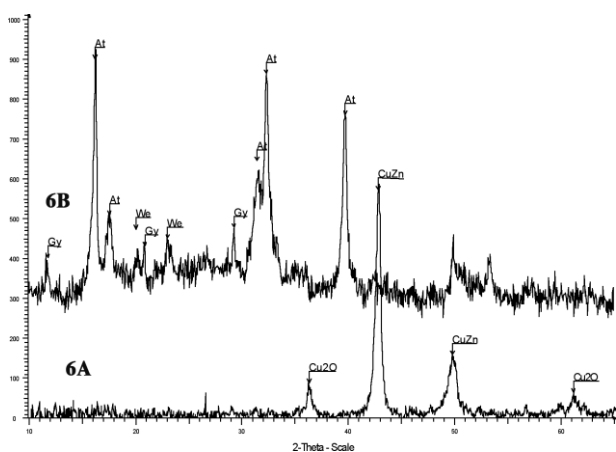
Elemental analysis of the samples 1 and 3 shows the presence of copper and oxygen. This last element is difficult to attribute to the oxidation of Cu because may form part different compounds present in the base material. However, the x-ray diffraction powder taken directly from the sample shows the presence of  $\text{Cu}_2\text{O}$  (Fig. 6 a)).

**Figure 6.** XRD patterns of oxidized material of samples 1 and 3 ( $\text{Cu}_2\text{O}$  and Cu-Zn) (A) and XRD patterns of corrosion and environmental contamination products of samples 1 and 3 (Gy=gypsum; At=atacamite; We=weddellite) (B).

The elemental analysis of corrosion products from samples 1 and 3 show the presence of copper, chlorine, zinc, silicon, sulphur, calcium, iron, aluminium and oxygen (Fig. 7 a)) The XRD patterns show that the sample is constituted by atacamite (basic copper chloride), gypsum and weddellite (Fig. 6 b)). Atacamite has been detected previously in copper and copper alloys exposed outdoors due to environmental contamination. This environmental contamination is also responsible of the presence of gypsum and quartz. Both may also come from the restoration process that was carried out around the gateway. The weddellite, also present, may be formed by reaction between environmental gypsum or calcite, with oxalate ions from dissolved acid. In urban areas oxalic acid is abundant in rain and mists<sup>[16]</sup> or it may be secreted by micro organisms, such as fungi and liquens<sup>[17]</sup>.

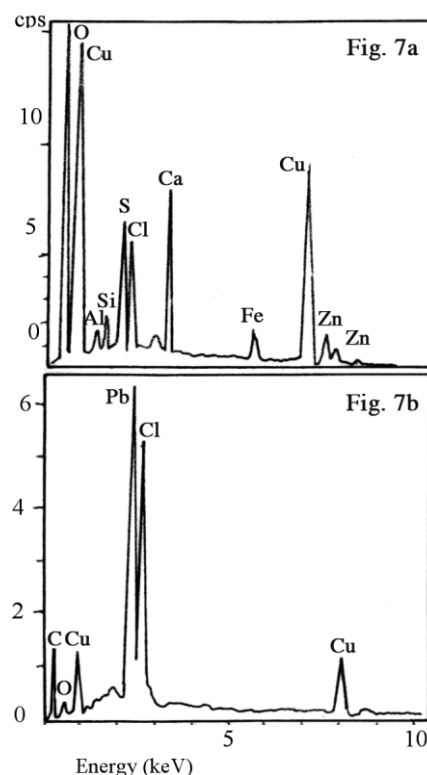
**Figure 7.** Elemental analysis of corrosion products a) from samples 1 and 3 (general); b) and sample 4 (punctual).

The sample 4 was taken from corrosion products that practically cover the two leaves of this gateway. The main component is the atacamite according with the results obtained by chemical analysis and XRD (figure not shown). Punctual analysis shows that some particles are constituted only by lead and chlorine (Fig.7 b)) confirming that the lead has been also attacked by chloride ions. This phase has not been confirmed by x-ray diffraction due to the scarce amount of the sample.

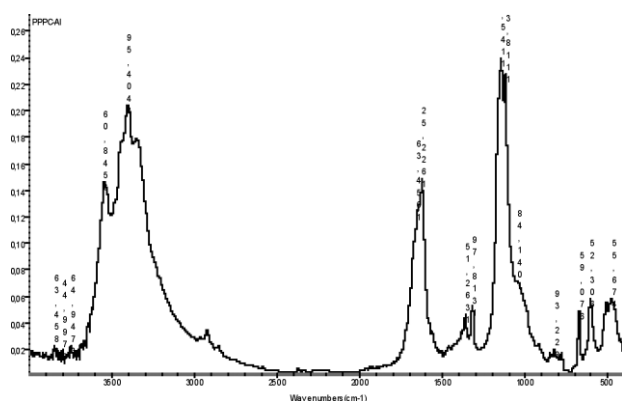
The infrared spectra of different corrosion materials from these leaves show characteristic bands of atacamite, gypsum and quartz. It also appears a band at  $1622\text{ cm}^{-1}$  assigned to oxalate (Fig. 8).

**Figure 8.** IR spectrum of corrosion (oxalate – band at  $1622\text{ cm}^{-1}$ ; atacamite – bands at  $3548\text{ cm}^{-1}$ ,  $3404\text{ cm}^{-1}$ ,  $822\text{ cm}^{-1}$ ) and environmental contamination products (gypsum – bands at  $1145\text{ cm}^{-1}$ ,  $1118\text{ cm}^{-1}$ ,  $670\text{ cm}^{-1}$ ,  $603\text{ cm}^{-1}$ –, quartz – band at  $1041\text{ cm}^{-1}$ –).
