# Autopsy on an RF-Processed X-band Travelling Wave Structure

F. Le Pimpec, S. Harvey, R.E. Kirby, F. Marcelja  
 SLAC, 2575 Sand Hill Road, Menlo Park CA 94025 , USA

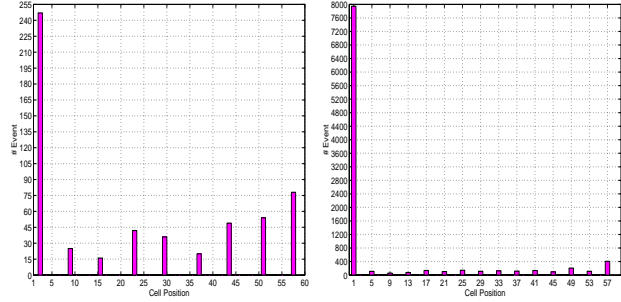
Figure 2: Example of damage localization in T53Vg3R (left) - T53Vg3RA (right) during operation

The breakdown pattern localization Fig.2 reveals that most of the breakdown are occurring in the input coupler (IC) of the TW. In Fig.3 we can see that the input coupler is divided into two parts the waveguide section, left side of the picture and the cell side in the center. The feature separating the waveguide side and the cell side is denominated "horns". The gap between the top and bottom horn is  $\sim 9$ mm.

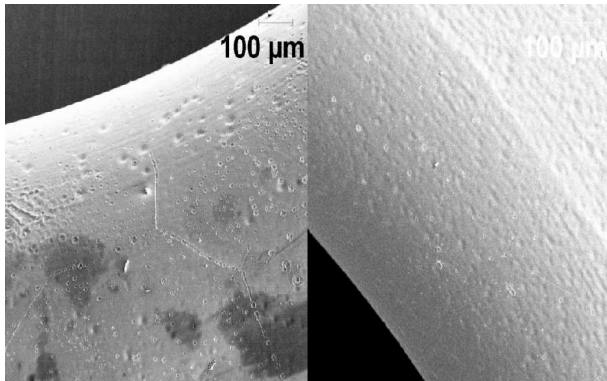
SEM (secondary electron microscopy) Fig. 7 shows the damage on the upstream side and the downstream side of the iris, respectif to the displacement of the NLCTA electron beam. On both sides etch pits can be seen as well as craters. However, the density of craters is much higher in the upstream side. Many craters are also located in the grain boundary. A particle search in and out of the craters shows MnS located in and out of them. Most of this inclusions are located in the grain boundary. The analysis of the contents of the craters shows mainly pure Cu. The black spots on the upstream side is carbon. An Auger analysis of the surface, not including those spots, shows heavy contamination by carbon of this iris [3]. Carbon contamination due to electron bombardement is a well known problem, [8]. There is no such contamination in iris 28 further down the structure [3].

Figure 7: Activity on the 1<sup>st</sup> iris, Upstream side left picture and downstream side right picture

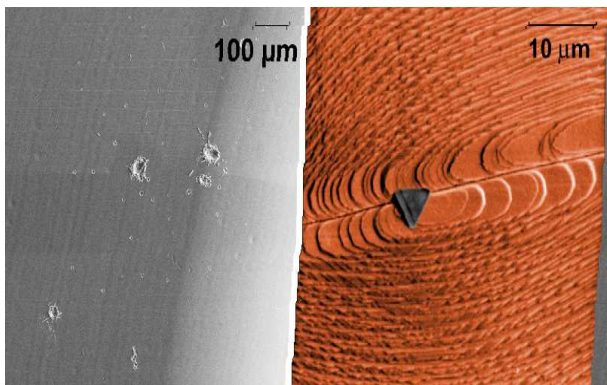
As we move toward the output coupler (OC), the activity on the irises decreases, endoscope (boroscope) monitoring. Fig.8 shows the sparse activity on the 28th iris of the structure. As we looked for particles/inclusions on the surface and at the grain boundary, we did not find MnS. However, some other sulfur compound were found [3], as the atypical one shown in Fig.8.

The cells used to make the structure are bonded and then brazed in a stainless steel (SS)  $\text{H}_2$  furnace at  $\sim 1020\text{ }^\circ\text{C}$ . The Sulfur (S) composition is 0.03 weight % in stainless steel. Other material like Mn, Cr, Ni are also used in the making of SS. The solubility of sulfur in copper is

Figure 8: Activity on the 28<sup>th</sup> iris, Upstream side. CrS inclusion at a twin boundary, right picture

very high at this temperature and significant at a few hundred °C. Hence, a significant amount of S can get into the copper. After its fabrication, the structure is vacuum baked in a SS pot at 650°C for few days, in order to desorb the H<sub>2</sub>. Metals might be present in the atmosphere of the H<sub>2</sub> furnaces and bakeout pot at this given temperature, with vapor pressures of 10<sup>-5</sup> Torr for Mn, 10<sup>-11</sup> Torr for Cr, 10<sup>-1</sup> Torr for Ca and below 10<sup>-11</sup> Torr for Ni [7]. At 300°C and above the S concentrates at the grain boundaries of the Cu. The S also start migrating to the surface at low temperature 75°C [9]. The Model for sulfur compound formation is that the sulfur getters the metal vapor out of the furnace atmosphere to form crystals/inclusions at/near the grain boundaries. A particle search on the IC reveals that ~80% of the particles are Mn-S. On the very next iris the proportion falls to ~50%. The search in the 28<sup>th</sup> cell shows no Mn-S but S-compounds are present at ~50%. Finally the search on the last cell in front of the OC shows Mn-S and other S-compounds. Finally in all the cases, other particles are compounds based on C, Al and Si not excluding the presence of Mn or S or other elements. This model might explain the sulfur compound formation, but the understanding of the distribution along the structure of those elements is under investigation.

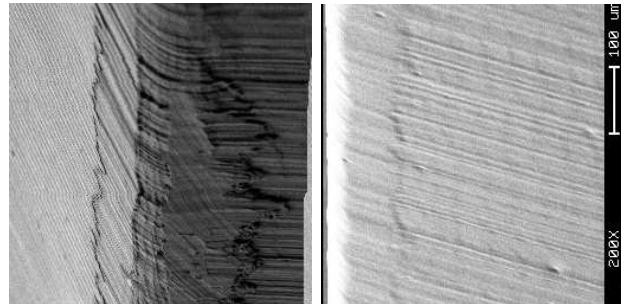
Figure 9: Surface of the edge, cell side, of a horn after machining (left) and after 60'' etch and thermal processing

Following our autopsy many studies and simulation led to the decision of rounding the edge to 3mm instead of 76 μm radius in order to avoid the thermal fatigue roughening mechanism. It is believed that the new design of the IC and OC implementing this rounding will cure our breakdown problem in those couplers. Also, machining a 3mm edge radius should leave the surface extremely smooth. We have shown on an identical input coupler of T53Vg3R, Fig.9, that the 4 edges of the cavity side of the horns present a roughness after machining. Following the etching and thermal processing, that sees the structure, do not removed this roughness. In a contrary, the edge on the waveguide side of the horns are well finished.
