Nice, Côte d'Azur, France, 27-29 September 2006

FAILURE ANALYSIS AND FIELD FAILURES: A REAL SHORTCUT TO RELIABILITY IMPROVEMENTS

G. Mura^a and G. Cassanelli^b

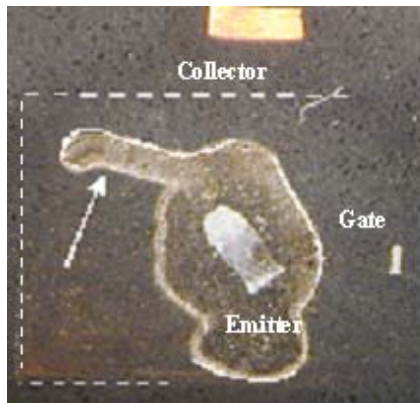
Fig. 1 Optical micrograph of the top surface after mechanical grinding. The dashed line defines the edges of the underlying chip. The view identifies the three sectioned metal connections (Emitter, Collector and Gate). The curvilinear lines delineate the carbonised plastic area, whose arrowed part belongs to the neighbourhoods of the original wire path.

The first set of hypotheses pointed towards sudden stresses, like EOS or ESD due to some transient event at the switching-on. An accurate Failure Analysis was then started to find the evidence of the real mechanism. The first attempt to remove the plastic package by mixed grinding and chemical etching revealed (fig.1) an extended thermal damage of the plastic itself all around the thick Emitter wire. Carbonisation of the plastic mould prevented from uniform removal of the package, but a first strong indication for a catastrophic overheating was obtained.

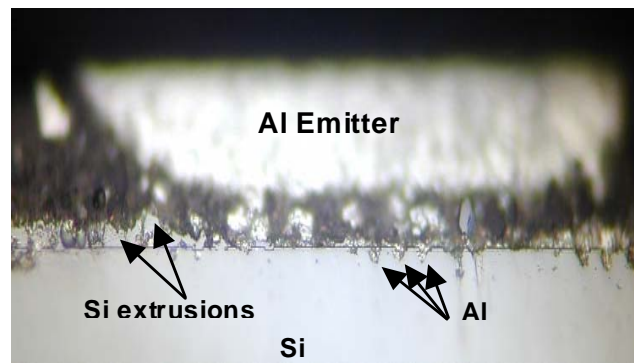
Fig. 3a General view of the sectioned area under the Emitter wire. Silicon extrusion into the Al metallization, and also Al intrusion into the Silicon crystal are displayed.

of Al-Si interdiffusion were present and manifest (fig.3 a,b,c):

- 1) the reverse Al pyramids, hanging from those parts of the top Silicon surface, laterally limited by the SiO₂ encapsulated polysilicon gates, where direct Al-Si contact makes the Emitter connection and
- 2) the Silicon precipitates inside the original upper Al thin film.

The key point is that the interdiffusion mechanism is not compatible with a sudden, transient phenomenon that would have resulted in fusion and chaotic re-crystallisation of the vertical structure. It should be argued that during the limited life of the device, an overcurrent was allowed to flow, undetected, able to expose the die to excessive temperature.

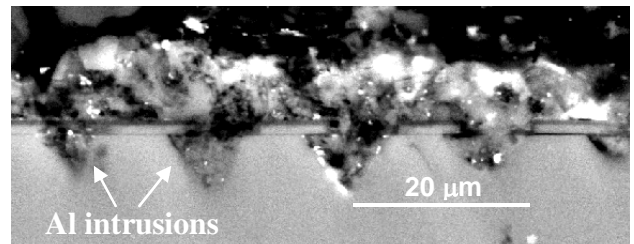
Fig. 3b SEM Detail of the Al intrusions. The polyhedric shape of the Al-filled cavities is a fingerprint of solid-state interdiffusion of Si into the overlying metallic thin film.

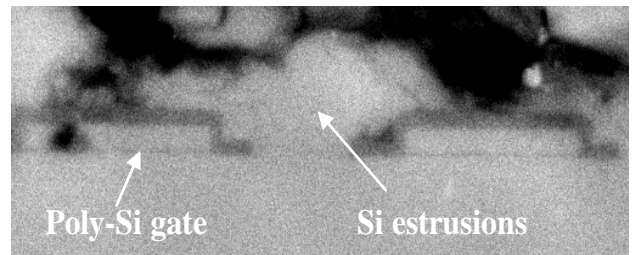
Fig. 3c SEM Details of the Si extrusions. The polysilicon gates (encapsulated in SiO₂) look intact.

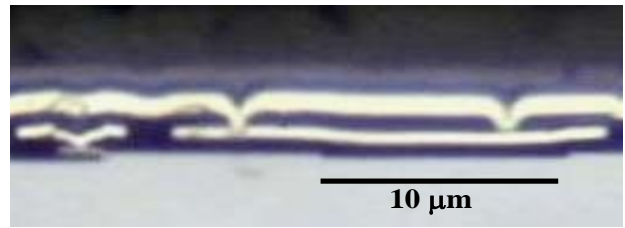
Fig. 5 Optical view of a cross sectioned device

A preliminary characterization of a device of the same lot revealed the structure of the multiple metal layer, where a very large upper metal layer (fig.5) run over the most part of the peripheral circuitry.

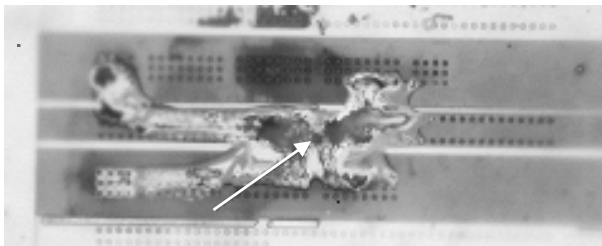
Fig. 8 (a) Optical view of the damaged area after complete HF etching.

Upon HF cleaning of the surface (fig.8), the evidence arose for a central, small spot (arrowed) into Silicon from which a “Si-fountain” sprung from the substrate into the metal layers, branching into four different directions. This ultimately allows, with the aid of fig.7 that compares the same region at different etching levels, to individuate the connection of the different structures of the damage: Silicon (amorphous) was present at the top metal level, which caused its removal under the etch of the passivation, while Aluminium penetrated the Silicon bulk, and was removed during the HF etch.

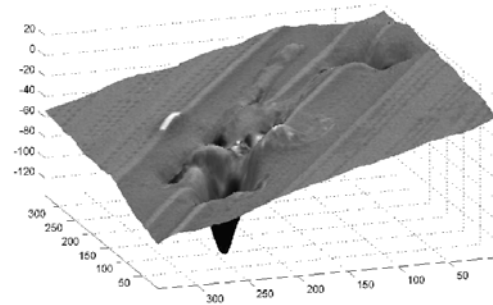
Fig 8(b) SEM 3D reconstruction [2] of the same detail, showing the central source of the Si material.

A 3D reconstruction [2] of the SEM images of the exposed Silicon surface (fig.8b) clearly shows the deep penetration of the damage (the interdiffusion “fountain”),

It should be noticed as, once again, the evidence for Al-Si interdiffusion does NOT state that it is the root failure mechanism: the small spot clearly addresses towards ESD. Anyway, it is a secondary consequence, whose occurrence witnesses that the device operated a relevant time after the first failure firing before reaching the short-circuit state that flagged the failure.

The relevant point is the casual occurrence of the discharge at some internal point of the circuits, but always under the wide upper metal layer. This suggested the possibility that not an I/O instability could cause the damage, but some capacitive coupling of the large parasitic capacitor, made of the upper metal layer and the substrate, and some huge electromagnetic disturbance near the device. The presence of a power switch very close to the board mounting the failed devices moved to introduce some specific protection (electrical shield and increased spacing between the critical elements), and the result was the complete disappearance of the problem.
