Pulse thermal imaging of FUHAO bronze artifact

Li Wang, Ning Tao, Wei Liu, Xiaoli Li, Yi He, Xue Yang, Jiangang Sun, Cunlin Zhang

Keywords: Pulsed thermal imaging, Bronze artifact, Cultural heritage diagnostics, Non-destructive evaluation, Thermal tomography

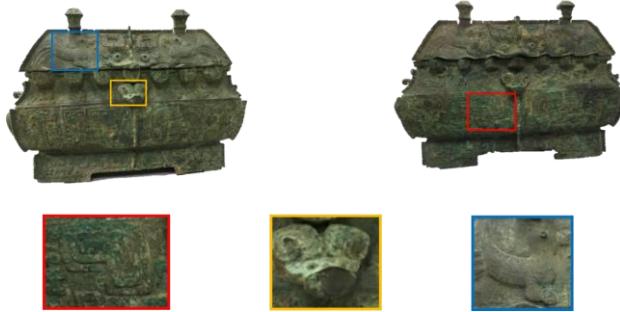
Figures 1 and 2 reveal a heterogeneous surface covered with various forms of corrosion (patina). The complexity of the surface is increased by the uneven thickness of the corrosion layer and the presence of obscured decorative details. When excavated, the artifact was found adjacent to a tomb wall, resulting in asymmetric corrosion: the side facing the wall (termed the “back”) exhibits more severe corrosion than the opposite (“front”) side.

Notably, the left elephant head is a modern replica, as the original was lost. Unlike the authentic right elephant head, which shows decorative patterns behind the ear, the replica lacks such detailing—a difference discernible by visual inspection. However, most restoration traces, such as repair crevices and patches, are not visually obvious.

Fig. 1 Artifact Surfaces: Front, Back, and Detailed Views.

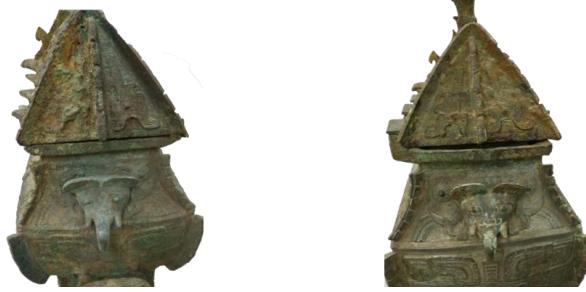
Fig. 2 The appearance characteristics of sides of the bronze artifact.

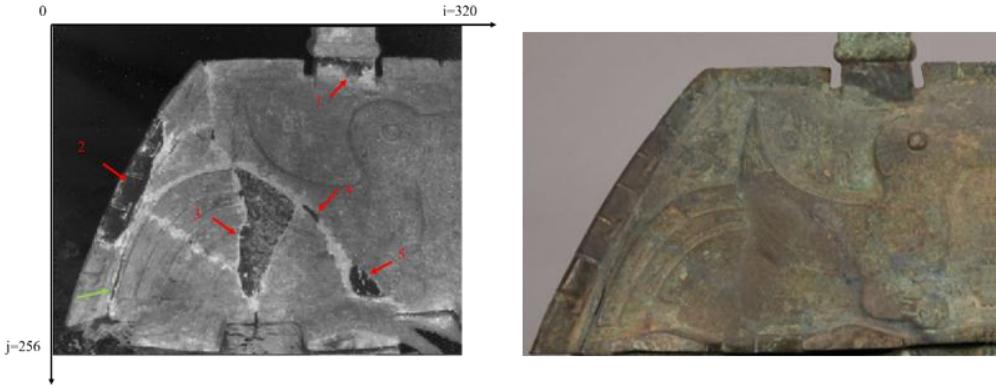
The infrared non-destructive testing image shown in Figure 6 reveals several thermal anomaly areas located on the left side of backside of the bronze ware cover. These thermal anomalies may be indicative of patching or repair materials added to the bronze after excavation. In Figure 6, we can observe 5 obvious thermal anomaly areas, numbered 1-5, which have been marked with red arrows in the figure. By comparing the visible light image on the right side of Figure 6, it is indicated that the green arrow marks a surface crack. The TT method was used to further analyze these anomalous structures and their thermal parameters. The thermal image results have $i=320$ pixels in the horizontal direction and $j=256$ pixels in the vertical direction. Place the graph in a coordinate system with horizontal coordinate i and vertical coordinate $j, (i, j)$, so that each point in the result can be represented by coordinates.

Fig. 7 Shows five obvious thermal anomaly areas and one obvious surface crack. The image on the right displays the visual appearance of this particular section of the artifact

We employed a similar method to investigate other regions of thermal anomalies, including the irregular shape marked in red in Figure 6, which is suspected to be caused by other repair materials, and the thermal anomaly area caused by surface cracks of the bronze ware in Figure 6. To investigate

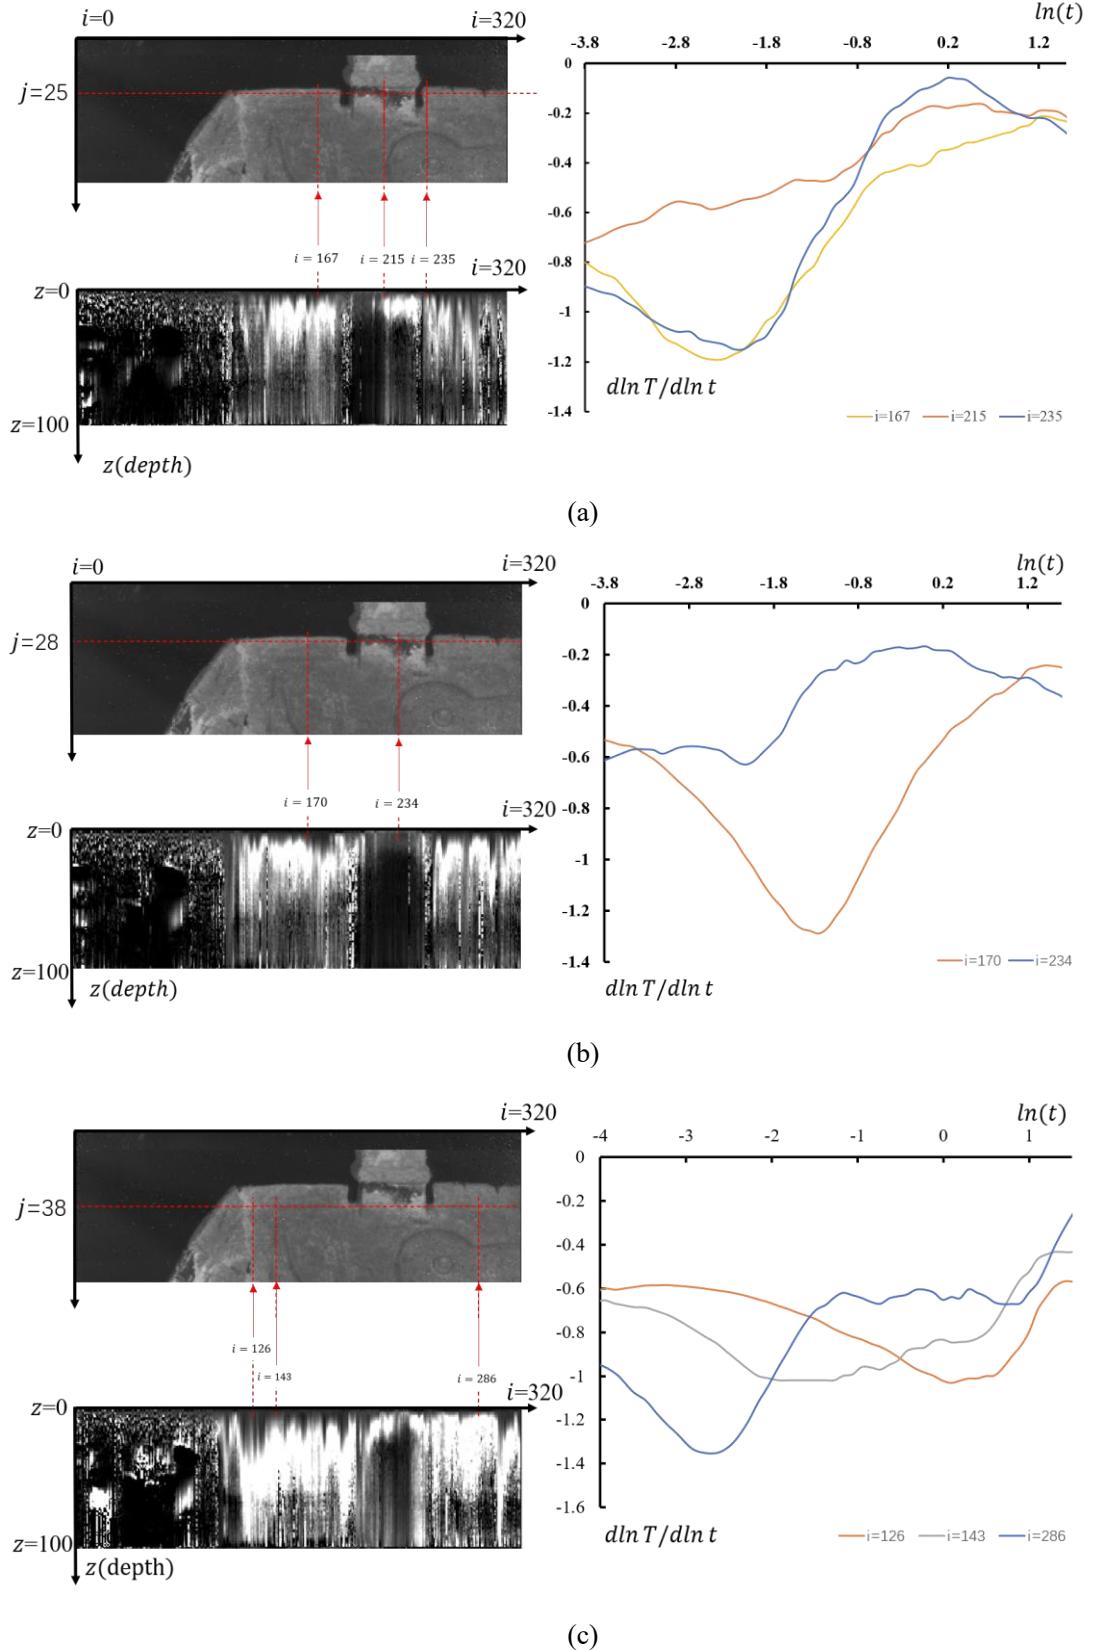
For No.1 thermal anomaly we selected three sets of data ($j = 25, 28, 38$) and obtained the corresponding cross-sectional effusivity image using the TT method. In the effusivity image, the value of z represents the relative depth of the point, and $z = 0$ means it is located on the surface of the bronze ware. $z = 100$ is the maximum relative depth present in this result. And there is a positive correlation between the grayscale value and the e -value in the results. the e -value of the bronze metal part in bronze vessels is greater than the e -value of the rust layer. In the results, along the z -axis, one can observe the grayscale variation of the e , which signifies the distribution of components at different relative depths. For bronze artifacts, their surfaces are covered with a layer of corrosion, whereas artificial repair materials do not possess this corrosion layer. Therefore, it is possible to differentiate between areas belonging to artificial repair materials and those inherent to the bronze artifact itself by examining the grayscale variations of e . For points (167,25), (235,25), and (170,28), situated at different locations on the bronze artifact, their curves all conform to the theoretical curve of a two-layer structure. Moreover, the negative peaks in the curves for points (167,25) and (235,25) occur at a similar time, indicating a comparable thickness of corrosion layer at these two points, which is consistent with their effusivity image. Conversely, for point (170,28), the negative peak in its curve appears later than the previous two, aligning with the results from the effusivity image. For points (215,25) and (234,28), their curves conform to the theoretical curve of a single-layer structure, indicating that both points are located on a single-layer structure. This conclusion is further supported by the effusivity image. The difference lies in the effusivity image, where near point (215,25), one can still observe the corrosion layer alongside the metallic layer. In contrast, this observation is not present near point (234,28). The cause for this disparity is attributed to the irregular shape of the repair material. This viewpoint can be further validated through the thermal image. The red dashed line marked by $j=38$ passes below the thermal anomaly region in Fig.8c. As a result, a typical single-layer structure e distribution is not observable in the corresponding effusivity image. Instead, along the i -direction, a segment of continuous two-layer structure distribution is evident. In the effusivity image, point (126,38) exhibits the thickest corrosion layer, hence its curve displays a negative peak positioned further to the right along the time axis. Conversely, point (286,38) has the thinnest corrosion layer, resulting in its curve's negative peak being located furthest to the left. Point (143,38) features a corrosion layer thickness between the aforementioned two points, leading to its curve's negative peak falling between the peaks of the other two.

Fig. 8(a)(b)(c) depict three datasets ($j = 25, 28, 38$) of the No.1 thermal anomaly region.

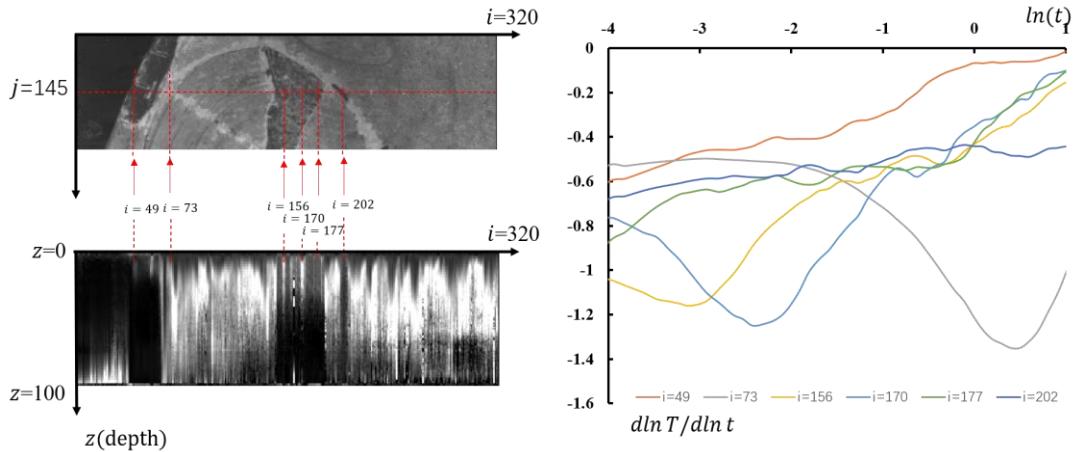
the characteristics of crack defects and repair materials, we analyzed the cross-sectional effusivity image of three red dotted lines, namely $j=145, 161, 201$, and the first-order logarithmic curve of some points on these dotted lines. The thermal and cross-sectional effusivity images of the bronze surface located at the red dotted line $j=145$ are presented in Figure 8. The dotted line $j=145$ intersects with three thermal anomaly areas, and the grayscale values are relatively low in the thermal image results. In Figure 8, we plotted the curve of the first-order logarithmic differentiation of some points on the dotted line $j=145$. The cross-sectional results of points $(49, 145)$, points $(177, 145)$, and points $(202, 145)$ on the dotted line indicate a single-layer structure model. This observation suggests that the thermal properties of the repair materials at these points are isotropic.

The first-order logarithmic differentiation curves of the three points at the red dotted line $j=145$ in Figure 9 support the aforementioned observations. Notably, points $(156, 145)$, $(170, 145)$, and $(177, 145)$ all belong to different surface positions of the same patch material. The cross-sectional results at points $(156, 145)$ and $(170, 145)$ reveal that the distribution of effusivity values at these positions is different from that at point $(177, 145)$, as the effusivity gray levels at $(156, 145)$ and $(170, 145)$ are higher and close to that of the bronze metal layer. Therefore, we can conclude that the effusivity distribution of this triangular patch material appears uneven, unlike other repair materials used on the bronze. The distribution of effusivity in other parts of the repair material is generally uniform. Hence, it is likely that different repair materials and processes were employed in this part compared to other repair parts.

The point $(73, 145)$ is of particular interest, as it is located at the intersection of the arc crack and the straight crack. By analyzing the cross-sectional image at this point, it was observed that the value of e near the surface is similar to that of the rust layer, whereas the distribution of e at a larger depth is similar to that of the metal layer. This suggests that the crack belongs to a two-layer heat conduction structure.

Fig. 9 Displays the cross-sectional effusivity image and thermal image of the bronze surface at the red dotted line $j=145$, and presents the first-order logarithmic differentiation curve of selected points on the same dotted line $j=145$.

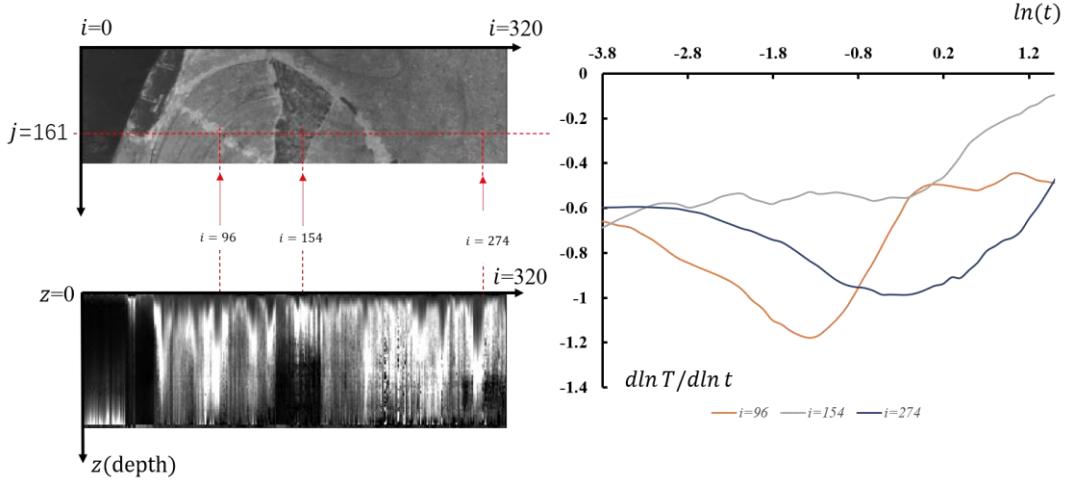
Figure 10, the cross-sectional image of point $(96, 161)$ shows that the crack at this site covers the rust layer, which is similar to the crack structure at point $(73, 145)$. The cross-sectional images of points $(96, 161)$ and $(274, 161)$ also show cracks that cover the rust layer. From the TT results, it is evident that the thickness of the corrosion layer at point $(96, 161)$ is smaller than that at point $(274, 161)$. Furthermore, in the curve graph, the negative peak at point $(96, 161)$ occurs earlier than at point $(274, 161)$. Although

points (154, 161) and point (156, 145) belong to the same repair part in the thermal image result, the distribution of e at point (154, 161) shows a single-layer heat conduction structure, indicating that the repair materials may also have certain areas with a two-layer structure, which is likely due to the repair techniques employed.

Fig. 10 The cross-sectional effusivity image and the thermal image of the bronze surface located at the red dotted line $j=161$, and the curve of the first-order logarithmic differentiation of some points on the dotted line $j=161$.

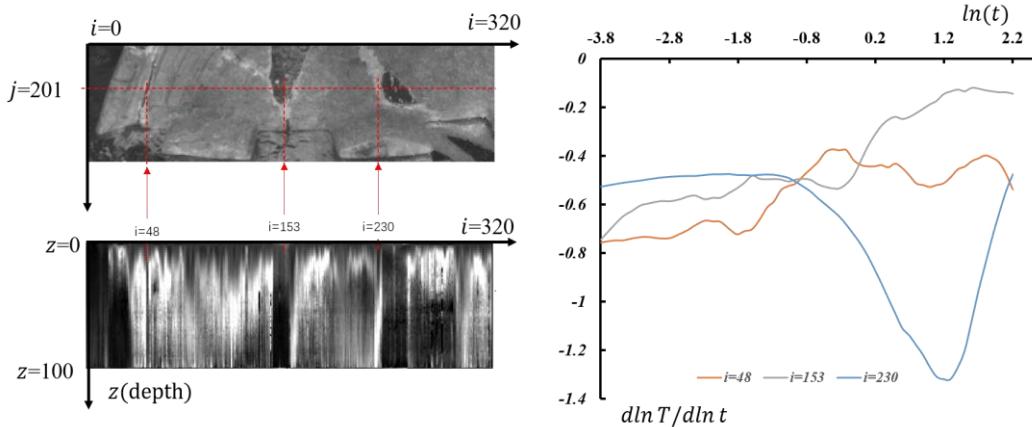
Fig. 11 the cross-sectional effusivity image and the thermal image of the bronze surface located at the red dotted line $j=201$, and the curve of the first-order logarithmic differentiation of some points on the dotted line $j=201$.

Figures 11, the thermal image result shows that the black thin strip at point (48, 201) does not exhibit significant peak characteristics in the corresponding curve. Upon closer examination, it is confirmed that this area corresponds to small cracks. The curve feature at point (153, 201) aligns with the characteristics of a single-layer structure, indicating it as a repair material region. At point (230, 201), significant peak features are observed in the curve, and the TT result also indicates a two-layer structure. Considering its proximity to the repair material region, it can be inferred that a filler was added at this location during the artifact restoration process, forming a two-layer structure over the original bronze substrate.

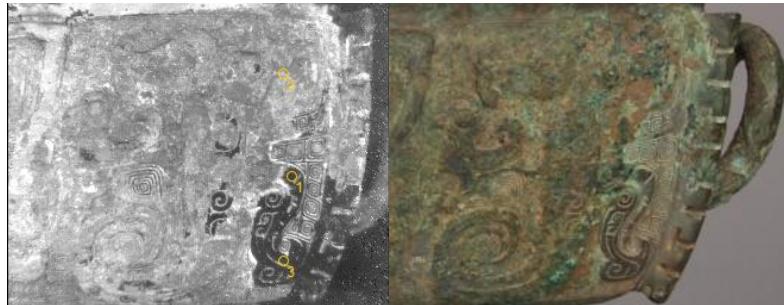
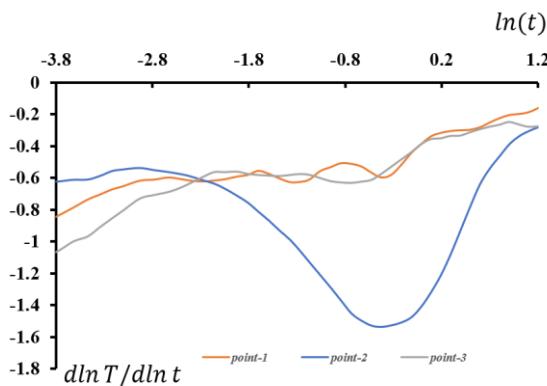
effectively preventing further corrosion of the internal bronze. Figure 11 showcases a portion of the bronze artifact where the oxide layer exhibits discontinuities, identifiable by lower grayscale values in the corresponding image. Typically, the corrosion of bronze artifacts occurs due to chemical reactions with water and carbon dioxide present in the surrounding air. These reactions lead to the formation of copper-containing salts, which are responsible for the majority of the observed corrosion on the bronze surface. However, in some fortuitous areas, a dense and compact layer of copper oxide forms, effectively acting as a protective barrier. This copper oxide layer inhibits further oxidation of the underlying bronze material by preventing the ingress of atmospheric oxygen.

Points 1 and 3 are situated on the surface exhibiting a black copper oxide layer, while Point 2 is located in a different region. Analysis of the corresponding curve graph reveals notable peak characteristics at Point 2, with the peak occurring towards the later stage, indicating a significant thickness of the corrosion layer compared to the bronze substrate. In contrast, no prominent peak features are observed at Points 1 and 3, suggesting that the corrosion layer in these areas can be considered negligible relative to the bronze substrate. Thus, the surface with the presence of a copper oxide layer can be regarded as a distinct single-layer structure.

Fig. 12 The thermal image result with 3 points locations and displays the visual appearance of this particular section of the artifact. (b) shows the curve of the first-order logarithmic differentiation of those points.

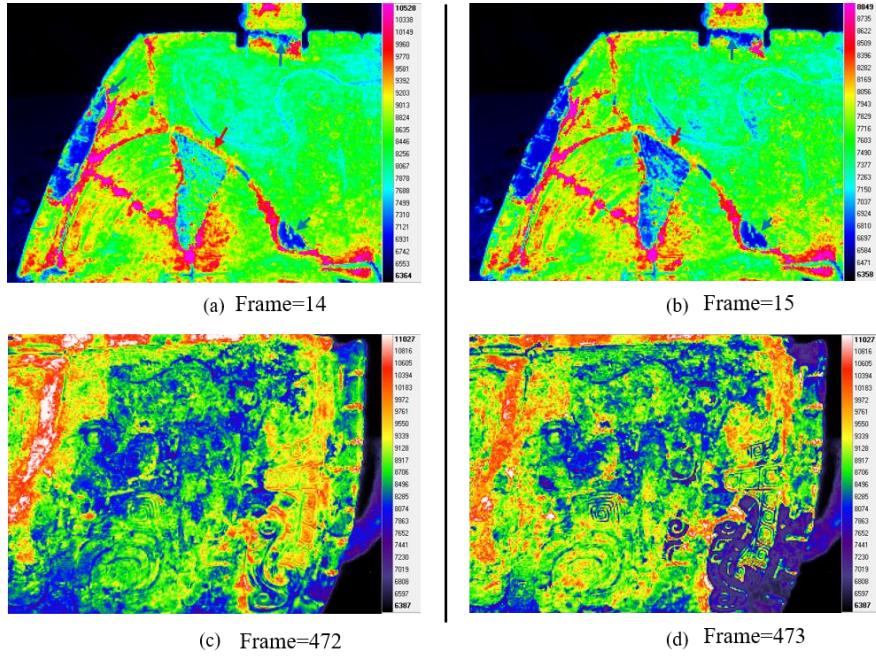
Fig. 13 Indicated the pseudo-colored raw results of the locations shown in Figures 6 and 13. Figures (a) and (c) are the pseudo-colored results of both images' flash frames, while Figures (b) and (d) are the pseudo-colored results of both images' frames immediately following the flash frames.

Through careful examination of Figures 13(a) and 13(c), notable observations can be made. Figure 13(a) reveals that during the occurrence of the flash, the temperature rise in areas containing repair materials is relatively lower compared to the surrounding regions of the bronze artifact. Conversely, in Figure 13(c), regions with a thin layer of copper oxide exhibit a temperature distribution that is relatively consistent with the adjacent areas.

After one frame of cooling, Figure 13(b) demonstrates that the repair area with a higher temperature (indicated by the red arrow) tends to approach the temperature of the surrounding repair area (indicated by the blue arrow). However, despite this convergence, a significant temperature difference between the repair area and the main body of the bronze artifact persists.

In Figure 13(d), the contour of the deep blue region (close to purple) shows a resemblance to the black contour observed in the grayscale image of Figure 12(a), while it is hardly visible in Figure 13(c). By comparing Figures 13(a)/(b) and 13(c)/(d), it becomes evident that the cooling rates differ noticeably between the repair materials and the copper oxide layer. Another obvious reason is that the obvious temperature difference around the repair material indicates that there is a crack structure around it (as indicated by the red arrow in Figure 13(a), the red temperature region around the repair material is irregular), while the oxide area around Figure 11(a) also has a red temperature area, but shows a clear pattern structure, corresponding to the surface pattern on the visible light picture. This indicates that no rupture has occurred in the surrounding area. It is feasible to employ similar methodologies to effectively distinguish between these components.

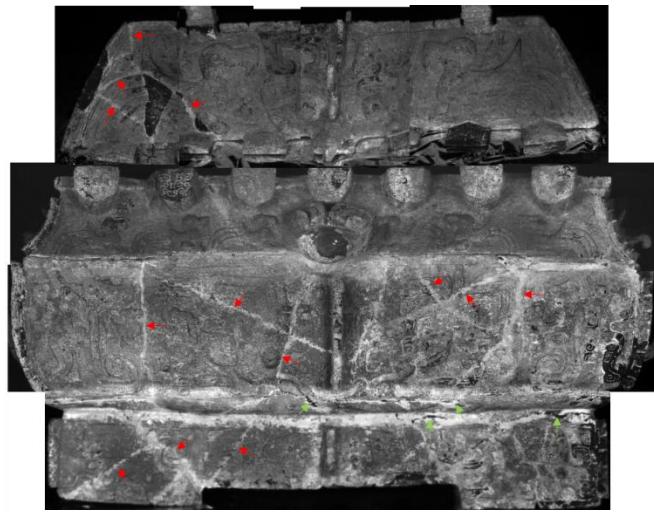
Fig. 14 Distribution of cracks on the backside surface of the bronze artifact.

Figure 14 and 15 displays the distribution of cracks observed on the backside and frontage of the bronze artifact. The image provides a visual representation of the spatial arrangement and characteristics of the cracks. The cracks on the bronze artifact typically exhibit regular straight or curved shapes and appear in a grayish-white color. These characteristics are indicated by red arrows in Figure 13 and Figure 14. For the backside surface, the cracks are primarily concentrated on the left side of the lid and surround the patch area. In the body of the artifact, several distinct grayish-white straight and curved lines can be observed, indicating that this side of the bronze artifact is composed of several large fragments that have been welded, repaired, and joined together. As for the frontage surface, the distribution of cracks is less prominent than on the backside surface. These cracks are mainly located on the right side of the lid, forming an irregular zigzag line that traverses the entire lid from top to bottom. There is also a less noticeable crack distribution in a northeast direction on the body of the artifact. However, this crack does not extend vertically across the entire body. The cracks in the foot section are not as apparent, but based on the distribution of grayish-

white areas, it can still be confirmed that there are two cracks present (indicated by red arrows in Figure 14 at the foot of the artifact). The green arrows in Figure 13 and Figure 14 indicate some gaps that have formed during the joining process of the bronze artifact. It is worth noting that there are many such gaps in the artifact, and the green arrows represent only a portion of them.

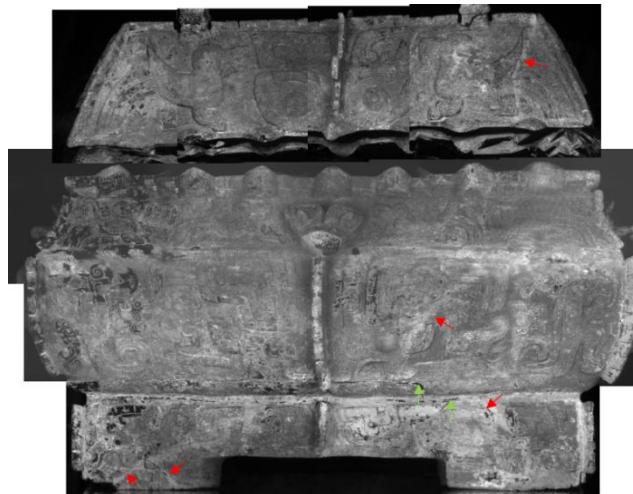
Fig. 15 Distribution of cracks on the frontage surface of the bronze artifact.
