Monitoring of slopes, rock faces and masonry walls in a 19th century public park: the example of the Buttes Chaumont Park (Paris, France).

Marc Peruzzetto, Isabelle Halfon, Clara Levy, Florian Masson, Aurore Ramage, Gildas Noury, Ribes David
BRGM, Orléans, France, m.peruzzetto@brgm.fr

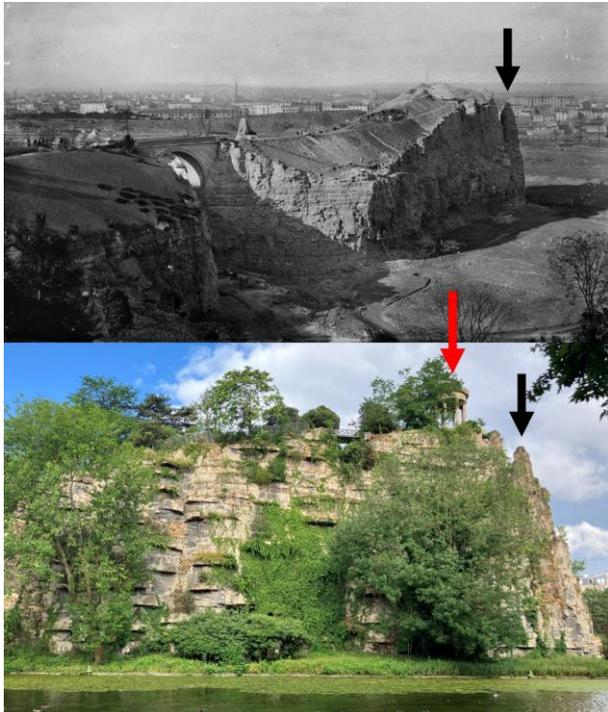
on the western and southern sides of the island. The northern and southern sides are more complex: to create a vertical and higher rockface (up to 20 m), the gypsum is recut and overtopped by retaining walls supporting the marls and backfills. The whole face is then recovered by a millstone cladding (Figure 1). Finally, a fully artificial cavern and a waterfall are created near the southern shore of the lake in a recess of the quarry face.

Figure 1. Picture of the eastern side of the island during construction works around 1865 (top) and in 2025 (bottom). The black arrows locate an artificial peak on both images. The red arrow locates the Temple of Sybil.

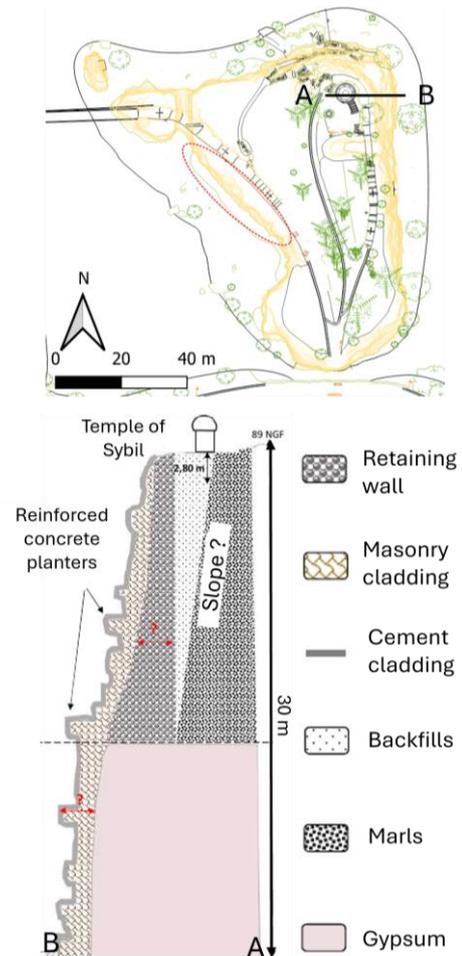
Figure 2. Top: Topographic map of the island. The red ellipse locates topographic targets from Figure 5. Bottom: Cross-section of the island eastern wall with main geological / geotechnical units (section A-B on map). The Temple of Sybil is shown in Figure 1.

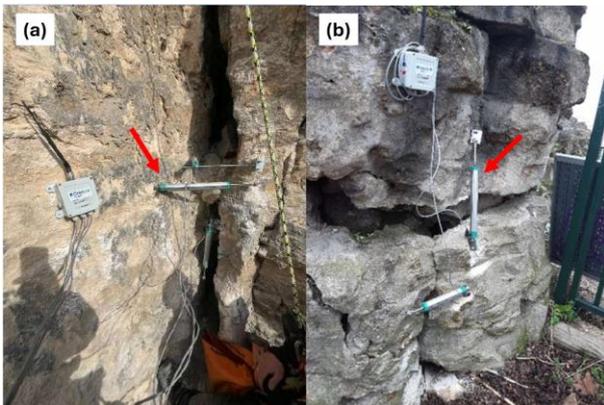
Figure 3. Example of electronic extensometers installed on a 30 cm vertical crack in the gypsum on the western side of the island (*fissure 1*, a), and on a 15 cm horizontal crack in masonry walls below the Temple of Sybil (*fissure 2*, b). The red arrow points at the extensometers analyzed in this work.

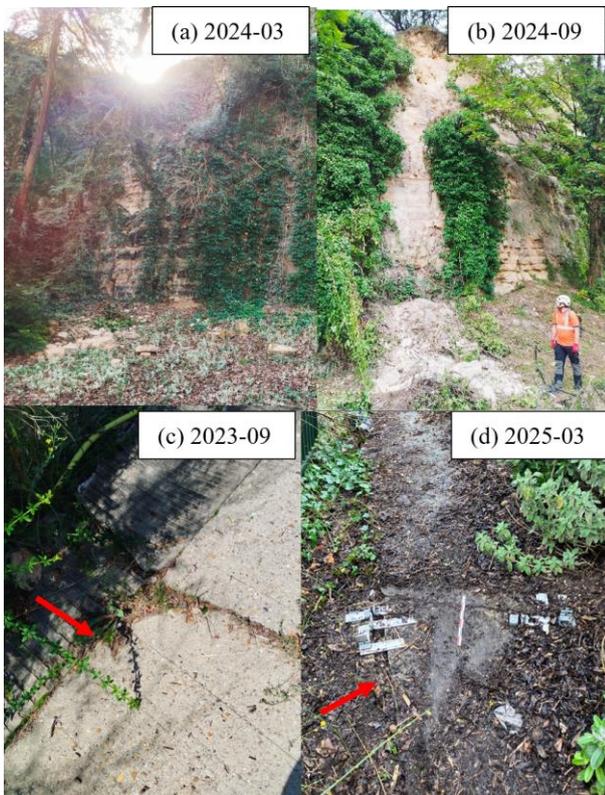
Figure 4. Observations during field visits. Top: examples of rockfalls. Bottom: Pathway photographed in September 2023 and March 2025, showing crack evolution (between pathway and gutter, red arrows) and manual gauges installed in 2024 (bottom right)

Quarterly visits include an overview of the whole park but focus on the island sector. 10 visits were carried out between March 2023 and June 2025. Regular rockfalls from the gypsum rock faces have been identified, most of them involving blocks of about 1 liter. However, at least 4 more important rockfalls (between 0.5 and 1m³) also occurred, initiated from the top of the gypsum rock faces where roots development and associated meteoric water circulations favor the development of cracks (Figure 4a and b).

The movements of a shallow landslide on the island were also monitored (Figure 4c and d). Located in marls and probably associated with the ageing of historical geotechnical structures, its initiation date is not known. However, the BRGM witnessed its reactivation starting between September and December 2023, as evidenced by growing gaps between an inclined pathway and adjacent rainwater drainage channels.

- recommended to establish a 10 m security perimeter above the gypsum rock face, following the rockfalls that occurred between December 2023 and March 2024;
- identified cracks to be instrumented with manual gauges or electronic extensometers, at the beginning of the instrumentation and later on to complement it following observed evolutions;
- noted some structural disorders in other ageing structures (e.g. retaining walls) in the park that do not require immediate repairs but that are worth characterizing by future, more detailed, geotechnical diagnostics.

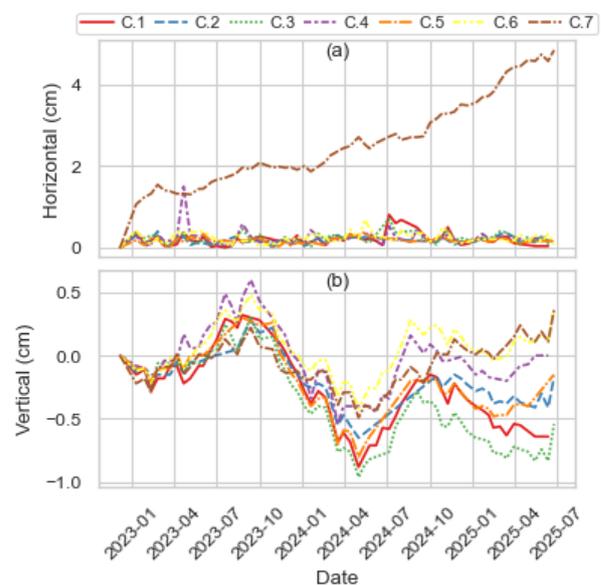
Figure 5. Horizontal (a) and vertical (b) displacements measured with tacheometric surveys since 2023 on 7 targets (C.1 to C.7) on the western side of the island (red ellipse in Figure 2).

The topographic surveys carried out since December 2022 aim at detecting (1) detachments of individual compartments already partly detached from the masonry walls and/or rock faces and (2) generalized movements at the scale of the rock faces/ masonry walls. The expected precision, as given by the surveyor, is of about 1 mm. In practice, displacements of up to 0.5 – 1cm were observed both horizontally and vertically, without being necessarily associated to clear trends. Only one target, located on purpose on a ~1 liter gypsum block partially detached from the rock face, showed a clear and homogenous horizontal movement away from the rock face (totalizing about 2.5 cm between January 2023 and June 2025, Figure 5a). This steady displacement accelerated in October 2024, from an average ~1 to 2 mm/month. There is, however, no sign of imminent rupture. Besides, no significant vertical displacement is measured.

was vertical displacements, with upward movement from April to October, and downwards movements from October to April (Figure 5b). The amplitude of these movements varies between the targets and the period. For instance, on the western side of the island, targets moved about 5 mm upwards in April – October 2023 and 7 mm in April – October 2024, and 1 cm downwards in October 2023 – April 2024 and only 2.5 mm in October 2024 – April 2025. In the same period, on the eastern side of the island, up to 7 mm of downward displacement was measured. Over the 60 targets and 2.5 years, a global trend of downward movement seems to emerge (on average 0.5 to 1 mm since January 2023).

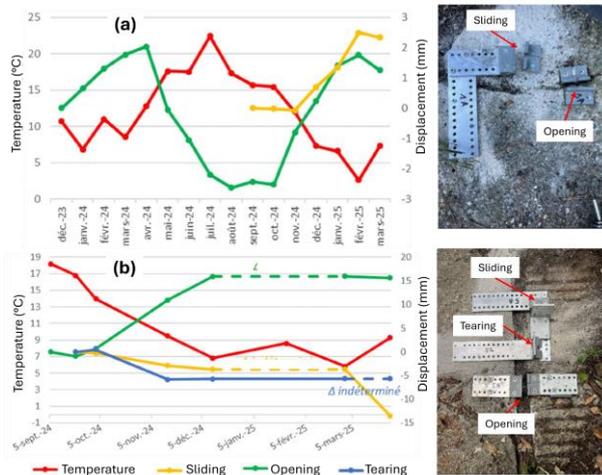
Figure 6. Manual gauges measurements on two cracks located on pathways on the island, along with ambient temperature measurements. Dashed lines on the bottom subfigure correspond to measurement gaps for which the displacements are not known. The bottom graph corresponds to the gauges in Figure 4d.

Manual measurements carried out on specific instrumented fissures provide more precise measurements of opening, sliding and tearing. Measurements are carried out on wedges fixed on both sides of the cracks with a digital fissure gauge, with an announced precision of 0.01 mm and a measurement range of 27 mm. Apart from a few seemingly aberrant measurements (i.e. significantly different of the mean of previous and following measurements), measurements are relatively stable which facilitates interpretation. The most significant displacements are measured on pathways, with opening/closing amplitudes of 3 to 4 mm (Figure 6a). Gauges installed on masonry walls display displacement of less than 1mm. These variations are associated to clear seasonal trends, with cracks opening during autumn/winter, and closing during spring/summer. The only place where clear, non-seasonal, displacement trends are observed is on the path going through the shallow landslide mentioned in section 4.1, with crack opening of more than 1.5 cm and exceeding the gauges measurement range (Figure 6b).

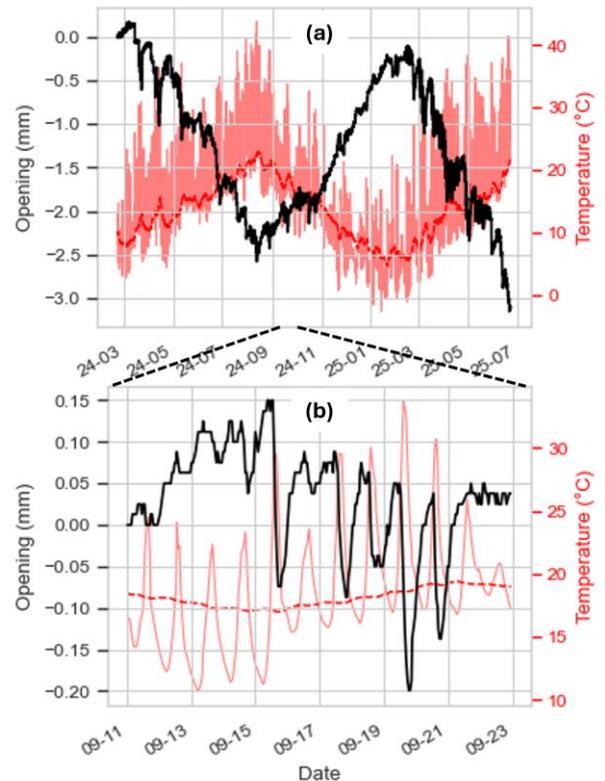
This is clearly visible in the short-term with day/night temperature variations for *fissure 1* (Figure 7b). Associated opening/closing cycles are all the more important as temperature differences are significant (Figure 8a). The correlation is less clear with temperature measured at depth (Figure 8b), suggesting these processes are related to surface mechanisms. The most important daily opening/closing amplitudes are mostly associated with sunny days (Figure 8c) with little rain (Figure 8c). Interestingly, these daily cycles are clearly visible when the cracks are closing in the medium term but are less visible when the crack is opening.

Figure 7. Automatic extensometer measurements at fissure 1 (Figure 3a). Black: opening time series. Light red curve: temperature of the extensometer digitizer. Dashed red curve: Temperature at 50cm depth. Top: Times series between March 2024 and June 2025 (date format is year-month). Bottom: time series between 9 and 23 September 2024 (date format is month-day).

The correlation between temperature and crack opening is also clear in the medium-term with cracks closing in spring/summer and opening during autumn/winter (Figure 7a). For *fissure 1*, a simple linear relation can be derived between the opening/closing of the crack, and the temperature at 50 cm depth within the rock face (Figure 9a). The crack closing/opening rate is $\sim 0.2 \text{ mm}/^\circ\text{C}$, but deviations around this trend lead to an irreversible behavior: the crack closed by about 0.5 mm between the summers of 2024 and 2025. As for daily cycles, significant precipitations seem to reduce the closing/opening velocity (Figure 9b), but no clear relation can be drawn.

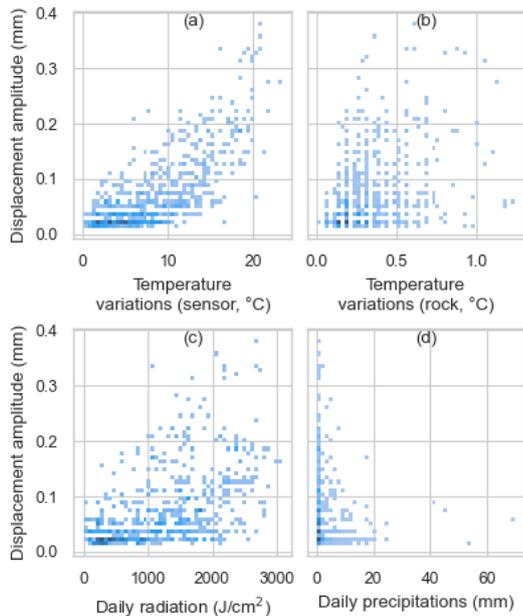
Figure 8. Normalized distribution of daily opening/closing amplitude at fissure 1 (Figure 3a) and daily temperature variations of the sensor (a), at 50 cm depth (b), daily radiation (c) and daily precipitations (d) at the Luxembourg park meteorological station (Météo-France, 2025).

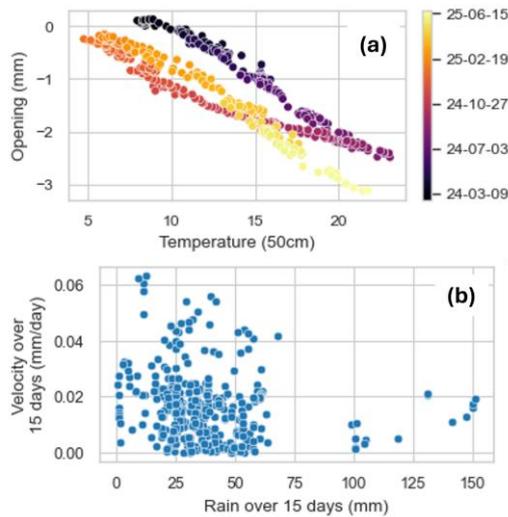
Figure 9. Analysis of displacements at fissure 1 between March 2024 and June 2025 (Figure 3a). (a) Mean daily opening (y-axis) vs mean daily temperature (y-axis) measured at 50 cm depth (date format is year-month-day in the colorbar). (b) Velocity computed over a 15 days time window (y-axis) vs precipitations over the previous 15 days at the Luxembourg park meteorological station (Météo-France, 2025).

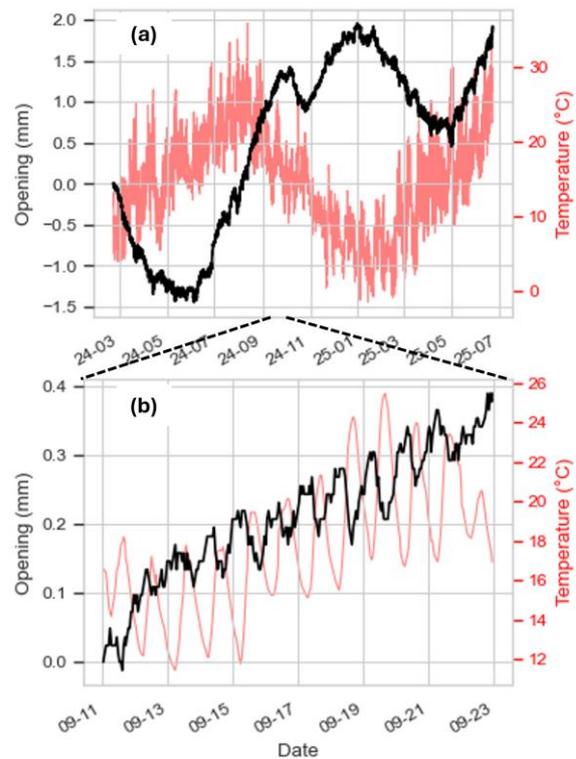
Daily opening/closing cycles are also visible at *fissure 2* and the autumn/winter period is also associated with crack opening (Figure 10). However, contrary to *fissure 1*, the opening phase started in June 2024 and May 2025 while

temperatures were still increasing. In turn, the fissure seems to follow a pluri-annual opening trend (about 2 mm between May 2024 and May 2025). Nonetheless, at least another full annual cycle is required to confirm this trend.

Figure 10. Automatic extensometer measurements at fissure 2 (Figure 3b). Displacement time series are given in black. The light red curve is the temperature recorded by the extensometer digitizer. Top: Times series between March 2024 and June 2025 (date format is year-month). Bottom: time series between 9 and 23 September 2024 (date format is month-day).
