# Collector Failures on 350 MHz, 1.2 MW CW Klystrons at the Low Energy Demonstration Accelerator (LEDA)

D. Rees, W. Roybal, J. Bradley III, LANL, Los Alamos, NM 87545, USA

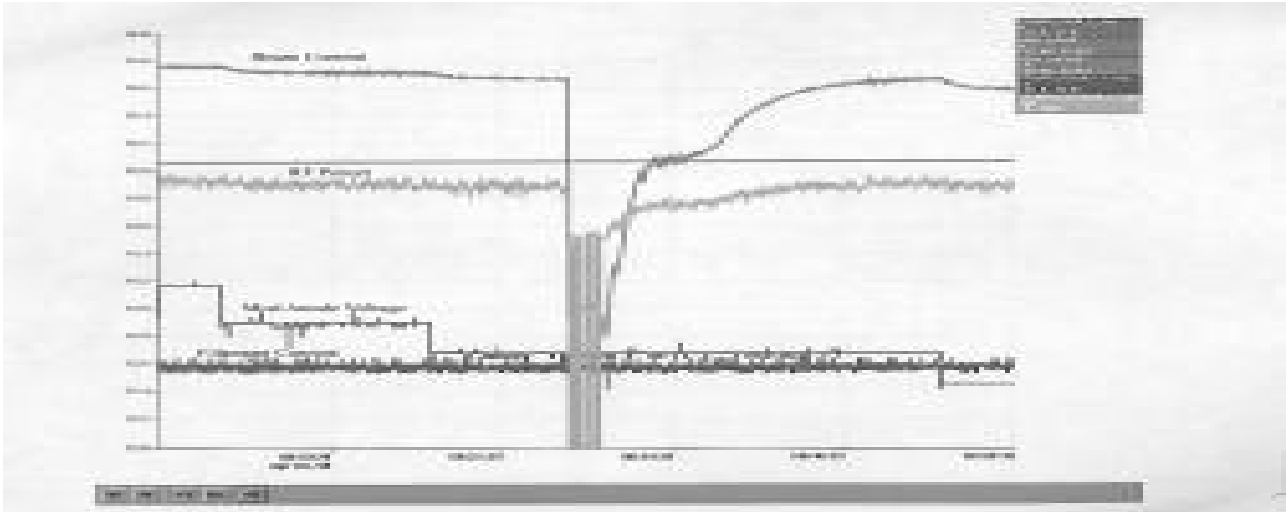
Figure 2: Strip chart record illustrating variable emission with changes in collector power.

Fig. 2 shows the results of one of these tests. In the figure, the RF power is observed to go to zero and a corresponding plunge in cathode current is observed. When the RF power is reestablished, the cathode current is observed to slowly return to its previous value. The filament current and mod-anode voltage relative to cathode voltage is observed to be constant over the variation in cathode current. From this data we concluded copper vapor from the collector was poisoning the cathode emission as we increased the thermal load in the collector. It was also interesting that the vac-ion pump power supply did not register an increase in vacuum and indicated very low current throughout this test.

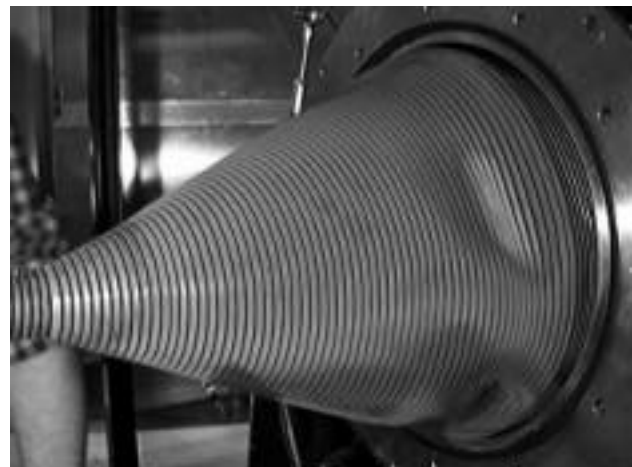
Based on this result and conversations over the duration of our testing, EEV had two klystron engineers visit our site. We removed the end of the collector water jacket from the klystron and observed the damage shown in Fig. 3. From Fig. 3 it is observed that several portions of the collector had become quite hot and dimples had resulted from a combination of the heat, water pressure, and vacuum forces. The general collector shape had also distorted. It was now elliptical in cross section rather than round. Also, the collector end had drooped and the bottom of the conical shaped portion of the collector was actually resting on the water jacket.

We inspected the collectors of all the klystrons and all showed various levels of damage ranging from minimal to the significant damage shown in Fig. 3. All collectors showed indications of droop and three of the four collectors were becoming elliptical rather than round in cross section. All collectors had less than 1000 high voltage hours and one had only 60 high voltage hours since delivery.

Of the four klystrons, one klystron had a bucking coil in place to minimize magnetic field penetration into the collector. This klystron had the least damage. Two other klystrons had this bucking coil installed but not electrically connected to the magnetic circuit. The fourth klystron did not have the bucking coil installed. We were dismayed to discover the variation in the magnetic circuit of the klystrons, but were encouraged by the fact that the klystron with the bucking coil operable showed the least damage. We took the following short-term steps to return the klystrons to service due to programmatic pressure.

Figure 3: External view of collector damage.

The klystron in Fig. 3 was returned to the factory for rebuild still under vacuum and operable at low beam powers. The collector jackets of the remaining three klystrons were adjusted to center the collectors in the water jackets in order to compensate for the droop, and supports were welded on the inside of the water jacket to support the end of the collector to avoid further droop. An acoustical measurement system was installed on the collector to validate the effect of the bucking coil and to characterize safe regions of operation. The sensor was a microphone on the collector cooling return. These results are presented in Fig. 4. The four curves in Fig. 4 show some unexpected results. The mixed phase boiling that the collector was designed to accommodate manifests as an increase in the higher frequency audio components of Fig. 4. This increase can be used as a qualitative indication of peak collector heat load. From Fig. 4 it can be seen that the localized collector heat load at 77 kV, 14.5 A is actually higher than at 85 kV, 17.1 A. This suggests that the beam power is better distributed over the collector at 85 kV. The plots in Fig. 4 were measured without RF power with the full beam power dissipated in the collector. Fig. 4 also shows that application of the bucking coil lowers the localized collector heat load. Using this tool we were able to define an allowable safe operating region and also regions to avoid. Operation with three klystrons at an 85 kV voltage provides sufficient power for the RFQ with full accelerator beam current and sufficient control margin.

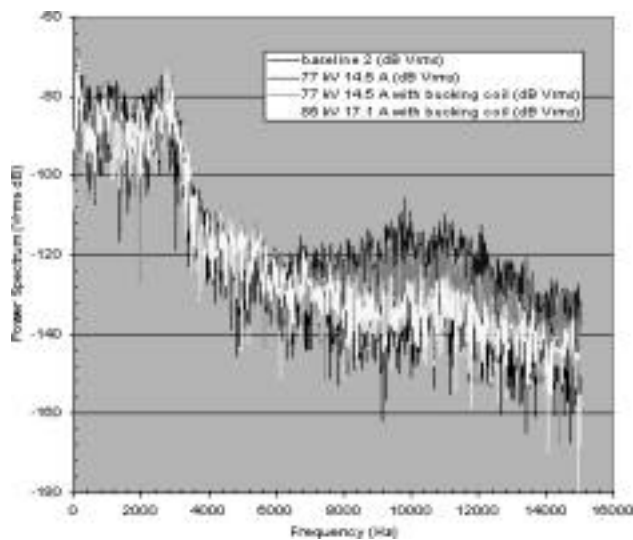
The data in Fig. 4 were measured on the klystron that had the second most significant amount of collector damage. The other two klystrons showed a similar behavior but not the same magnitude of acoustical variation. For all klystrons, operation between 70 kV and 80 kV resulted in audio indications of increased localized heating.

Figure 4: Collector audio profile.

In addition to the steps taken above, we also implemented a beam interlock such that above 70 kV of beam voltage, 100 kW of RF power was required or an interlock would remove high voltage within 15 seconds.
