# Investigation of condominium building collapse in Surfside, Florida: a video feature tracking approach

Xiangxiong Kong

Department of Physics and Engineering Science, Coastal Carolina University P.O. Box 261954, Conway, SC, USA 29528-6054

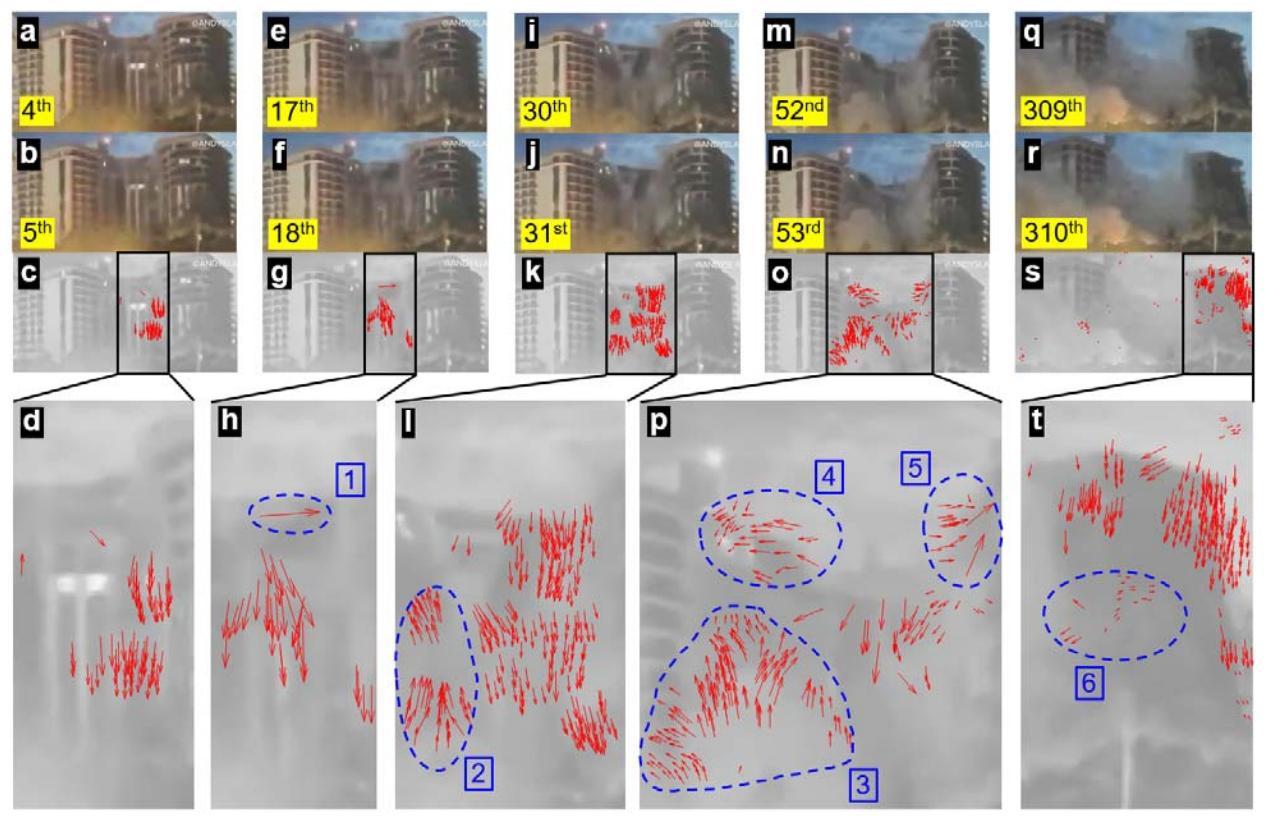
As can be found in Figure 6, the middle section of the building complex starts falling at the beginning of this video clip (see the first, second, and third columns in Figure 6). Consistently, the red arrows can pick up the falling structural components and further quantify their moving directions and magnitudes. Next, more components in the middle section fall (see the fourth column), and the camera view is partially obstructed by particulate matter made by the prior collapsing building debris. Thereafter, the right section of the building complex falls as can be seen in the last column of the figure.

Figure 6. Video processing results where Columns 1 to 5 are results for Instants 1 to 5 from the video clip. The first and second rows are the selected video frames; the third row shows the video analysis results with arrows indicting the moving directions and magnitudes of the falling structural components; the last row shows the blow-up views. The labels at the lower-left corners of the images at the first and second rows are the frame numbers from the video clip. The brightnesses of images in the third and last rows are adjusted for the purpose of illustration.

Several areas of the images in the last row in Figure 6 are highlighted by blue dotted circles. In dotted circle 1, the horizontal arrow may be caused by an incorrect KLT matching and hence shall be considered as the outlier. In dotted circles 2, 3, and 6, arrows can be found in the upward directions due to movements of particulate matter (dust and/or smoke). This can be further confirmed by inspecting the particulates in video frames (e.g., Figure 6i and q). In dotted circle 4, arrows depict the horizontal movements of the structural components. This shall be considered as the correct detection. These structural components may be initially attached to the left building section through reinforcing steel bars in the slabs, which prevents the components from moving down. In the dotted circle 5, horizontal and upward arrows can be found. This may be caused by both the horizontal movements of the structural components and the upward movement of the particulates.
