LIFETIME TESTING 700 MHZ RF WINDOWS FOR THE ACCELERATOR PRODUCTION OF TRITIUM PROGRAM

K. A. Cummings, M. D. Borrego, J. DeBaca, J. S. Harrison, M. B. Rodriguez, D. M. Roybal,
W. T. Roybal, S. C. Ruggles, P. A. Torrez, LANL, Los Alamos, NM 87545, USA
G. D. White, Marconi Applied Technologies, Chelmsford, England

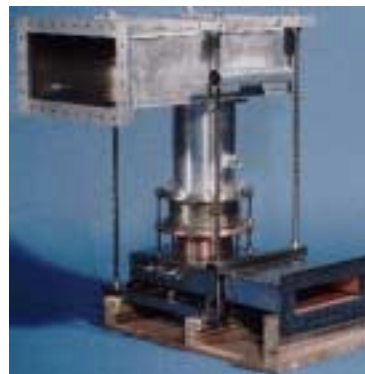
Figure 1: EEV 700 MHz RF Window.

The windows are a coaxial geometry using an AL995 alumina ceramic. As shown in Figure 1, the window assembly consists of half height WR 1150 waveguide on the vacuum side, a T-Bar transition into the coaxial region of the alumina ceramic, and another T-Bar to transition to full height WR 1500 waveguide on the air side. The configuration shown in Figure 1 is referred to as a right handed configuration. The air side waveguide may be rotated 180 degrees around the axis of the coax to yield a

left handed configuration. Both the right handed and the left handed configurations are used to feed power to the Coupled Cavity Drift Tube Linac (CCDTL) on the APT accelerator. The vacuum side waveguide is copper plated stainless steel. The inner and outer coax is copper and the air side waveguide is aluminum.

The windows are cooled with 40 CFM of air cooling and 2 GPM of water cooling. The air inlet is at the air side T bar. The air flows through the T bar on the air side, down the inner conductor, and then exits the inner conductor through a series of exit holes and flows across the alumina ceramic. The air exits the coaxial region through a series of exit holes on the outer conductor and is vented to the ambient environment. The water circuit cools the vacuum side T bar region and the vacuum waveguide.

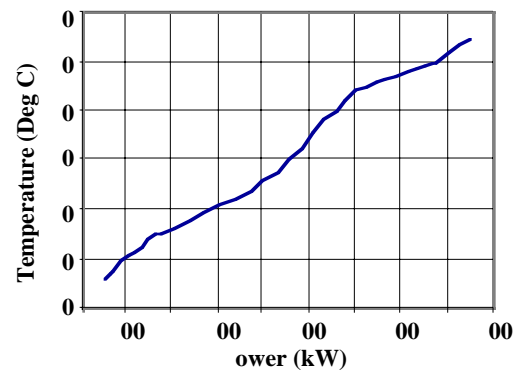
Figure 2: Steady State Temperature vs. Power.

The steady state temperature of the outer coaxial surface at various power levels are shown in Figure 2. The temperatures shown are from windows that did not show any arcing, glowing or heating problems. During the high power acceptance testing the outer coaxial surface temperatures of the windows are compared to this data as a tool to indicate any problems.

The variations in the coaxial surface temperature, air outlet temperature, amount of arcing, and vacuum pressure are examined over time. As shown in Figure 3, the coaxial surface temperature is plotted at various power levels during each month for serial numbers 12 and 13. As expected from Figure 2, the average temperature increases with the average power, however, there is no correlation of temperature, either increasing or decreasing, with time. Figure 4 shows no correlation between the air outlet temperature and test time; however, the noticeable increase in the air out temperature with power can be easily seen. The vacuum pressure remained very constant throughout the testing and there were no significant number of arcs.
