Shock machine for the mechanical behaviour of hip prostheses: a description of performance capabilities.

ABSTRACT

Keywords: hip prostheses; shock machine; wear stripe; alumina

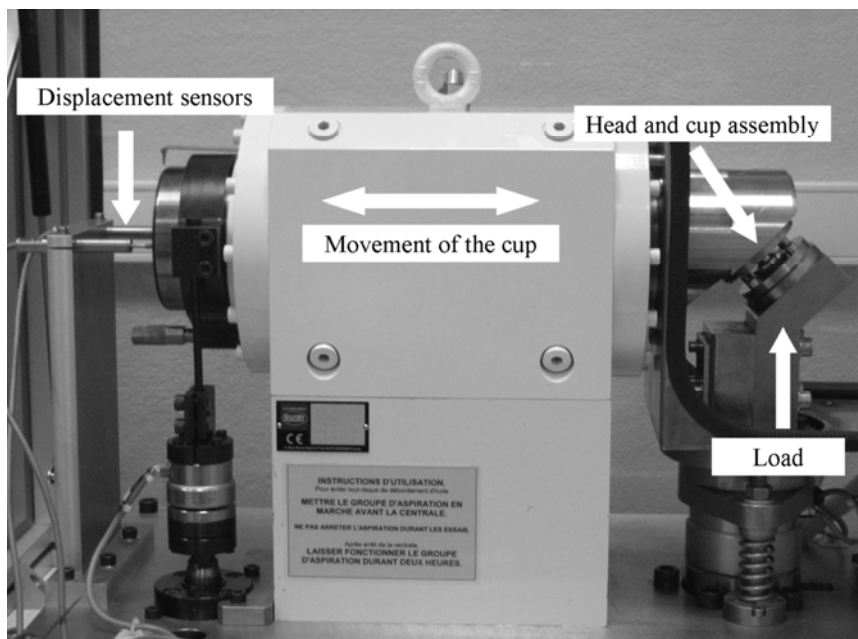
Figure 3. Shock machine

The shock machine (QUIRI Hydromecanique) is shown in Figure 3. This device was designed specially for testing hip prostheses, head and cup assembly, subjected to shocks.

Force varies between from 0 to 10kN with an adjustable duration from 20 to 100ms and a frequency between 0.1 and 5Hz. Tests in both dry and wet conditions are possible. The main feature that makes this machine different from usual hip simulators is the opportunity to impose a microseparation. A control by displacement is possible. Microseparation between cup and head was controlled.

Displacements signals from LVDT, see Figure 3, were recorded and analysed in order to determine the mechanical behaviour of the cup after the impact. The cup response was described as a damped spring-mass system. The cup oscillates during 0.2s which is about seven times the duration of the peak of force. Positive sign means the cup moves in the positive x direction.

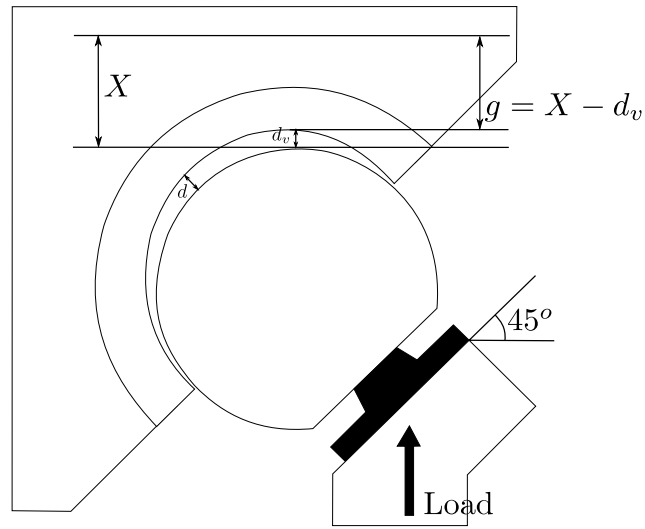
Figure 5. Virtual distance $g=X-d_v$. d : microseparation, d_v : vertical distance to obtain the value d . X is the displacement imposed to the head

Several values of microseparations (d), Figure 5, were tested: 0, 0.7, 1, 1.3, 1.6 and 1.9mm. They are related to the *in vivo* behaviour. To each microseparation corresponded a vertical distance, (dv). For each microseparation, a displacement of X was imposed to the head. Since the distance between the head and the cup was dv , a force is applied when $X > dv$ and increased with X . The distance $g = X - dv$ was defined as "relative distance", Figure 5.
