ATLAS Pixel Detector: Operational Experience and Run-1 to Run-2 Transition

Alessandro La Rosa*, on behalf of the ATLAS Collaboration

*The 23rd International Workshop on Vertex Detectors,
15-19 September 2014
Macha Lake, The Czech Republic*

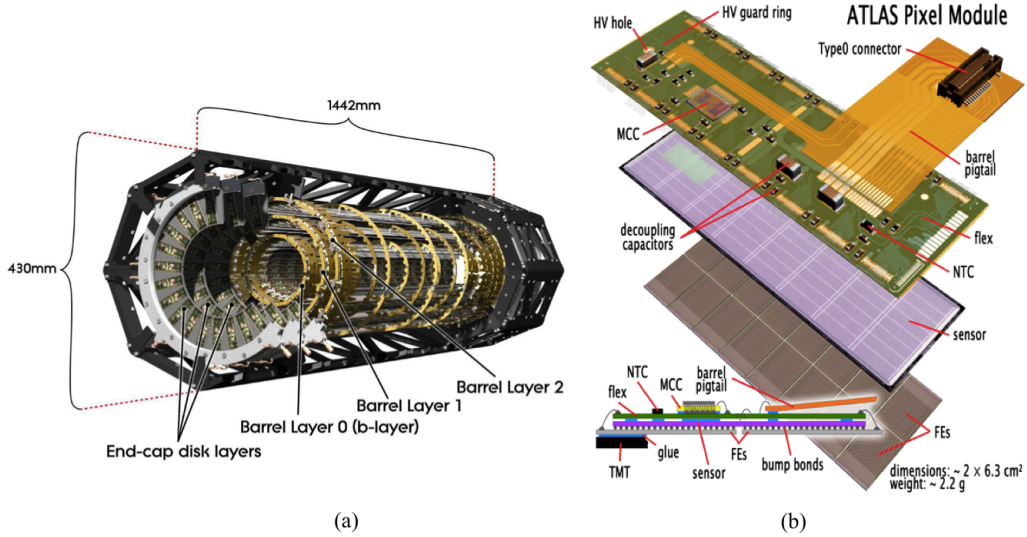
Figure 1: (a) Schematic drawing of the ATLAS Pixel Detector. The detector comprises three concentric barrel layers and two end-caps with three discs each. The single detector modules are mounted on carbon fibre support structures with incorporated cooling circuits. (b) Assembly view and cross-section of an ATLAS Pixel Detector module. Sixteen front-end chips are bump bonded to the silicon pixel sensor. Interconnections are done on a flexible kapton PCB, which is connected by wire bonds to the electronics chips [2].

The Pixel Detector [2] is the core of the ATLAS Inner Detector (ID), and as shown in Figure 1, it consists of three concentric barrel layers with mean radii of 50.5 mm, 88.5 mm and 122.5 mm centred around the beam axis and two end-caps with three discs each, forming a three-hit system up to pseudo-rapidities of ± 2.5 . The full detector contains 1744 pixel modules, which are mounted on carbon fibre local supports (staves). An evaporative C_3F_8 cooling system is incorporated into the staves to absorb the heat produced by the modules and to allow for an operation at temperatures below 0°C to limit the effects of radiation damage. The individual pixel modules are made of a $250 \mu\text{m}$ thick n^+ -on- n silicon sensor, 16 front-end chips (FE-I3 [3]) and a module controller chip (MCC [4]). The sensor is divided into 47232 pixels with a typical pixel size of $(50 \times 400) \mu\text{m}^2$ and approximately 10% of pixels (long pixels) have a size of $(50 \times 600) \mu\text{m}^2$ to bridge the gaps between the front-end chips. In addition, in each column eight pairs of pixel implants, located near the center lines, are ganged to a common read-out, resulting in 320 independent read-out rows or 46080 pixel read-out channels. The front-end chip provides pulse height measurement by means of time over threshold (ToT) with zero suppression on chip while the module event is built by the MCC.

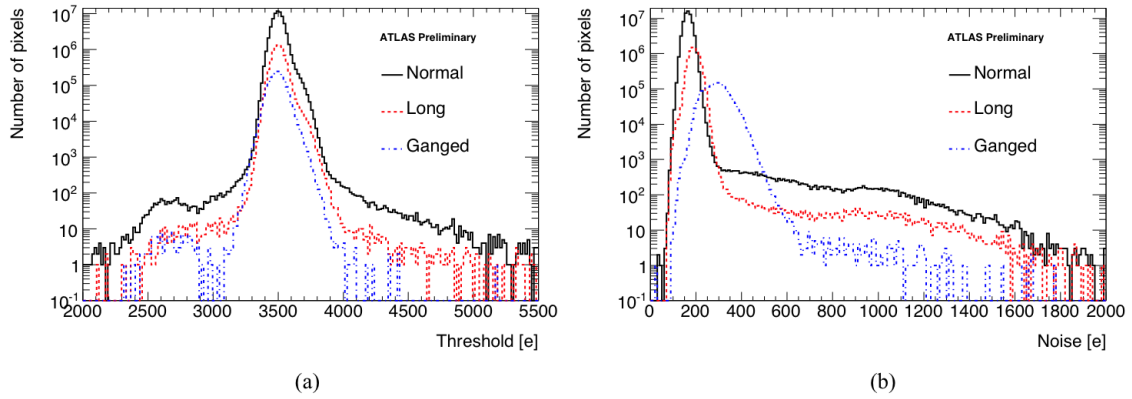
Figure 2: Measured threshold values for all pixels in the detector. Prior to the scan the threshold setting have been tuned to $3500 e^-$. (b) Noise values obtained from the same threshold scan [5].

The pixel thresholds were tuned to $3500 e^-$ with a typical dispersion of $40 e^-$. The measured noise was $180 e$ for normal sized pixels, with a higher value for long pixels and about $300 e$ for ganged pixels as expected due to the higher capacitance these pixels present to the readout electronics. Threshold and noise values obtained from a threshold scan are shown in Figure 2 [5]. Pixels exceeding noise occupancy of 10^{-6} hits per bunch crossing in dedicated noise data taking runs were masked for data taking already in the module configuration. Typical occupancies for physics data have been in the order of 10^{-4} . Only 0.1% of the pixels needed to be masked out to achieve such performance. The front-end chip has the capability to provide information about the deposited charge by the measured Time Over Threshold (ToT), which has a nearly linear dependence on the charge released in the sensor. The tuning target was a ToT of 30 bunch crossings for an injected charge of $20 ke^-$ that corresponds to a minimum ionization particle deposited charge.

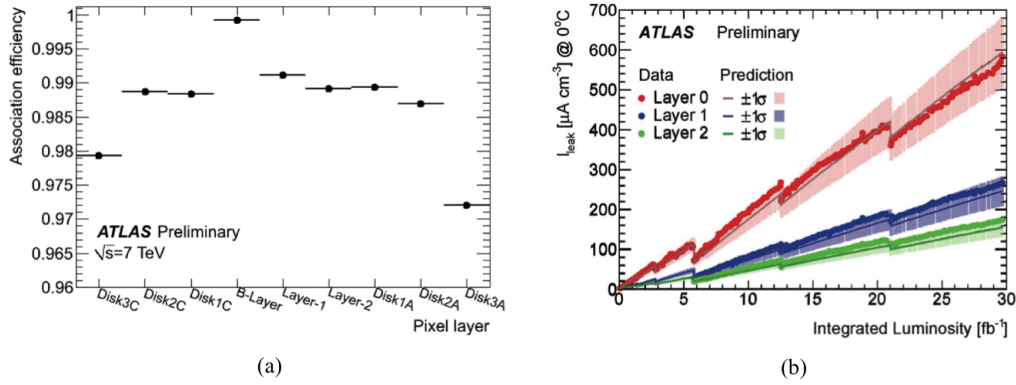
Figure 3: (a) Hit association efficiency for the different parts of the ATLAS Pixel Detector. The high efficiency of the B-layer is an artefact of the track set used for the measurement, whereas the low efficiency of the outermost discs is due to few bad modules known from production [5]. (b) The averaged reverse-bias current for all Pixel modules in the different barrel layers as a function of the integrated luminosity [5].

Looking at the detector performance the efficiency of tracks having associated hits in the different Pixel Detector layers was about 99%. As shown in Figure 3(a), a slightly lower efficiency in the outermost disks (Disk 3C of ~ 0.98 and Disk 3A of ~ 0.97) was measured and it was due to few bad modules that were already identified at the production stage.

The radiation damage effects were within expectation and they become visible when a significant increase in leakage currents has been observed in Pixel Detector. The leakage current was mainly measured by high voltage power supplies on a level of 6 or 7 modules per channel and with a precision of $80 nA$. As shown in Figure 3(b), the evolution of leakage current with the respect to the integrated luminosity was in agreement with the prediction. The steps in the leakage current evolution correspond to annealing during detector warm-up periods.

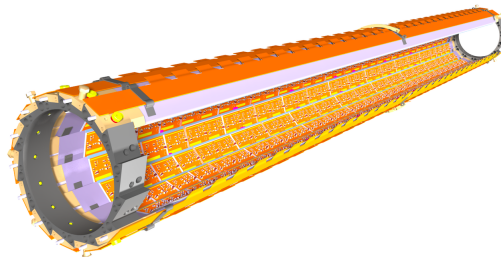
Figure 4: Schematic drawing of the ATLAS IBL Detector. The single detector modules are mounted on carbon fibre support structures with incorporated CO₂ cooling circuits.

The IBL Detector is the additional fourth pixel layer that has been built around the new Beryllium beam pipe (4 mm of radius) and then inserted inside the Pixel Detector in the core of ATLAS detector. It consists of 14 carbon fibre staves 64 cm long, 2 cm wide, and tilted in ϕ of 14° surrounding the beam-pipe at a mean radius of 33 mm and a pseudo-rapidity coverage of ± 3 . Each staff, with CO₂ cooling integrated, is equipped with 32 front-end chips (FE-I4 [6]) that are bump bonded with the Silicon sensors.

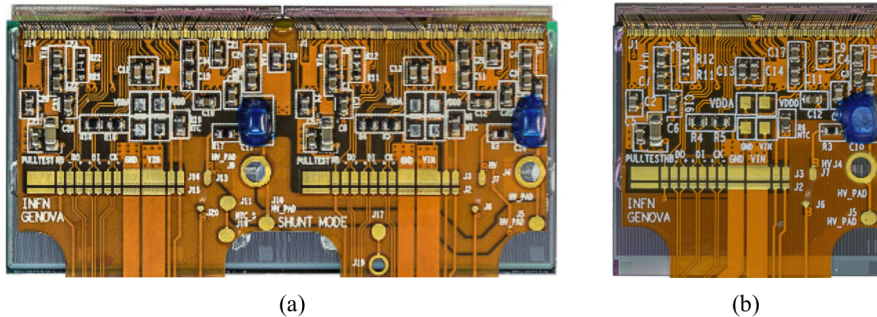
Figure 5: Photo of a dressed IBL two-chip (a) and a single-chip (b) module.

A total of 710 modules have been produced in between January and October 2013. The thinning and the bump-bonding of the modules were carried out at IZM (Germany). The front-end chips were thinned to a thickness of $150 \mu m$ and flip-chipped to the sensors using Sn Ag solder bumps. Then a double copper layer flex circuitry (so called module-flex) was glued onto the sensors and a wire bonding connection was done to electrically connect front-end chips and module flexes. Figure 5 shows a photo of a dressed IBL two-chip (a) and a single-chip (b) module. All the

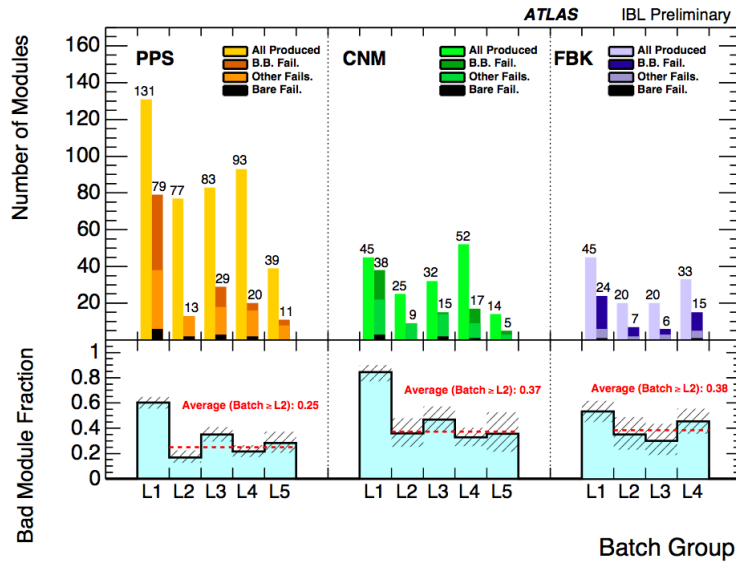
Figure 6: Yield of IBL module production for module types of two-chip(Planar, as PPS) and single-chip (3D as CNM, and FBK) per production batch group. In the top panel for failure modules, "B.B. Fail." stands for large bump-bonding failure, "Bare Fail." stands for the module not assembled due to mainly mechanical damages, and "Other Fails." stands for both electrical and sensor failures discovered after assembly [5].

produced modules have been mechanically, electrically and functionally qualified. The quality assurance procedure included short electrical and functional tests (e.g. IV-curves, threshold and noise scans) after the assembly at $15^\circ C$, thermal stress (ten cycles from $-40^\circ C$ to $+40^\circ C$), radioactive sources tests and intensive electrical and functional tests and calibration at $-15^\circ C$. During the modules production the first batch of both single- and two-chip modules had a large number of bump bonding failures which was traced back to the excessive flux in flip-chip process. Figure 6 summarizes the yield of the produced modules for both sensor technologies, where a yield of 75 % for the two-chip module, and 63% for single-chip (CNM) and 62% (FBK) modules. This production yields do not include the first production batch.

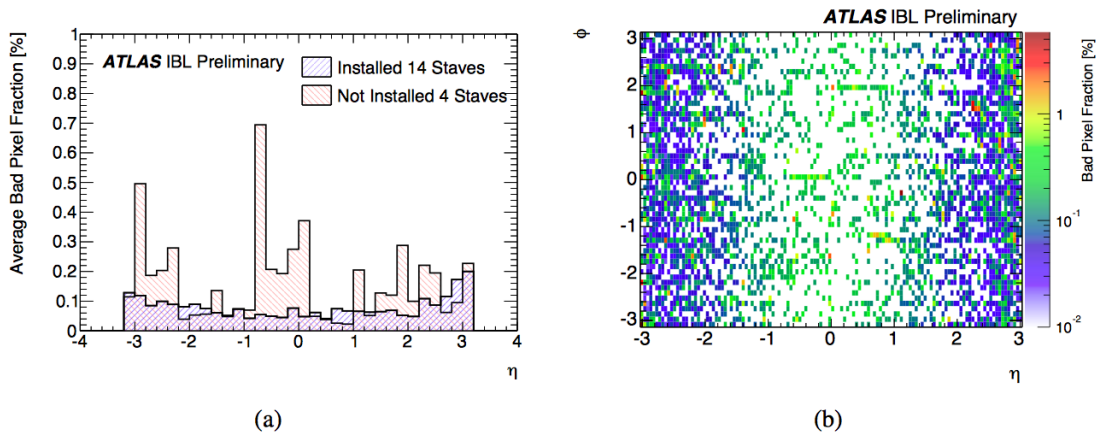
Figure 7: (a) Average bad pixel ratio distribution as a function of η for installed and not installed production staves and (b) in the $\eta - \phi$ plane for the 14 IBL staves [7].

18 staves have been produced, qualified, and out of them the best 14 have been selected to be assembled in the IBL Detector. The quality assurance (QA) procedure allowed a detailed characterization of all the staves including calibration in cold conditions and data taking with radioactive sources. The pixel defects were classified by type of failures as pertaining to the front-end chip, the sensor or the bump bonding. Figure 7 shows the distribution of the bad pixel fraction for the produced staves, while Figure 8 the threshold and noise distributions after tuning all pixels to a target threshold of $1500 e^-$ at $-12^\circ C$ module temperature for the 14 IBL staves.

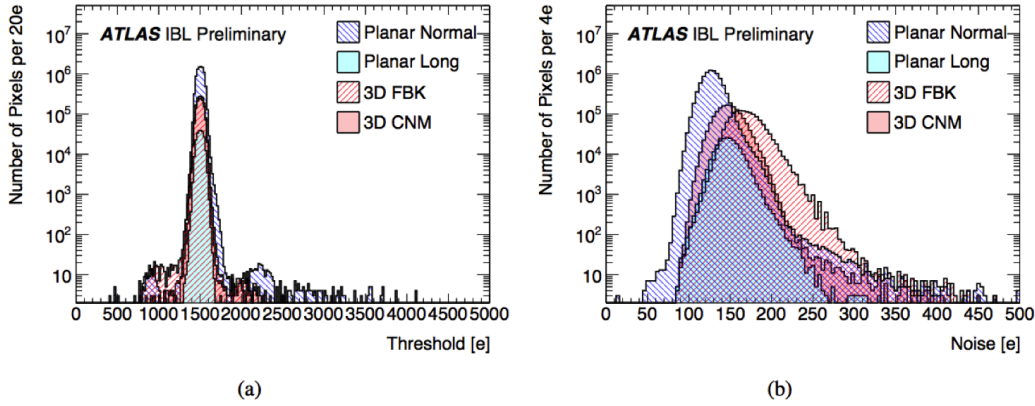
Figure 8: (a) Threshold and (b) noise distributions after tuning all pixels to a target threshold of 1500 e⁻ at -12 °C module temperature for the 14 IBL staves. The pixels are displayed in four categories according to normal and long pixels on planar sensors as well as pixels on FBK and CNM 3D sensors. [7].
