# Steam Degradation of Ytterbium Disilicate Environmental Barrier Coatings: Effect of Composition, Microstructure and Temperature

## Abstract

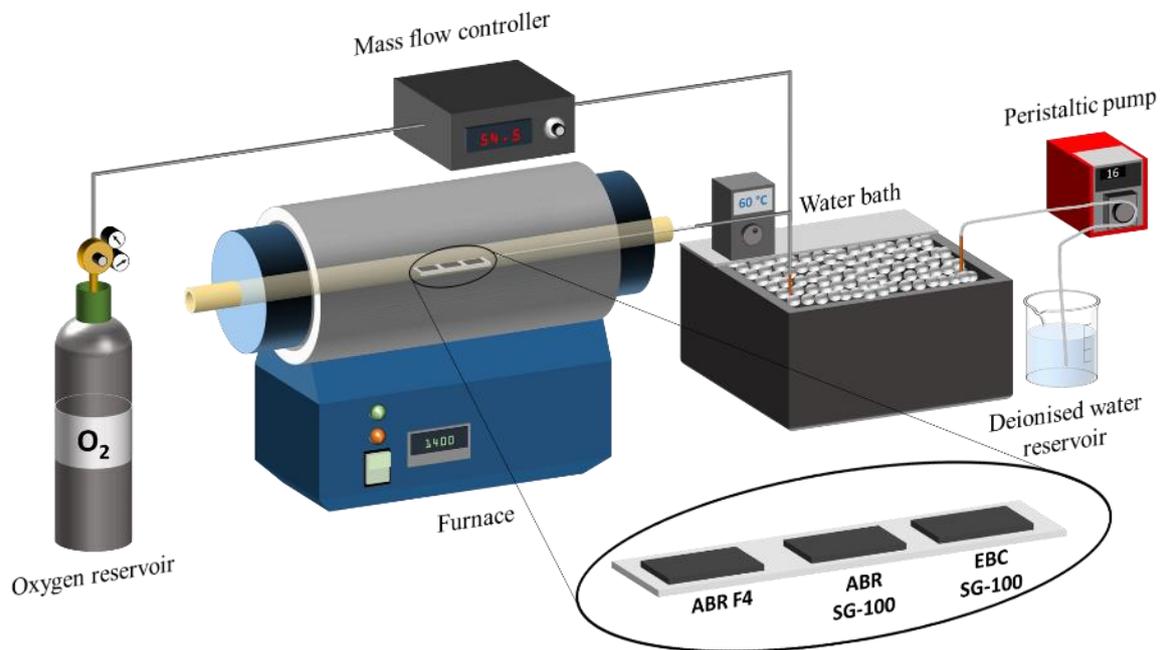
Figure 1: Schematic of the custom steam rig designed and built for the steam exposure

For the steam exposure, a custom steam rig was designed and built, comprised of the different components shown in Figure 1. The base of the steam rig is an Elite Thermal Systems Ltd (Market Harborough, UK) TSH15/25/180 tube furnace with an alumina tube with an internal diameter of 25 mm. An oxygen bottle is connected to one of the open ends of the tube, being the oxygen flow controlled with a MKS Instruments Inc. (Andover, Massachusetts, USA) type 247 mass flow controller. Deionized water is introduced in the furnace via a Watson-Marlow (Falmouth, UK) 120S peristaltic pump with 0.63 mm bore PVC tubing. The deionized water is first passed through a Grant Instruments (Shepreth, UK) Optima TC120 heated circulating bath kept at 60  $^\circ\text{C}$  to facilitate the evaporation once inside the furnace. Both the oxygen and water line are connected through a T connector outside the furnace, being the mixture introduced into the tube furnace using an alumina tube (99.7 % purity) with an internal diameter of 1.5 mm, supplied by Almath Crucibles Ltd. (Newmarket, UK), reaching until the start of the hot zone. The other end of the tube furnace was kept open to maintain atmospheric pressure. Oxygen and water flow were set to obtain a flowing atmosphere at the hot zone with a content of 90 vol.%  $\text{H}_2\text{O}/10$  vol.%  $\text{O}_2$ , and a gas velocity of ~100 mm/s. Oxygen and water flow were started once the furnace reached

the desired temperature. Samples were placed on top of a alumina plate in the order shown in Figure 1.

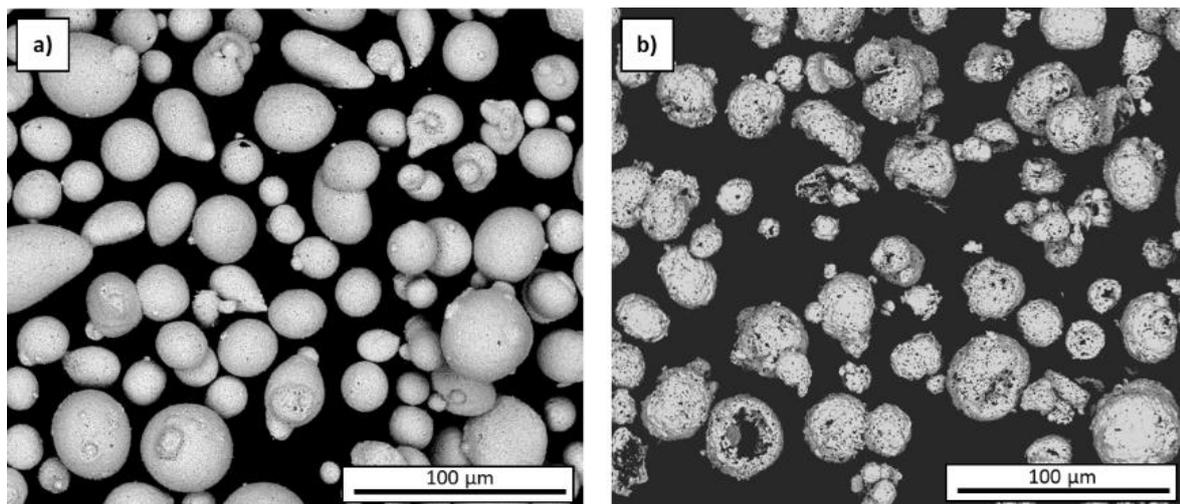
*Figure 2: BSE images of the powders used in this work: a) corresponds to sample EBC, b) corresponds to samples ABR*

The morphology of the EBC powder, as shown in Figure 2a, is spherical in shape with a smooth surface, mostly lacking any defects or inclusion. On the other hand, ABR powder, as shown in Figure 2b, presents a more irregular shape, still mostly spherical, but with a rough surface and the presence of pores and visible hollow cores.

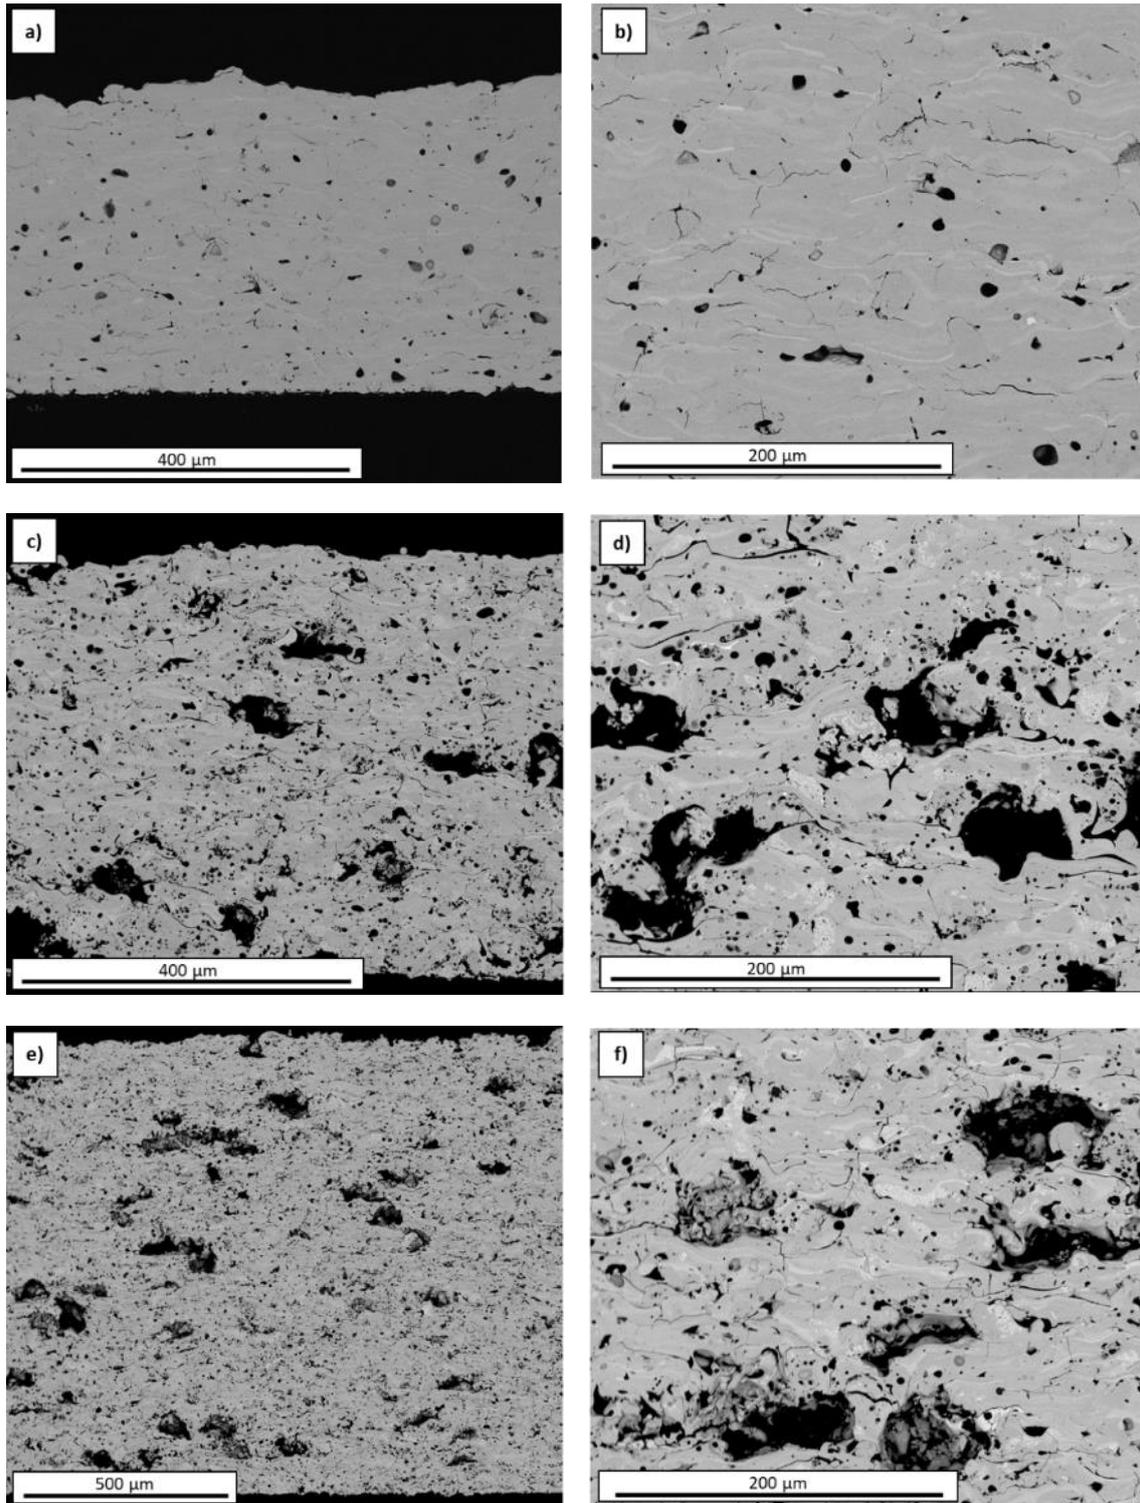
Figure 3: BSE images of the three free-standing coatings after annealing. Images a) and b) show sample EBC SG-100, c) and d) ABR SG-100 and e) and f) ABR F4

The cross-section SEM images shown in Figure 3 reveal that sample EBC SG-100 has a lower porosity level and thickness when compared to the two ABR coatings. This is confirmed by the porosity

measurements, showing a porosity level of  $2.4 \pm 0.3$  % for EBC SG-100. On the other hand, sample ABR SG-100 has a porosity of  $21.3 \pm 1.1$  %, and ABR F4 has  $19.4 \pm 4.0$  %. The higher porosity in the two ABR coatings is a direct consequence of the addition of polyester in the feedstock powder. During the annealing, the polyester burns off, leaving empty pores behind. As for the thickness, measurements of sample EBC SG-100 revealed a thickness of  $368.6 \pm 10.4$   $\mu\text{m}$ , while ABR SG-100 was  $509.9 \pm 9.2$   $\mu\text{m}$  and ABR F4 was  $1099.7 \pm 12.7$   $\mu\text{m}$ . The different thicknesses were chosen to represent the typical values required for each application in service, with EBCs traditionally remaining below 400  $\mu\text{m}$ , whereas abrasable coatings are generally thicker.

Despite this very similar starting composition of the annealed coatings, microstructure presents a differentiating factor between the EBC SG-100 sample and the two ABR coatings. As shown in the cross-section SEM images in Figure 3, EBC SG-100 presented a lower porosity level ( $2.4 \pm 0.3$  %) which can be explained by the absence of pores and defects in the feedstock powder as well as the lack of added polyester as pore former, as seen in Figure 2a. On the other hand, both the abrasible coatings, ABR SG-100 and ABR F4, present much higher levels of porosity,  $21.3 \pm 1.1$  % and  $19.4 \pm 4.0$  %, respectively. This is due to the presence of porosity and hollow cores in the feedstock powder (Figure 2b) and the addition of polyester as a pore former. When comparing the top surface of the annealed samples, there is also a clear difference between the EBC samples and the abrasible ones, as can be seen in Figure 4. EBC SG-100 presents a smoother surface caused by well-molten splats that flattened upon impact. The abrasible samples show the presence of semi-molten, but not completely flat splats, giving rise to a rougher surface where individual splats are easily identifiable. In all of the three samples, intra- and inter-splat cracks could be found.

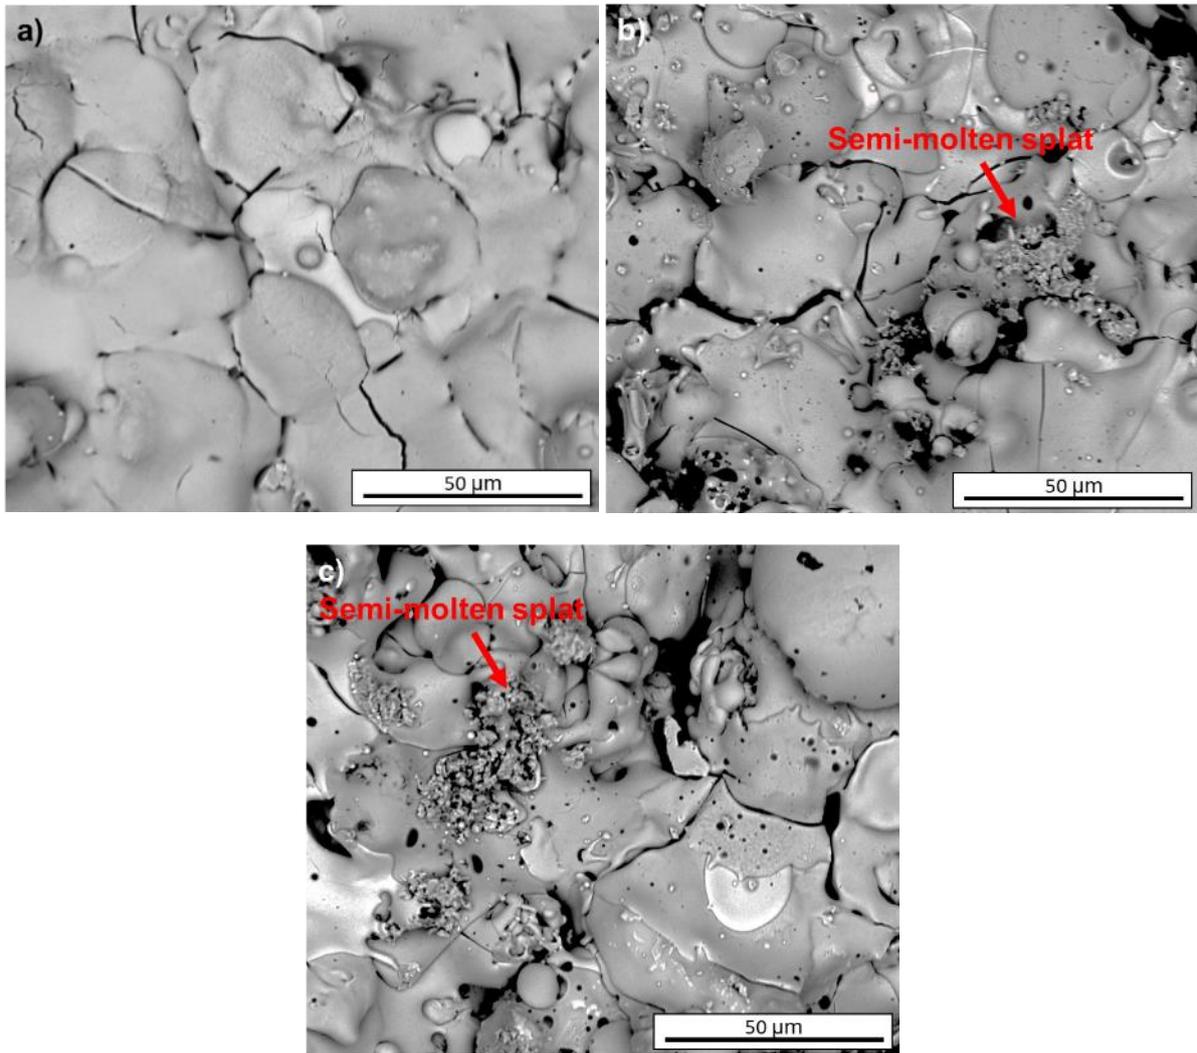
Figure 4: BSE images of the top surface of the annealed samples. Image a) corresponds to sample EBC SG-100, image b) to ABR SG-100 and image c) to ABR F4

From the images of the top surface shown in Figure 4, it can be seen that sample EBC SG-100 presents a smooth surface with well-molten splats, along with cracks distributed across the surface. In the case of the two abradable samples, ABR SG-100 and ABR F4, Figure 4b and c respectively, the surface presents a combination of well molten and semi-molten splats, the latter being labelled in the images.

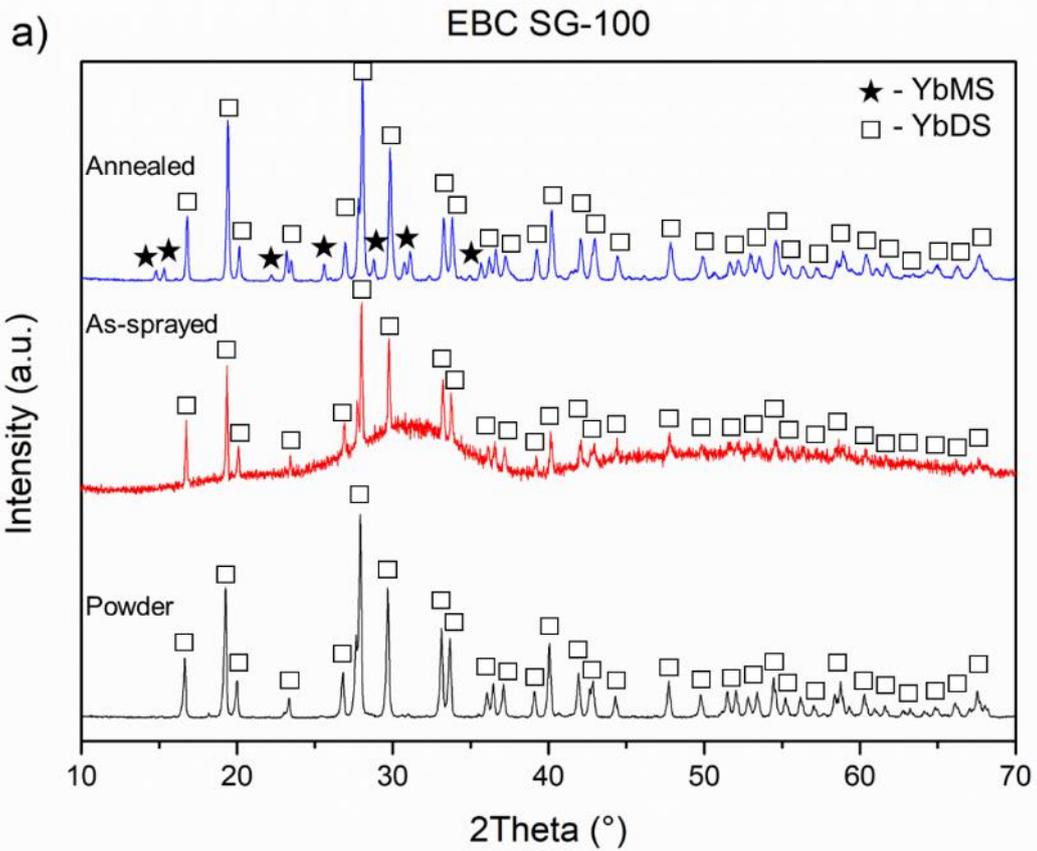
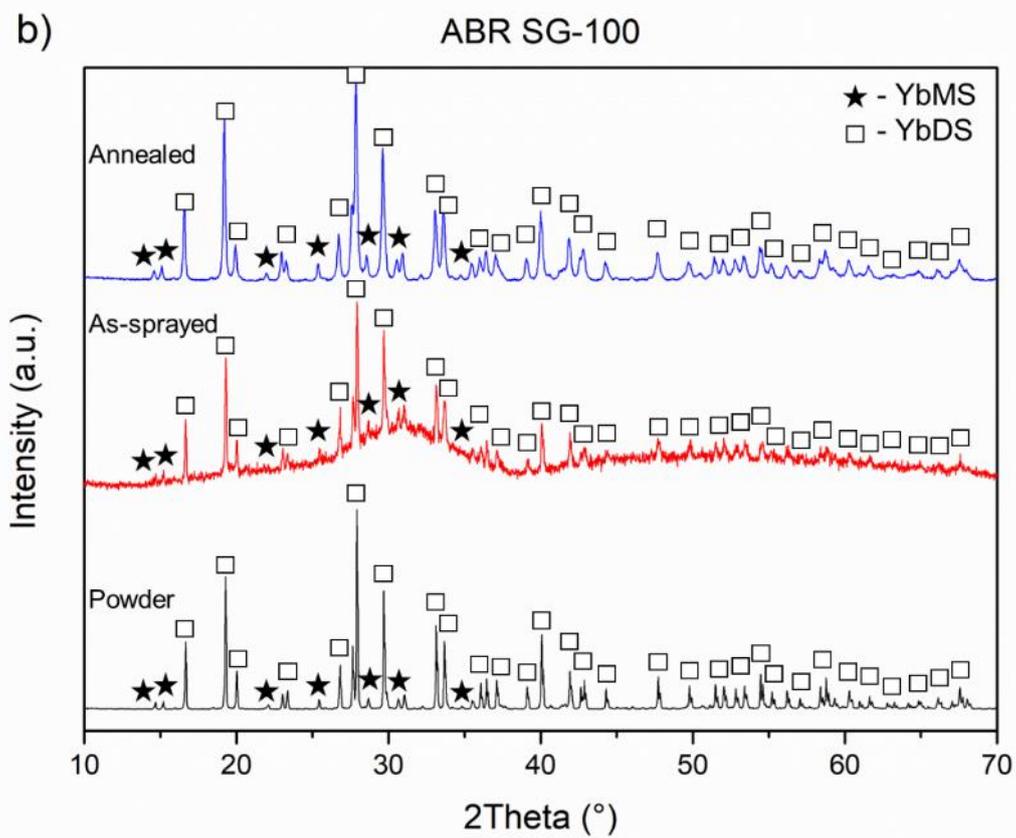
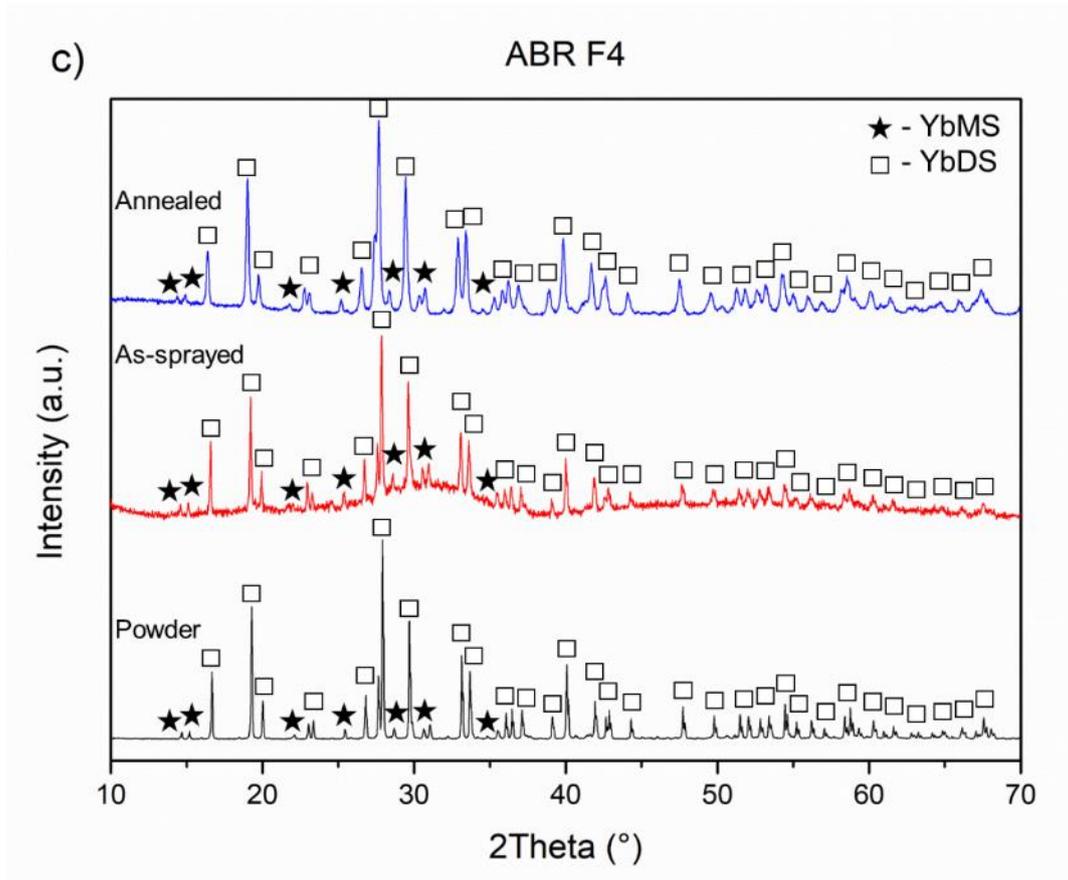
Figure 5: XRD measurements for a) EBC SG-100, b) ABR SG-100 and c) ABR F4. On each graph, the bottom plot corresponds to the powder, middle to the as-sprayed coating and top to the annealed coating. Phases have been identified with a star (★) for YbMS and a square (□) for YbDS

The XRD measurements show that the EBC powder, Figure 5a, presents only peaks from the YbDS phase (PDF card number 00-082-0734), although Rietveld refinement identified a small quantity of YbMS (5.4 wt.%). The powder used to spray the abrasible samples, Figure 5b and c, shows the presence of a higher quantity of YbMS (PDF card number 00-040-0386), measured as 18.7 wt.%. In the as-sprayed condition, EBC SG-100 only shows the presence of YbDS peaks with a 63.6 wt.% of amorphous content, whereas samples ABR SG-100 and ABR F4 show YbMS peaks accounting for ~25 wt.%. In addition to the crystalline peaks, all of the three as-sprayed coatings show two broad amorphous humps, centered on ~30° and ~55°. The annealing process removes the presence of these amorphous humps, showing all of the three samples consist mainly of YbDS, with approximately ~30 wt.% of YbMS. The detailed phase content as measured through Rietveld refinement is presented in Figure 11.

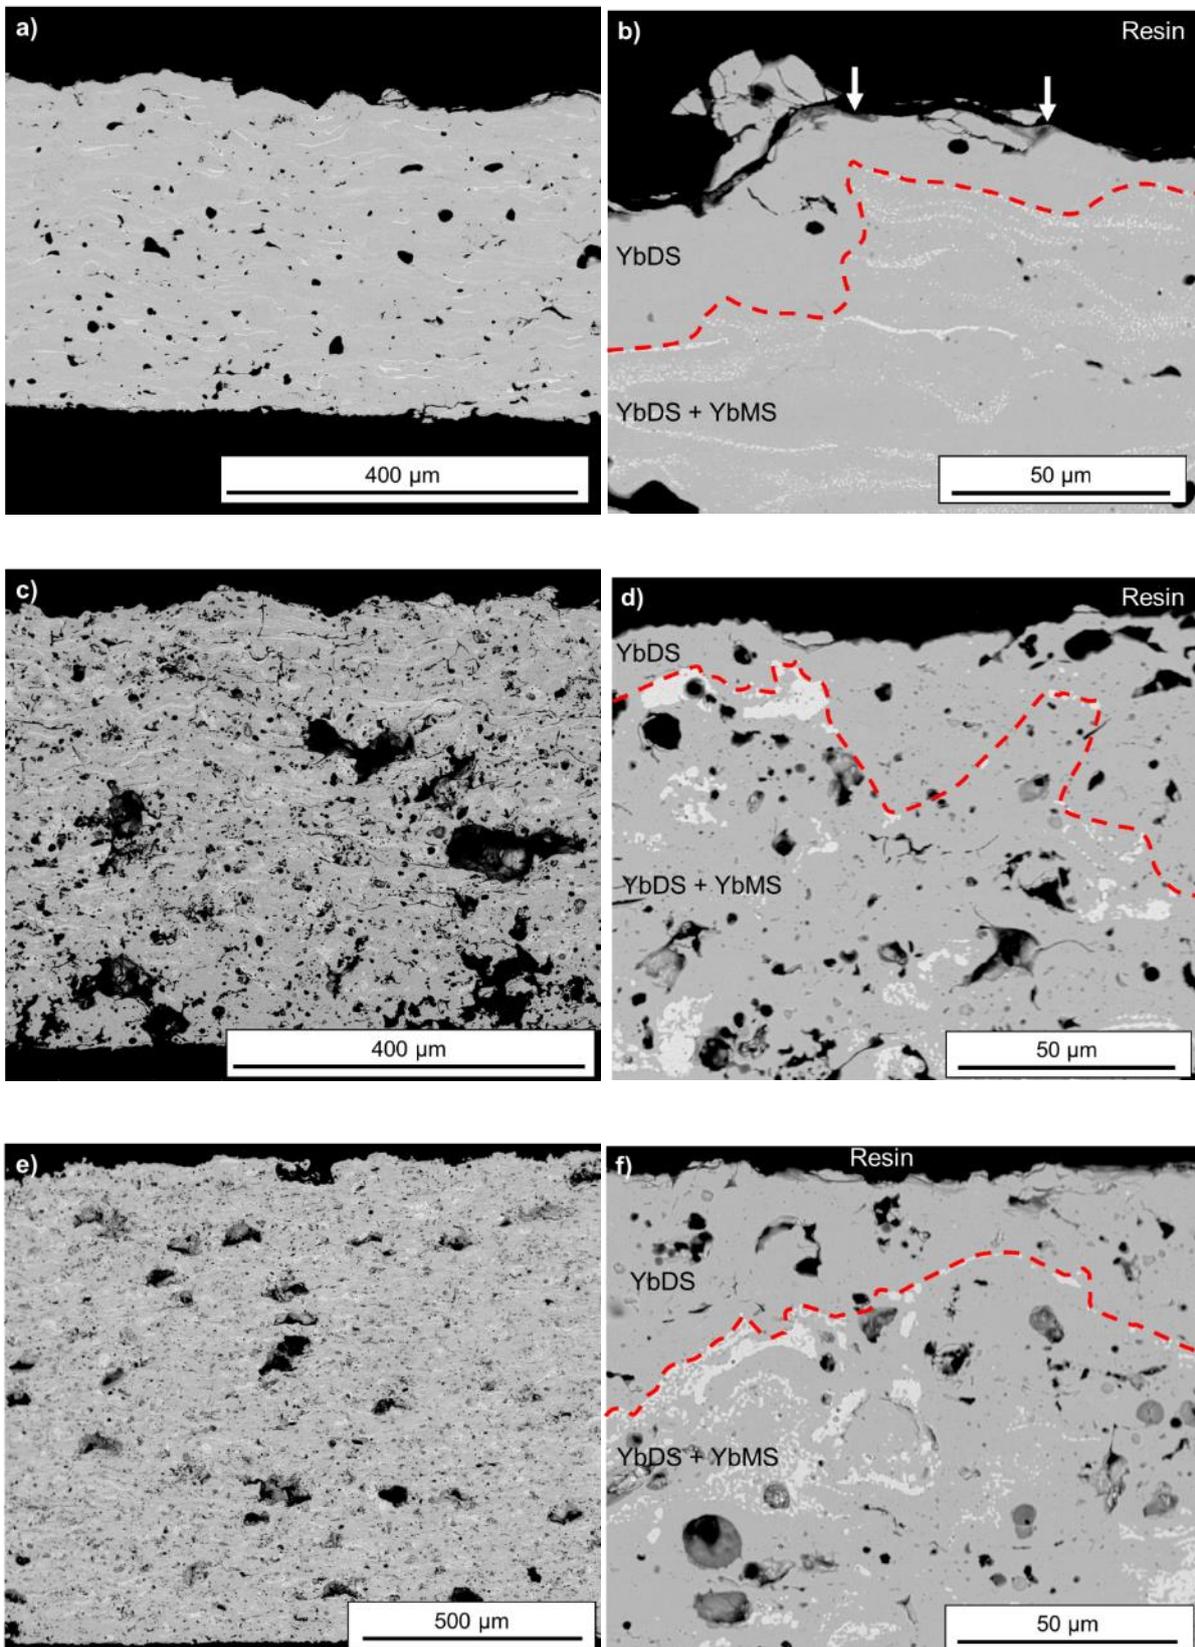
*Figure 6: Low and high magnification BSE images of the cross-section of the samples exposed to steam for 96 h at 1350 °C. Images a) and b) correspond to sample EBC SG-100, images c) and d) to ABR SG-100 and images e) and f) to ABR F4. The red dashed line marks where no more YbMS could be found. White arrows in image b) indicate where a new phase was detected*

From the SEM images shown in Figure 6, it can be seen that exposure to steam at 1350 °C caused the depletion of the YbMS closest to the surface, leaving behind a YbMS depleted layer. In the case of sample EBC SG-100, the high magnification image in Figure 6b shows small amounts of a new phase (marked with arrows) present at the surface of the coating. Due to the size of these features and the overlap between the Al-K $\alpha$  and Yb-M $\alpha$  lines, EDS quantification proved to be challenging. More details and identification are provided in the section 3.3 “Steam exposure at 1400 °C”.

reported by Maier *et al.* [24] and Rohbeck *et al.* [25]. Exposure to steam at 1350 °C caused the appearance of a YbMS depleted layer on all of the three coatings, as shown in Figure 6, being particularly visible in the high magnification images. In addition to the depletion of YbMS from the top layers near the surface, XRD measurements indicate the formation of a new phase, identified as ytterbium garnet. Figure 11 shows the evolution of the quantitative phase content for each of the three coatings here studied. In all three coatings, a reduction in the YbMS content could be observed as the content of garnet increased.

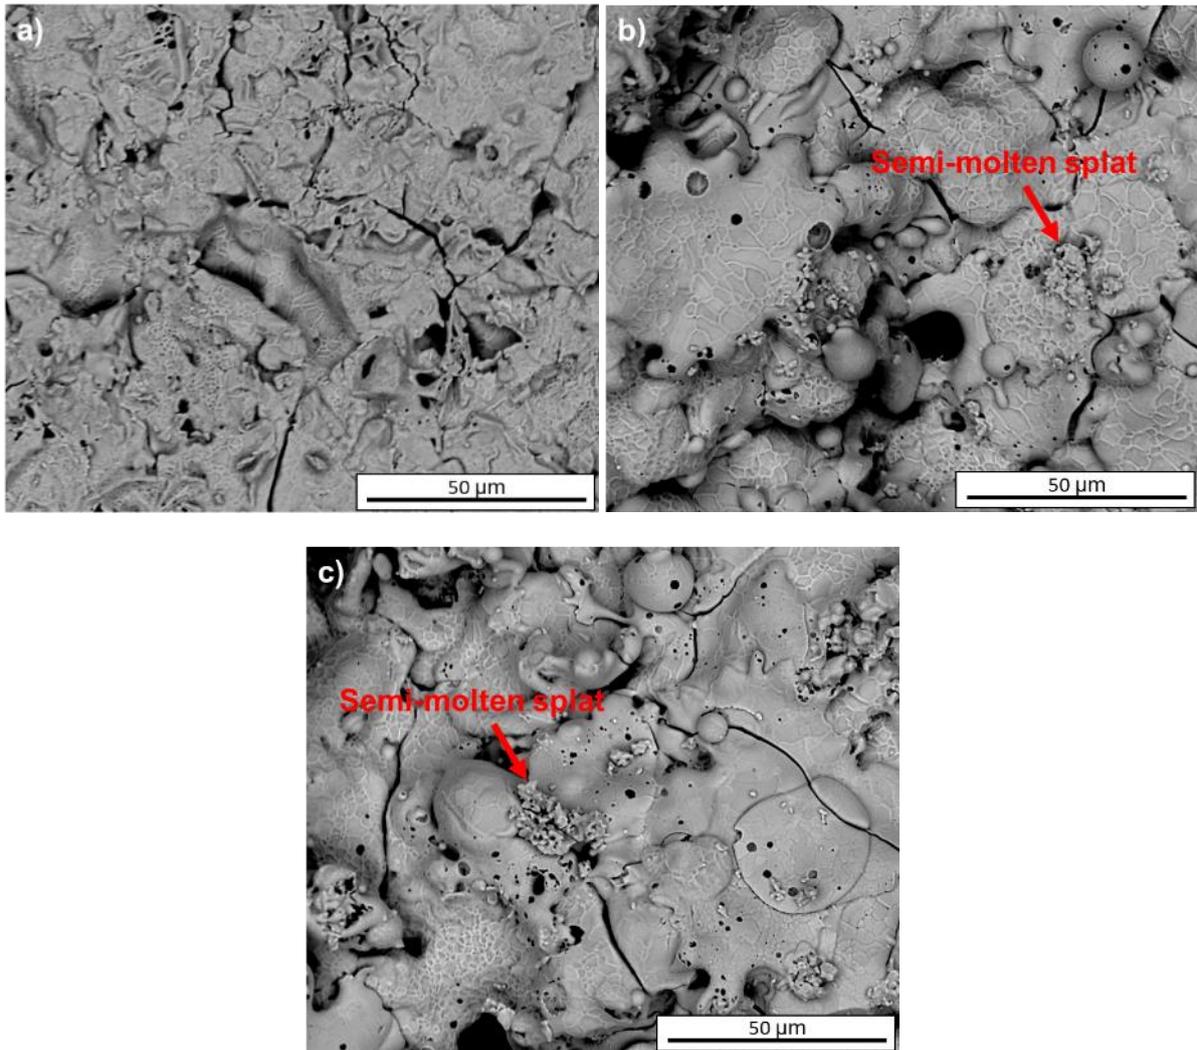
Figure 7: BSE images of the top surface of the samples exposed to steam at 1350 °C for 96 h. Image a) corresponds to sample EBC SG-100, image b) to ABR SG-100 and image c) to ABR F4

From the images of the top surface shown in Figure 7, it can be seen that sample EBC SG-100, Figure 7a, has a smoother aspect, meaning the individual splats are more difficult to distinguish. On the other hand, samples ABR SG-100 and ABR F4, Figure 7b and c, still show the presence of individual splats, both molten and semi-molten. All of the three samples show the effects of steam exposure; the grain boundary attack on the splats is clearly visible. Multiple cracks, both intra- and inter-splat, are also visible on the three samples.

From the SEM images of the top surface of the three steam exposed coatings, shown in Figure 7, it can be seen that the interaction between the steam (including the presence of gaseous Al-containing impurities) and the coatings takes place preferentially at the grain boundaries, a phenomenon also

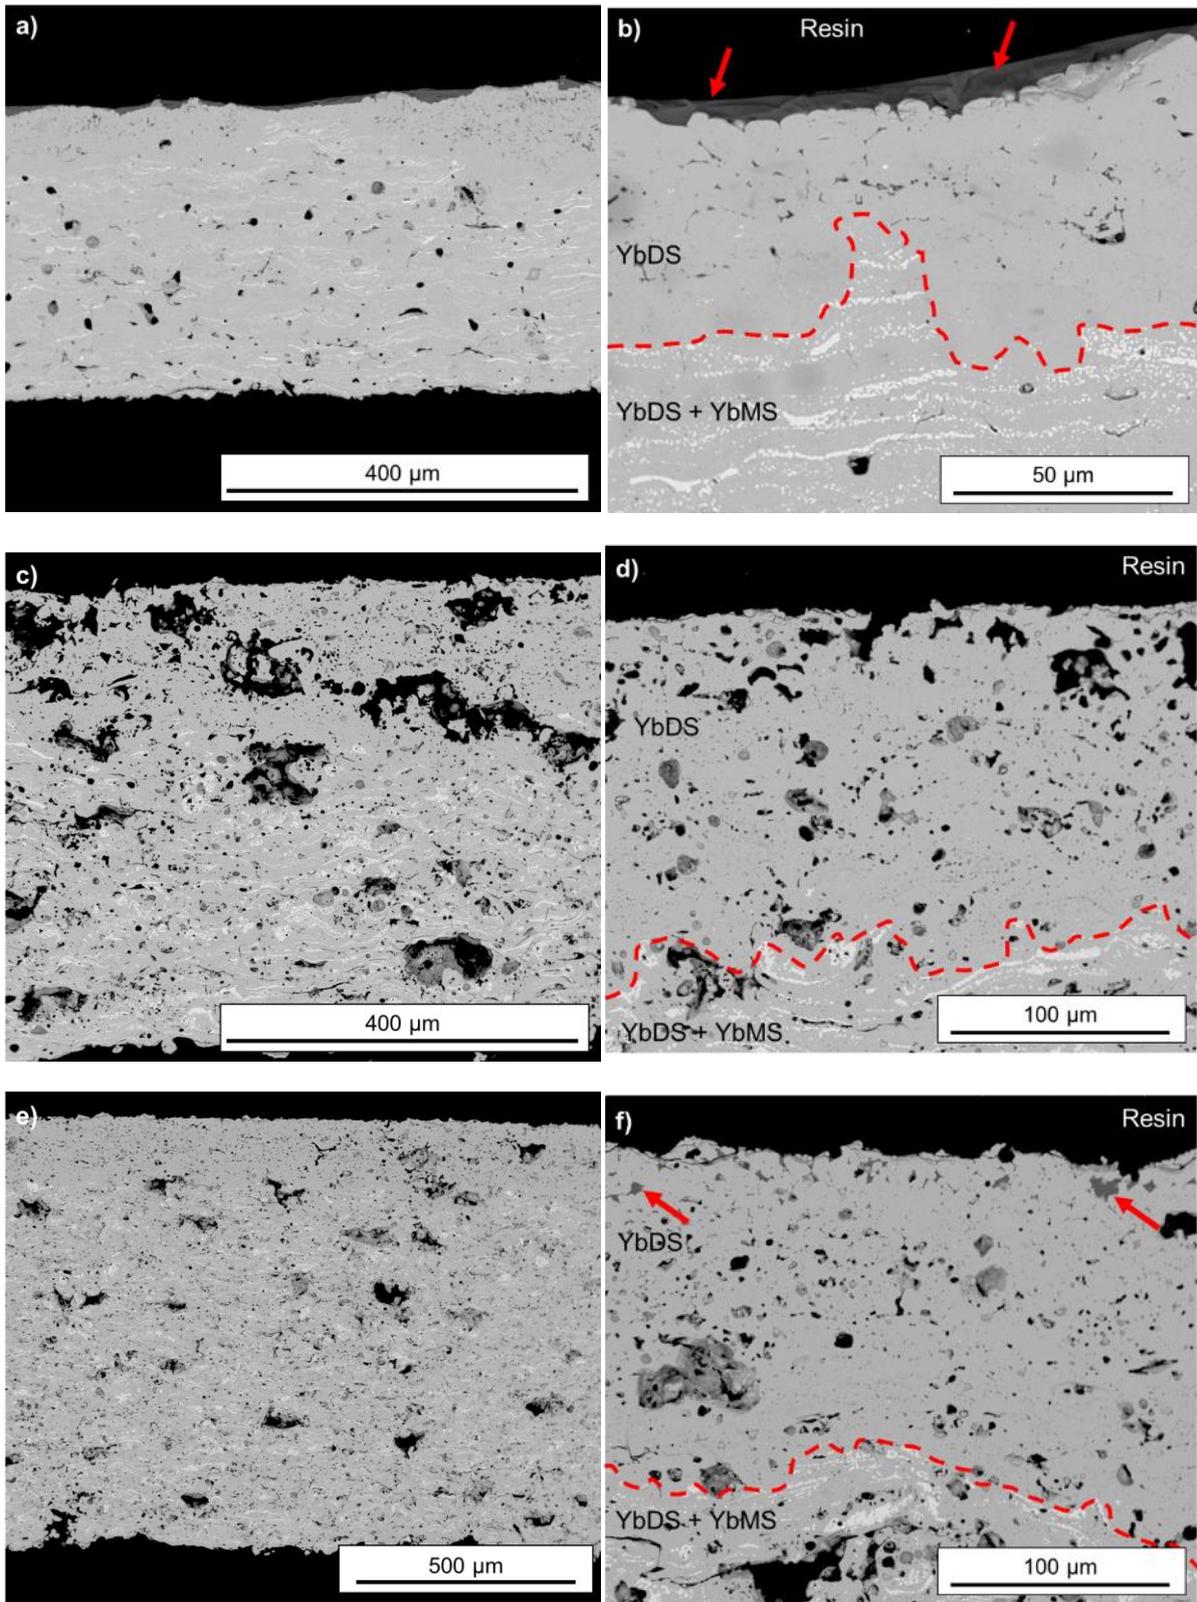
Figure 8: Low and high magnification BSE images of the cross-section of the samples exposed to steam for 96 h at 1400 °C. Images a) and b) correspond to sample EBC SG-100, images c) and d) to ABR SG-100 and images e) and f) to ABR F4. The red dashed line marks where no more YbMS could be found. Red arrows in images b) and f) indicate where a new phase was detected

From the low and high magnification images of the three coatings exposed to steam at 1400 °C, as shown in Figure 8, some differences can be appreciated. First, there is a clear new phase on the surface of sample EBC SG-100, marked with red arrows in Figure 8b. This scale, visible even at low magnification, was only present to such an extent on this sample. Smaller traces could be found within the coatings, especially in ABR F4, as marked with red arrows in Figure 8f. In the case of the abradable samples, this new phase was not seen as a homogenous scale on top of the surface but as small patches and within filled pores. EDS identification was tried (not shown here), but the results were unreliable due to the already mentioned issue of overlapping peaks between the Al-K $\alpha$  and Yb-M $\alpha$  lines, which is why XRD measurements were used for identification, as shown in Figure 10.

Another feature observed was the previously mentioned YbMS depleted layer near the surface of the coating. The thickness of the depleted layer is thinner in the case of sample EBC SG-100, approximately 50  $\mu\text{m}$ , whereas the thickness of the depleted layer on the abradable samples is closer to  $\sim 125 \mu\text{m}$ . In addition, the top area of the depleted layer presents visible inter-splat boundaries, not present in the samples exposed to steam at 1350 °C, as it can be seen in Figure 6. This newly formed feature were located at the inter-splat boundaries and can be more clearly seen in sample EBC SG-100 due to the initial low level of porosity. The top surface of the three coatings exposed to steam at 1400 °C was imaged, as shown in Figure 9.

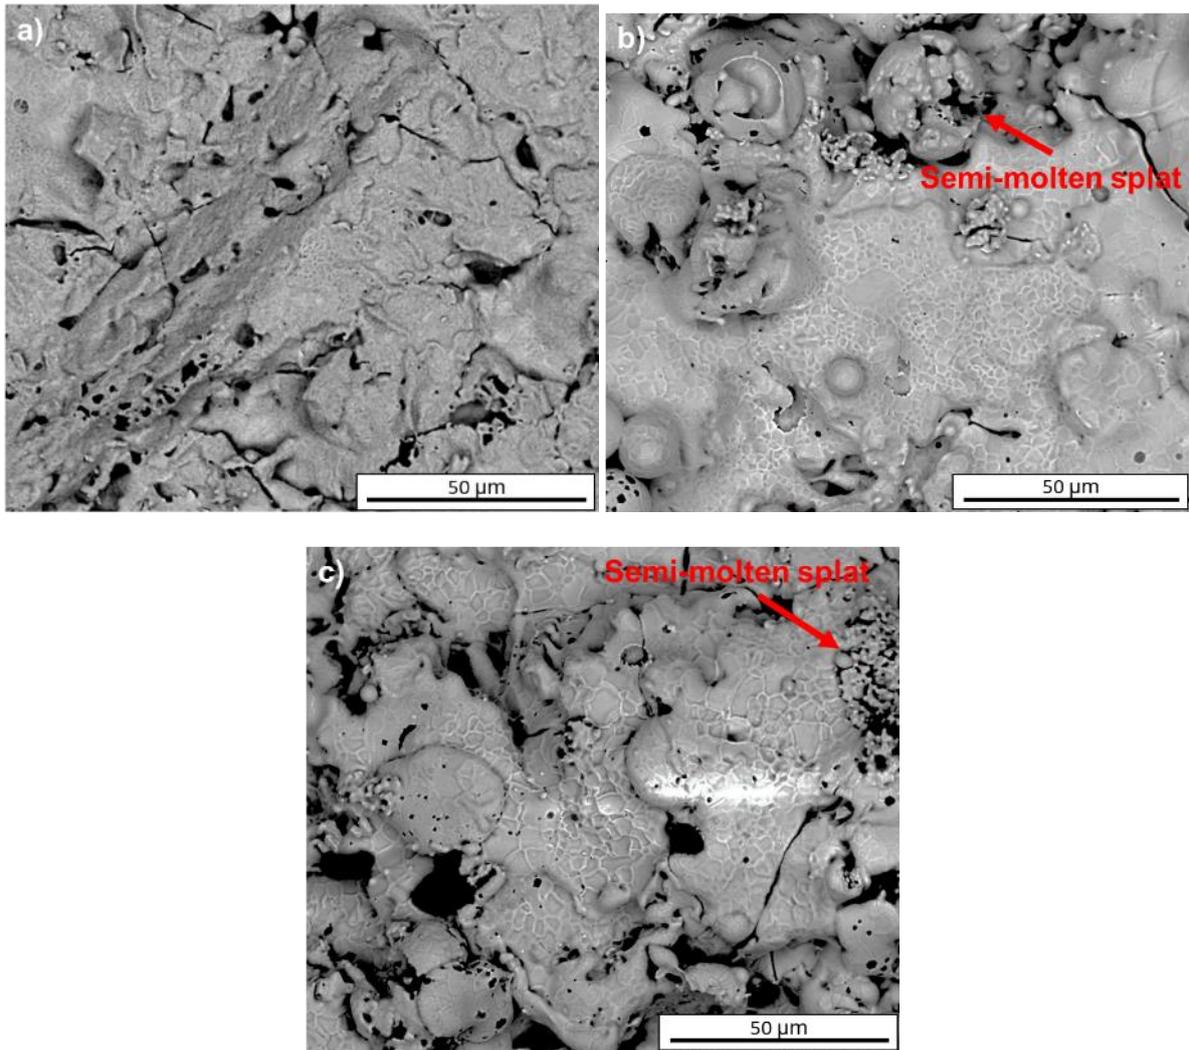
Figure 9: BSE images of the top surface of the samples exposed to steam at 1400 °C for 96 h. Image a) corresponds to sample EBC SG-100, image b) to ABR SG-100 and image c) to ABR F4

From the SEM images of the top surface, the grain boundary attack is less visible in the EBC SG-100 sample exposed to 1400 °C (Figure 9a) compared to 1350 °C (Figure 7a). Individual splats are difficult to identify, whereas cracks are visible. The top surface of the two abrasible coatings, ABR SG-100 (Figure 9b) and ABR F4 (Figure 9c), show very similar features, with presence of semi-molten splats. Individual splats affected by grain boundary corrosion can be seen, as well as cracks.

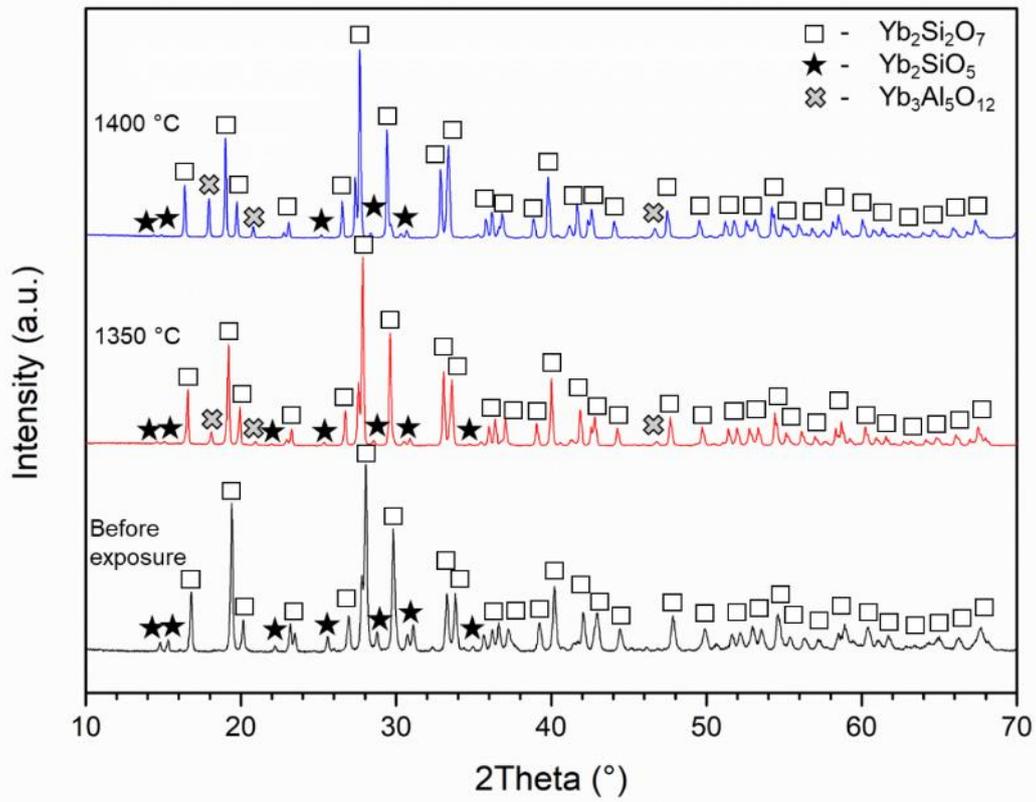
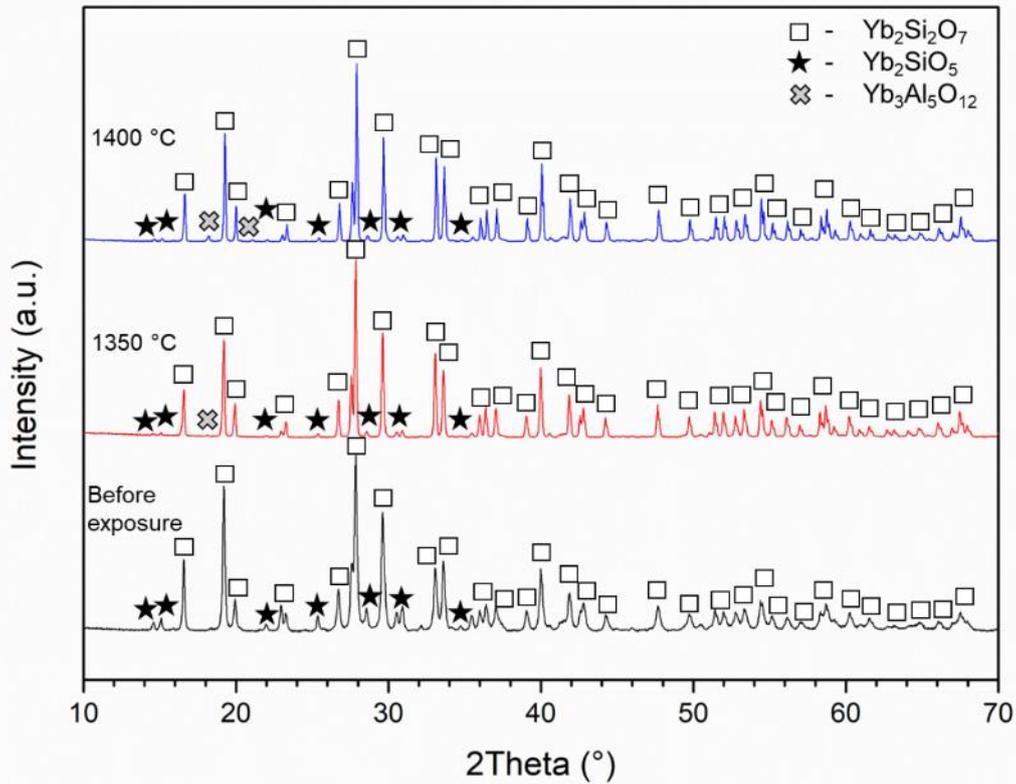
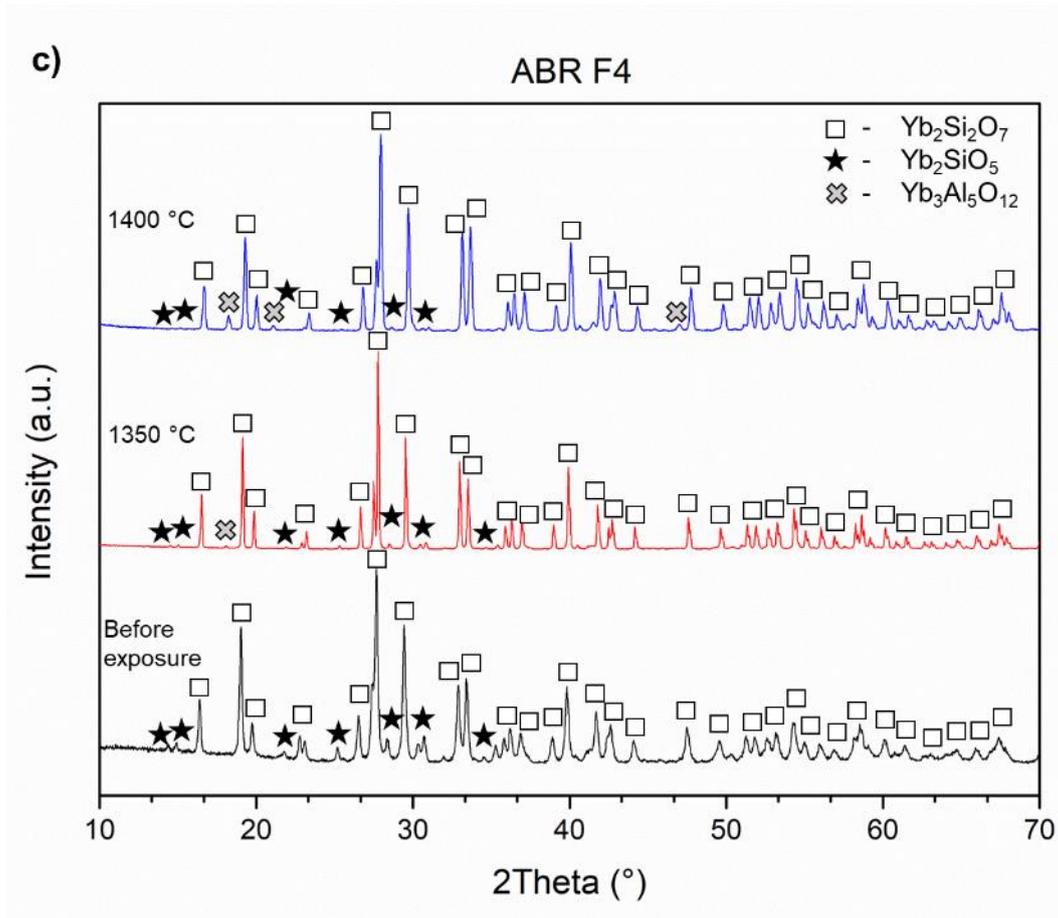
Figure 10: XRD measurements for a) EBC SG-100, b) ABR SG-100 and c) ABR F4. On each graph, bottom plot corresponds to the coating before steam exposure, middle to the 1350 °C steam exposure and top to the 1400 °C steam exposure. Phases have been identified with a square (□) for YbDS, a star (★) for YbMS and a cross (⊗) for the garnet

XRD measurements were performed to study the phase content of the three coatings. Figure 10 shows the XRD measurements of the three coatings on the three different conditions studied: before exposure, after exposure at 1350 °C and after exposure after 1400 °C.

The XRD measurements for sample EBC SG-100, Figure 10a, show how once the sample is exposed to steam at 1350 °C, there is a reduction in the intensity of the YbMS peaks. For EBC SG-100, this means a reduction from a YbMS content of 29.3 wt.% down to 8.1%, as shown in Figure 11. In the case of the two abradable samples, ABR SG-100 and ABR F4, the reduction is from ~29 wt.% to ~12 wt.%. At the same time, a new phase can be seen, identified as ytterbium garnet ( $\text{Yb}_3\text{Al}_5\text{O}_{12}$ , PDF card number 00-023-1476). This new phase was seen on the SEM images of the cross-section, Figure 6 and Figure 8. The presence of garnet is most predominant on EBC SG-100, with a 7.0 wt.%, whereas the two abradable samples present a garnet phase content around or below 1 wt.%. This trend continues for the samples exposed at 1400 °C. EBC SG-100 experiences a further reduction in the YbMS content, down to 3.9 wt.%, with garnet content rising to 17.6 wt.%. Regarding ABR SG-100, exposure to steam

at 1400 °C did increase the amount of garnet formed (2.6 wt.%) compared to exposure at 1350 °C (0.1 wt.%). This change is most notable in ABR F4, having a garnet content of 1.0 wt.% when exposed at 1350 °C, rising to 7.2 wt.% when exposed at 1400 °C. It should be noted that the phase content only takes into account the top 10 -15 µm of the coatings due to the estimated penetration depth of x-rays for this composition [23].

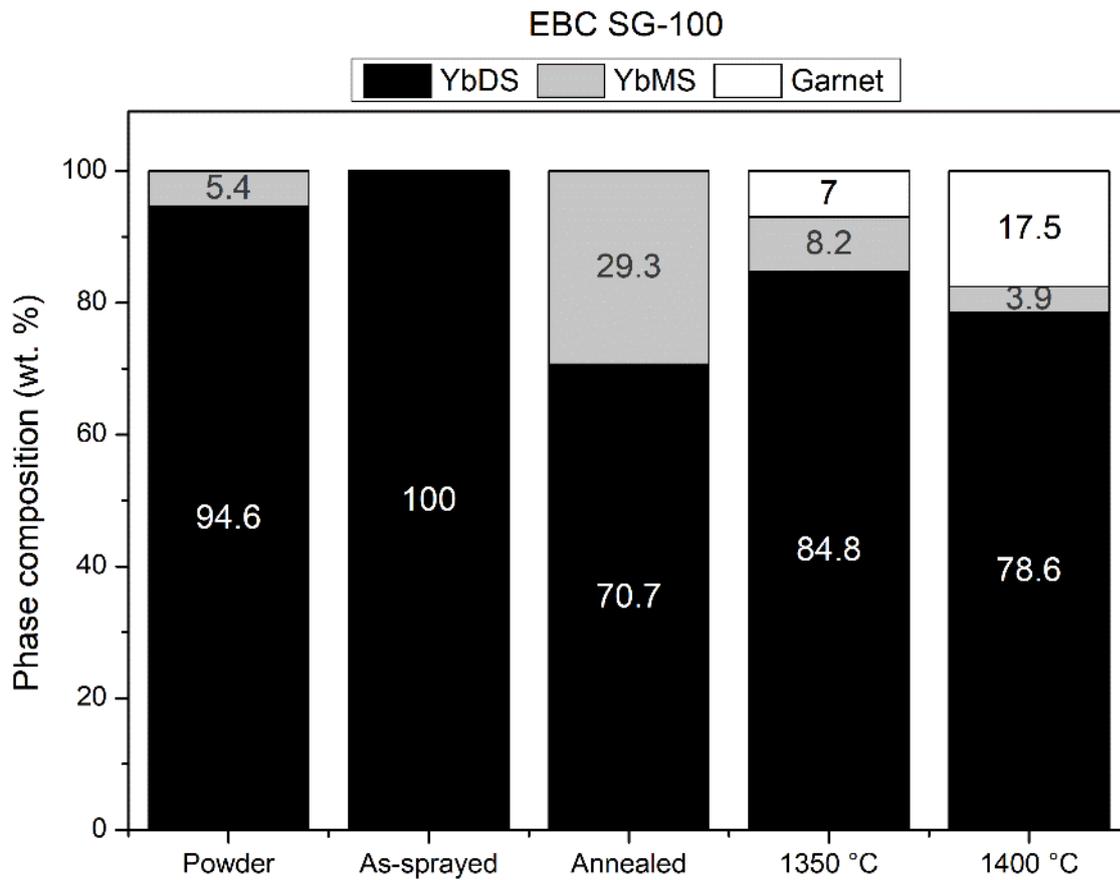
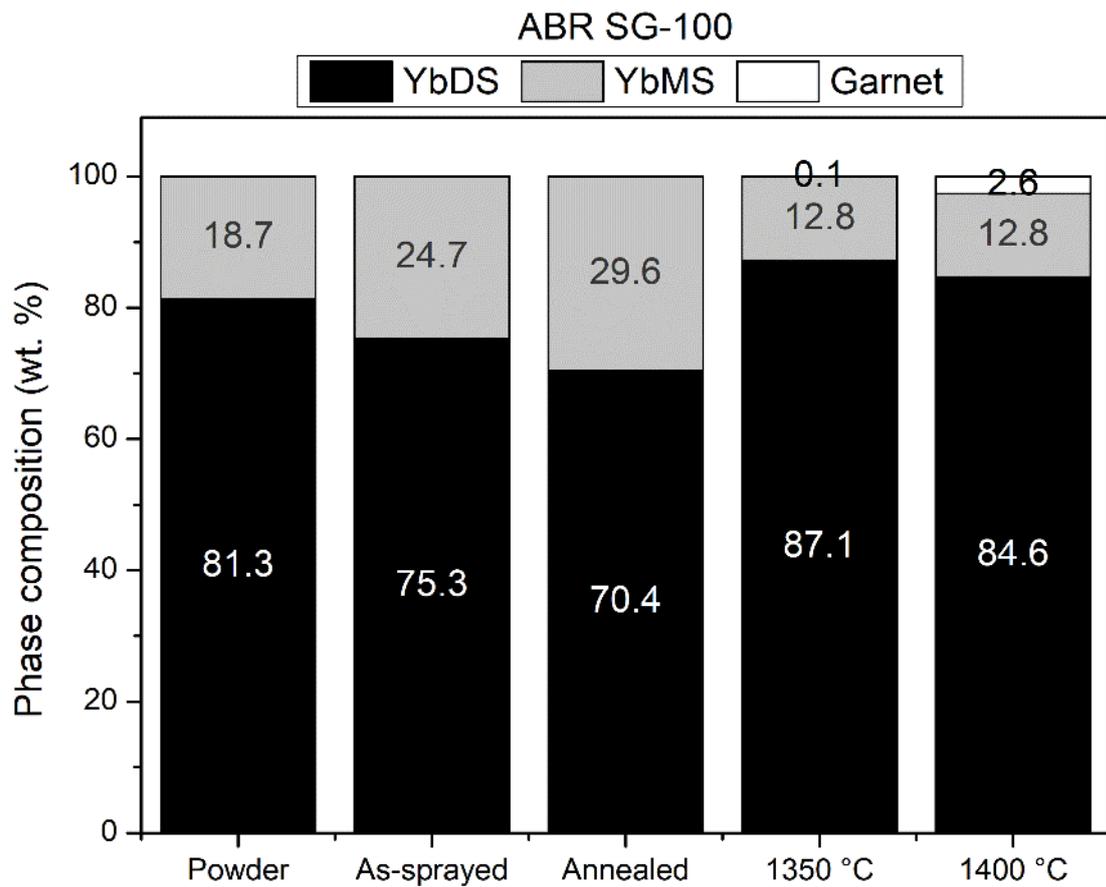
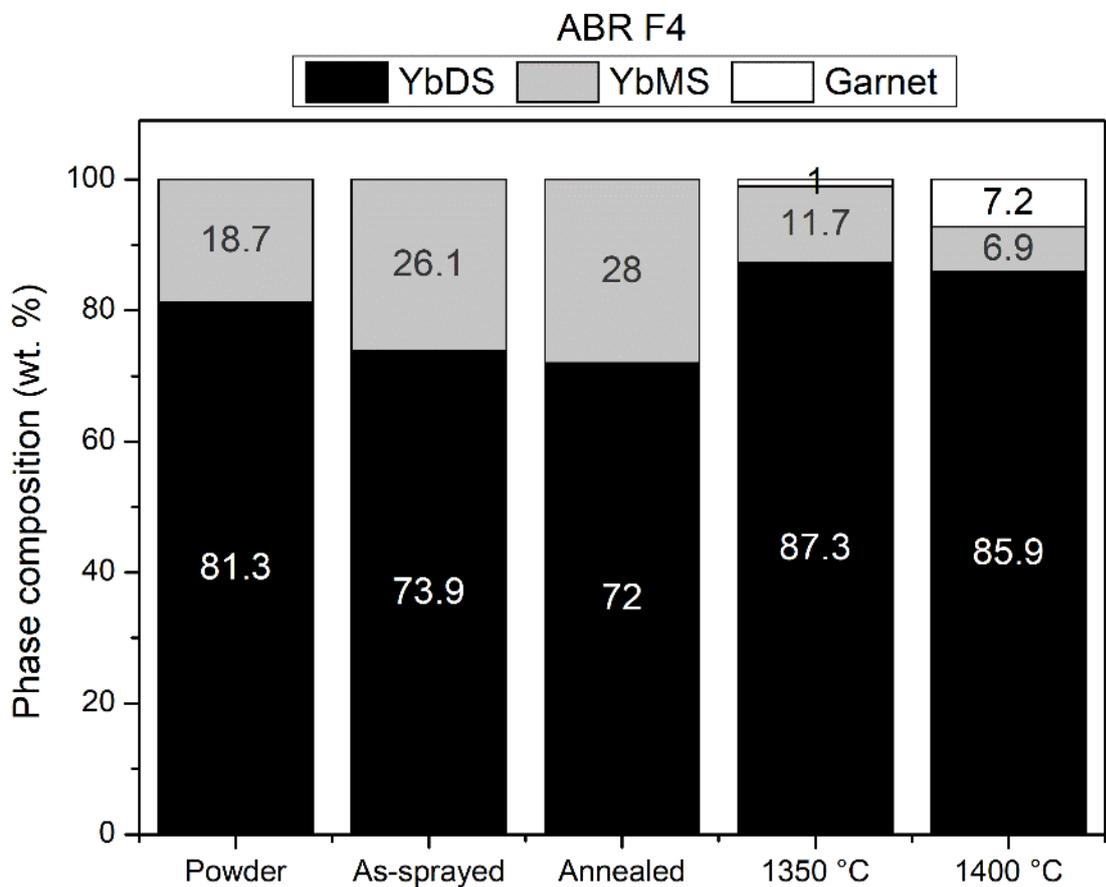
*Figure 11: Crystalline phase content quantified using Rietveld refinement for coatings EBC SG-100, ABR SG-100 and ABR F4*

The phase content as quantified through Rietveld refinement for all the samples here studied can be found in Figure 11.
