# Steam Degradation of Ytterbium Disilicate Environmental Barrier Coatings: Effect of Composition, Microstructure and Temperature

## Abstract

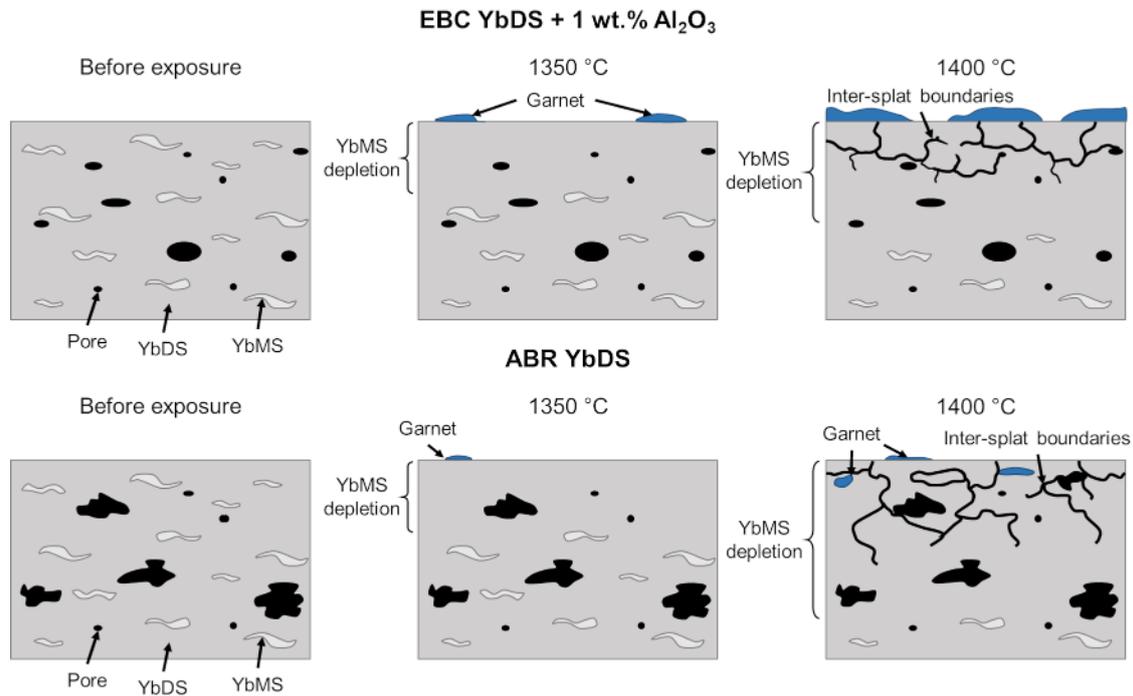
Figure 12: Schematic with the different behavior of EBC YbDS + 1 wt.% Al<sub>2</sub>O<sub>3</sub> and abrasible YbDS coatings when exposed to steam at high temperature

explain the phenomenon detected here. A schematic representing the interaction between high-temperature steam and both EBC YbDS coating and abrasible coatings is presented in Figure 12.

From Figure 12, it can be seen how EBC SG-100 presents depletion of YbMS once exposed to steam at 1350 °C, while forming small quantities of garnet located at the top surface. At 1400 °C, the formation of garnet is more extensive, leading to a scale at the surface and a slightly larger depleted layer. Inter-splat porosity can be observed in the depleted layer. In the case of the abrasible samples, exposure to steam at 1350 °C also produces a YbMS depleted layer, although lower quantities of garnet are formed due to the absence of added alumina to the coatings. At 1400 °C, however, evidence of garnet formation can be observed, both at the surface and inside pores located near the surface. The depletion layer is considerably larger, containing finer pores aligned with the splat boundaries, along with larger pores. As previously mentioned, the presence of these fine pores within the inter-splat boundaries indicates that splat boundary is the preferential ingress path of gaseous Al-containing impurities.
