Thermal and dimensional evaluation of a test plate for assessing the measurement capability of a thermal imager within nuclear decommissioning storage

J McMillan¹, M Hayes, R Hornby, S Korniliou, C Jones, D O'Connor, R Simpson and G Machin

National Physical Laboratory, Hampton Road, Teddington, TW11 0LW, UK

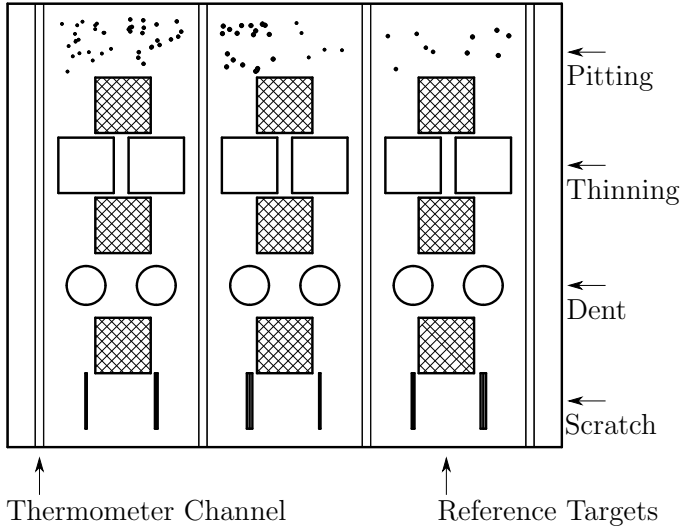
(a) Cross-section of the assembly.

(b) Lateral view of the target plate.

Figure 1: The assembly designed for this investigation. (a) Cross-section of the assembly, from inside to out: target plate, thermal conductor plate, heater and housing. (b) Lateral view comprising the artefact zones and coated reference targets.

A schematic of a cross-section from the assembly can be seen in Fig 1(a). For the highest heat conduction from the silicone rubber wire wound heater mat to the target plate, the two should be in direct contact with an appropriate pressure and thermal paste between them. To increase the heating uniformity for the target plate, an aluminium thermal conductor plate was placed in between. To reduce heat losses from the target-conductor-heater assembly, a low thermal conductivity housing was designed to surround it. This housing was designed to have a sufficiently thick wall in order to insulate the target-conductor-heater assembly and reduce heat transferred by natural convection to the surroundings.

An array of reference temperatures were determined through a set of thermocouples located between the target and thermal conductor plate. To avoid the thermocouples introducing an air gap between the two plates, a set of recessed thermometer channels were machined into the thermal conductor plate. To support the radiance temperature determination from the target plate, an array of coated regions was applied. The radiating surface of the target plate can be seen in Fig 1(b).

The plate was set up according to the schematic in Fig 1. One control thermocouple was mounted to the heater surface (between the heater and thermal conductor); one monitoring thermocouple was located within the centre of each thermometer channel, these were each class one type K thermocouples. The monitoring thermocouples were connected to a Fluke 1586A Super-DAQ precision temperature scanner. Each scanner channel was configured as a type K thermocouple and used the same internal reference point. The plate and thermocouple locations can be seen in Fig 6. The thermal imager was mounted 20° from the surface normal of the plate and at a distance of 480 mm from the plate to the front of the lens, this can be seen in Fig 7. At this angle, the distance from centre of the lens to both the far and near edges on the plate was estimated to range from 490 mm to 450 mm.

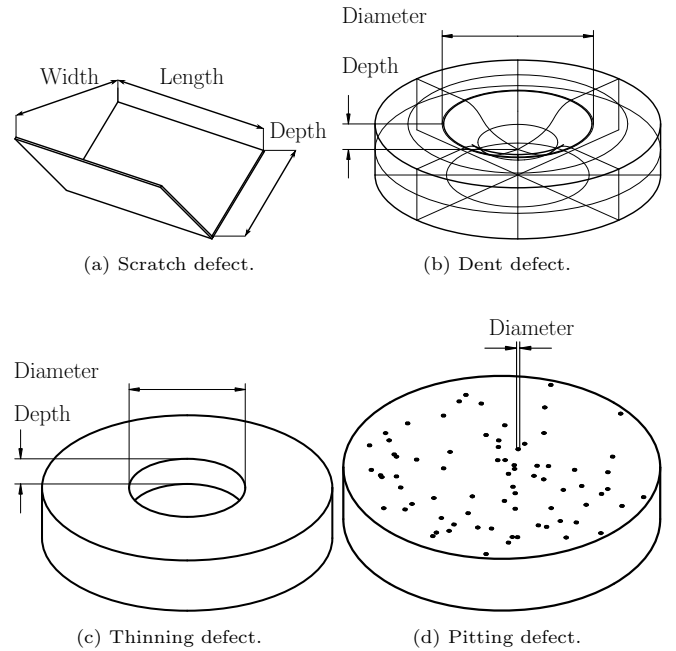
Figure 2: The array of surface defects engineered and their geometrical definition.

Dents are ellipsoidal impressions in a surface, this can be seen in Fig 2(b). The depth of the impression is the distance between the top edge and the centre of the base. The diameter is the distance between two top edges where the impression begins.

Surface thinning is a recess into a surface, this can be seen in Fig 2(c). The depth of the recess is the distance between the top edge and the base. The diameter is the distance between the two top edges where the recess begins.

Surface pitting is a random array of cylindrical voids of a specified diameter and depth, this can be seen in Fig 2(d). The diameter of the void distance between the

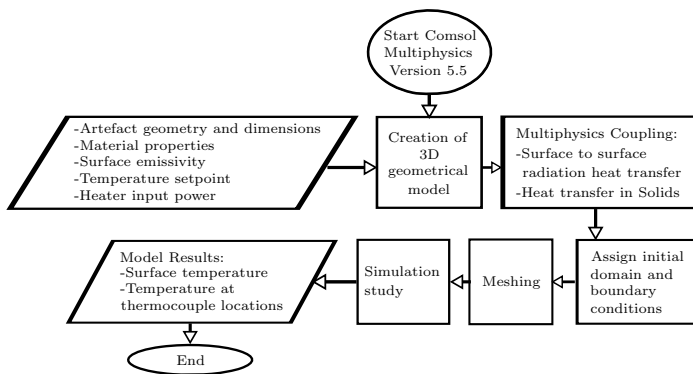
Figure 3: Flow chart of modelling steps using COMSOL.

In order to model heat transfer in the plate assembly, the heat transfer in solids interface was coupled with the surface to surface radiation interface in COMSOL Multiphysics V5.5. The solution was derived using finite element analysis. The computational problem was a 3D coupled conduction, convection and radiation heat transfer problem. In order to model this heat transfer process, both conduction in the solid, and natural convection in the surrounding fluid were taken into account. For natural convection, known correlations for heat transfer coefficients were used. The input, output and model flow process is described in a flow chart in Fig 3.

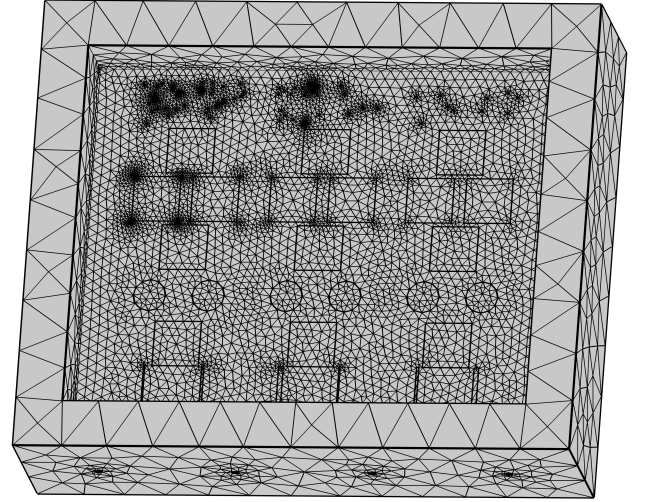
Figure 4: 3D mesh of target-conductor-heater-insulator assembly model produced by COMSOL.

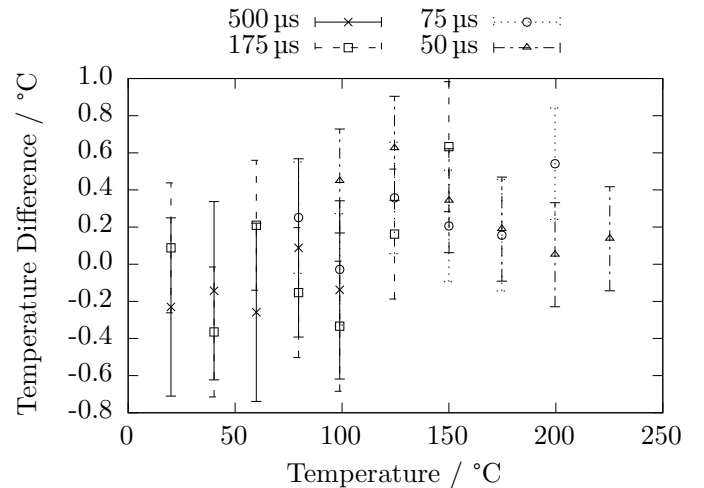
Figure 5: The validation measurements of the calibrated thermal imager. These measurements show the temperature difference between ITS-90 and the apparent radiance temperature from the thermal imager. The error bars indicate the expanded uncertainty with a coverage probability of 95%.

This was calibrated against a series of reference cavity blackbody sources from 20 °C to 225 °C as detailed in [9]. The suitability of this calibration across the temperature range for four integration times can be seen in Fig 5 by comparison of the calibrated apparent radiance temperature against ITS-90. In addition to this, additional temperature response checks accounting for the size-of-source effect [10] and distance variation were carried out.

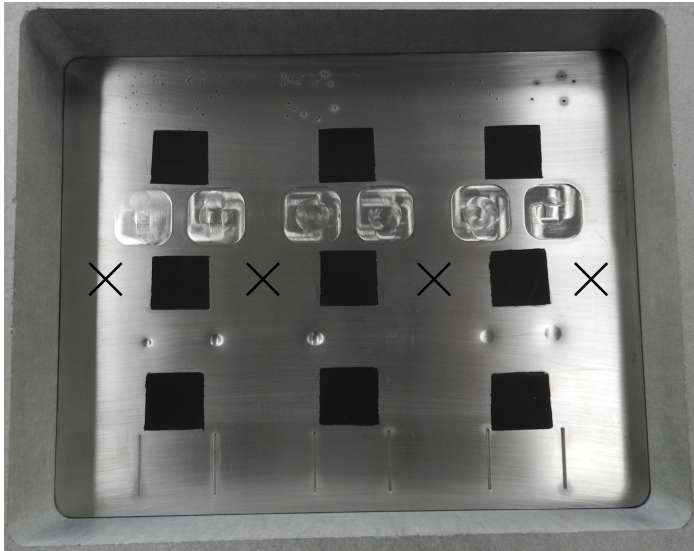
Figure 6: The target plate can be seen, the thermocouple locations are indicated by crosses.

The target plate was manufactured from stainless-steel 316L, its geometry was 1 mm thick, 200 mm long and 160 mm wide. The artefact zones were manufactured both internally and externally. The pitting was manufactured using centre drills, the scratches and thinning were manufactured using a 12 mm carbide slot drill. The dents were manufactured using a range of ball bearings mounted within an Avery 7110 compression machine that were loaded up to 30 kN. From left to right (in Fig 1(b)) the dents were manufactured using a 10 mm ball bearing under 10 kN, 20 kN and 30 kN load, and a 40 mm ball bearing under 10 kN, 20 kN and 30 kN load respectively. Following the artefact manufacturing, the 20 mm square reference targets were coated with Senotherm Ofen-spray schwarz 17-1644-702338 paint in order to ensure a higher emissivity region for surface radiance temperature measurement. From previous experience and similar coatings, it is anticipated that the emissivity of this material is close to 0.85 [7]. The completed artefact can be seen in Fig 6.

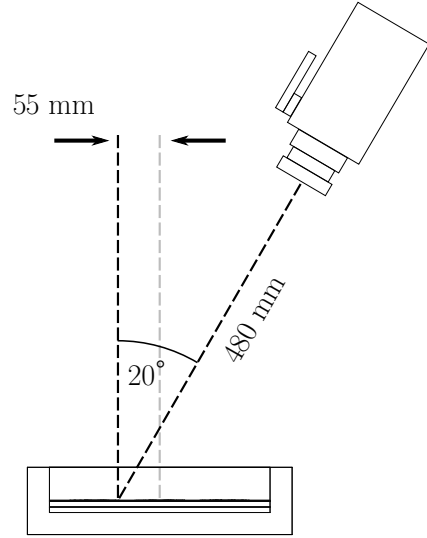
Figure 7: Schematic diagram of the thermal imager observing the plate. The imager was 20° from the surface normal and there was nominally 480 mm between the plate to the front of the lens. The distance from the centre of the plate to the intersection of the imager optical axis was nominally 55 mm.

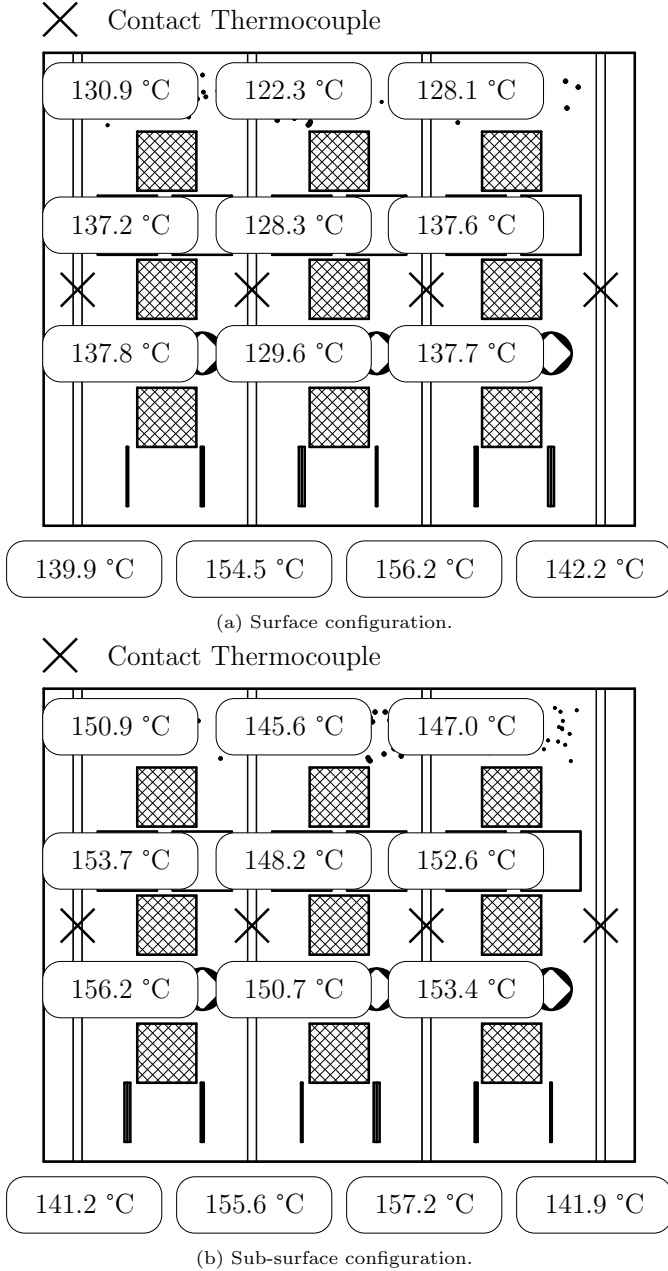
Figure 8: The measured temperature distribution of the plate during measurements at 170°C. The four measurements at the bottom correspond to the respective thermocouples indicated by the crosses. The nine central values denote the emissivity corrected radiance temperatures of the adjacent regions. During the sub-surface measurements the same array locations to the surface configuration coated regions were evaluated. Note that the artefacts are shown for context but both coated regions and artefacts were present on the rear surface from view in the sub-surface measurements.

The radiance and thermocouple temperatures for the surface and sub-surface plate configurations at a heater setpoint temperature of 170 $^{\circ}\text{C}$ can be seen in Fig. 8. Here the radiance temperature for the coated regions (hatched squares) are evaluated as the mean from the image series and over the appropriate integration times; the thermocouple temperatures were similarly evaluated over the measurement sequence and their location is indicated by the cross.

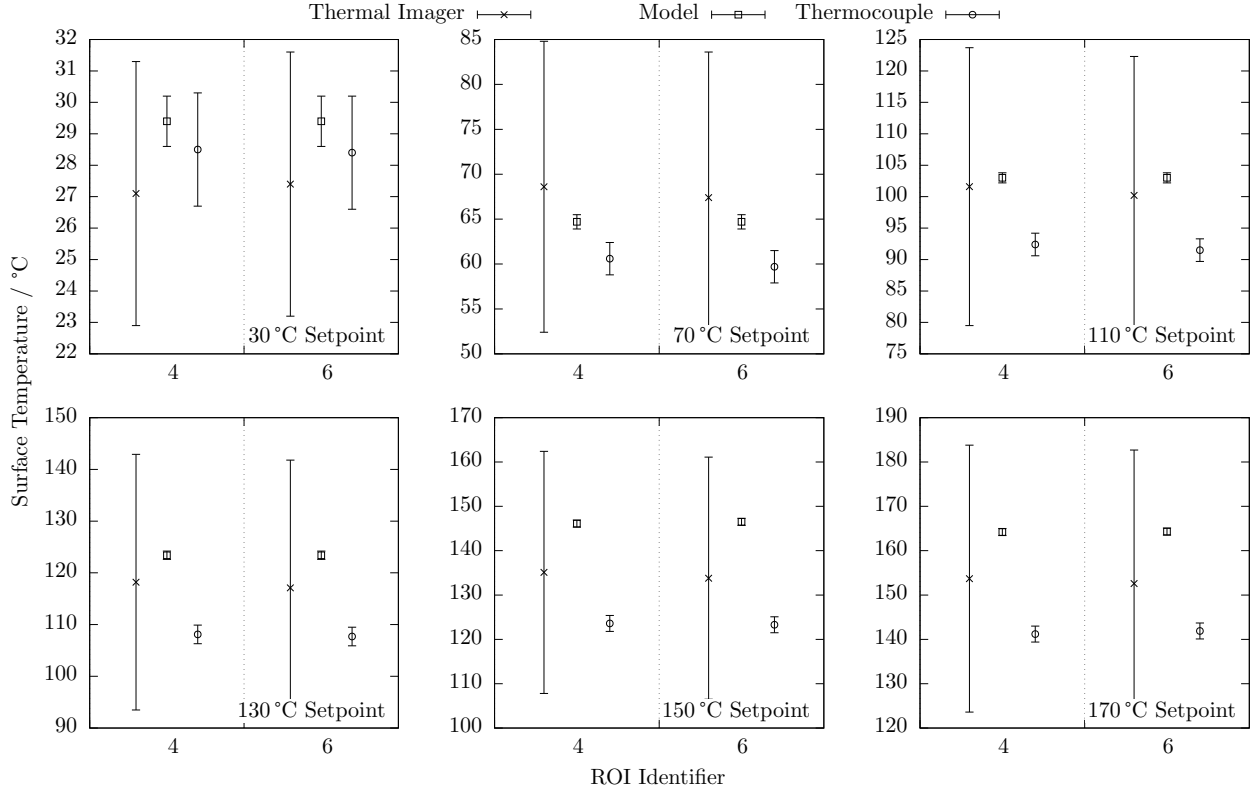
Figure 10: A comparison between the surface temperature determinations of the uncoated regions using the thermal imager, thermocouples and the model with their equivalent uncertainties ($k = 2$) at each temperature setpoint.

For the sub-surface plate measurements (uncoated stainless-steel) seen in Fig. 10, the thermocouple and radiance measurements are in agreement at all temperature setpoints. In this case the radiance temperature is typically greater than the contact measurement; therefore a greater emissivity of 0.25 (as opposed to 0.20) may be more appropriate. The model temperature does not agree with the thermocouples but does agree with the thermal imager. Both of these reduced dataset comparisons support a moderate reduction in the measurement uncertainty of each instrument, assuming the agreement with the model can be demonstrated.

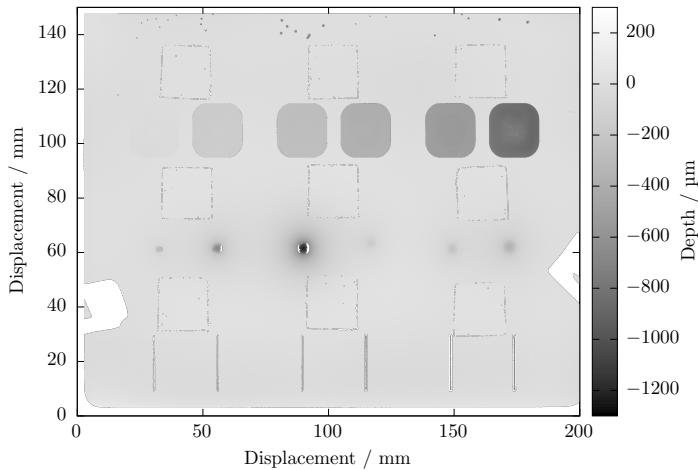
Figure 11: Dimensional topography measurement of the plate and the surface artefacts. Note that regions of large depth gradient were not measurable and were out of range, these are white in this representation. A number of the pitting artefacts are not displayed here but were measured in a separate data set.

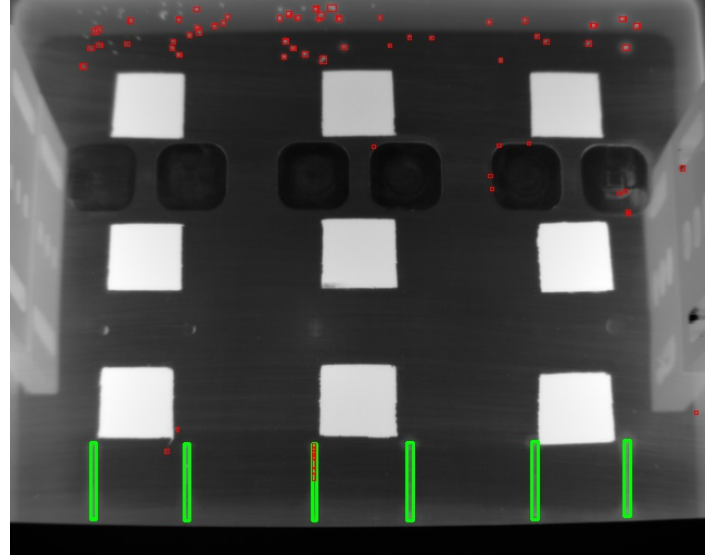
Figure 12: Plate surface artefacts identified using the contrast-based image analysis. The results at 170°C and $50 \mu\text{s}$ show identified pits in red circles and scratches in green rectangles.

The effectiveness of the geometrical defect measurements using thermal imagers can be seen in Fig. 12, the complete dataset can be seen in the Appendix. It can be seen that for most temperature setpoints, the thermal imager is capable of successfully identifying both scratches and pitting on the surface of the plate. However, it should be noted that for lower temperature surfaces, there were a significantly larger number of false positives due to the higher level of noise present in the images. This indicates that thermal imagers could be used for defect detection in regimes where a sufficient level of thermal contrast is visible.

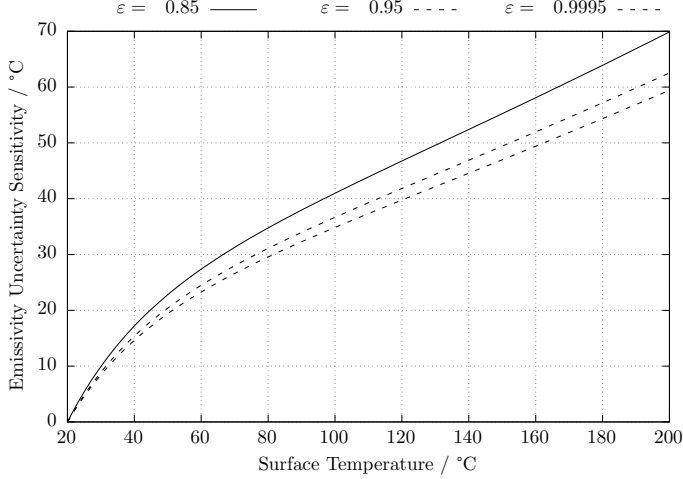
Figure 13: Functional form of the emissivity sensitivity (Eq. 6) for increasing temperature at a number of emissivities for a single wavelength and ambient temperature. Note that this sensitivity is largely dominated by the difference between apparent and ambient temperatures and that the emissivity itself has a smaller effect.

between apparent and ambient temperatures as opposed to the emissivity itself (see Fig. 13).

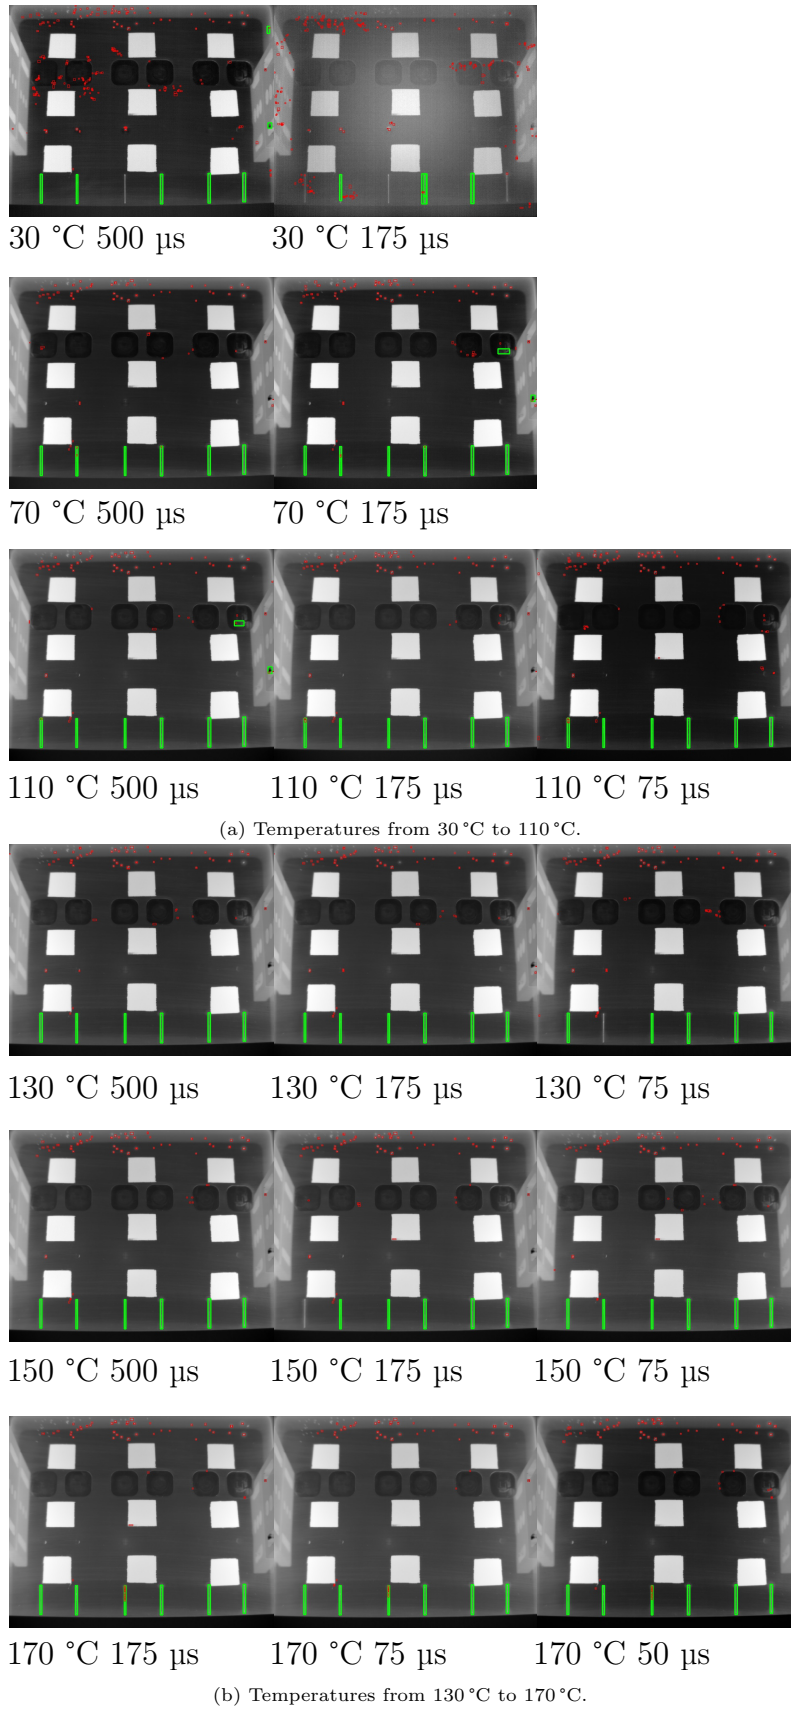
Figure 14: Geometric defects identified using the thermal during each of the measurement sets. The green outline corresponds to a detected scratch and the red outline denotes a pit.

A complete set of results from the defect detection can be seen in Fig. 14(a) and Fig. 14(b); for each temperature setpoint the respective imager integration times are denoted. The green outline corresponds to a detected scratch and the red outline denotes a pit.
