Effect of annealing on the corrosion-fatigue strength and hot salt corrosion resistance of fine-grained titanium near- α alloy Ti-5Al-2V obtained by Rotary Swaging

Abstract

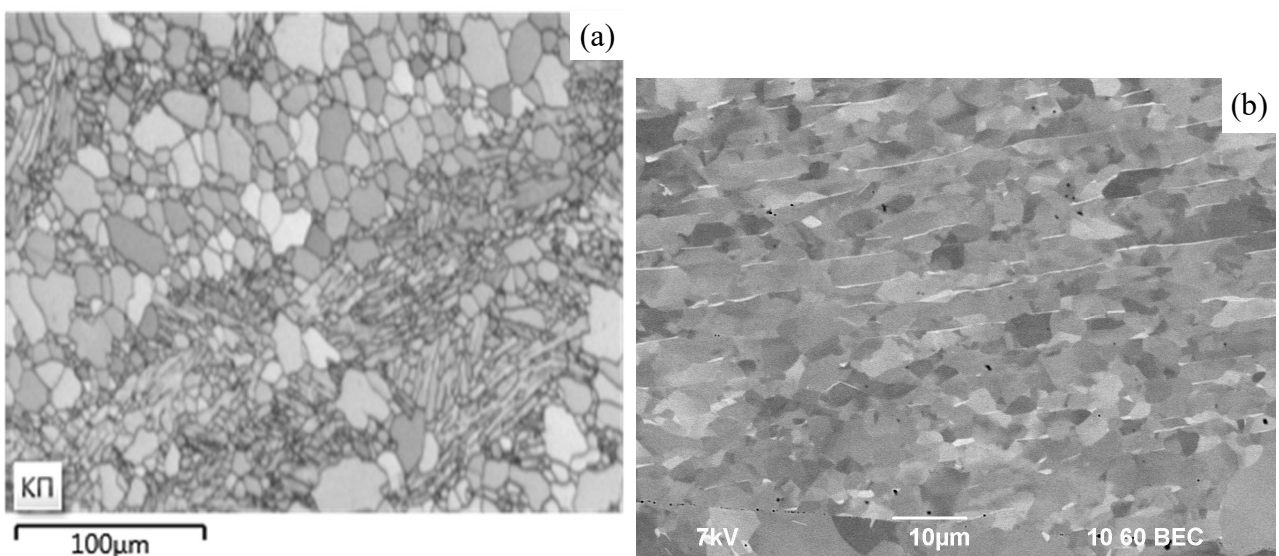
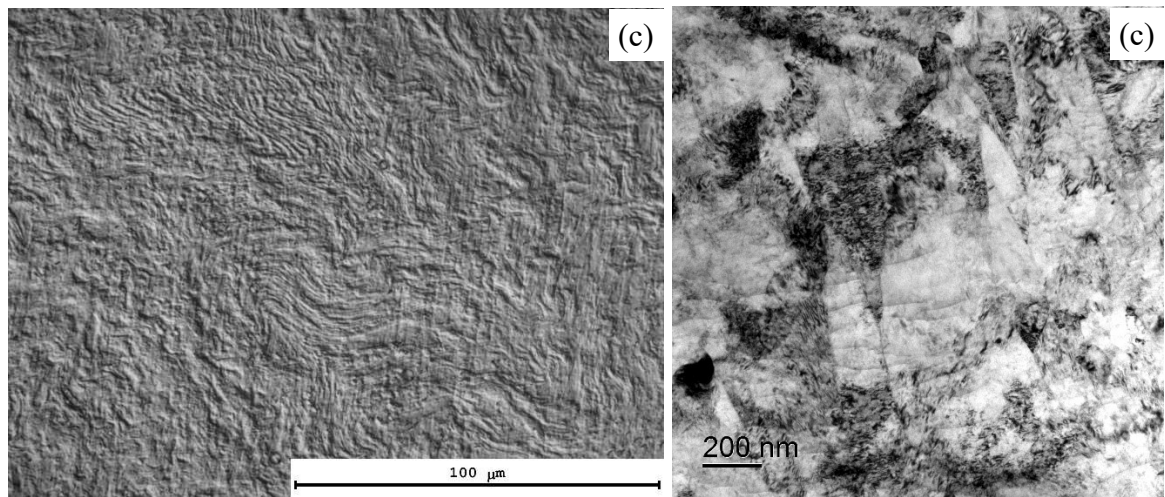
Fig. 1 Structure of the Ti-5Al-2V alloy: (a, b) microstructure of the coarse-grained alloy (SEM) [35]; (c) macrostructure of the UFG alloy; (d) microstructure of the UFG state after RS (TEM) [35]

The microstructure of the coarse-grained Ti-5Al-2V alloy in its initial state was described in detail in [35], and we will not dwell on this issue in details here. It is important to stress that the microstructure of the titanium alloy in the initial state is highly nonuniform – the microstructure of the alloy consists of equiaxial α -grains up to 50 μm in size surrounded by areas of smaller plate-like α' -grains (Fig. 1a, b), along the boundaries of which precipitation of β -phase particles can be observed (Fig. 1b). Such a microstructure is conventional for titanium near- α alloys obtained by hot deformation with a gradual decrease in temperature from the β -region to the $(\alpha+\beta)$ -region [57]. The microhardness of the coarse-grained alloy in the initial state is $H_v = 1.9\text{-}2.0 \text{ MPa}$. The yield strength of a titanium alloy in its initial state is $\sigma_{0.2} \sim 735\text{-}800 \text{ MPa}$, which is 135-150 MPa higher than the

An inhomogeneous macrostructure is formed in the titanium rod after the RS. The vortex-like macrostructure characteristic of the RS is clearly visible on the cross section of the rod (Fig. 1c, see [49-52]). After RS, a UFG microstructure with an average fragment size of $\sim 0.2\text{-}0.5 \mu\text{m}$ was formed in the alloy. (Fig. 1d). Analysis of the results of electron microscopy has shown that the fine-grained microstructure obtained by RS can be characterized as a mixed grain-subgrain microstructure (Fig. 1d). No large β -phase particles were found in the microstructure of UFG alloys. Probably their strong grinding occurred during RS. The average microhardness of the UFG alloy was $3.0\text{-}3.1$ GPa. The hardness of the samples surface layer was $150\text{-}200$ MPa higher than the one of the central part of the sample (Fig. 2). The yield strength $\sigma_{0.2}$ of the alloy increases to 795 MPa after RS, and the physical yield strength σ_y increases to 1070 MPa (Table 1). After RS, the value of the Hall-Petch coefficient of Ti-5Al-2V titanium alloy decreases to $K \sim 0.45\text{-}0.5 \text{ MPa}\cdot\text{m}^{1/2}$ (at $d = 0.5 \mu\text{m}$).

Now let us discuss the reasons for the decrease in the fatigue characteristics of the fully recrystallized Ti-5Al-2V alloy as compared to the characteristics of the coarse-grained alloy (Table 1, Fig. 8). As it was shown earlier, recrystallization annealing leads to the formation of an equilibrium microstructure, where the grain boundaries have a low density of excess defects. In addition, the grain boundaries of the recrystallized titanium alloy are free from large β -phase particles (Fig. 3), which are present in the grain boundaries of the coarse-grained alloy (Fig. 1b). This leads to rapid

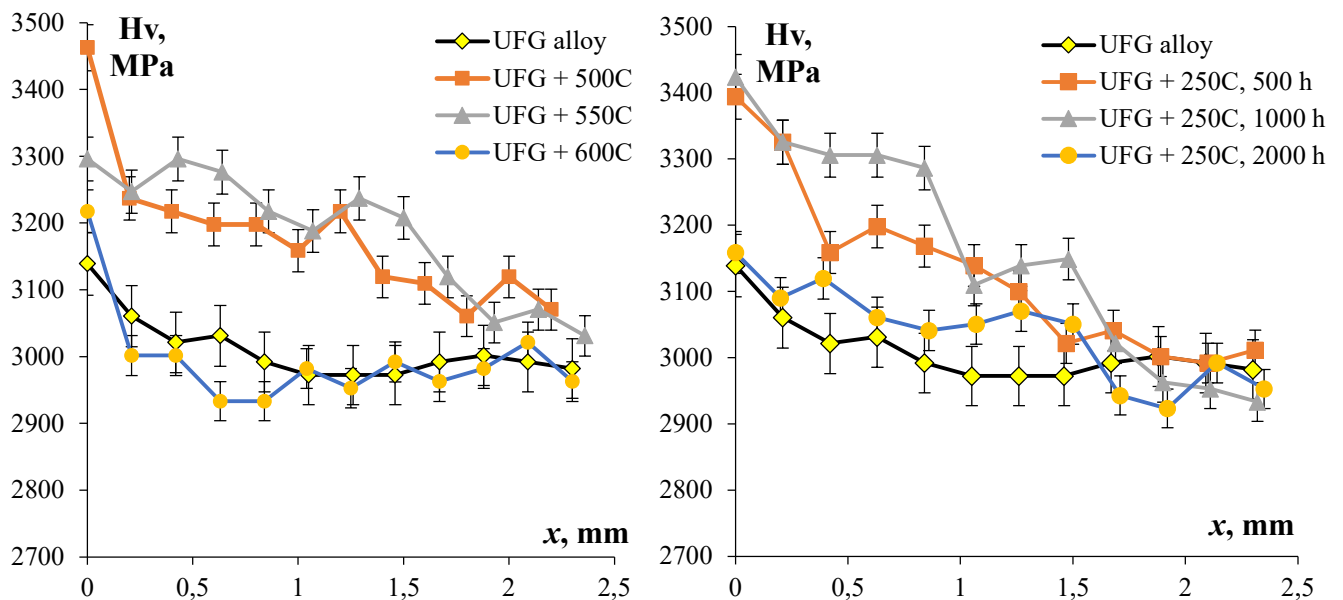
Fig. 2 Distribution of microhardness along the bar diameter after different treatment modes: (a) the effect of the 30-minute annealing temperature; (b) the effect of the annealing time at 250 °C

The results of the microhardness investigation of the annealed alloys are presented in Fig. 2. From Fig.2a, one can see that the microhardness of the Ti-5Al-2V alloy increases when heated up to 550°C and exceeds the microhardness of the unannealed UFG alloy. The microhardness of the UFG alloy also increases after 500-1000 hours of exposure at 250 °C (Fig. 2b). It should be noted that the uneven distribution of microhardness over the diameter of the titanium rod remains (Fig. 2). The effect of increasing microhardness in the Ti-5Al-2V UMP alloy is associated with the release of TiC nanoparticles [35]. After heating up to 600-700°C, a decrease in microhardness was observed attributed to the recovery and to the start of grain growth (Fig. 3). The unevenness of the hardness distribution in annealed alloys decreases, primarily due to a decrease in the microhardness of the surface layer (Fig. 2).

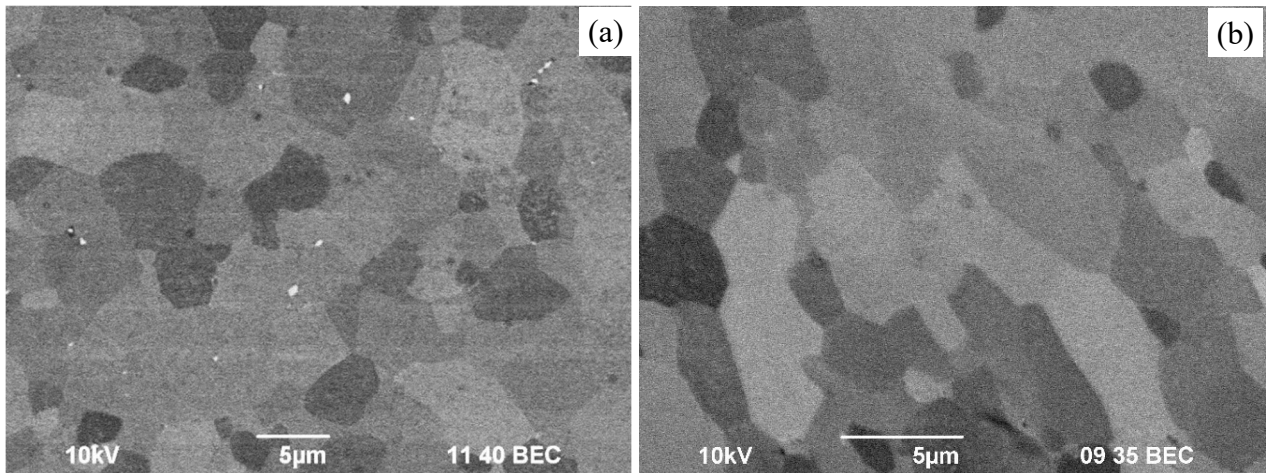
Fig. 3 Microstructure of the Ti-5Al-2V alloy after annealing at 700°C for 30 minutes: (a) edge of the sample; (b) center of the sample. SEM

temperature in the UFG Ti-5Al-2V alloy after RS is close to the grain growth start temperature in the UFG Ti-5Al-2V alloy obtained by ECAP [35]. After a 30-minute annealing at a temperature of 700°C, a fully recrystallized microstructure with grain sizes ranging from 1 to 10 μm was observed (Fig. 3). The central parts of the samples had a larger grain sizes than the edge ones (Fig. 3). This is due to the nonuniform distribution of strain from the sample surface to the center during RS.

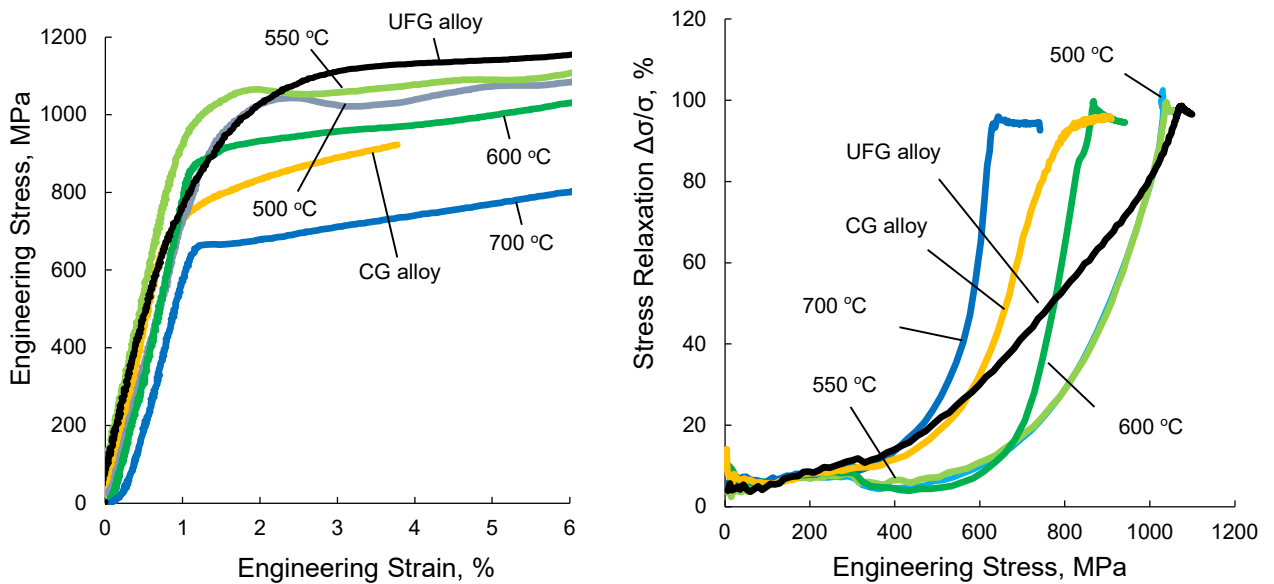
Fig. 4 Stress-strain curves for the titanium alloy Ti-5Al-2V samples during compression tests: (a) tests according to GOST 25.503-97; (b) stress-relaxation tests according to GOST R 57173-2016

The results of the comparative tests of the samples are summarized in Table 1. The stress-strain curves of the samples are shown in Fig. 4. The analysis of the results shows that RS leads to an increase in the yield strength as well as an increase in the flow stress corresponding to the onset of the stage of uniform plastic deformation of the UFG material. Annealing results in a reduction in the yield strength and flow stress of the UFG material. It is noteworthy that after a 30-min annealing at 700°C, the mechanical properties of the UFG alloy decrease to values that are lower than the one of the coarse-grained alloy in its initial state (Table 1, Fig. 4). This is quite an unexpected result, as it is assumed traditionally that annealing of UFG metals leads to a decrease in mechanical properties to the level corresponding to the performance of the coarse-grained metal.

Attention should be paid to the results of stress-relaxation compression tests shown in Fig. 4b and in Table 1. From the Table 1 it can be seen that the dependence $\sigma_0(T)$ has a maximum at 550-600 °C. Previously, a similar dependence of $\sigma_0(T)$ was found for the UMP alloy Ti-5Al-2V obtained by the ECAP method and using *in-situ* TEM it was shown that it is due to the release of titanium carbide particles [35].

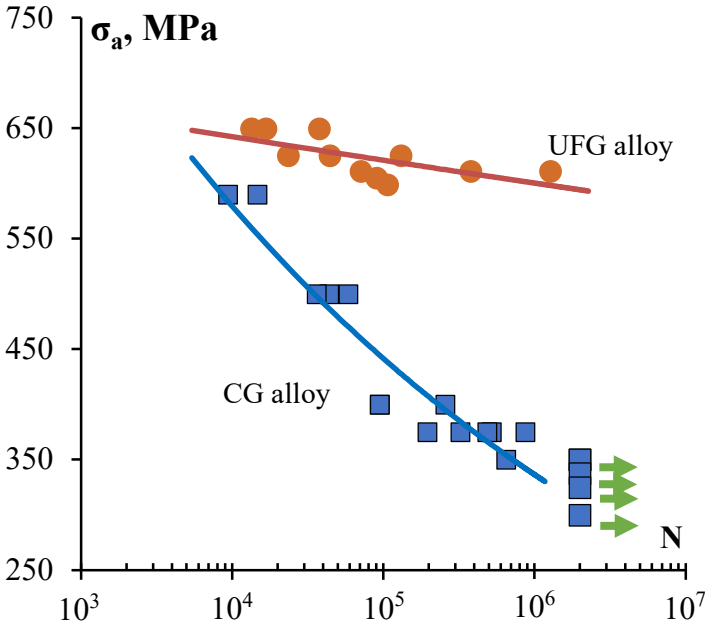
Fig. 5 Results of corrosion-fatigue tests of coarse-grained and UFG Ti-5Al-2V alloy

The results of the corrosion-fatigue tests of the coarse-grained and UFG Ti-5Al-2V alloy samples in the unannealed state are presented in Fig. 5. The slope of the $\sigma_a(N)$ curve for the UFG alloy is much greater than the one for the coarse-grained alloy. Note also that the UFG alloy has much higher cyclic durability – at a stress amplitude of 590-600 MPa, the number of cycles to failure for the coarse-grained alloy is $(0.9-1.5) \times 10^4$ cycles while for the UFG alloy it exceeds 10^5 cycles. The fatigue limit for the UFG alloy based on $N^* = 3 \cdot 10^6$ cycles is $\sigma_{-1} = 600-610$ MPa, which significantly exceeds the fatigue limit of the coarse-grained alloy ($\sigma_{-1} = 300-320$ MPa). The relative fatigue limit

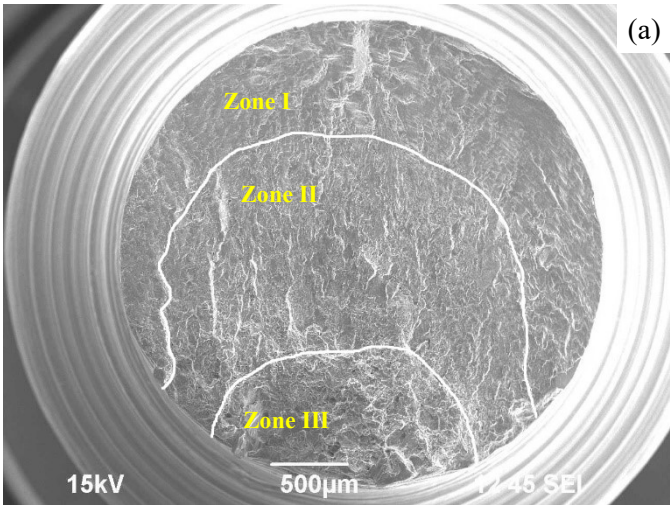
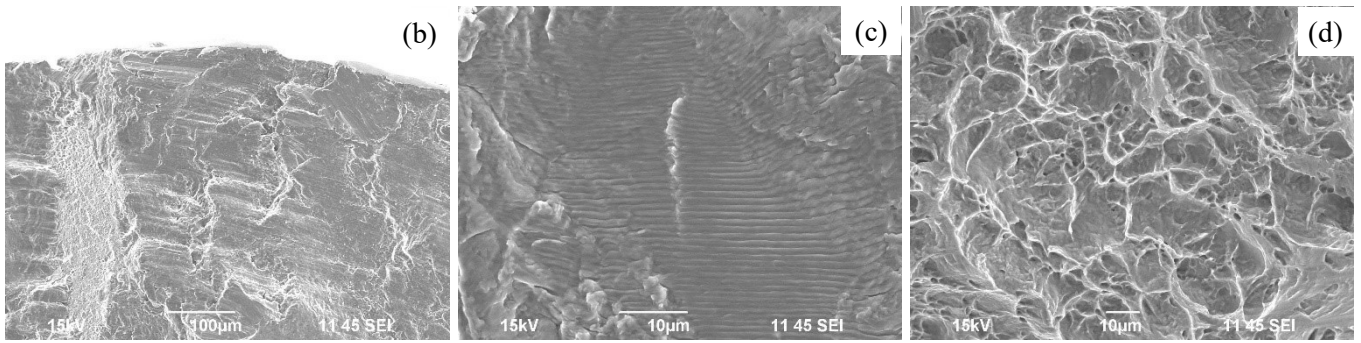
Fig. 6 Fractographic analysis of the fracture surfaces of coarse-grained Ti-5Al-2V alloy samples: (a) general view of the fracture; (b) microcrack initiation area (zone 1 in Fig. 6a); (c) crack growth zone (zone 2 in Fig. 4a); (d) break region (zone 3 in Fig. 6a). Stress amplitude 500 MPa. SEM

Fig. 6 shows the results of SEM analysis of the fracture surfaces of the coarse-grained alloy samples after corrosion-fatigue tests. The fracture structure in Fig. 6 is typical for fractures of samples after fatigue tests (see [59]).

Several characteristic zones can be distinguished on the fracture surfaces of the coarse-grained samples (Fig. 6a): the microcrack initiation zone (Zone #1), the crack growth zone (Zone #2), and the break zone (Zone #3). Depending on the stress amplitude magnitude, one or several microcrack initiation zones can be observed. At high stress amplitude magnitudes, typically only one crack initiation zone is observed. Study of Zone #2 indicates that the microcrack initiation occurs via the intragranular mechanism. The area of crack growth (Zone #2) is the largest one; the fracture surface at the stage of stable crack growth exhibits a mixed brittle-ductile nature. In Zone #2, the areas of brittle fracture (facet inside the grain, Fig. 6b) and the ones of ductile fracture (fatigue beachmarks, with an average spacing of $\sim 1 \mu\text{m}$, Fig. 6c) can be observed. In the break zone of the sample (Zone #3), numerous pits and dimples indicative of ductile fracture are observed (Fig. 6d).

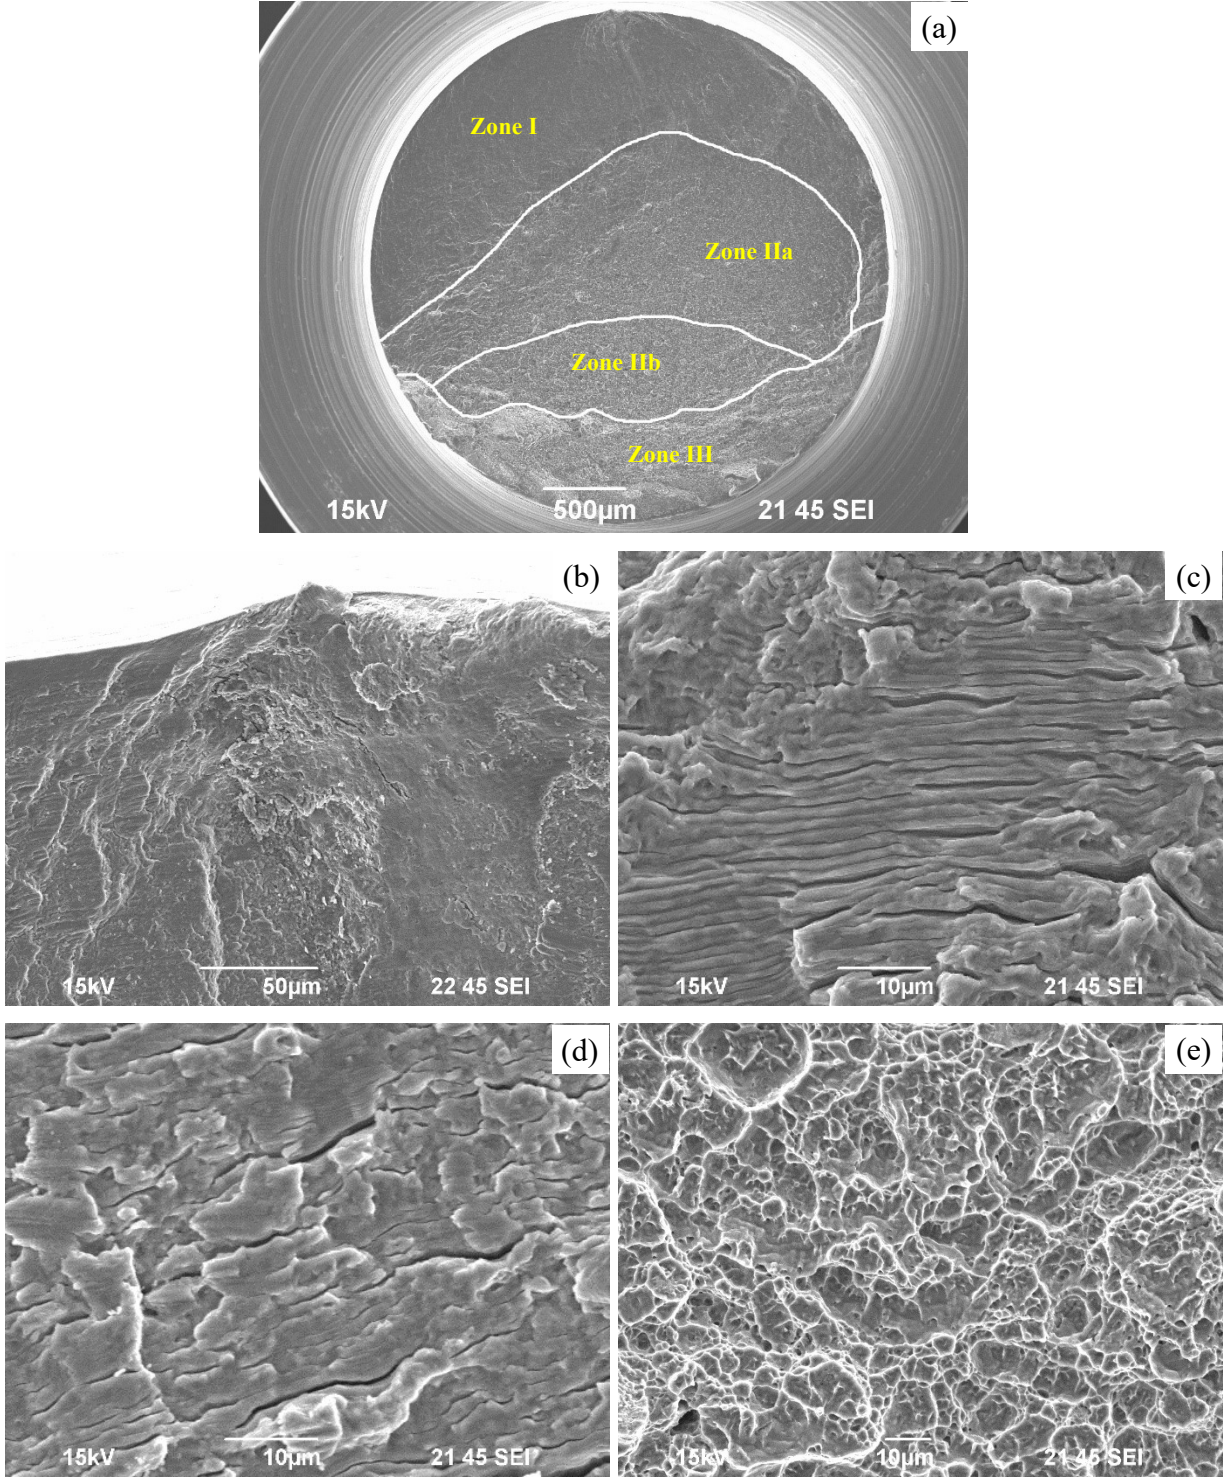
Fig. 7 Fractographic analysis of the fracture surface of UFG Ti-5Al-2V alloy samples: (a) general view of the fracture; (b) microcrack initiation area (Zone #1 in Fig. 7a); (c) stable crack growth zone (Zone #2a in Fig. 7a); (d) accelerated crack growth zone (Zone #2b in Fig. 7a); (e) break region (Zone #3 in Fig. 7a). Stress amplitude 620 MPa. SEM

The fatigue fractures of the UFG Ti-5Al-2V alloy samples have a more complex nature – Zone #2 is divided into a stable microcrack growth zone (Zone #2a) and an accelerated crack growth zone (Zone #2b) (Fig. 7). The fracture of the UFG alloy at the stage of stable crack growth exhibits a mixed brittle-ductile nature. Due to the small grain size, no intragranular facets are observed in the stable crack growth zone. In the Zone #2a, fatigue beachmarks are often observed (Fig. 7c). The distance between the fatigue beachmarks in the UFG samples is much smaller than in coarse-grained samples. The obtained result indirectly indicates that the growth rate of fatigue cracks in UFG alloys turns out to be much lower than in coarse-grained alloys. In the accelerated crack growth zone,

secondary cracks are often observed (Fig. 7d). According to [59], the presence of the secondary cracks indicates ductile fracture in the accelerated crack growth zone. The area of Zone #3 in the UFG samples is much larger than in the coarse-grained samples. Numerous pits resulting from the merging of micro-pores can be observed in Zone #3, indicating the ductile nature of the fracture of the UFG material.

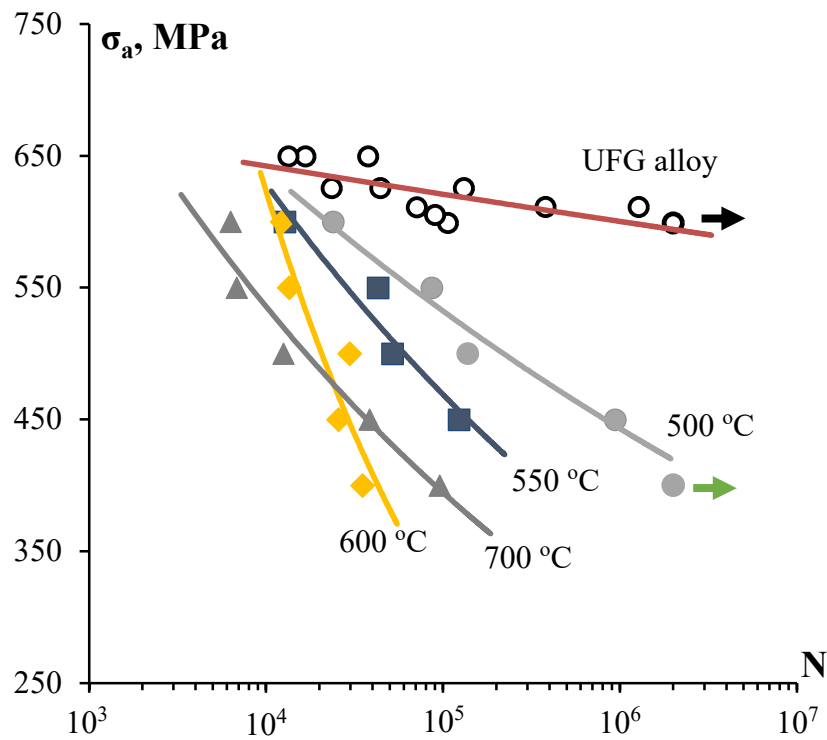
Fig. 8 Results of corrosion-fatigue studies of annealed UFG alloys

Fig. 8 shows the $\sigma_a(N)$ dependencies for the UFG Ti-5Al-2V alloy samples subjected to 30-minute annealing at various temperatures. For ease of the analysis, the results of fatigue tests of the unannealed UFG Ti-5Al-2V alloy in the as-swaged state are also presented in Fig. 8. One can see from Fig. 8 and Table 1 the slopes of the $\sigma_a(N)$ curves to depend on the annealing temperature non-monotonously – the slope increased with increasing annealing temperature up to 600°C and decreased again after annealing at 700°C. At the same time, an increase in the annealing temperature resulted in a decrease in the fatigue limit and a reduction in the fatigue life of the alloy. The fatigue characteristics of the UFG Ti-5Al-2V alloy after annealing at 600 and 700°C are close to the ones of the coarse-grained alloy.

So far, the alloy with a partially recrystallized microstructure manifested an anomalous increase in the slope of the $\sigma_a(N)$ curve. In the UFG material with a fully recrystallized microstructure, the slope of the $\sigma_a(N)$ curve decreased again (Fig. 8). It is noteworthy that the non-monotonous nature of the change in the slope is quite an unexpected result. Traditionally, annealing is assumed to lead to a monotonous decrease in the parameter q in the Basquin equation. It should be noted also that the reduction in fatigue strength characteristics of the UFG titanium alloy Ti-5Al-2V begins at temperatures (500-550°C) lower than the grain growth start temperature (see Subsection 3.1).

The effect of annealing temperature on the coefficient A in the Basquin equation is quite unusual. As one can see from Fig. 8 and Table 1, the increase in the slope of the $\sigma_a(N)$ curve was observed in the UFG alloy with partially recrystallized microstructure, and after annealing at 700°C, the slope of the $\sigma_a(N)$ curve decreases again. It should be noted also that the value of coefficient A in the UFG alloy was smaller than in the coarse-grained alloy (Table 1).

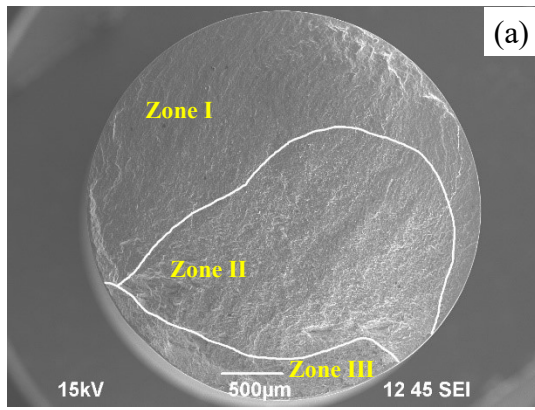
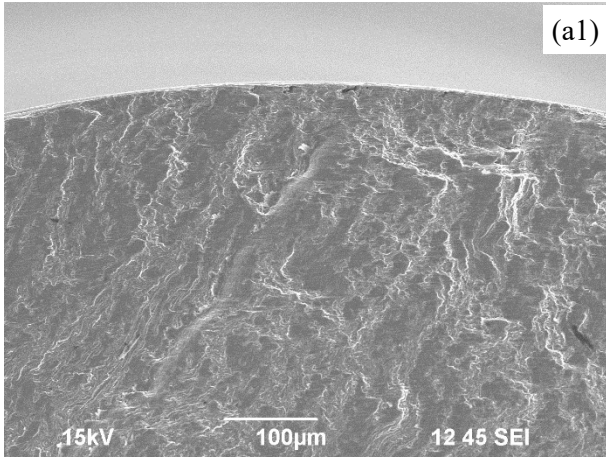
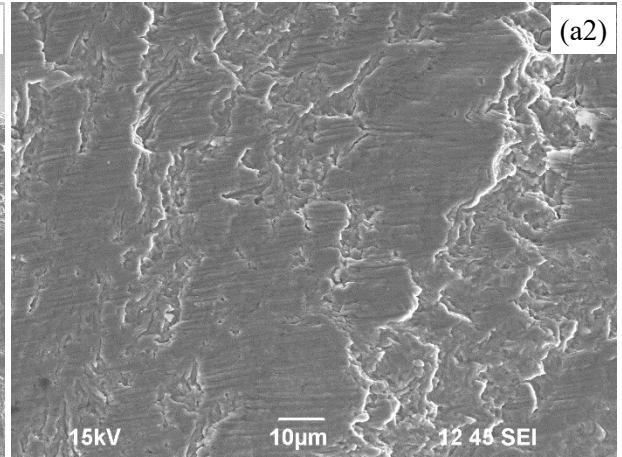
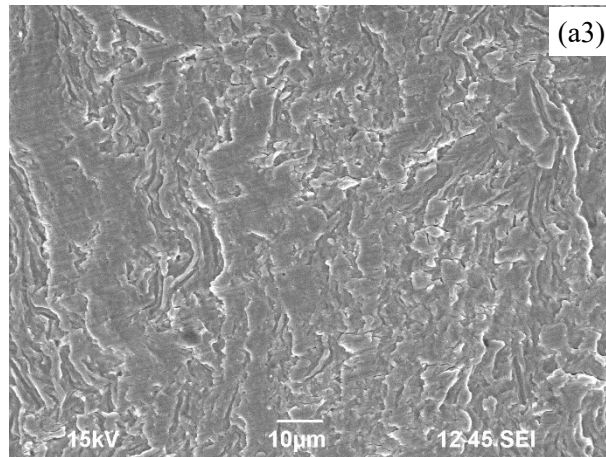
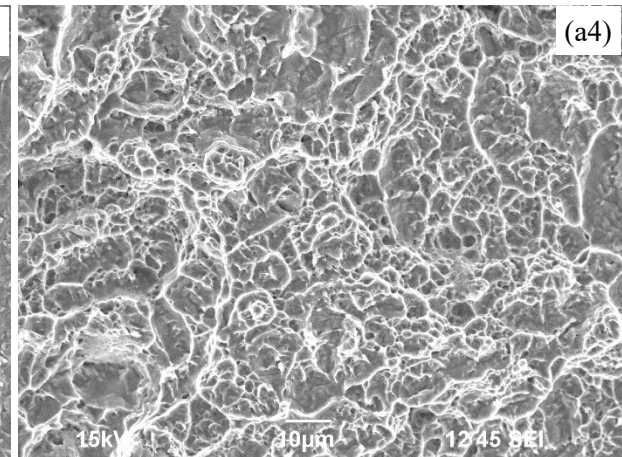
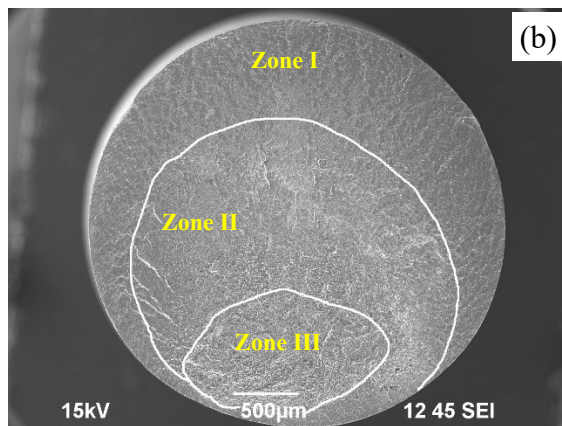
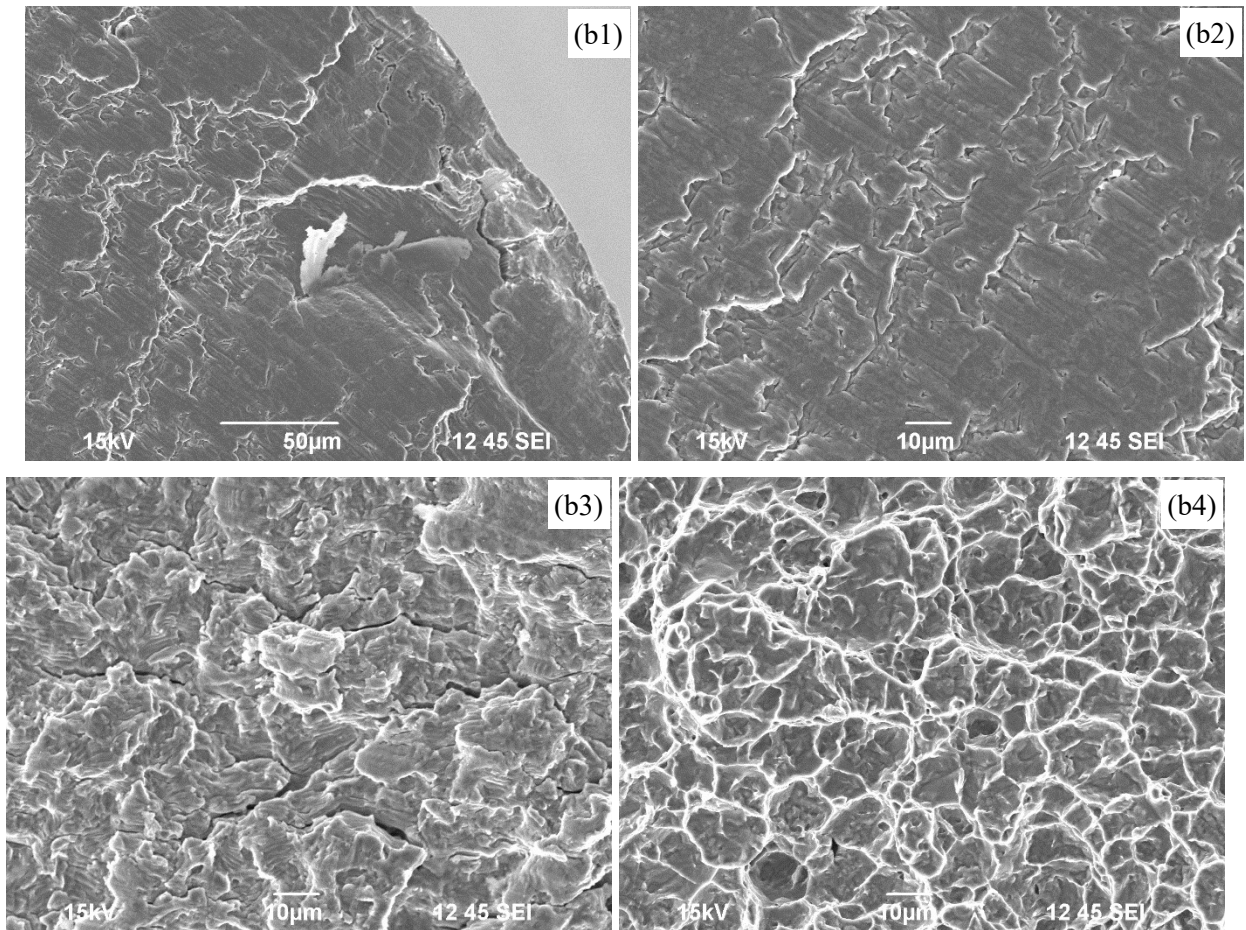
Fig. 9 Fractographic analysis of fractures of UFG alloy samples after annealing at temperatures of 500 °C ($\sigma_a = 450$ MPa) (a, a1, a2, a3, a4) and 700 °C ($\sigma_a = 400$ MPa) (b, b1, b2, b3, b4): (a, b) general view of the fracture; (a1, b1) microcrack initiation area (Zone #1), (a2, a3, b2, b3) crack growth area (Zone #2); (a4, b4) break zone (Zone #4). SEM

Fig. 9 shows the results of fractographic analysis of fractures of annealed UFG samples after corrosion and fatigue tests. The analysis of the results of fractographic studies shows that on the surface of the fractures of annealed samples, an area of microcrack nucleation can be identified (Zone I in Fig. 9a, b), the crack growth zone (Zone II in Fig. 9a, b) and the break zone (Zone II in Fig. 9a, b). It is impossible to distinguish a sub-zone of stable crack growth and a sub-zone of accelerated crack growth in annealed samples. A ductility type of fracture is observed in the crack growth zone - secondary cracks are rarely found in Zone II and fatigue beachmarks are completely absent. The distance between the fatigue beachmarks in the UFG alloys annealed at 500-600 °C is very small - at the same resolution, the distance between the beachmarks is practically not visible even at high magnification.

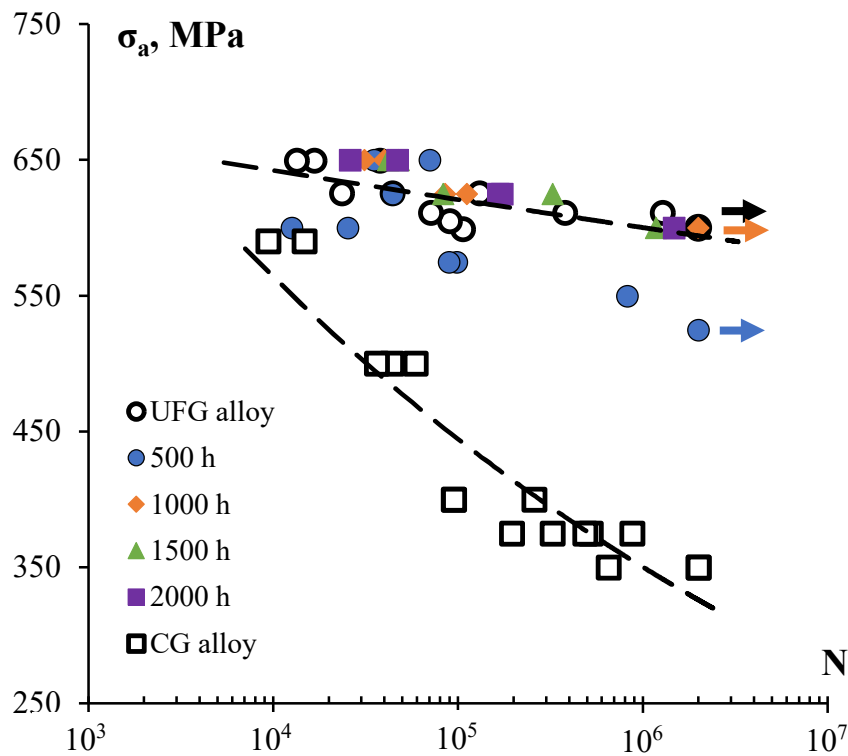
Fig. 10 Results of investigations of the effect of annealing time at 250 °C on the fatigue strength of the UFG titanium alloy Ti-5Al-2V

From Fig. 10, one can see the prolonged annealing of the UFG alloy Ti-5Al-2V at 250 °C not to affect its corrosion-fatigue strength characteristics significantly. The UFG alloy Ti-5Al-2V after prolonged annealing at 250 °C demonstrated high corrosion-fatigue strength indicating the high thermal stability of the UFG alloy microstructure. The parameters of the Basquin equation do not depend on the annealing time within the measurement uncertainty and are: $A = 790-825$ MPa, $q = 0.02-0.03$. The fracture characteristics of the samples annealed at 250 °C are identical to the ones of the unannealed UFG samples.

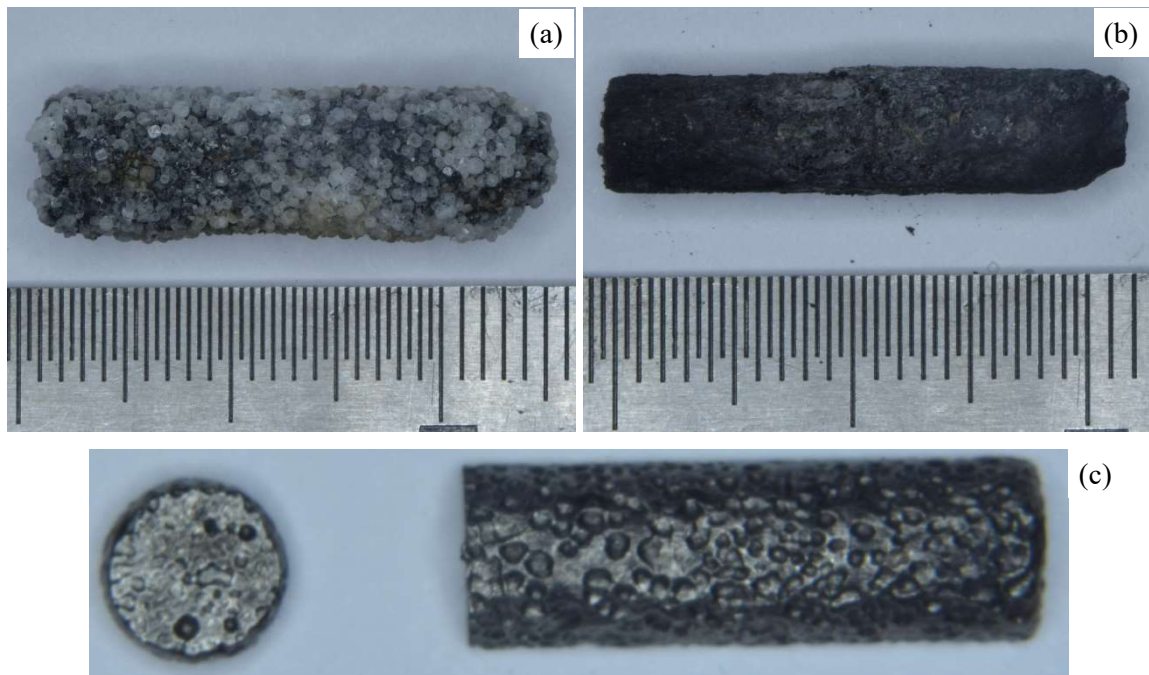
Fig. 11 Character of the corrosion damage of the coarse-grained alloy Ti-5Al-2V specimen after HSC testing: (a) general view of the specimen after HSC testing; (b) general view of the specimen after rinsing in a hot water stream; (c) specimen surface after chemical removal of the corrosion products

A dense salt layer formed on the surfaces of the coarse-grained samples (Fig. 11a) showing good adhesive strength with the titanium alloy surfaces. The composition analysis of the surface layers using EDS revealed the corrosion products to consist of (in wt.%) 26.5% O, 23.8% Na, 1.4% Al, 0.2% S, 36.0% Cl, 11.7% Ti, and 0.4% V. This result indicates the surface layers of the titanium alloy samples after HSC tests to consist of NaCl salt, which includes sulfur microadditives as well as complex oxides of titanium, aluminum, vanadium, and intermetallic compounds based on them. After rinsing the sample in a stream of hot water, the salt crystals and easily soluble corrosion products dissolved leaving a dark-colored corrosion products on the sample surfaces - titanium, aluminum, and vanadium oxides as well as Ti-Al-V intermetallics (Fig. 11b).

The undissolved corrosion products were removed by chemical treatment according to GOST R 9.907-2004. Large corrosion pits approximately 1 mm in size were observed on the surfaces of the

cleaned coarse-grained samples (Fig. 11c). The corrosion pits up to 0.5 mm deep were distributed evenly over the entire surface of the coarse-grained alloy. The average reduction in the cross-sectional area of the coarse-grained alloy sample after HSC testing did not exceed 4-5%.

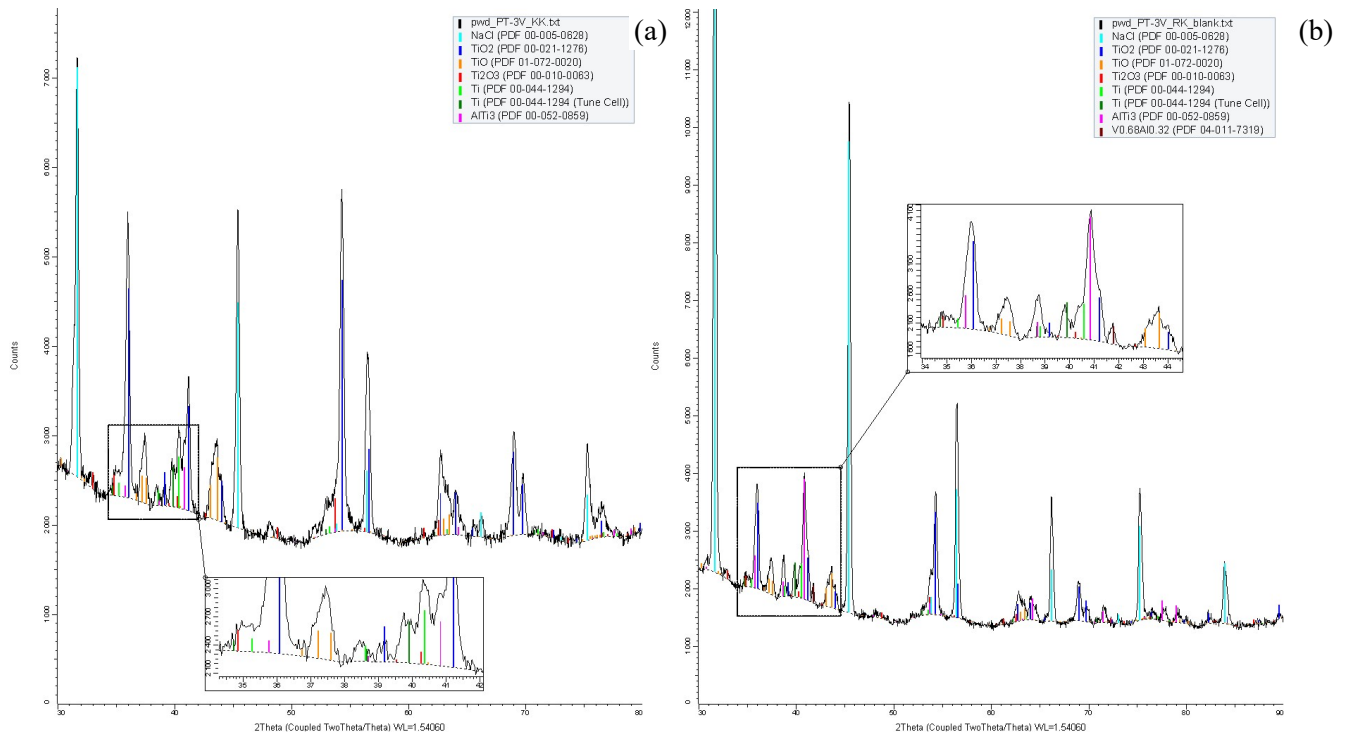
Fig. 12 Results of XRD phase analysis of products of HSC of coarse-grained (a) and UFG alloy Ti-5Al-2V (b)

The analysis of the XRD curves presented in Fig. 12a shows the composition of the products of HSC of the coarse-grained alloy Ti-5Al-2V to include the phases of the NaCl structure type (PDF #00-005-0628), titanium oxides (rutile TiO_2 (PDF #00-021-1276), which is the main phase, mon-TiO (PDF #01-072-0020), Ti_2O_3 (PDF #00-010-0063)), and Ti_3Al (PDF #00-052-0859). In addition, the XRD curves manifested the peaks from α -Ti, the lattice parameters of which were increased as compared to the reference data (PDF #00-044-1294, ICSD #44390). It should be noted that in the XRD experiments it is not possible to distinguish between the phases Ti_3Al (PDF #00-052-0859) and $\text{Ti}_{2.76}\text{Al}_{1.24}\text{O}_{0.35}$ (PDF #01-074-9927). So one can assume the corrosion products of the titanium alloy to contain both the Ti_3Al ($a = 5.793 \text{ \AA}$, $c = 4.649 \text{ \AA}$) phase and $\text{Ti}_{2.76}\text{Al}_{1.24}\text{O}_{0.35}$ ($a = 5.787 \text{ \AA}$, $c = 4.678 \text{ \AA}$) one from the same space group $P6/mmc$.

The composition of the HSC products on the surfaces of the UFG specimens (Fig. 14d) was similar to the ones for the coarse-grained alloy. The results of XRD phase analysis (Fig. 12b) show the phase composition of the corrosion products of the UFG alloy to be similar to that of the coarse-grained alloy. The XRD peak at $2\theta \sim 41.7^\circ$ is visible in the XRD curve of the corrosion products of the UFG alloy. This XRD peak may be ascribed to the phase $V_{0.68}Al_{0.32}$ (Im-3m, PDF #04-011-7319), which is a product of corrosion damage of grain boundaries enriched with vanadium (see [35, 48]).

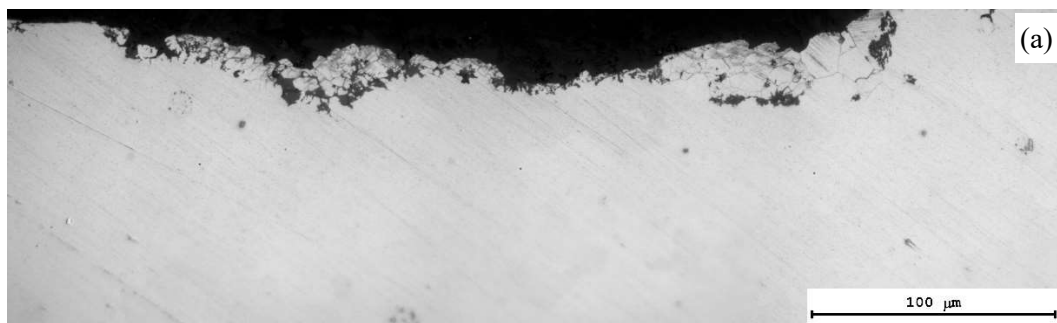
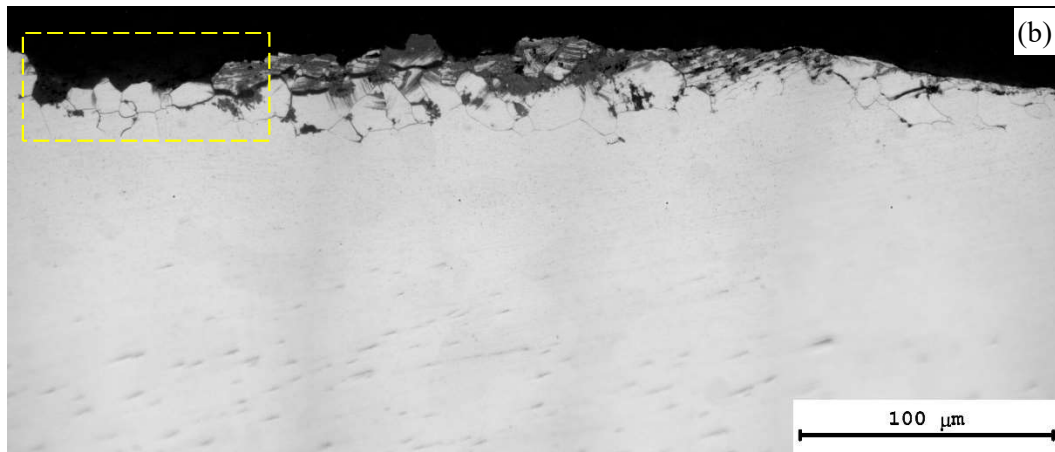
Fig. 13 Character of the corrosion damage to the surface of PT-3V coarse-grained alloy specimens after HSC. Metallographic optical microscopy

In the initial state, the coarse-grained alloy had an increased susceptibility to HSC. The micro-damage of the surfaces of the coarse-grained alloy goes via the intergranular corrosion (IGC) mechanism (Fig. 13). During the test, quite intensive destruction of the sample surfaces and destruction of the grain groups took place. This area is marked with a yellow dashed line in Fig. 13b. Subsequently, these areas are transformed into large corrosion pits (Fig. 13c, g). The maximum depth of IGC defects varied from 16 to 72 μm ; the average depth of IGC defects was close to $\sim 50 \mu\text{m}$.

The characteristic distance between the IGC defects in the UFG alloy specimens was 5-10 μm (Fig. 13b, 14b). The microhardness of the UFG alloy after the HSC tests decreased slightly down to 2890 ± 180 MPa while the microhardness of the coarse-grained alloy remained unchanged and was

From Figs. 13, 14, and 18, one can see that HSC in near- α titanium alloy Ti-5Al-2V specimens has an intergranular character. The key factors affecting the tendency of titanium alloys Ti-Al-V to hot salt intergranular corrosion (under the specified conditions of HSC testing) are: (i) the presence of the β -phase particles, which contain an increased concentration of alloying elements stabilizing the β -Ti phase at room temperature and (ii) an increased concentration of alloying elements at the grain boundaries, primarily vanadium [6, 35, 48].

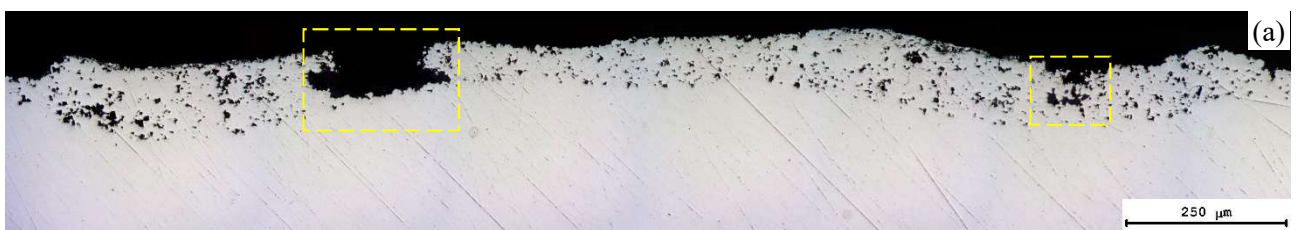
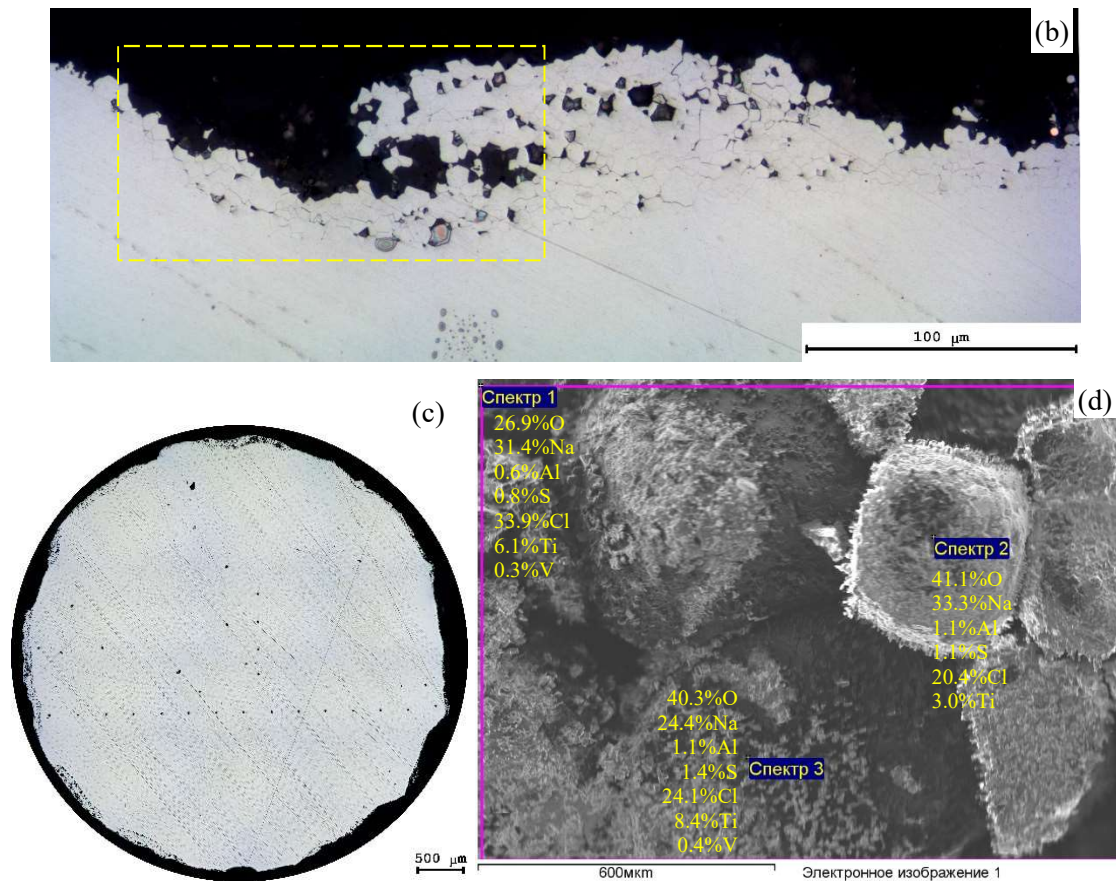
Fig. 14 Results of the HSC tests of the UFG Ti-5Al-2V alloy specimens: (a) general view of the specimen surface with IGC defects; (b) area of transformation of the IGC defect into a corrosion pit; (c) cross-section of the specimen after HSC testing; (d) EDS analysis of the composition of the corrosion products

Fig. 14 presents the results of metallographic optical microscopy examination of the nature of surface damage to the UFG Ti-5Al-2V alloy specimens after HSC testing. Surface damage to the UFG alloy goes via the IGC mechanism. The corrosion was quite uniform over the entire metal surface. The depth of the IGC defects reaches 100-120 μm . As the depth of the IGC defects increases, these ones transform into corrosion pits with a depth of 50-70 μm . The areas of transformation of the IGC defects into the corrosion pits are marked with yellow dashed lines in Fig. 14a, b. Thus, the HSC process of the alloy Ti-5Al-2V has a two-stage character: first, IGC occurs, and then the IGC defects transform into the corrosion pits. Afterwards, at further increasing of the test time, the IGC starts on again. As a result of this alternation of corrosion mechanisms, the cross-section area of the specimen decreases relatively uniformly as shown in Fig. 14c.

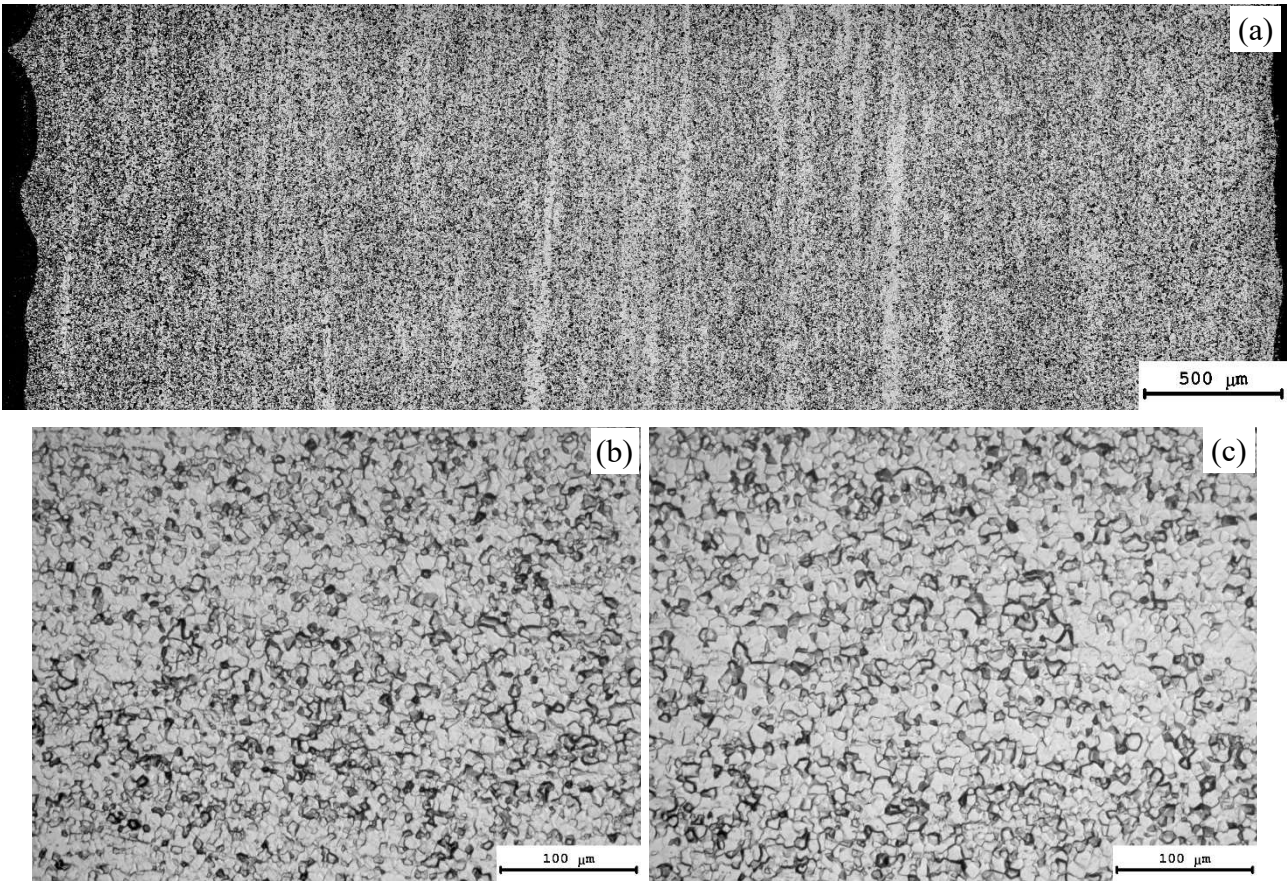
Fig. 15 Microstructure of Ti-5Al-2V alloy specimens after HSC testing: (a, b) after RS, (c) after RS and annealing at 250 °C for 500 h

close to the hardness of the alloy in the initial state (Table 1). These results indicate that the process of recrystallization takes place in the titanium alloy specimen during HSC testing. As an example, Fig.15a, b present the results of the microstructure investigation of the UFG titanium alloy specimen after HSC testing (250 °C, 250 h). One can see from Fig. 15a, b the Ti-5Al-2V alloy specimens after HSC testing to have a recrystallized microstructure with average grain size of ~10 μm. The heterogeneity of the macrostructure, formed during RS, remains – lighter areas of recrystallized metal are visible in the sample volume (Fig. 15a). It is known that as the degree of strain increases, the size of the recrystallized grain decreases. The presence of areas of recrystallized metal in the central part of the bar indicates less strain during RS.

18b, the IGC develops during HSC testing, which then transforms into the submicron-scale corrosion pits. The average depth of the IGC defects' penetration does not depend on the annealing time at 250 °C within the measurement uncertainty (Fig. 18c, d). The average size of the fragment surrounded by the IGC defects was approximately 10 μm (Fig. 18c, d) that is close to the grain size in the alloy (Fig. 15c).

Prior to analyzing the results, it should be noted that titanium is characterized abnormally low grain boundary diffusion activation energy [61]. As a result, the diffusion processes in titanium is controlled by grain boundaries actively and occur at temperatures $T < 0.5 T_m$, where $T_m = 1943$ K is the melting point of titanium. As the analysis of the results shows, after prolonged 2000-hour holding at 250 °C under conditions of hot salt corrosion, grain growth was observed (Fig. 15).
