Effect of annealing on the corrosion-fatigue strength and hot salt corrosion resistance of fine-grained titanium near- α alloy Ti-5Al-2V obtained by Rotary Swaging

Abstract

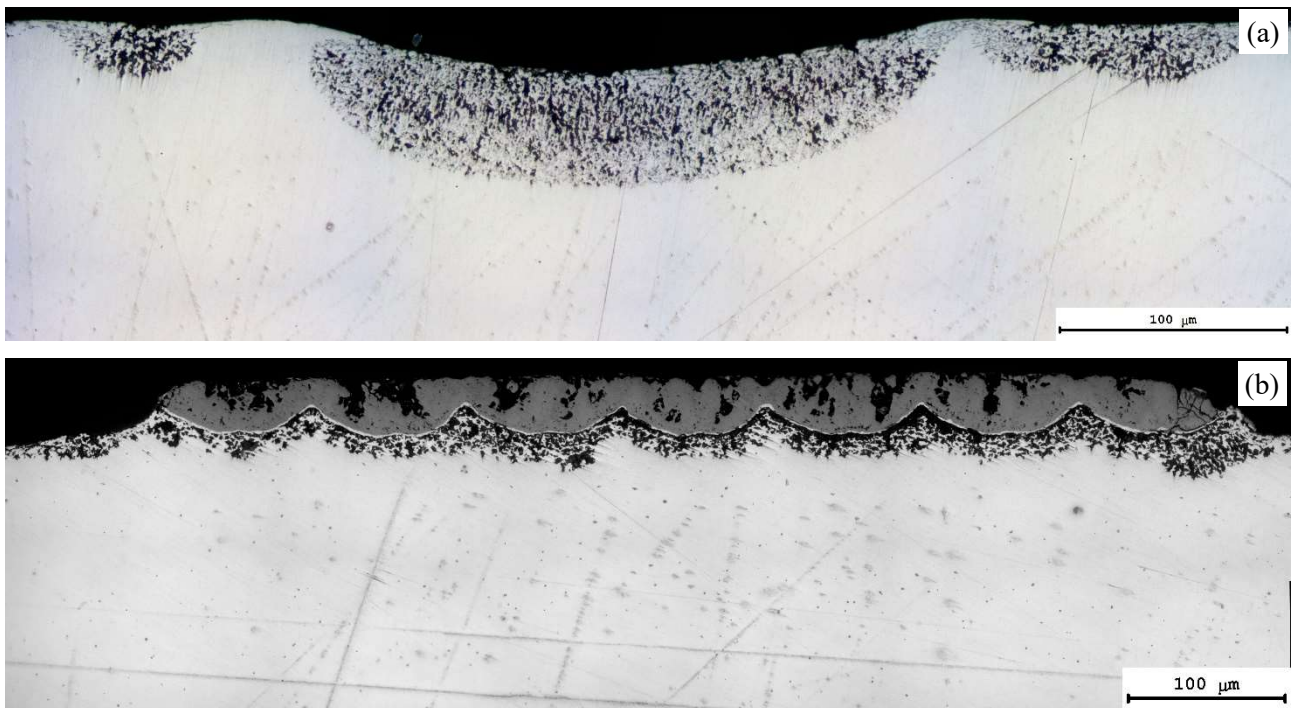
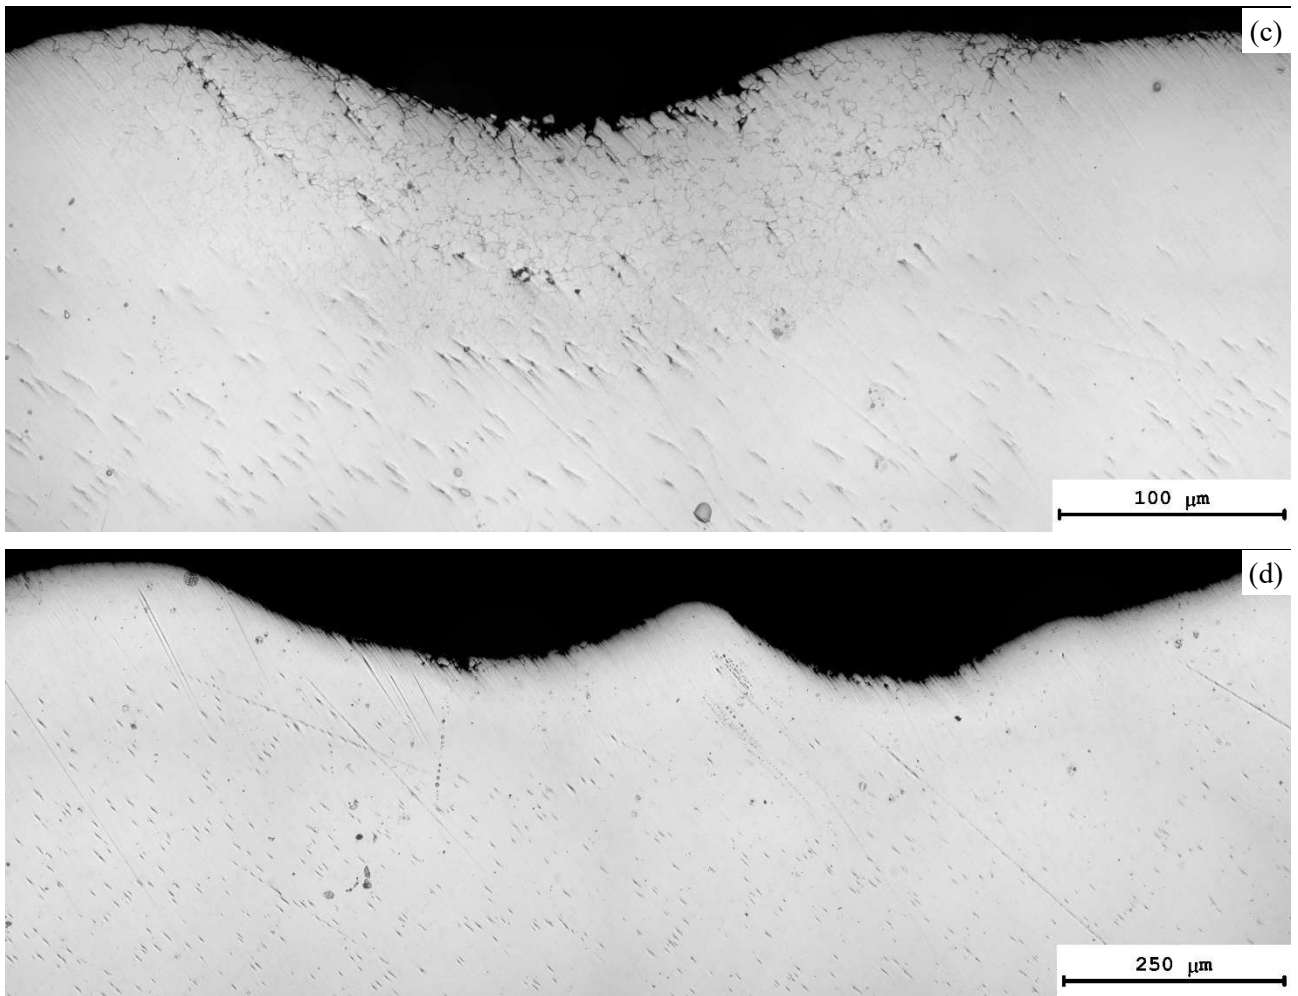
Fig. 16 Character of the corrosion damage to the surface of UFG Ti-5Al-2V alloy specimens annealed at 550 °C (a), 600 °C (b), and 700 °C (c, d). Metallographic optical microscopy

Fig. 16 presents the results of the investigation of the nature of the corrosion damage to the UFG alloy specimens annealed at different temperatures. In the alloys with partially recrystallized microstructure, the local acceleration of IGC takes place (Fig. 16a) leading to the appearance of relatively small (50-100 μm) corrosion pits on the surfaces of the alloy specimens (Fig. 16b). The propagation rate of IGC exceeds the rate of formation and growth of the corrosion micro-pits. As a result, the IGC defects have a greater depth than the corrosion pits (Fig. 16b).

On the surfaces of fully recrystallized specimens, the local IGC was present also (Fig. 16c) leading to the appearance of the corrosion pits up to 300-500 μm in size (Fig. 16d). The measurements of the corrosion defects' depths have shown an increase in the annealing temperature to result in a reduction in the IGC depth (Fig. 17). It was noted also that the alloys with fully recrystallized microstructure exhibit an increased overall corrosion rate. In the alloys with partially recrystallized microstructure, the reduction in the cross-sectional areas of the specimens after HSC testing was 6-8% while in the specimens annealed at 700 °C, it was 11-12%. The higher corrosion pit growth rate and overall corrosion rate lead to a decrease in the number of IGC defects on the surfaces of the specimens with fully recrystallized microstructure.

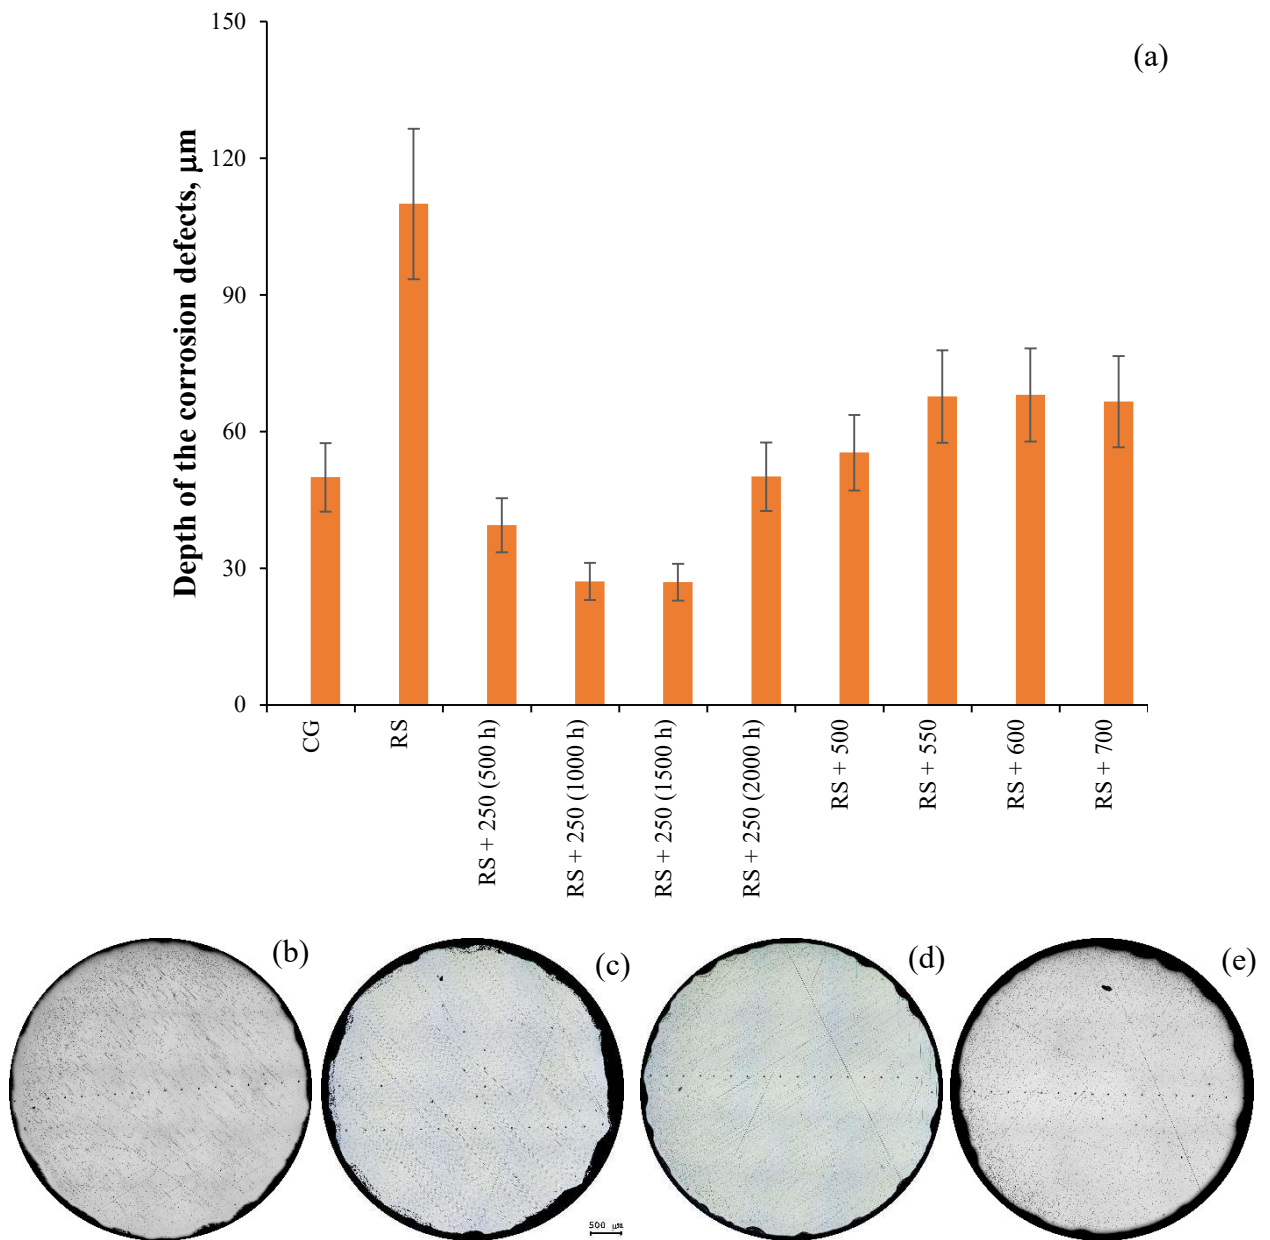
Fig. 17 Depth of the defects in titanium specimens after HSC testing (a) and images of the cross-section of samples after testing on HSC (b-e): (b) coarse-grained sample, (c) un-annealed UFG sample, (d) UFG sample after annealing by, (e) UFG sample after annealing by 700 °C

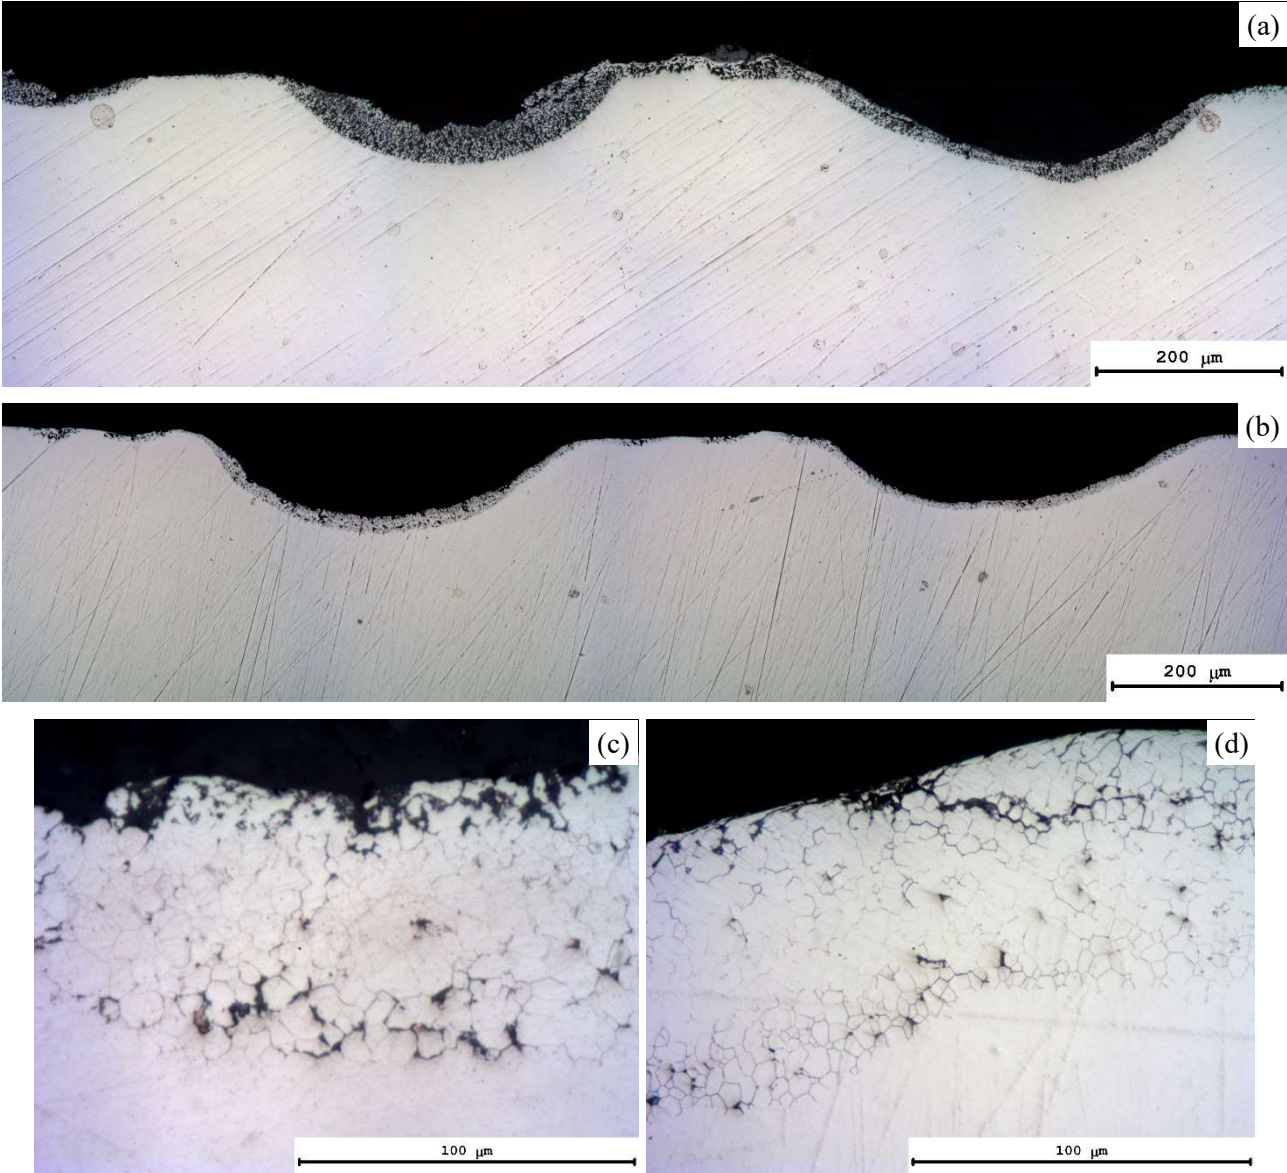
Fig. 18 Character of the corrosion damage to the surfaces of UFG Ti-5Al-2V alloy specimens after HSC testing: (a, c) annealing at 250 °C, 500 h; (b, d) annealing at 250 °C, 2000 h

The results of HSC testing show the annealing time at 250 °C not to affect noticeably the mechanism and corrosion rate of the UFG titanium near- α alloy Ti-5Al-2V specimens. The phase composition of the HSC products of the UFG specimens annealed at 250 °C matches to the one of the unannealed UFG alloy specimens. As one can see from the comparison between Fig. 18a and Fig.

18b, the IGC develops during HSC testing, which then transforms into the submicron-scale corrosion pits. The average depth of the IGC defects' penetration does not depend on the annealing time at 250 °C within the measurement uncertainty (Fig. 18c, d). The average size of the fragment surrounded by the IGC defects was approximately 10 μm (Fig. 18c, d) that is close to the grain size in the alloy (Fig. 15c).

From Figs. 13, 14, and 18, one can see that HSC in near- α titanium alloy Ti-5Al-2V specimens has an intergranular character. The key factors affecting the tendency of titanium alloys Ti-Al-V to hot salt intergranular corrosion (under the specified conditions of HSC testing) are: (i) the presence of the β -phase particles, which contain an increased concentration of alloying elements stabilizing the β -Ti phase at room temperature and (ii) an increased concentration of alloying elements at the grain boundaries, primarily vanadium [6, 35, 48].

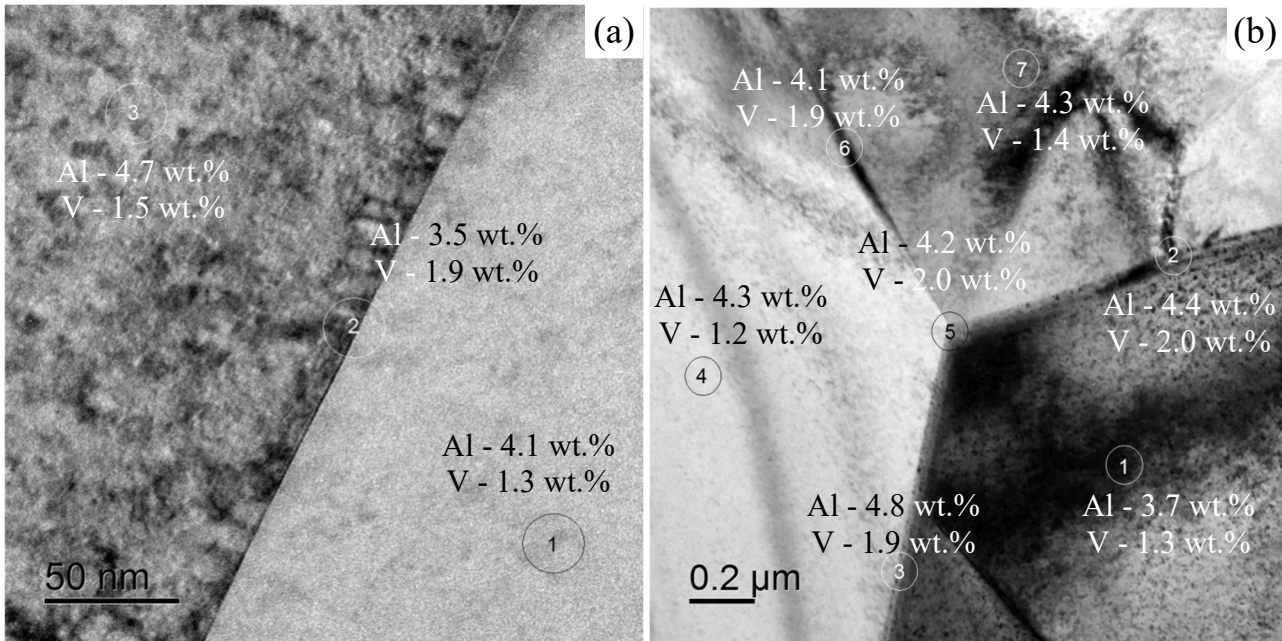
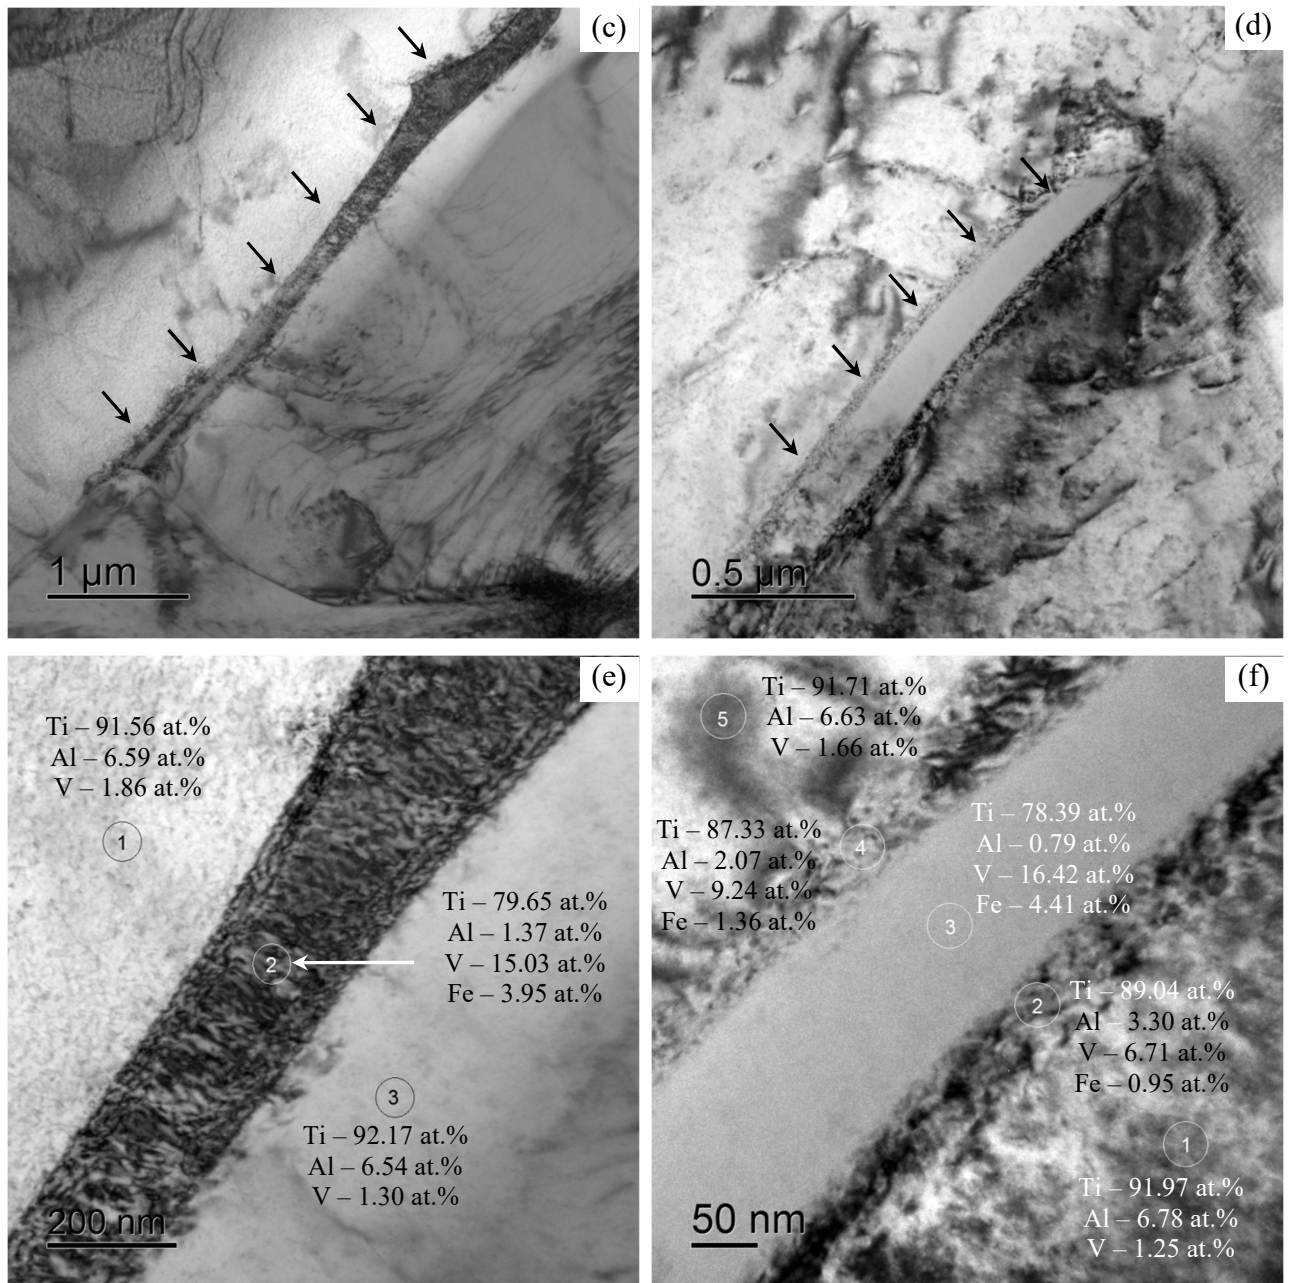
Fig. 19. Microstructure of the coarse-grained alloy Ti-5Al-2V: (a, b) conventional grain boundaries (type I) (c, d) precipitation of the β -phase particles (TEM) (β -phase particles are shown with arrows); (e, f) EDS results for the grain boundaries composition (type II) [35]

Earlier, two types of grain boundaries were shown in coarse-grained titanium alloy Ti-5Al-2V [35]: (i) conventional grain boundaries, where the concentrations of aluminum and vanadium are close to the ones in the grains' crystal lattice; and (ii) grain boundaries with an increased local vanadium concentration (up to 10 wt.%) containing β -phase particles often (Fig. 19). According to the results of EDS analysis, the β -phase particles in the Ti-5Al-2V alloy contain up to 16 wt.% V, as well as minor concentrations of aluminum and iron [35] (Fig. 19). The volume fraction of the second-type V-enriched grain boundaries was not large and was approximately 10%. The presence of two types of grain boundaries in the microstructure of the Ti-5Al-2V alloy leads to the appearance of two types of IGC defects during HSC testing – thin, shallow defects propagating along the grain boundaries of the first type, and thick, deep IGC defects associated with the grain boundaries of the second type.
