# An extreme thermal cycling reliability test of ATLAS ITk Strips barrel modules

**ABSTRACT:** At the end of Run 3 of the Large Hadron Collider (LHC), the accelerator complex will be upgraded to the High-Luminosity LHC (HL-LHC) in order to increase the total amount of data provided to its experiments. To cope with the increased rates of data, radiation, and pileup, the ATLAS detector will undergo a substantial upgrade, including a replacement of the Inner Detector with a future Inner Tracker, called the ITk. The ITk will be composed of pixel and strip sub-detectors, where the strips portion will be composed of 17,888 silicon strip detector modules. During the HL-LHC running period, the ITk will be cooled and warmed a number of times from about  $-35^{\circ}\text{C}$  to room temperature as part of the operational cycle, including warm-ups during yearly shutdowns. To ensure ITk Strips modules are functional after these expected temperature changes, and to ensure modules are mechanically robust, each module must undergo ten thermal cycles and pass a set of electrical and mechanical criteria before it is placed on a local support structure. This paper describes the thermal cycling Qu

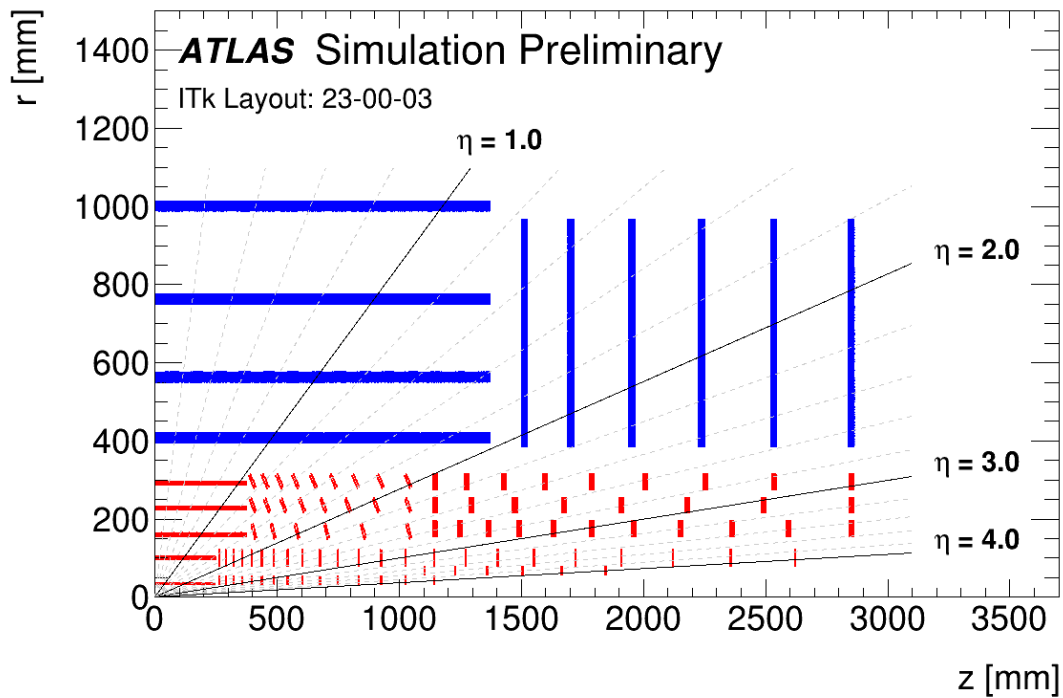
**Figure 1:** The ITk layout [2].

During Long Shutdown 3 (LS3) of the Large Hadron Collider (LHC) running schedule, the accelerator complex will be upgraded in order to increase the instantaneous luminosity of its particle beams. This upgraded phase of the LHC, the HL-LHC (High-Luminosity LHC), is estimated to deliver 3000-4000 fb<sup>-1</sup> of proton-proton collisions to the LHC experiments [1]. An increase in instantaneous and integrated luminosity of this magnitude requires the LHC experiments to be upgraded to cope with higher rates of data and long term effects from radiation damage, in addition to an increased number of simultaneous interactions known as pileup. As a part of the ATLAS detector's upgrade for the HL-LHC, the Inner Detector (ATLAS tracker) will be entirely replaced by a fully silicon tracker composed of pixel and strip subdetectors, called the Inner Tracker (ITk), partitioned into a barrel and end-caps with different geometries, as shown in figure 1.

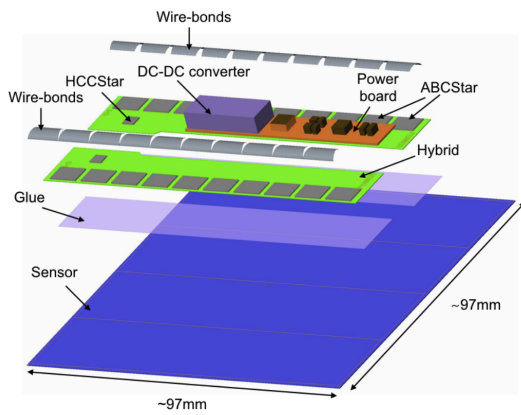
(a) An example barrel module diagram [5].

**Figure 2:** Diagram and picture of a module.

ATLAS ITk Strips modules are built from a silicon sensor as the active detection material, with a hybrid glued directly on top hosting ASICs for readout, alongside a powerboard to power module components. The ITk Strips endcaps will be built from 6 types of modules with different geometries in order to satisfy the radial geometry requirement, while the barrel will be composed of Short Strip (SS) and Long Strip (LS) modules, whose names correspond to the modules' relative strip sizes. A diagram portraying an example barrel module is shown in figure 2a. A photo of a Long Strip module, defined as a sensor with two "streams" of strips, a single powerboard and hybrid with 10 ASICs, is shown in figure 2b. Note that strips under (away from) the powerboard are defined as stream 0 (1).

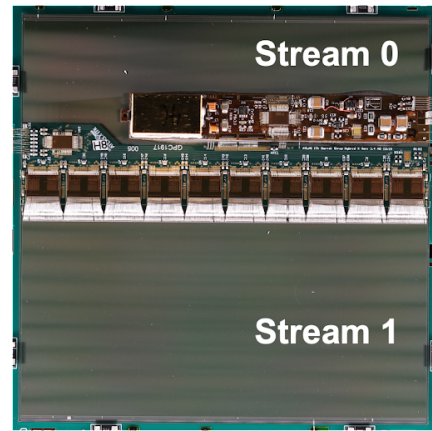
(b) A photo of a Long Strip module [6], with streams 0 and 1 labelled. Note that strips are aligned in the vertical direction.

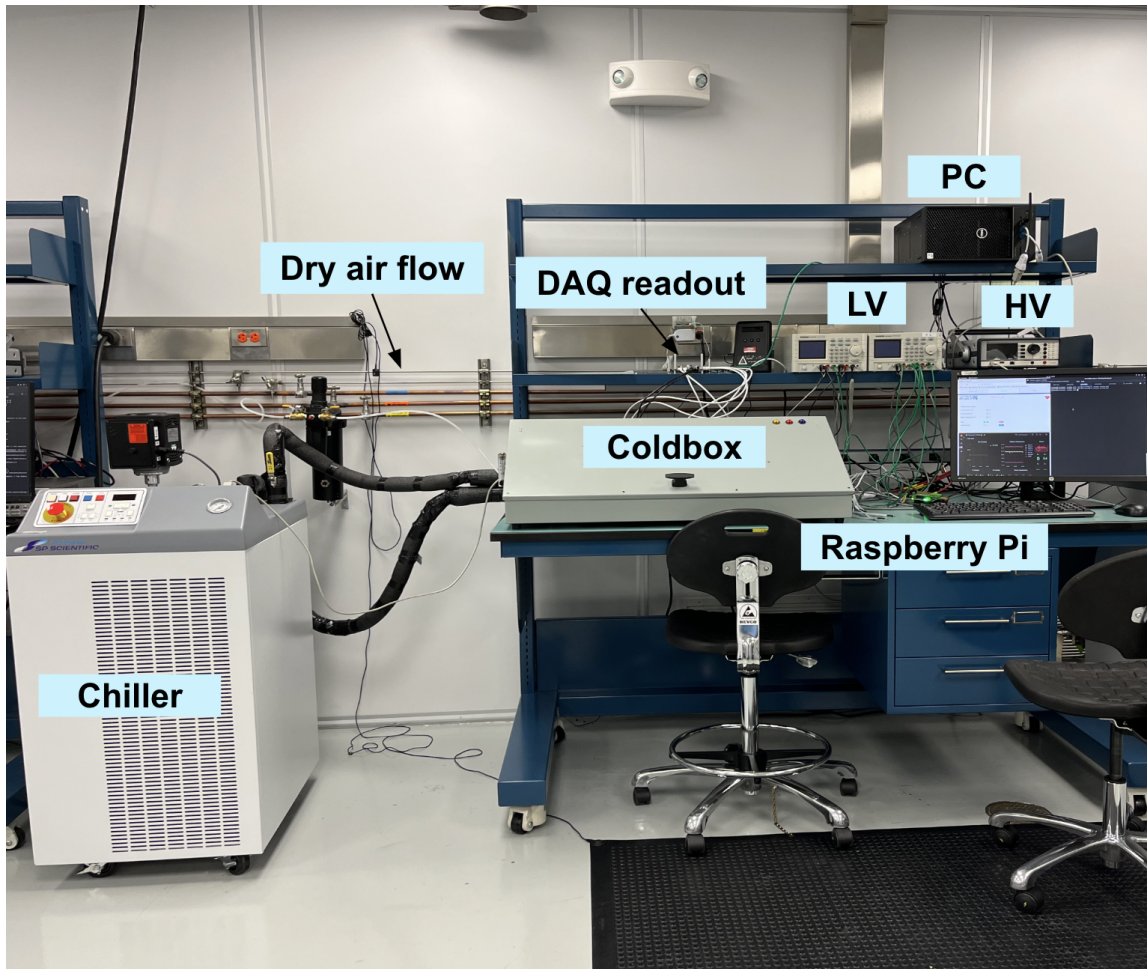
**Figure 3:** An example coldjig setup, comprised of a coldbox housing modules, and its associated hardware to control and monitor module environment and DAQ.

Thermally cycling modules requires an experimental setup which controls and monitors both environmental and data acquisition (DAQ) features. This is accomplished in the ITk Strips project with a coldjig, defined as a setup including a coldbox and associated hardware, an example of which is shown in figure 3. The following are pictured: A coldbox, containing up to four modules screwed into metal plates called "chucks". The temperatures of the chucks, and thereby the modules, is controlled with a set of cooling pipes between the chiller and the chucks. The coldbox is constantly flushed with dry air flowing from external pipes in order to minimize humidity, to prevent any ice or moisture from condensing on the modules during testing. A DAQ readout, consisting of a Nexys field programmable gate array [7] for fast processing of module data, and a custom interface board (FMC-0514-DP [8]) between the Nexys and modules, is used to perform various DAQ tests to measure module noise and gain at the strip level [4]. Low voltage (LV) power supplies are connected to the coldjig to provide 11V to module electronics. A High voltage (HV) power supply is connected to provide -350V bias voltage for sensor depletion during electrical tests and to take I-V measurements up to -550V. A PC is present to run DAQ software, and a Raspberry Pi [9] is

used for monitoring and control of the environmental elements of the setup including temperature, humidity, and dew point.

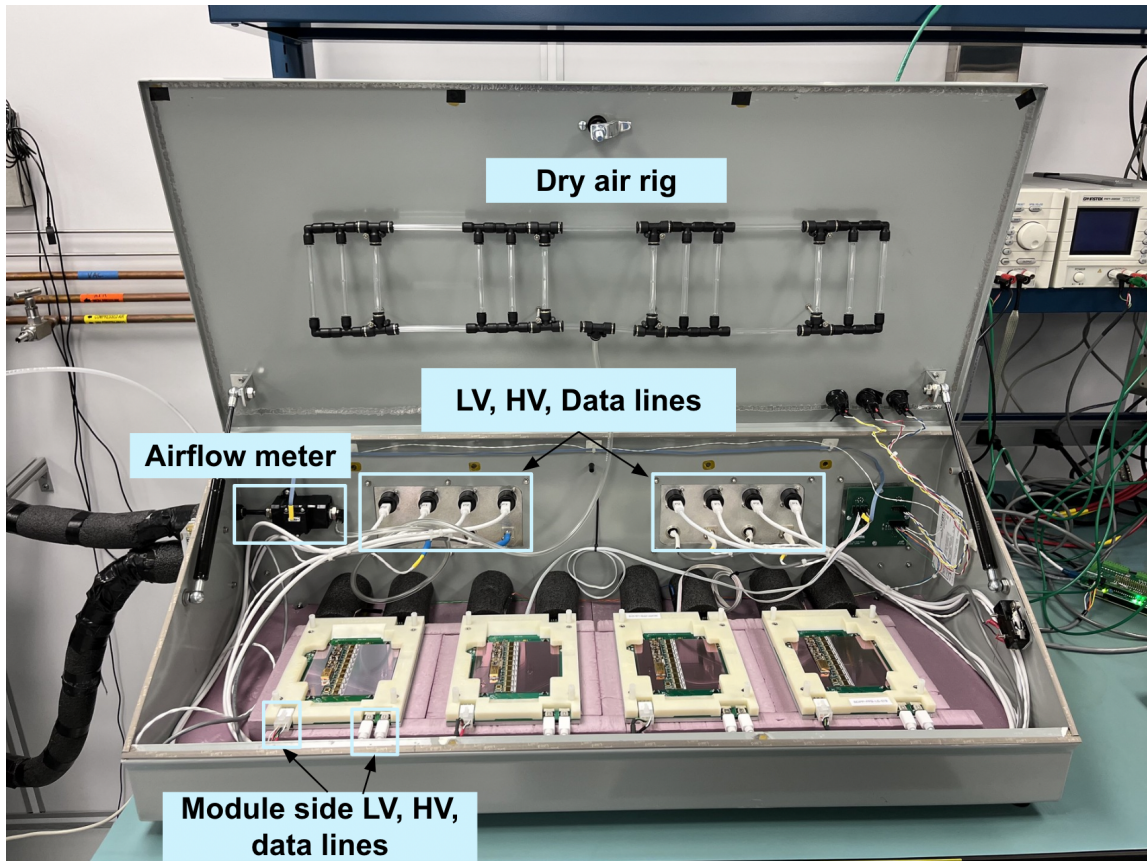
**Figure 4:** Opened coldjig with four Long Strip barrel modules attached.

A photo of the interior of a coldjig with four Long Strip barrel modules inside is shown in figure 4. The dry air rig directs dry air from the external pipes onto the modules. An airflow meter is installed in order to monitor the rate of airflow in Standard Cubic Feet per Minute (SCFM), which must be above 1.5 SCFM at all times. LV and HV are provided to the module via a Molex connection to a test frame. Through the same test frame, data from the module is read out through the back of the box, where it is connected to the FMC-0514-DP with DisplayPort cables.

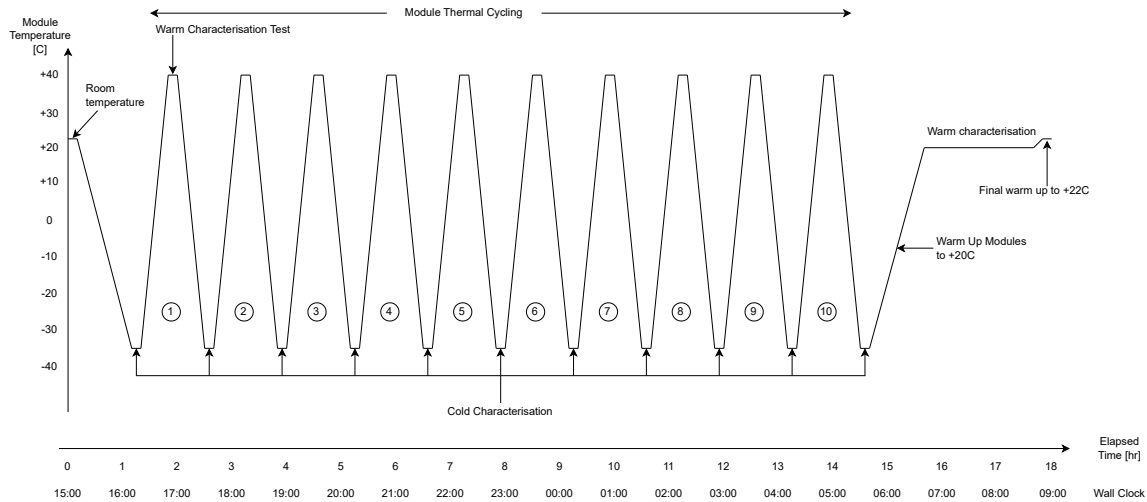
**Figure 5:** The thermal cycling QC procedure. The diagram shows an upper limit for the thermal cycle of  $+40^{\circ}\text{C}$ , as per the original QC plan.

changes on modules is emulated with thermal cycling: One thermal cycle is defined as the chiller starting at the required cold temperature, a cold electrical test, the chiller warming to the pre-defined warm temperature, a warm electrical test, and the chiller returning to the required cold temperature to begin another thermal cycle. This is achieved using setups identical or similar to that described in section 2. This procedure is shown in figure 3, where the original QC procedure included an upper limit for the thermal cycle of  $+40^{\circ}\text{C}$ . However, while developing this procedure during pre-production, the upper limit was reduced to  $+20^{\circ}\text{C}$  after it was found that powered modules at  $+40^{\circ}\text{C}$  approached the glass transition temperature of the glue securing electronics to the sensor. Additionally, a nominal thermal gradient of  $2.5^{\circ}\text{C}$  per minute is defined as part of the standard procedure. This is the final step of the module QC program: all modules must pass a post-cycling electrical test, and an I-V before being placed on a local support structure.

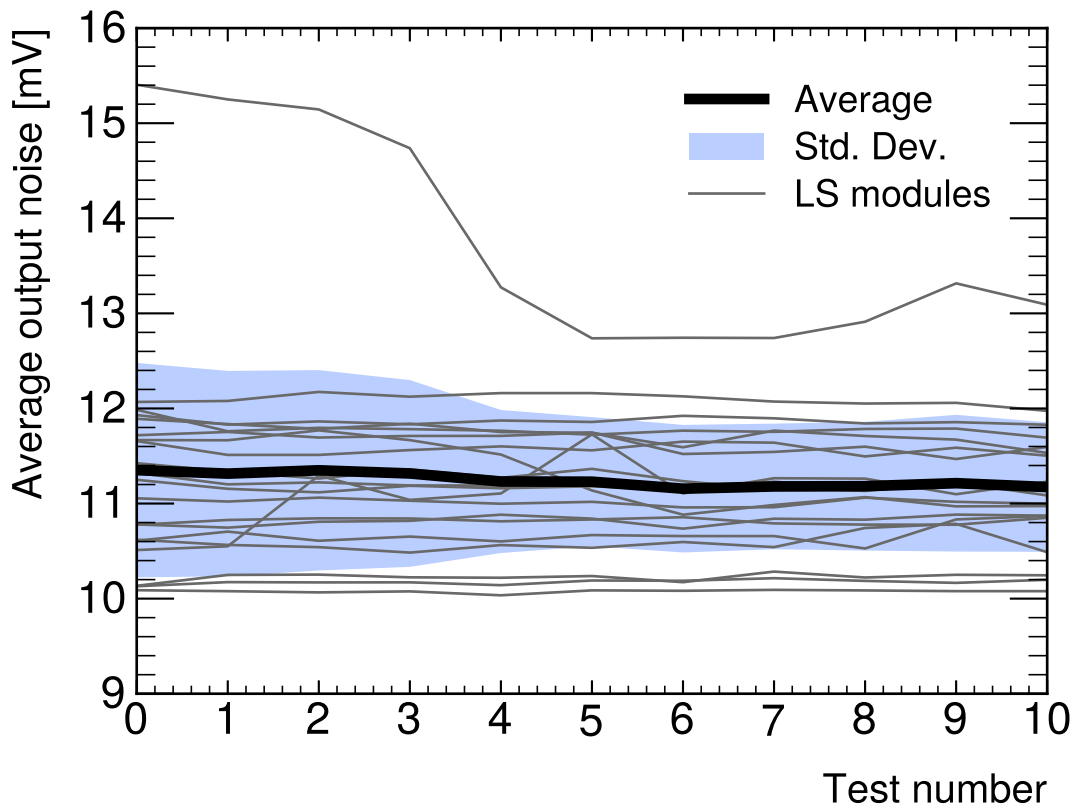
**Figure 6:** The average output noise of all strips in LS modules, during the 11 cold tests of thermal cycling (Test number 0 corresponds to the cold test before the first thermal cycle, see figure 3). The thin grey lines show trends of 20 individual pre-production LS modules, along with the average and standard deviation between all modules shown by the black line and blue area respectively.

Results from these thermal cycling tests as a function of test number indicate whether there is any clear degradation in electrical performance as a consequence of the thermal stress. Figure 6 shows the development of output noise in 20 pre-production LS modules, at each of the 11 cold tests. Most individual modules demonstrate a stable noise that is almost unchanged in each of the cold tests, and the average results of all modules is consistent with there being no gradual noise

increase. One module shows above average noise during cold tests, which improves as more cold tests are taken. In contrast, the noise from this module’s warm tests are stable. It is not understood why this particular behavior is observed for this module.

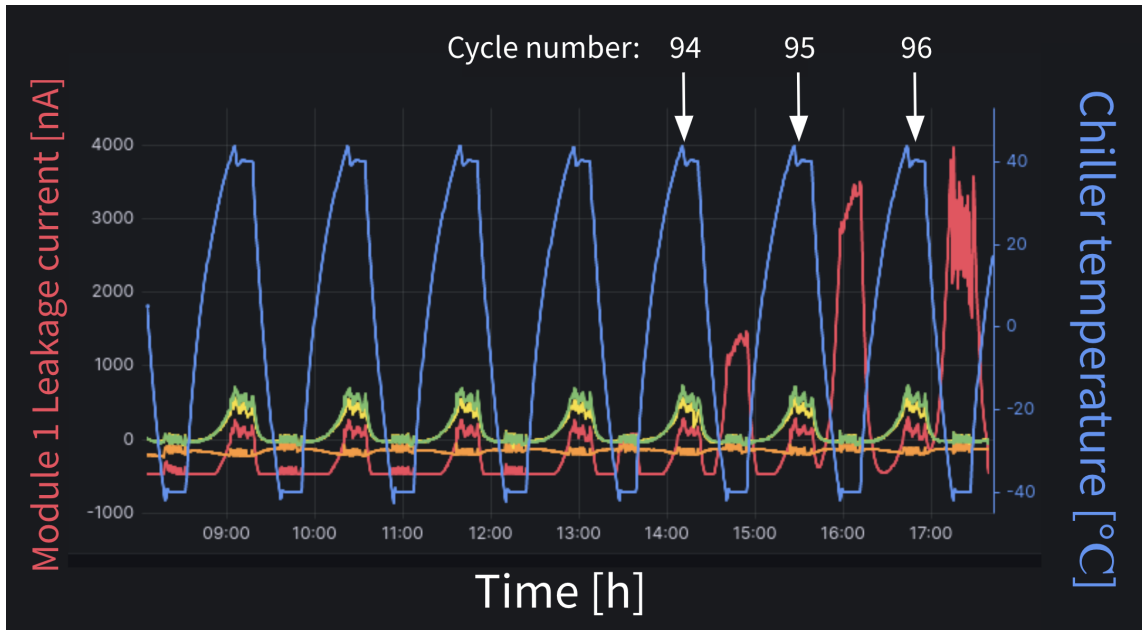
**Figure 7:** Module 1 leakage current (in red) during thermal cycles 90 to 96. The leakage current from Module 2, Module 3, and Module 4 are shown in yellow, green, and orange respectively.

During its next day of thermal cycling three days later, the first two thermal cycles did not show changes in behavior, but increased leakage current was again observed from cycles 66-70, this time up to about  $4\ \mu\text{A}$ . The next time the module was cycled four days later, the module showed no changes in behaviour during cycles 71-80. On its second to last day of cycling, an instance of increasing leakage current while cooling down was observed during cycles 94-96 as shown in figure 7, and relatively high leakage currents of about  $4\ \mu\text{A}$  are seen during the final 5 cycles. In all of these instances, the current values are under the specification limit of  $10\ \mu\text{A}$ . It should be noted that during HL-LHC operations, sensor current will increase by several orders of magnitude, and irradiation will often remove any breakdown. It is also noted that increasing sensor current during temperature changes while sensors are biased, similar to what was observed for Module 1, has been observed in other modules during pre-production.

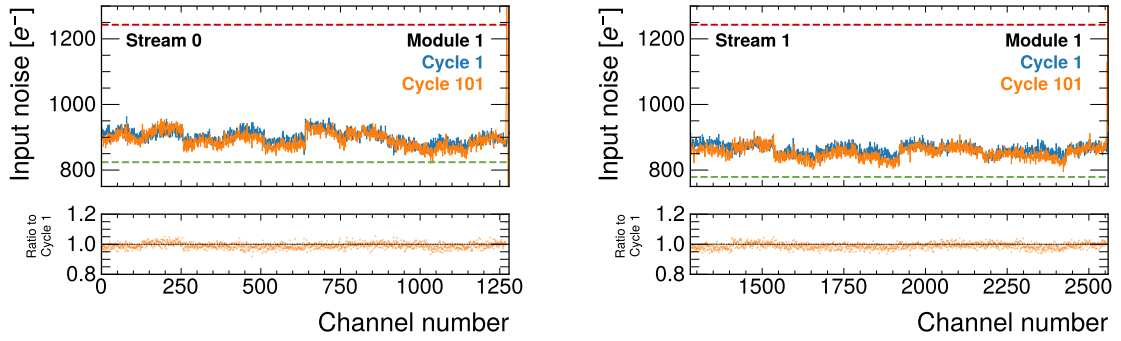
(a) Stream 0: corresponds to strips under the hybrid. (b) Stream 1: corresponds to strips away from the hybrid.

**Figure 8:** Comparison of Module 1 noise measured during first and final cold tests for streams 0 and 1.

A comparison of Module 1's noise during its first, and 101st cold tests is shown in figure 8 for both streams of strips. While there are a few noisy strips on the edges of each stream (near

channel numbers 1280 and 2550), the vast majority of strips have the same measured noise within 5% before and after cycling. Additionally, the measured noise is well below the maximum allowed noise of 1243 ENC. One would expect a higher noise measurement if taken at room temperature, but would not expect the noise to increase by the  $\approx 300$  ENC necessary to reach the threshold as noise increases of this magnitude are not typically seen in Long Strip modules between cold and room temperature tests. The measured noise exceeds the target room temperature noise in green, 824 (779) ENC for stream 0 (1), even when measured cold, indicating this module is noisier than expected. Upon inspection after testing, this module was found to have glue on the guard ring, which is known to increase sensor current measurement.

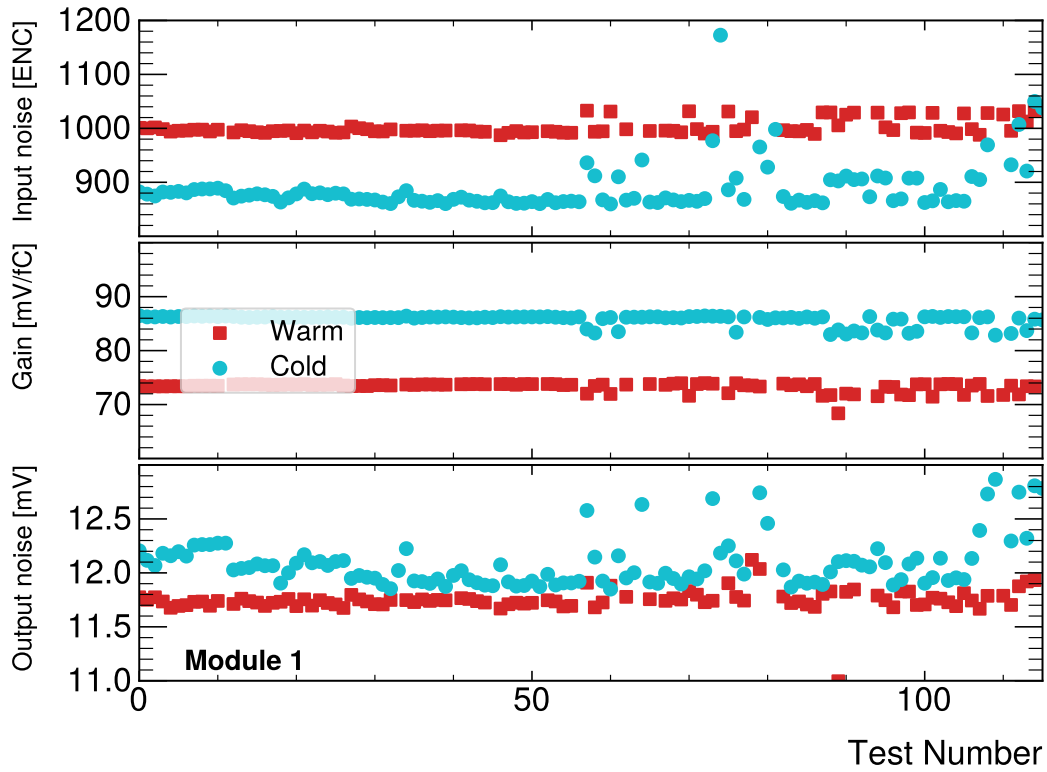
**Figure 9:** Module 1 input noise, gain, and output noise as a function of test number, separated by warm (Chiller at +40°C) and cold (Chiller at -40°C) tests. Note that there were more tests taken than number of thermal cycles, as sometimes a day of cycling would end on a warm test without completing a cycle, or one day would end with a cold test and the next day would start with a cold test.

Trends of Module 1's input noise, gain, and output noise during warm and cold tests as a function of test number are shown in figure 9. These trends show a roughly steady increase in average input and output noise vs. test number, indicating that the module is relatively stable.

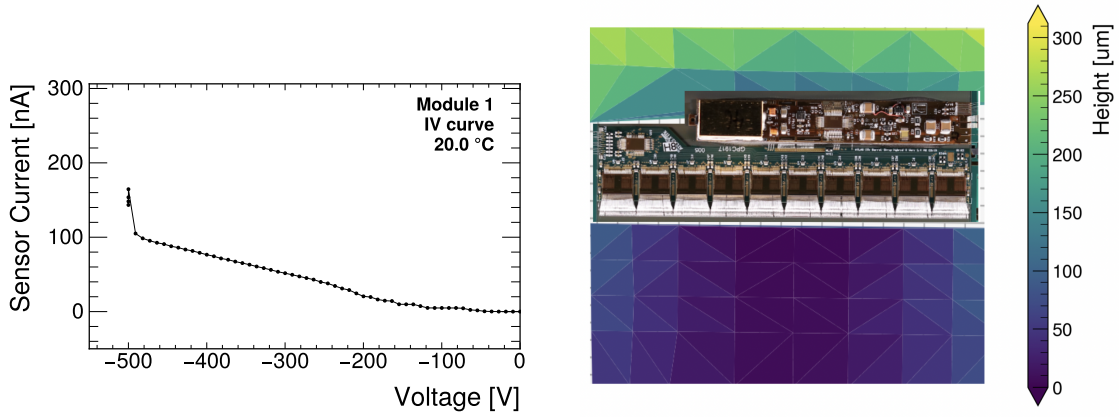
(a) I-V curve.

(b) Measured height as a function of module position, considering the same orientation as shown in figure 2b.

**Figure 10:** Post-cycling measurements of Module 1.

To further evaluate electrical performance, an I-V curve was taken at room temperature after thermal cycling, and is shown in figure 10a. Around -500V, the module begins to exhibit breakdown-like behavior, indicating it may have failed the nominal module QC which requires no breakdown before reaching -500V. However, this I-V shows signs of "training", as the current around -500V goes down with time as seen during its final three measurements, indicating the observed signs of breakdown may not be permanent. Furthermore, this module exhibits a large operational voltage range before reaching -500V. During operation, a module is expected to experience a convolution of effects from thermal cycling, radiation, and the ATLAS magnetic field. However, if behavior like this is seen during operation, the magnitude of the operating voltage can be decreased to move away from the breakdown region. After testing, this module was discovered to have pinholes. This can potentially explain the irregular step-like shape of the I-V curve.

A post-cycling metrology measurement was also taken, and is shown in figure 10b. Deformations are seen in the module in both the horizontal and vertical planes, and a maximum height of about 300 microns was measured. This exceeds the acceptable metrology specifications, as the corners can be no greater than 150 microns above the center of the module, and no less than 50 microns below the center of the module. This measurement, along with comparisons to shape measurements of modules thermally cycled to warm temperatures of +40°C and +20°C led to the decision to change the thermal cycling warm temperature in the QC procedure to +20°C, where a much less severe shape distortion was observed.

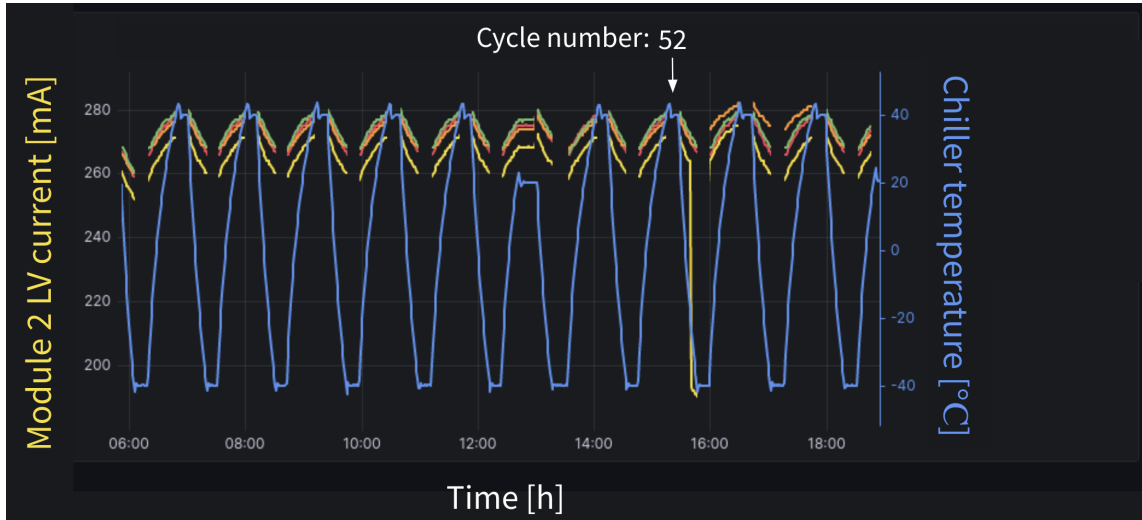
**Figure 11:** Module 2 LV current from cycles 45 to 54 (in yellow). The LV current for Module 1, Module 3, and Module 4 are shown in red, green, and orange, and stay around the expected value of 280 mA, with changes of about 10 mA due to cooling and warming.

Module 2 was thermally cycled 101 times<sup>3</sup> in the coldjig described in section 2. For the first 51 cycles of this module, no significant deviations in sensor noise or current were observed. Starting with the 52nd cycle, intermittent instability was observed in input noise and LV current draw. An example of this is shown in figure 11. This suggests that either the pedestal trim was not properly applied during these tests, or the ASICs were not properly powered.

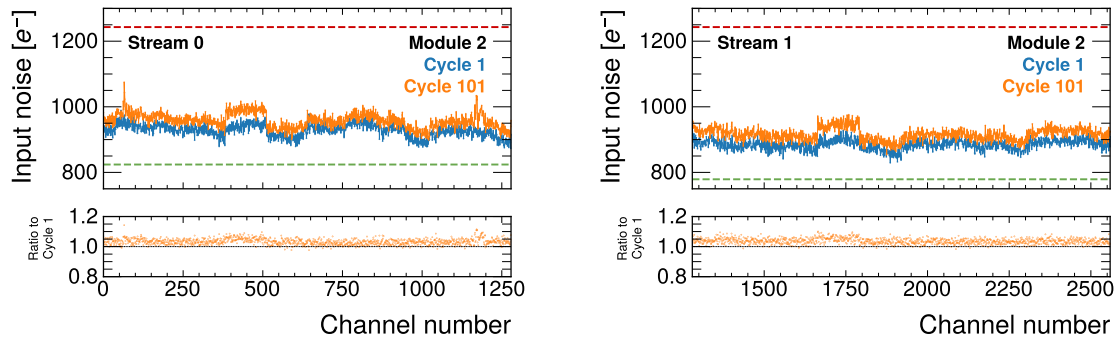
(a) Stream 0: corresponds to strips under the hybrid.

(b) Stream 1: corresponds to strips away from the hybrid.

**Figure 12:** Comparison of Module 2 noise measured during first and final cold tests for streams 0 and 1.

A comparison of input noise between its first and final cold test is shown in figure 12. While there are a few relatively noisy strips around channels 60 and 1175 (also seen in the output noise results), and there is a roughly constant increase in noise among all strips of this module after thermal cycling, the majority of strips are less than 5% noisier after cycling. As with Module 1, the measured noise is well below the maximum allowed room temperature noise of 1243 ENC. Also similar to Module 1, the measured noise exceeds the target room temperature noise in green, 824 (779) ENC for stream 0 (1), even when measured cold, indicating this module is noisier than expected.

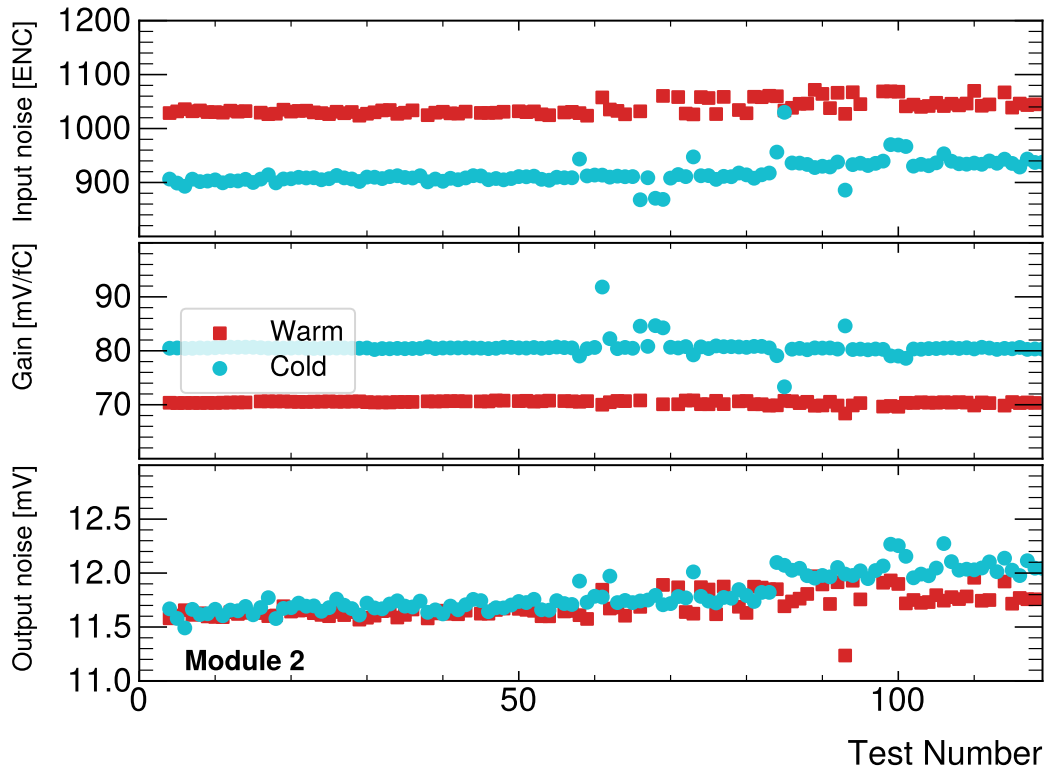
**Figure 13:** Module 2 input noise, gain, and output noise as a function of test number, separated by warm (Chiller at +40°C) and cold (Chiller at -40°C) tests. Note that there were more tests taken than number of thermal cycles, as sometimes a day of cycling would end on a warm test without completing a cycle, or one day would end with a cold test and the next day would start with a cold test.

Trends of Module 2’s input noise, gain, and output noise during warm and cold tests as a function of test number are shown in figure 13. These trends show a slow rise in average input

and output noise vs. test number. While this is non-desirable behavior, noise is still well within specification and 100 cycles is far beyond the expected detector induced stress. Finally, an I-V curve was taken after cycling, and is shown in figure 14a.

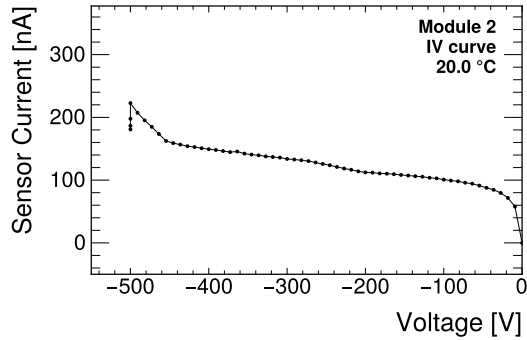
(a) I-V curve.

**Figure 14:** Post-cycling measurements of Module 2.

Similar to Module 1, this module begins to show increased leakage current as it approaches -500V. It is possible that this module would have failed the nominal QC, as it exhibits breakdown-like behavior before -500V. However, as was the case with Module 1, this I-V shows signs of training indicating its observed signs of breakdown may not be permanent. Also similar to Module 1, it may still be possible to operate this module depending on how the rest of the in-situ effects alter the module's electrical performance.

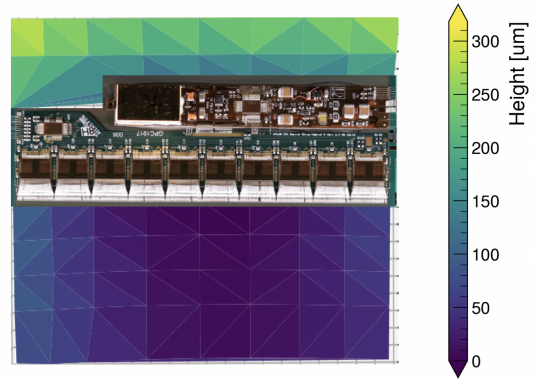
(b) Measured height as a function of module position, considering the same orientation as shown in figure 2b.

A post-cycling metrology measurement was also taken, and is shown in figure 14b. A similar

shape measurement to that of Module 1 is seen.

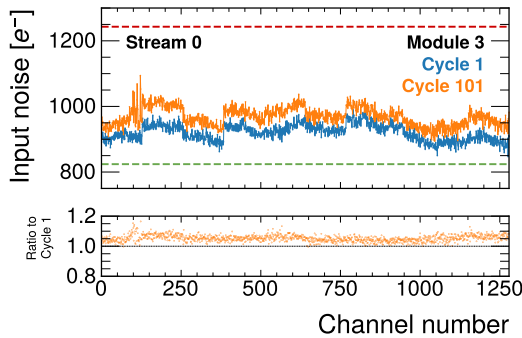
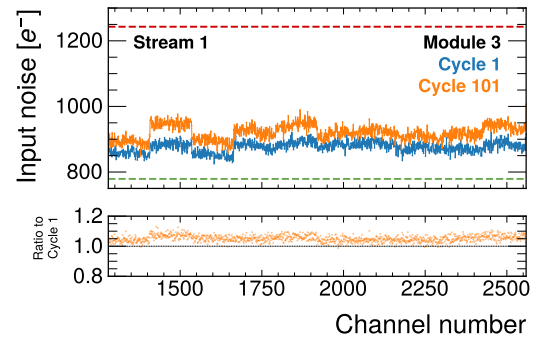
(a) Stream 0: corresponds to strips under the hybrid.

(b) Stream 1: corresponds to strips away from the hybrid.

**Figure 15:** Comparison of Module 3 noise measured during first and final cold tests for streams 0 and 1.

A comparison of input noise between its first and final cold test is shown in figure 15. Similar behavior is seen to that of Module 2: there are a few relatively noisy areas around channels 100 and 1175, and a roughly constant increase of about 5% in noise among strips after thermal cycling. As with Module 1 and Module 2, the measured noise is well below the maximum allowed room temperature noise of 1243 ENC. Additionally, the measured noise exceeds the target room temperature noise in green, 824 (779) ENC for stream 0 (1), even when measured cold, indicating this module was noisier than expected before any thermal cycling.

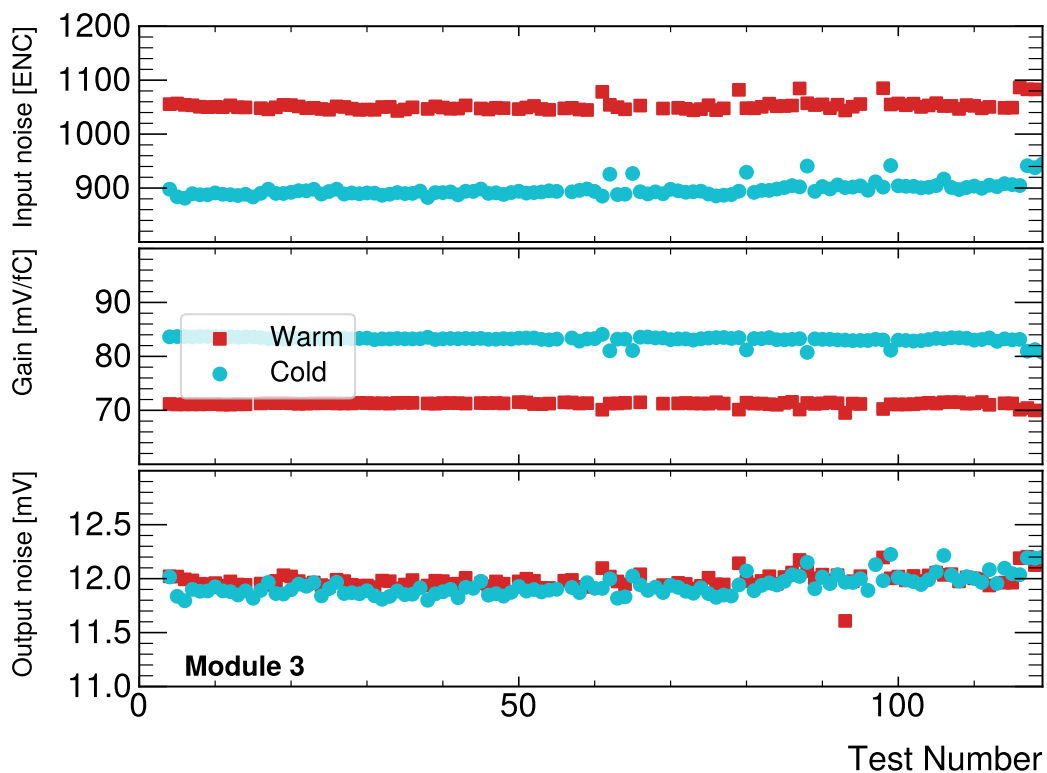
**Figure 16:** Module 3 input noise, gain, and output noise as a function of test number, separated by warm (Chiller at +40°C) and cold (Chiller at -40°C) tests. Note that there were more tests taken than number of thermal cycles, as sometimes a day of cycling would end on a warm test without completing a cycle, or one day would end with a cold test and the next day would start with a cold test.

Trends of this module's input noise, gain, and output noise during warm and cold tests as a function of test number are in figure 16. Noise is consistently higher on average for warm tests, as expected. Additionally, these trends show a roughly steady increase in average input noise vs. test number, indicating that the module is relatively stable, similar to Module 2.

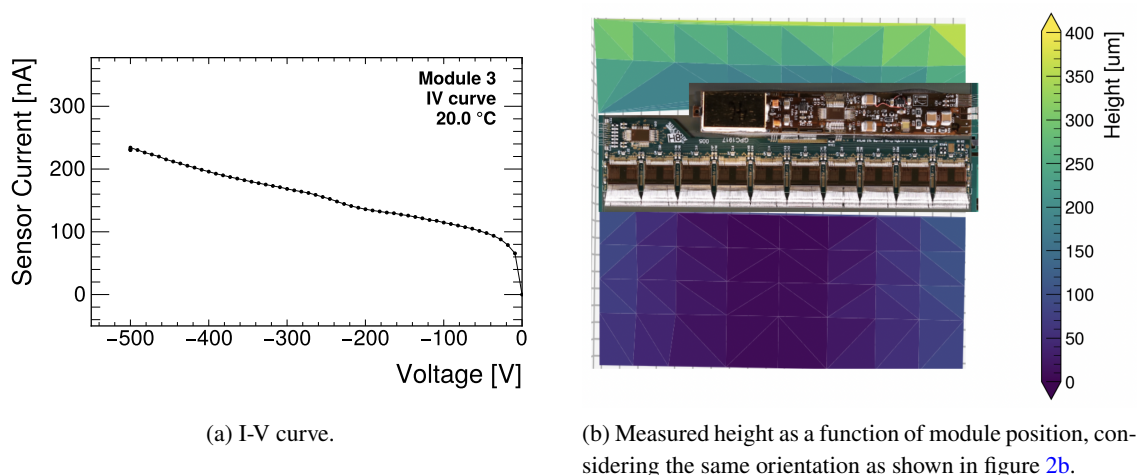
(a) I-V curve.

(b) Measured height as a function of module position, considering the same orientation as shown in figure 2b.

**Figure 17:** Post-cycling measurements of Module 3.

Finally, an I-V curve was taken after cycling, and is shown in figure 17a. This module does not show any indications of breakdown, and would have passed the I-V step of the nominal module QC.

A post-cycling metrology measurement was also taken, and is shown in figure 14b. A similar shape measurement to that of Module 1 and Module 2 is seen.
