Studies of VCSEL Failures in the Optical Readout Systems of the ATLAS Silicon Trackers and Liquid Argon Calorimeters

Mark S. Cooke
Lawrence Berkeley National Laboratory, Berkeley, CA, USA

The readout systems for the ATLAS silicon trackers and liquid argon calorimeters utilize vertical-cavity surface-emitting laser diodes to communicate between on and off detector readout components. A number of these VCSEL devices have failed well before their expected lifetime. We summarize the failure history and present what has been learned thus far about failure mechanisms and the dependence of the lifetime on environmental conditions.

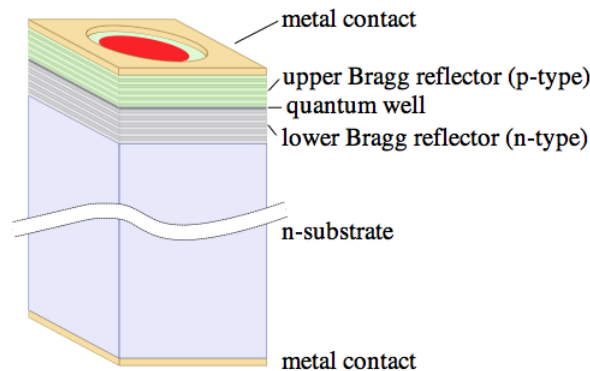
Figure 1: A schematic depiction a typical VCSEL device.

Figure 1 shows a schematic depiction of a typical VCSEL structure. The laser resonator consists of two doped reflector regions about an active region. The reflector regions alternate layers of high and low index of refraction (e.g. GaAs/AlGaAs). Quantum wells in the active region provide optical gain, and enhanced transverse current confinement is typically achieved with an oxidized layer or a layer containing ion implants (not depicted in the figure). VCSELs may be fabricated as single channel devices or in arrays. Single channel VCSELs are often hermetically packaged, as the devices are known to be sensitive to damage from external sources [3], such as humidity [4] and electrostatic discharge (ESD) [5]. Hermetic sealing of arrays is generally not an economic option, and some ATLAS VCSEL arrays have been coated with epoxy instead.

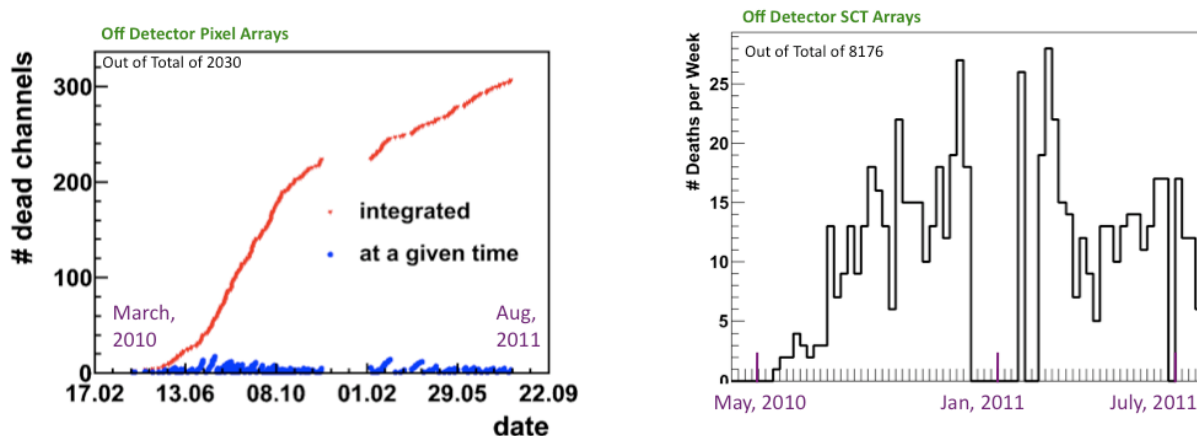
Figure 2: (Left) The integrated number of failed pixel TX-plugin channels versus time. (Right) The number of SCT TX-plugin deaths per week versus time.

The pixel and SCT detectors have experienced VCSEL deaths in the off-detector optical readout electronics. Early failures in the epoxy covered VCSEL arrays of the TX-plugins were observed in 2009, and a full replacement was performed with batches produced using a higher degree of quality assurance, particularly for ESD. Nonetheless, failures continue to persist. Figure 2 (left) shows the integrated number of failed pixel TX-plugin channels versus time between March 2010 and August 2011. Figure 2 (right) shows the total number of SCT TX-plugin deaths per week versus time between May 2010 and July 2011. In both cases, order 10 deaths occur per week. As these failures occur in the off-detector electronics, they are continuously replaced during sufficiently long periods between LHC fills.

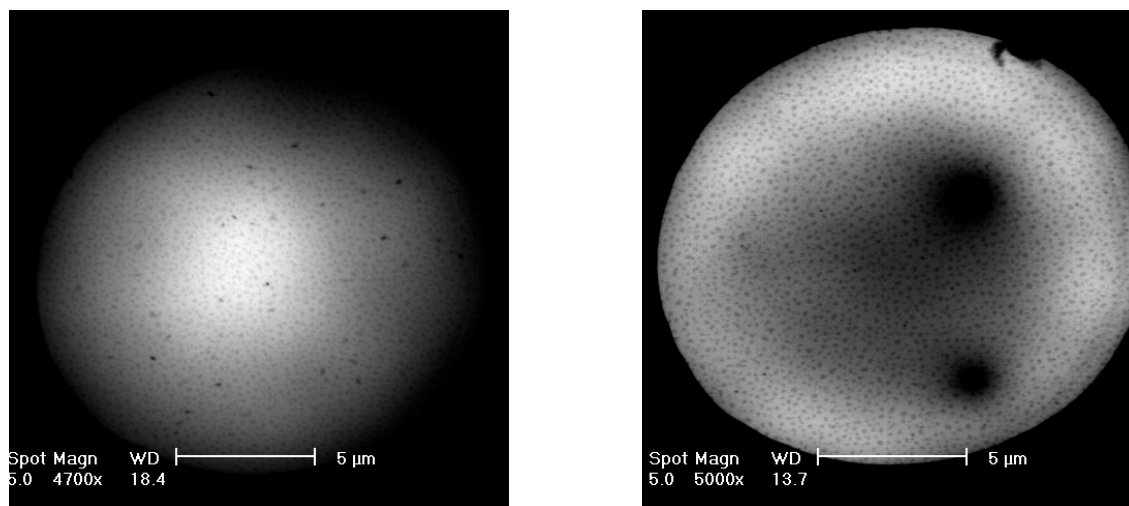
Figure 3: (Left) An EBIC image of a working VCSEL channel in a used pixel TX-plugin. The small dark speckles reflect small variations in surface topography. (Right) An EBIC image of a failed VCSEL channel in the same array as the channel shown on the left. The image reveals two large defect regions.

Electron beam induced current (EBIC) analysis utilizes the scanning electron microscope beam to reveal defects in biased semiconductor devices, as the induced current will vary when the electron beam is scanned over such regions. Figure 3 (left) shows an EBIC image of a working VCSEL channel in a used pixel TX-plugin device. The small dark speckles reflect small variations in surface topography. Figure 3 (right) shows an EBIC image of a failed VCSEL channel in the same array. Two localized dark regions are evident.

Figure 5 (left) shows a plan view STEM image of a vertical slice containing the oxide and quantum well layers of the working channel whose EBIC image is shown in Figure 3 (left). A ring of dislocations about the oxide layer aperture is observed. No such defects were seen on this channel in the EBIC analysis, as the defects were evidently too far below the surface. The absence of dislocations within the ring suggests they had not yet grown into the active region and the channel therefore remained functional.

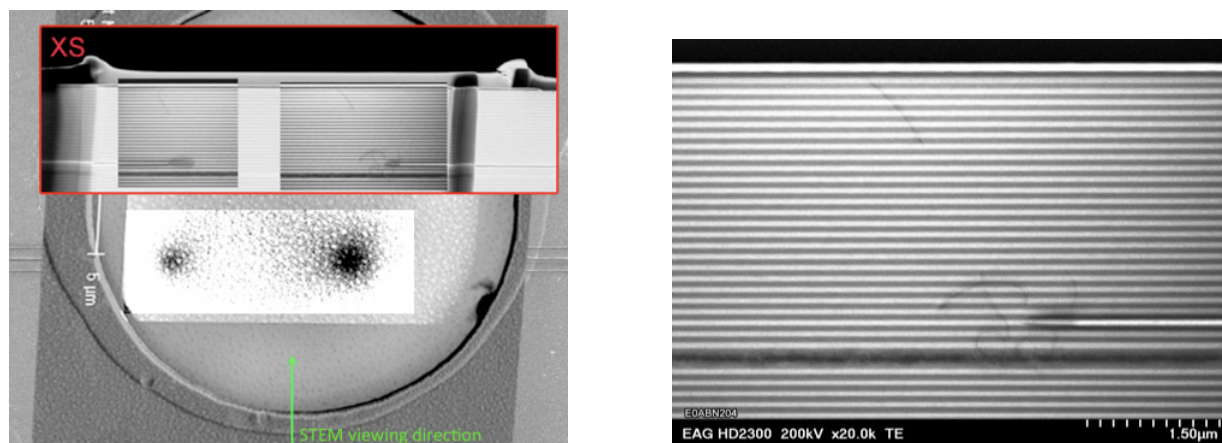
Figure 4: (Left) A second EBIC plan view of the failed channel in Figure 3 (right) indicating the region prepared for STEM analysis. The boxed inlay labeled XS shows an STEM image of a cross-section slice through the defect regions. (Right) A zoomed-in STEM image of the right oxide layer aperture and neighboring quantum well region.

The EBIC image of the failed VCSEL channel informed the preparation of a cross-sectional slice using a focused ion beam for analysis with a scanning transmission electron microscope (STEM). Figure 4 (left) presents a second EBIC image of the failed VCSEL channel, and indicates the region prepared for STEM analysis. The boxed inlay shows the STEM image of the cross section slice. Dislocations are observed to emanate from the oxide layer, recognized as the white band protruding into the reflector region from the left and right of the inlay. Figure 4 (right) provides a zoomed view of the right oxide layer tip and the neighboring quantum well region. In addition to the dislocation growth emanating from the oxide layer, defects are seen within the quantum well region, observed as the wide dark band layer.

The pixel array under investigation also contained an unbonded and hence unused VCSEL channel. Figure 5 (right) shows an STEM cross section image of this channel. An absence of defects is clear when compared with the similar image of the failed device in Figure 4 (right).

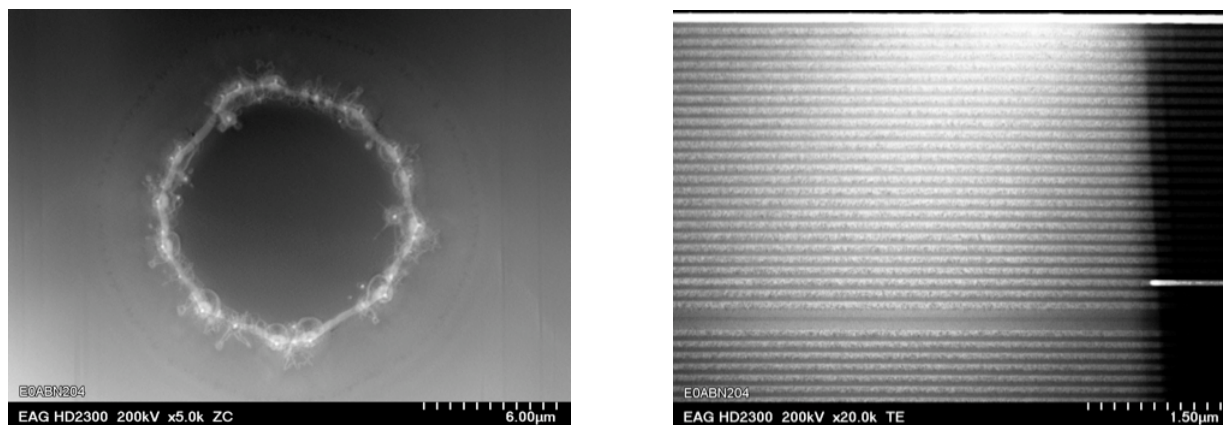
Figure 5: (Left) Plan view STEM image of a vertical slice of the working VCSEL channel containing the oxide and quantum well layers. (Right) Cross section STEM image of an unused VCSEL channel.

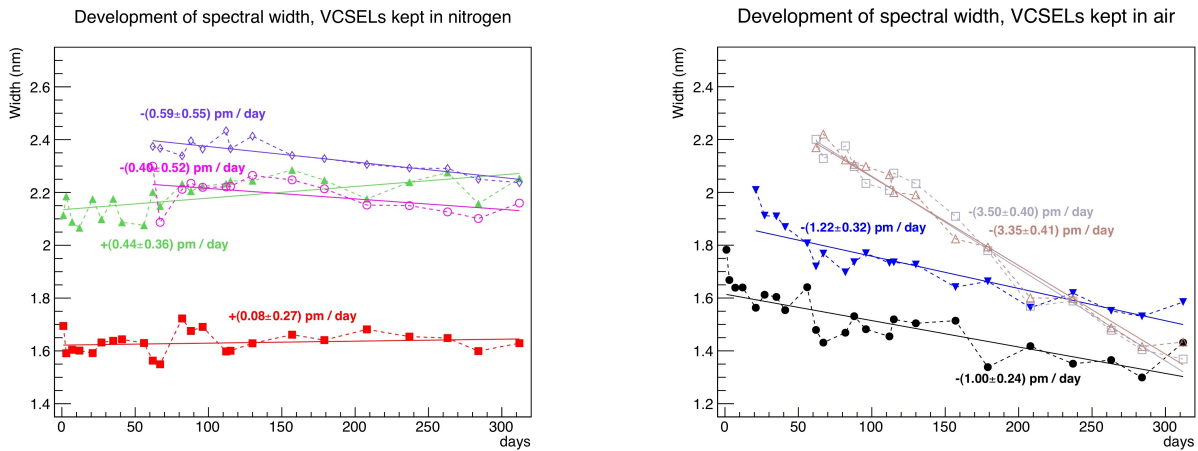
Figure 6: (Left) Development of the spectral width over time of four TX-plugin arrays kept in nitrogen gas (1% relative humidity) at 20°C. (Right) Development of the spectral width over time of four TX-plugin arrays kept in air (50% relative humidity) at 20°C.

A similar test has also been performed by the SCT collaboration using spare TX-plugin arrays. Figure 6 (left) shows the average spectral width versus time of four spare TX-plugin arrays operated in a low humidity nitrogen gas environment at 20°C . The widths have remained stable for ~ 250 days. In contrast, Figure 6 (right) shows the development of the width of four arrays operated in an air environment at 20°C and 50% relative humidity. Each array shows significant spectral narrowing in time when exposed to humid air.

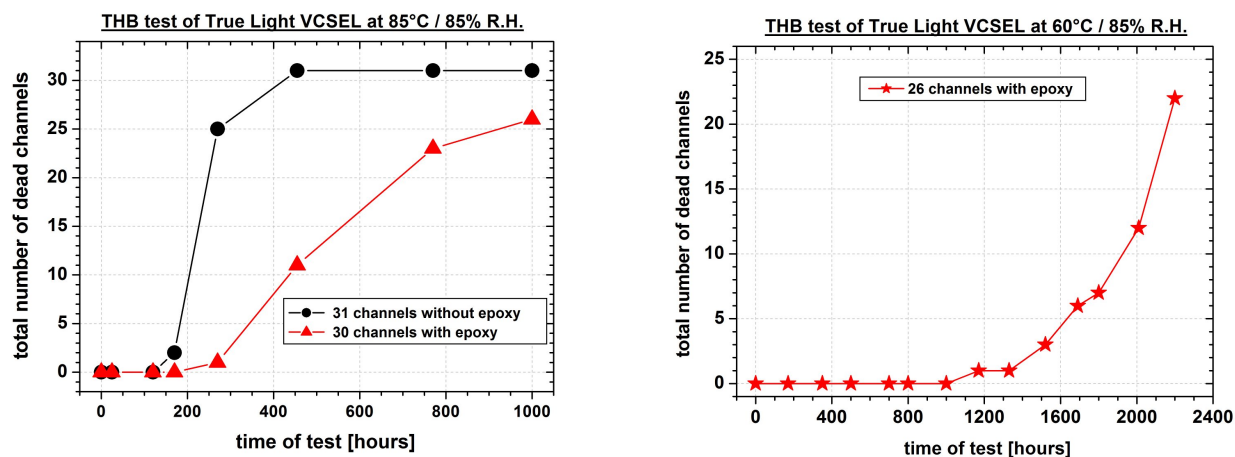
Figure 7: (Left) The integrated number of failed VCSEL channels versus time in Test 1 at 85°C and 85% relative humidity. Arrays with and without epoxy coated were studied in this test. (Right) The integrated number of failed VCSEL channels versus time in Test 2 at 60°C and 85% relative humidity. This test was performed on epoxy coated arrays.

Test 1 was carried out at a temperature of 85°C and 85% relative humidity, and examined arrays with and without epoxy coating. The number of failed channels during the test is shown as a function of time in Figure 7 (left). A device surviving operation in such conditions for 1000 hours is generally thought to be able to survive approximately 10 years in typical use conditions [4]. The channels on arrays without epoxy began to fail after only a couple hundred hours, and those on arrays with epoxy fared only marginally better.

Test 2 was performed with a lower temperature, 60°C, and the same 85% relative humidity as Test 1. Only epoxy covered arrays were studied in this test. Figure 7 (right) displays the results. The first failures occurred shortly after 1000 hours, and nearly all had failed by 2200 hours.
