DEALING IN PRACTICE WITH HOT-SPOTS

ABSTRACT: The hot-spot phenomenon is a relatively frequent problem occurring in current photovoltaic generators. It entails both a risk for the photovoltaic module's lifetime and a decrease in its operational efficiency. Nevertheless, there is still a lack of widely accepted procedures for dealing with them in practice. This paper presents the IES-UPM observations on 200 affected modules. Visual and infrared inspection, electroluminescence, peak power and operating voltage tests have been accomplished. Hot-spot observation procedures and well defined acceptance and rejection criteria are proposed, addressing both the lifetime and the operational efficiency of the modules. The operating voltage has come out as the best parameter to control effective efficiency losses for the affected modules. This procedure is oriented to its possible application in contractual frameworks.

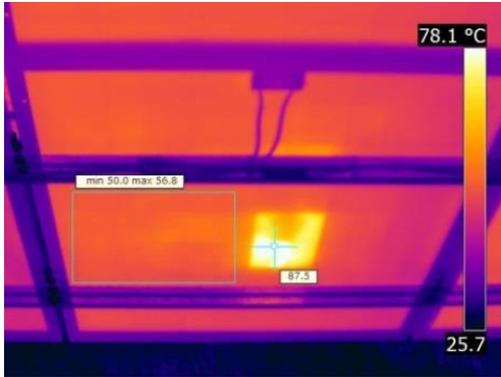
Figure 1. Hot-spot caused by micro-cracks. The operating temperature of the hot-spot is 87 °C while the mean temperature of the rest of the module is 53 °C, which represents a temperature difference of 34 °C.

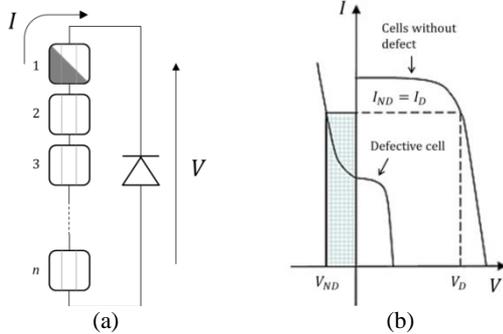
Figure 2. (a) Electrical connection of n originally identical cells protected by a by-pass diode. One of the cells is affected by a shade or an internal defect that limits its short-circuit current. (b) I - V curve of both the affected cell and the non-affected ones.

For explanation purposes, we first consider the case of a group of n identical solar cells, associated in series and protected by a by-pass diode (Figure 2-a). The operating conditions: incident irradiance, G , operating cell temperature, T_C , and polarization voltage, V , are such that a certain current, I_C , is circulating through these cells. A hot-spot appears in a cell (Figure 2-b) when some defect (micro-crack, shade, etc.) reduces its corresponding short circuit current, $I_{SC,D}$, so that

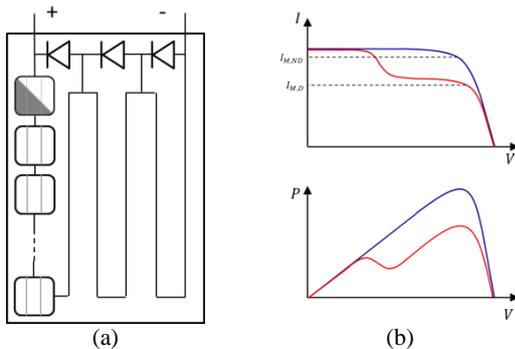
Figure 3. (a) Electrical scheme of a PV module with 3 groups, each made up of n cells and a by-pass diode. (b) I - V and P - V curves of a defective and a non-defective module. Observe the difference in the current at the maximum power point.

Now, let us consider the case of a PV module made up of three series associated groups, each made up of n cells and a bypass diode (Figure 3-a). Note that many currently commercial PV modules respond to this configuration, with n ranging typically from 20 to 24. A defective cell like the one described above does not reduce now the PV module short-circuit current but becomes an anomalous step in the first quadrant of the I - V and P - V curves (Figure 3-b).

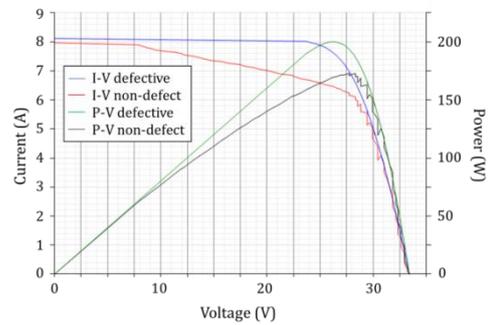
Figure 4. I - V curve of a defective module affected by a fill-factor loss.

Again, ΔT_{HS} depends on the operating voltage of the concerned group, which, in turn, depends on the operating voltage of the PV module. The voltage at the step marks the bypass diode turning ON, and ΔT_{HS} reaches its maximum for the voltage range below this step. Figure 4 shows examples of I - V curves of real modules affected by hot-spots. It is worth noting that current at the maximum power point of the defective module, $I_{M,D}$, is always lower than that corresponding to the non-defective ones, $I_{M,ND}$:

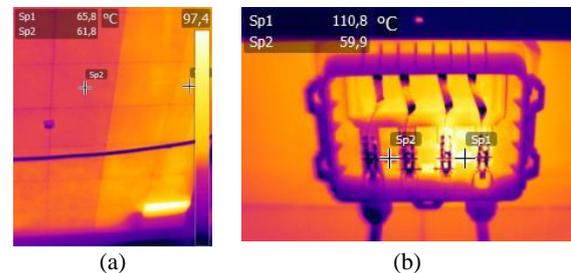
Figure 5. (a) PV module with one conducting by-pass diode. The cells protected by the diode are 4 °C hotter than the rest of the cells. (b) Close view of the connection box. The affected diode is at 110 °C while the others are working at 70 °C.

Finally, not only defective cells but also defective by-pass diodes can bring about hot-spots. In the latter case, short-circuited diodes give rise to an easily recognizable thermal pattern, consisting of an anomalous hotter band, somewhat like a brushstroke extended over the cells protected by the affected diode, with several cells exhibiting temperature differences of about 5 °C. Figure 5 shows an example of a PV module with a conducting by-pass diode.

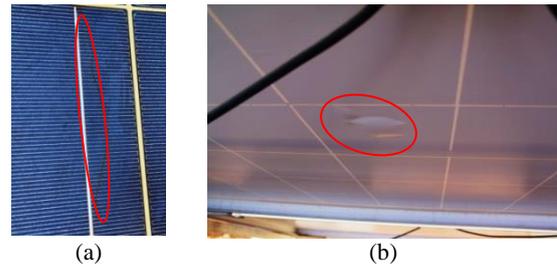
Figure 6. (a) Burnt metallization fingers caused by micro-cracks (b) Bubbles at the rear part of a PV module affected by hot-spots.

Figure 6 show examples of visible defects, where micro-cracks cause a current drift and a corresponding heat that leads to the burning of the metallization fingers and in bubbles at the rear of the modules. However, we found observable defects in only a 19% of the concerned PV modules, which is too weak a correlation for considering visual defects as a basis for dealing with hot-spots.

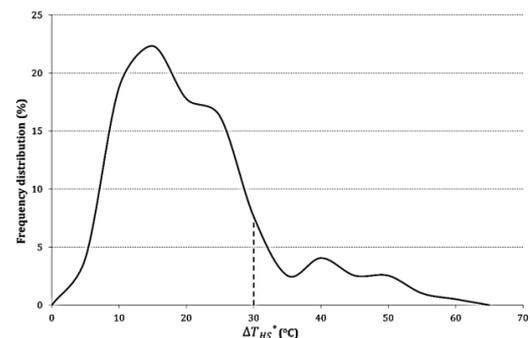
Figure 7. Frequency distribution of the temperature difference in the PV modules with hot-spots. The values with $\Delta T_{HS}^* > 30\text{ }^\circ\text{C}$ reflect the hot-spot evolution.

We obtained the IR images by means of an infrared camera (FLIR-E60). As the relevant parameter in this test is more the temperature difference than the absolute temperature value, imaging can be done at either the front or the back of the module. Just for convenience, we did all of them at the rear. Figure 7 shows the frequency distribution of ΔT_{HS} . This does not reflect the total hot-spot occurrence, but only the hot-spots observed some months after the substitution of all the modules with $\Delta T_{HS}^* > 30 \text{ }^\circ\text{C}$. Hence, the distribution tail beyond this value is a clear symptom of hot-spot time evolution. We did not observe any PID phenomena (which typically lead to a recognizable spatial pattern), thus most hot-spots are likely to be due to micro-cracks and depend on the temperature of the module, as the thermal stress affects the contact resistance between the two sides of the crack. Hence, an evolution of ΔT_{HS}^* is to be expected over the year, being larger in summer than in winter. On the other hand, daily thermal cycling typically entails module degeneration, leading to a probable worsening of hot-spots over time. However, these are not absolute rules. Each micro-crack is somewhat unique and even an improvement with thermal cycling can be observed [8].

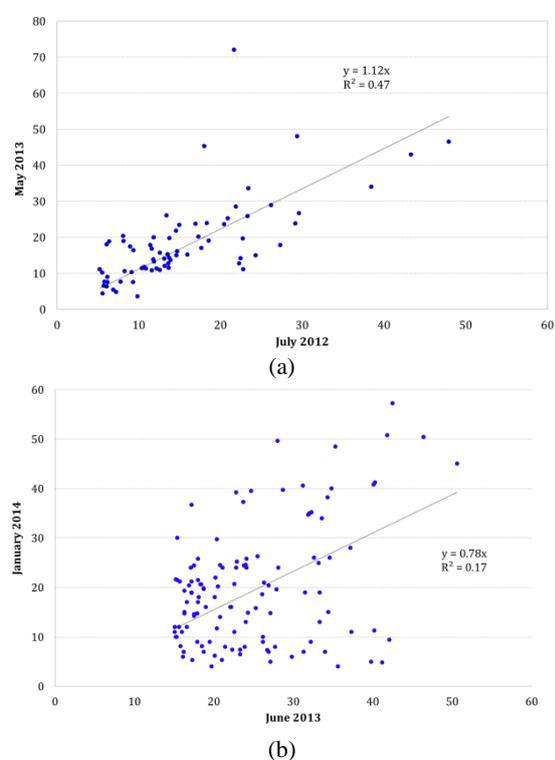
Figure 8. Hot-spot temperature evolution. Each point corresponds to ΔT_{HS}^* of a particular module at two different moments. At the Cáceres PV plant (a), both took place during hot months. A general ΔT_{HS}^* increase over time is noticeable. At the Cuenca PV plant (b), the latter moment corresponds to a colder month than the former. In this case, an average ΔT_{HS}^* decrease can be observed.

Figure 8 shows the combined result of these effects. Each point in the graph describes the observed ΔT_{HS}^* at two different moments. Figure 8(a) shows the evolution at the Cáceres PV plant between July 2012 (average ambient temperature, $T_A = 34\text{ }^\circ\text{C}$) and May 2013 ($T_A = 25\text{ }^\circ\text{C}$). All the modules showing $\Delta T_{HS}^* > 5\text{ }^\circ\text{C}$ in July have been considered. Despite the dispersion being high, on average, ΔT_{HS}^* has increased 11%. Figure 8(b) shows the case at the Cuenca PV plant between June 2013 ($T_A = 28\text{ }^\circ\text{C}$) and January 2014 ($T_A = 10\text{ }^\circ\text{C}$). Only those modules with $\Delta T_{HS}^* > 15\text{ }^\circ\text{C}$ in June have been considered on this occasion. Here, the average ΔT_{HS}^* has decreased by 22%, in an example of seasonal effects overcoming the degradation over time.

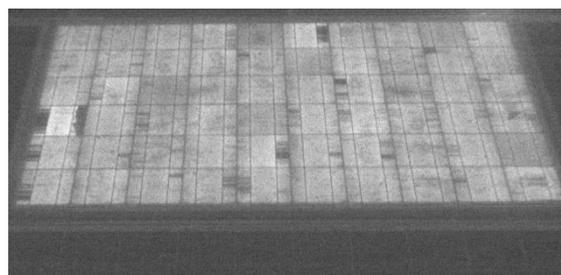
Figure 9. Electroluminescence image of a hot-spot affected PV module obtained in the field. Two cells with appreciable isolated areas can be observed (nearly a 40% for the left side cell – 20% B-type and 20% C-type crack – and almost 20% for the upper side cell – B type crack).

plant, due to the difficulties of implementing this test on site. We have followed the crack type classification proposed by Köntges et al. [8], dividing the affected cells into C-type (those exhibiting only background noise for the inactive cell part) and B-type (those exhibiting a reduced intensity but higher than the background noise). Figure 9 shows an example of an EL image obtained in the field and figure 10 shows the relationship between the fraction of cell that is isolated and the temperature difference.

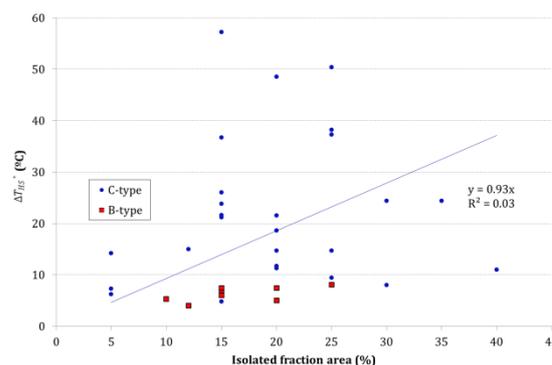
Figure 10. Relationship between ΔT_{HS}^* and the fraction of cell isolated by a crack. Squares and circles represent B-type and C-type cracks respectively.

We observed that all the modules showing a hot-spot in the summer IR inspections had some micro-crack in the affected cell but none of the cells with B-type cracks generated a hot-spot in winter. A proportional but very weak trend between the isolated area and ΔT_{HS}^* ($R^2=0.03$) was found. The relationship between the isolated fraction area and the power loss of the module, which remained very weak ($R^2=0.05$) was also analysed. A possible explanation is that the contact resistance between the two sides of the micro-crack varies with module temperature and can thus be much larger during the day (when hot-spots are observed) than during the night (when EL are obtained). Then, some areas can be miss-classified, leading to an incorrect estimation of the hot-spot problem. Whichever the case, EL images, despite being a very useful tool for quality control during the PV manufacturing processes, are not appealing for dealing with hot-spots in the field.

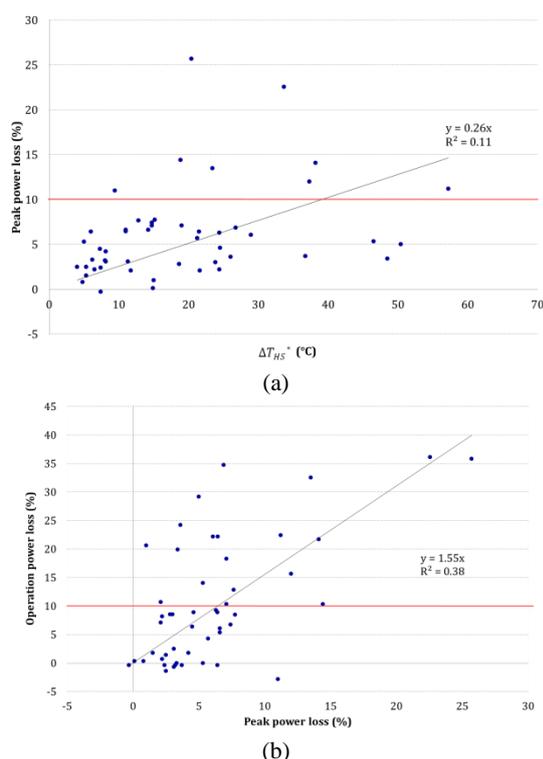
Figure 11. (a) Relationship between the temperature difference and the power loss for 50 PV modules. 8 of them are out of warranty conditions. (b) Relationship between the power loss and the operating voltage loss (effective power loss). In this case, 19 modules do not comply with warranty requirements.

Individual I-V curves of all the affected PV modules were obtained with a commercial I-V tracer (Tritec Tri-ka) and extrapolated to STC in accordance with the IEC-60891 (procedure 1), using the current and voltage temperature coefficients given by the manufacturer. Around 53% of the modules presented some anomalies in the I-V curve, as steps or an abnormally low fill factor. Figure 11(a) shows the relationship between ΔT_{HS}^* and the power loss in respect to the manufacturer's flash value, for 50 PV modules of the Cuenca PV plant. The high spread can be observed as can the fact that most of the modules satisfied the usual power warranty condition (typically, 90% of the minimal rated power output after 10 years). However, this is scarcely representative of their in-field behaviour, which is better appreciated through the operating voltage of the module, when working within the PV array. The latter was measured by simply inserting "T" connectors into the module output wires. Then, the voltage losses as regards the non-defective modules can be understood directly as power losses, as the current is common for all the modules connected in series. Figure 11(b) shows the relationship between the power loss and the operating voltage loss for the same 50 modules. As can be observed, the effective losses are a 55% higher than the power losses when considering the module alone.

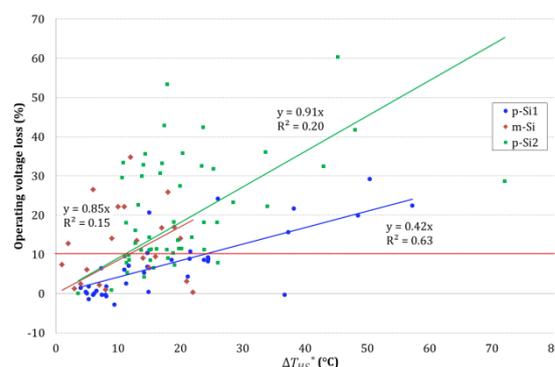
Figure 12. Relationship between the temperature difference and the operating voltage loss for 113 modules from 3 different manufacturers.

be disregarded for dealing with hot-spots. Second, the correlation between ΔT_{HS}^* and ΔV_{HS}^* and thus, power losses during operation, is positive, but the large dispersion does not allow the correlation at individual levels to be applied. In other words, the power loss of a defective module must be deduced from direct voltage measurements not from thermal observations. Apart of that, figure 12 shows the relationship between the temperature difference and the operating voltage loss for a more complete ensemble of the 113 PV modules of the three different manufacturers.

It can be observed that the behaviour is not the same for every manufacturer (neither in the correlation slope nor in the spread around it). The correlation between operating voltage loss and temperature difference is stronger in the case of module p-Si1 ($R^2=0.63$) and weaker for the cases of modules m-Si and p-Si2. These divergences likely reflect differences in the original material as well as non-uniform degradation affection due to different operation times (3 years in the case of module p-Si1 and 5 years for modules m-Si and p-Si2). Whichever the case, this behaviour spread is not relevant here.

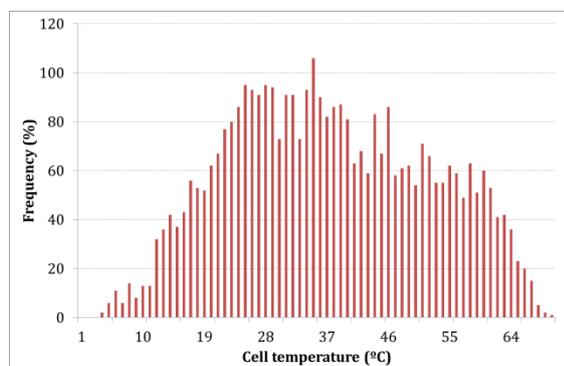
Figure 13. Annual frequency distribution of the operating temperature at the Cuenca PV plant

Hot-spots threaten the PV module lifetime, as degradation processes are generally accelerated by temperature. In particular, encapsulate discoloration and browning, and delamination [14]. Previous experiences do not allow a clear relation between module temperature and lifetime [7] to be established. Therefore, in order to set a maximum acceptable value, $\Delta T_{HS,MAX}^*$, we must rely on intuitive but reasonable approaches. We propose to consider 85°C, which is the maximum temperature of the thermal cycling tests described in the IEC-61215 as the maximum absolute PV module temperature for acceptance/rejection purposes. This limit has been also proposed by other authors [7]. Then, $\Delta T_{HS,MAX}^*$ should be thus so as to guarantee that the hot-spot absolute temperature remains below that limit. Figure 13 shows the annual frequency distribution of the day-time operating temperature in the Cuenca PV plant, which can be considered as representative of a Mediterranean climate (characteristic of Southern Europe and some parts of USA, Australia or South America). The maximum cell temperature is 70 °C and the 99-percentile temperature is

65 °C. As these high temperatures are also associated to high irradiances, setting $\Delta T_{HS,MAX}^* = 20\text{ °C}$ limits the time above 85 °C to around 40 hours a year (1% of the time) for these climate conditions, which seems a reasonable commitment. Moreover, it avoids reaching 100 °C, which has been sometimes suggested as an absolute maximum for preventing early degradation [15].
