# The Pixel Detector of the ATLAS experiment for the Run2 at the Large Hadron Collider

**Y. Takubo on behalf of the ATLAS collaboration**

**ABSTRACT:** The Pixel Detector of the ATLAS experiment has shown excellent performance during the whole Run-1 of LHC. Taking advantage of the long shutdown, the detector was extracted from the experiment and brought to surface, to equip it with new service quarter panels, to repair the modules and to ease installation of the Insertable B-Layer (IBL). The IBL is a fourth layer of pixel detectors, and has been installed in May 2014 between the existing Pixel Detector and a new smaller radius beam-pipe at a radius of 3.3 cm. To cope with the high radiation and pixel occupancy due to the proximity to the interaction point, a new read-out chip and two different silicon sensor technologies (planar and 3D) have been developed. Furthermore, the physics performance will be improved through the reduction of pixel size while, targeting for a low material budget, a new mechanical support using light weight staves and CO<sub>2</sub> based cooling system have been adopted. An overview of the refurbishing of the Pixel Detector and the IBL project as well as

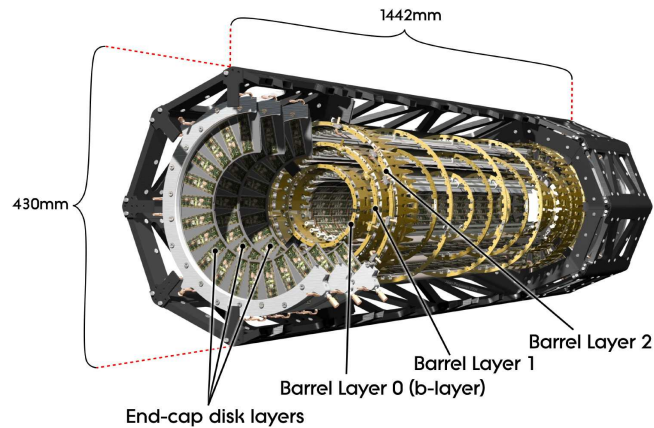
**Figure 1.** Schematic drawing of the ATLAS Pixel Detector. The detector consists of three barrel layers and two endcaps with three disc layers each.

The ATLAS Pixel Detector [1] is the innermost tracking detector of the ATLAS experiment [2]. It consists of three barrel layers placed at the radius of 50.5 mm, 88.5 mm and 122.5 mm centered around the beam axis ( $z$ ) and 2 endcaps with three disc layers each (Fig. 1). The full detector contains 1744 modules, and the total number of the pixels is 80 million.

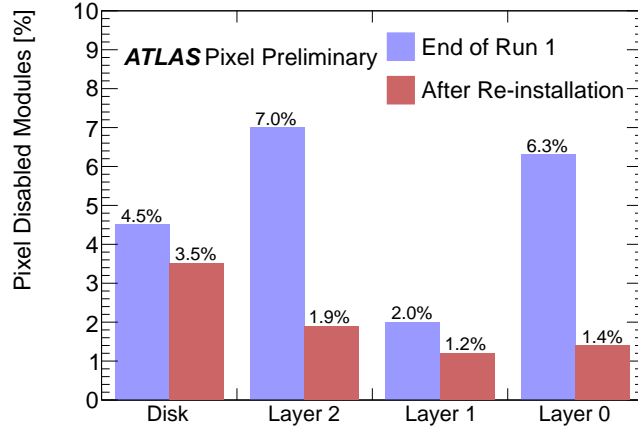
**Figure 2.** The number of the disabled Pixel modules at the end of Run-1 and after re-installation of the Pixel Detector with the nSQPs into the ATLAS detector [3]. Layer-0 in the figure means B-Layer.

At the beginning of Run-1, the fraction of disabled modules in the Pixel Detector was 2.5%, and then it increased gradually during operation. The fraction of the disabled modules became 5% at the end of the Run-1. Once the Pixel Detector was moved to the ground, the non-operational modules were investigated. There were several sources of problems like broken front-end chips and disconnection of the electrical lines in SQP. They were fixed as much as possible during replacement of the SQPs. The Pixel Detector was re-installed into the ATLAS detector in December 2013. Figure 2 shows the fraction of the disabled modules in each layer of the Pixel Detector at the end of the Run-1 and after the re-installation. The disabled modules were reduced to 1.9% after the re-installation [3].

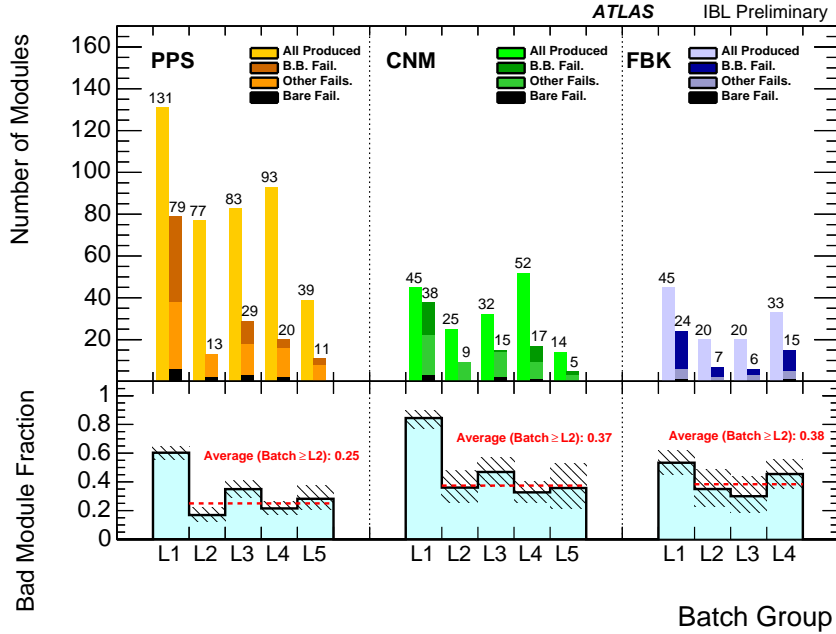
**Figure 3.** The number of the produced modules (top) and the fraction of the bad modules (bottom) per production batch group for planar (PPS) and 3D sensors (CNM and FBK) [3]. FBK and CNM are two vendors of 3D sensors.

Figure 3 shows the number of the produced modules and the fraction of the bad modules [3]. At the beginning of the production (L1 in Fig. 3), open and merged bumps were found in a high rate of the modules. One of the reasons of this issue was to use too much flux during the flip-chip process. The problem was solved after adopting flux-free flip-chip process. The total production yield was 75% for the planar module and 62% for the 3D module after solving the bump issues.

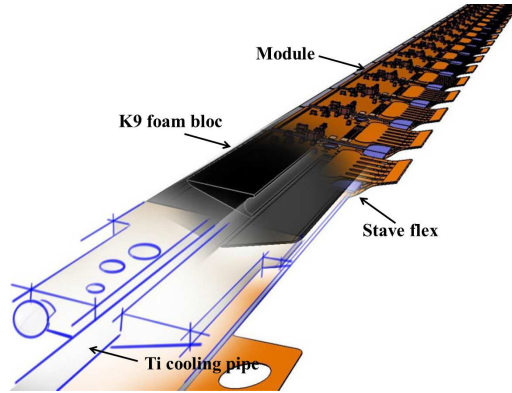
**Figure 4.** Schematic view of the IBL stave.

Figure 4 shows a schematic view of the IBL stave. A bare IBL stave is made of carbon foam with the size of  $74.8 \times 1.88 \text{ cm}^2$  and its cross-section has a triangular shape. Inside a IBL bare stave, a cooling pipe with 1.5 mm diameter is inserted, which is made of titanium. The planarity of the

$r$ -direction is required to be within  $350 \mu\text{m}$  to put the staves in the limited space between the beam-pipe and the B-Layer of the Pixel Detector. The material budget of the stave is only  $0.6\%$  ( $X/X_0$ ) including the cooling pipe.

Two flexible PCBs (stave flex) are glued on the two sides of  $z$ -direction of the bare stave to provide the electrical lines. In the stave flex, the low voltage (LV) lines for the FE-I4B chips are made of aluminum to reduce the material budget.

On each stave, 12 planar modules are mounted in the middle region in  $z$ -direction covering 75% area and 8 3D modules in the edge region covering 25% area. As described in Sec. 3.2, there is not enough space to put the modules with overlap in  $z$ -direction for the IBL, so that the

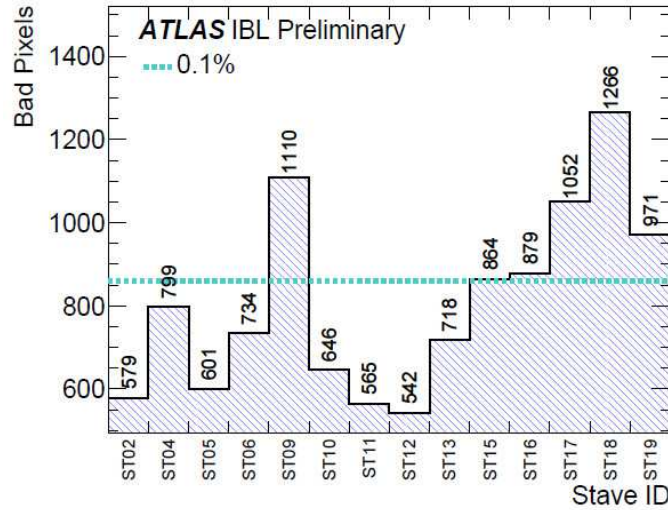
**Figure 5.** The number of the bad pixels in the 14 staves used for IBL [6].

Once the staves were produced, electrical functionality tests were performed to investigate their performance in detail. Any possible damage of the wire bonding and module surface was checked by optical inspection with a microscope. The quality of the sensors was confirmed with Current-Voltage (I-V) measurement. A breakdown voltage above  $80 \text{ V}$  and  $20 \text{ V}$  was required for the planar sensor and the 3D sensor, respectively. The functionality of the FE-I4B chips was checked by configuring the chips and reading data from them, including the tuning of the chip parameters. Finally, source scans with  $^{241}\text{Am}$  and  $^{90}\text{Sr}$  were performed to test the overall functionality of modules. In these tests, it was confirmed that IBL can be operated with a threshold value of 1500 electrons with noise values below 200 electrons. Figure 5 shows the number of the bad pixels in the 14 staves used for the IBL [6]. The fraction of bad pixels is required to be below 1% in this test, and all the staves well satisfied this requirement.

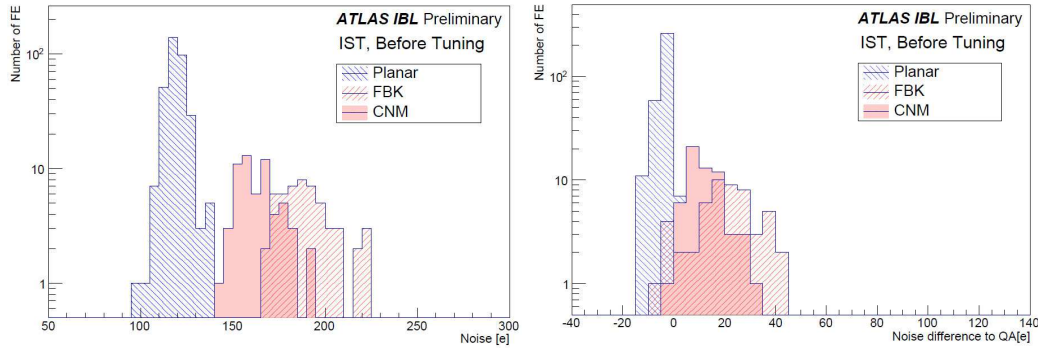
**Figure 6.** The noise distribution obtained after installation of the IBL (left) and the difference of the noise values from the results obtained before integration of the staves on the IST (right) [7].

The IBL was transported to the ATLAS experimental hall at 90 m underground on May 5, 2014 and installed into the ATLAS detector on May 7. After connecting the cooling pipes and service cables for the powering and environmental monitors, the performance of the IBL was tested again with the test system. In this test, the final DCS system was used for powering and reading the environmental monitors. The test system was connected with the service cables of the data lines to read-out the modules on the staves. Figure 6 shows the difference of the noise values between this test and the stave quality assurance test performed before integration of the staves [7]. In this test, it was confirmed that 100% of the sensors and FE-I4B chips is operational. Besides, there was no significant change of the performance from the stave quality assurance test.
