High temperature mechanical properties and microstructure of hard TaSiN coatings

Abstract

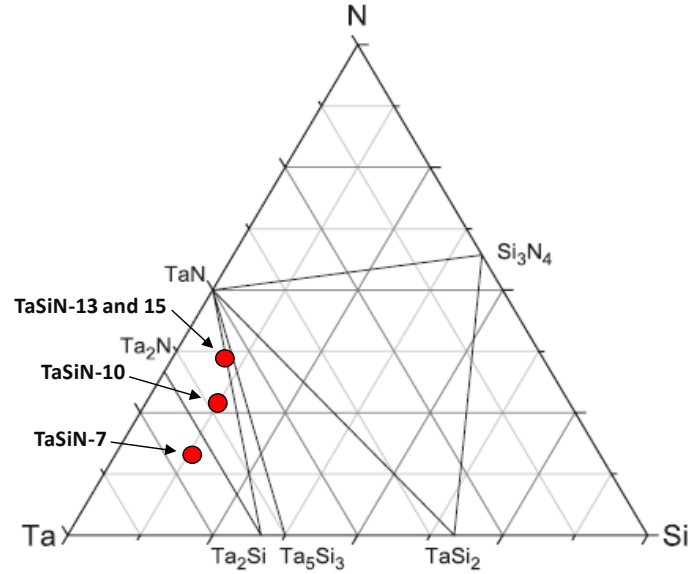
Fig. 1. Phase diagram of ternary Ta-Si-N system, showing the positions of the as deposited TaSiN studied in this work which are represented as circles.

As shown in the ternary phase diagram of Ta-Si-N corresponding to the isotherm calculated at 625°C and 1 atm [25], the TaSiN system can form many equilibrium compound phases for the range of compositions of the coatings, namely TaN, Ta₂N, Ta₂Si, Ta₅Si₃, TaSi₂ and Si₃N₄, while other metastable phases with different degrees of crystallinity might also be present, especially considering that the deposition conditions during sputtering are far from equilibrium. Therefore, X-ray diffraction (XRD) and transmission electron microscopy (TEM) studies are required to elucidate the phase composition and microstructure of the coatings.

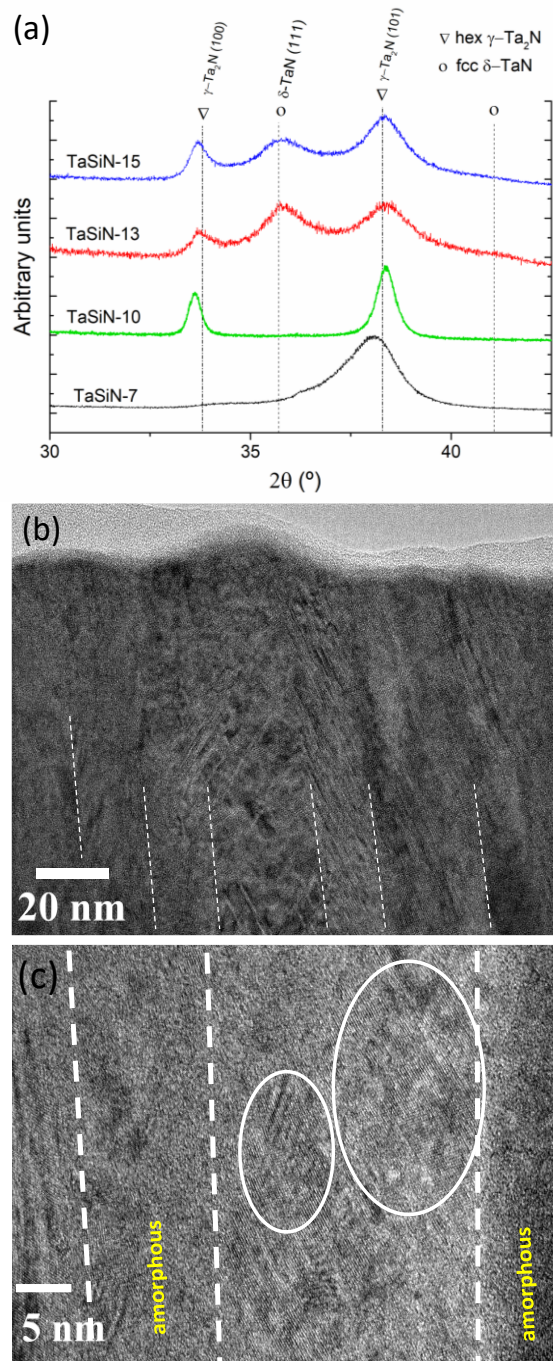
Fig. 2. (a) XRD spectra of the TaSiN films coatings; (b) BF TEM image of TaSiN-15 clearly showing signs of columnar morphology with columns being about 25-40 nm wide; and (c) representative HR TEM image of the microstructure of the TaSiN-13 coating, where columns are composed of several nanograins (circled in white) separated by amorphous regions.

Previous XPS results confirmed the presence of both Ta-N and Si-N containing phases [13]. The XRD patterns of the as-deposited TaSiN coatings are shown in Fig. 2a. The broad peaks in the XRD patterns suggest that the coatings are highly disordered, with very small grains. The XRD pattern of the coating with the lowest N content (TaSiN-7) showed the dominance of a broad peak

centred at $\approx 38^\circ$, which was attributed to the hexagonal γ -Ta₂N phase (PDF# 01-089-4764), with a preferred (101) orientation. However, this peak was slightly shifted to smaller diffraction angles than the theoretical position, implying an increased lattice parameter. With increasing N content, the peak position of this broad peak shifted to match the theoretical position of the γ -Ta₂N (101) peak and a new peak emerged at around 34° , corresponding to the (100) plane of the hexagonal γ -Ta₂N phase. A third peak at $\approx 35.9^\circ$ emerged in between the (100) and (101) γ -Ta₂N peaks for the coatings with the highest nitrogen content (TaSiN-13 and TaSiN-15), which can be attributed to the (111) plane of the cubic δ -TaN phase (PDF# 04-004-0787). Therefore, the TaSiN-13 and TaSiN-15 coatings consisted of a mixture of hexagonal γ -Ta₂N and cubic δ -TaN, probably co-existing with other amorphous phases. The fcc δ -TaN phase is a metastable phase, which frequently appears during sputter deposition [11]. The results are completely consistent with TEM studies carried out before [13], showing that the microstructure of the films deposited at 7% N₂ consisted of columnar and highly textured nanocrystalline grains of γ -Ta₂N. Increasing the N₂ content to 10% reduced the texture and induced the formation of an amorphous Si-N tissue in the grain boundaries, while further increases to 13%, resulted in the appearance of the δ -TaN phase. Fig 2b shows a cross-sectional bright field (BF) TEM image of the TaSiN-15 coating showing evidence of the columnar microstructure, with columns being about 25-40 nm wide. Fig. 2c shows an example of a cross-sectional high resolution (HR) TEM image of the TaSiN-13 coating, showing the nanocrystalline grains and the amorphous Si-N tissue.

phase, and the fact the (101) γ -Ta₂N peak in XRD appeared offset to lower angles, together with the absence of a distinct amorphous phase in the TEM, suggested that the Si might be incorporated into the N deficient γ -Ta₂N lattice. For TaSiN-10, however, the N/Ta ratio of 0.45 ensured the formation of stoichiometric γ -Ta₂N, and indeed the position of the XRD peak shifted to its theoretical position, and the excess N was available to form the amorphous Si-N tissue between the crystalline phases. Finally, a further increase in N was responsible for the onset of formation of the cubic δ -TaN phase in TaSiN-13 and TaSiN-15. The incorporation of N into the cubic δ -TaN phase also meant that less N was available to react with Si; hence, the concentration of Si for TaSiN-13 and TaSiN-15 (10 at.% Si) was smaller than for TaSiN-7 and TaSiN-10 (containing 13 and 14 at.% Si respectively).

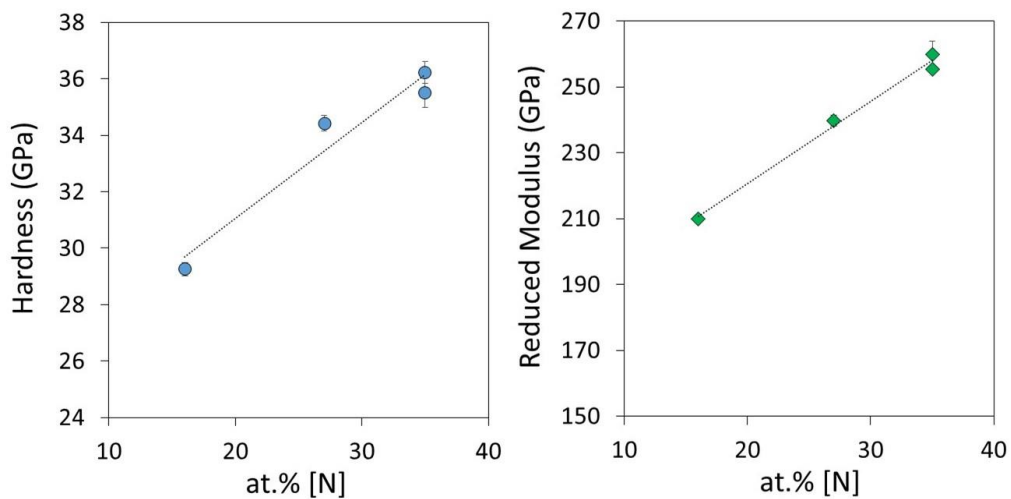
Fig. 3. Hardness and reduced modulus of deposited TaSiN coatings as a function of N content.

Room temperature hardness and elastic modulus of the TaSiN coatings as a function of nitrogen content are shown in Table II and in Fig. 3. Hardness and elastic modulus both increased with nitrogen content, with the hardness varying between 29 and 36 GPa, and the elastic modulus, between 210 and 255 GPa.

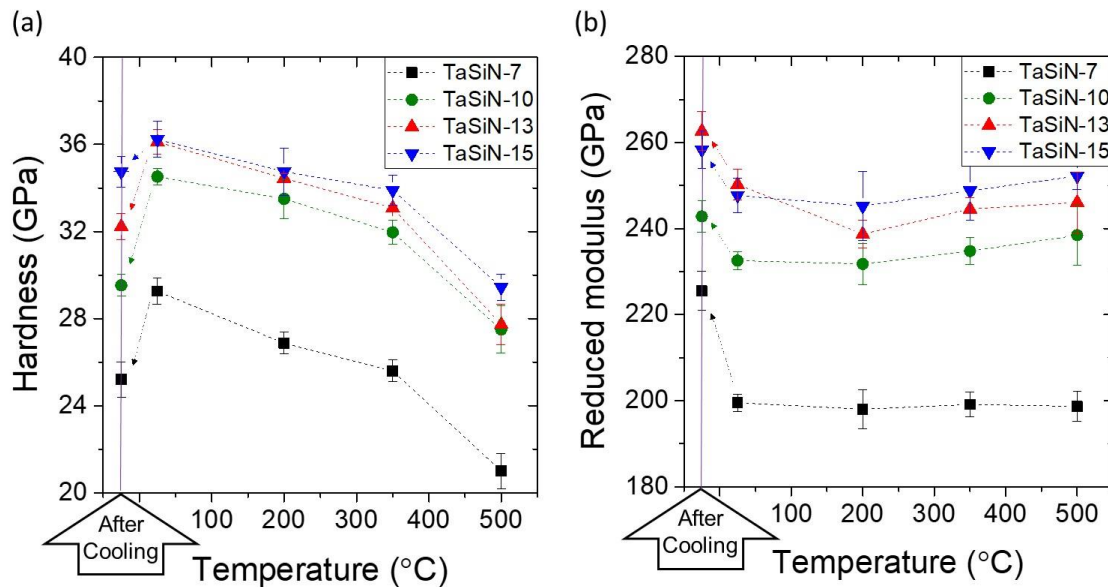
Fig. 4. (a) Hardness and (b) Reduced elastic modulus for the studied TaSiN coatings as a function of temperature. The hardness and modulus “after cooling” are also shown, being indicated by the large arrows in the “temperature” axis.

High temperature nanoindentation measurements were performed to investigate the effect of temperature on the coatings hardness and modulus. Figs. 4a and 4b show the hardness and reduced elastic modulus as a function of testing temperature, respectively. The effect of the testing temperature in the elastic modulus was not significant. However, the hardness reduction with temperature was similar for all coatings, with a drop of only 5% at 350°C and 15% at 500 °C. After the 500 °C tests (“after cooling values” in Fig. 4), the hardness values decreased between ~1.4 and 4.0 GPa, and the reduced modulus slightly increased, depending on the elemental composition of the coatings. The highest drop in hardness (~14%) and increase in modulus (~10%) was observed for sample TaSiN-7 and the lowest for TaSiN-15 (~4 % drop in hardness and ~4 % increase in modulus). This seems to indicate some microstructural change in the coatings, as will be discussed in more detail in section 3.4.

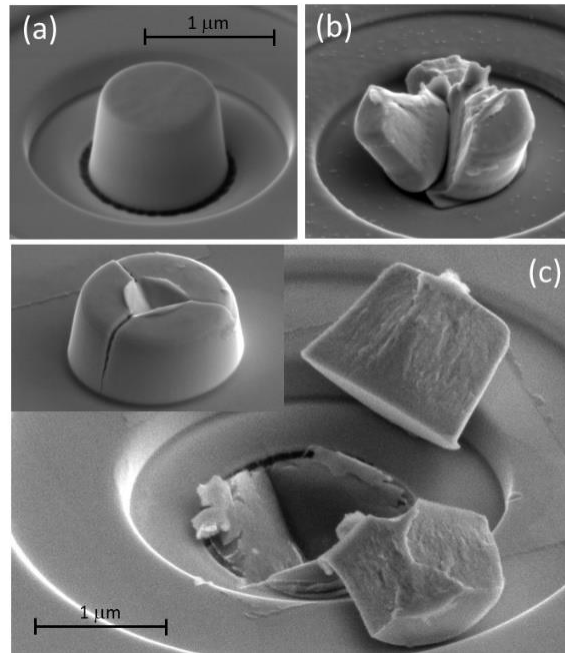
Fig. 5. SEM images of (a) micropillar before splitting test; (b) micropillar after splitting test at room temperature for TaSiN-7 and (c) micropillar after splitting test for TaSiN-15. The inset is a post-fracture micropillar tested with a standard tip. No variation in calculated toughness was observed for room temperature tests using either tip.

Hardness is not the only requirement for wear resistance; the coating toughness can be an equally important factor, particularly for abrasion, impact and erosive wear. In order to assess the coatings toughness, micropillar splitting tests were performed at the same temperature range as the nanoindentation tests, as described in section 2. A typical milled micropillar before fracture is shown in Fig. 5a, while post-fracture micropillar images are shown in Figs. 5b and 5c for TaSiN-

7 and TaSiN-15 coatings respectively. The load-displacement curves in Fig. 6a, and the post fracture micropillar images indicate that the deformation proceeded elasto-plastically in the initial stages until cracks were nucleated and propagated rapidly to the outer radius of the micropillar, triggering sudden splitting fracture (see Fig. 5c). The displacement-control tests were aborted manually after the critical load was detected by a sudden load drop and the feedback loop was unable to stop the tip crashing against the pillar base, right after the onset of the rapid cracking event. Sometimes, the fractured micropillar still stood after the test, typically for micropillars with a smaller aspect ratio that were loaded using a standard tip (rather than the special long shaft tip used for the high temperature tests), as observed in the inset of Fig. 5c. Despite the different post-fracture behaviour observed as a function of indenter tip, no variation in the calculated toughness values was observed for room temperature tests using either tip.

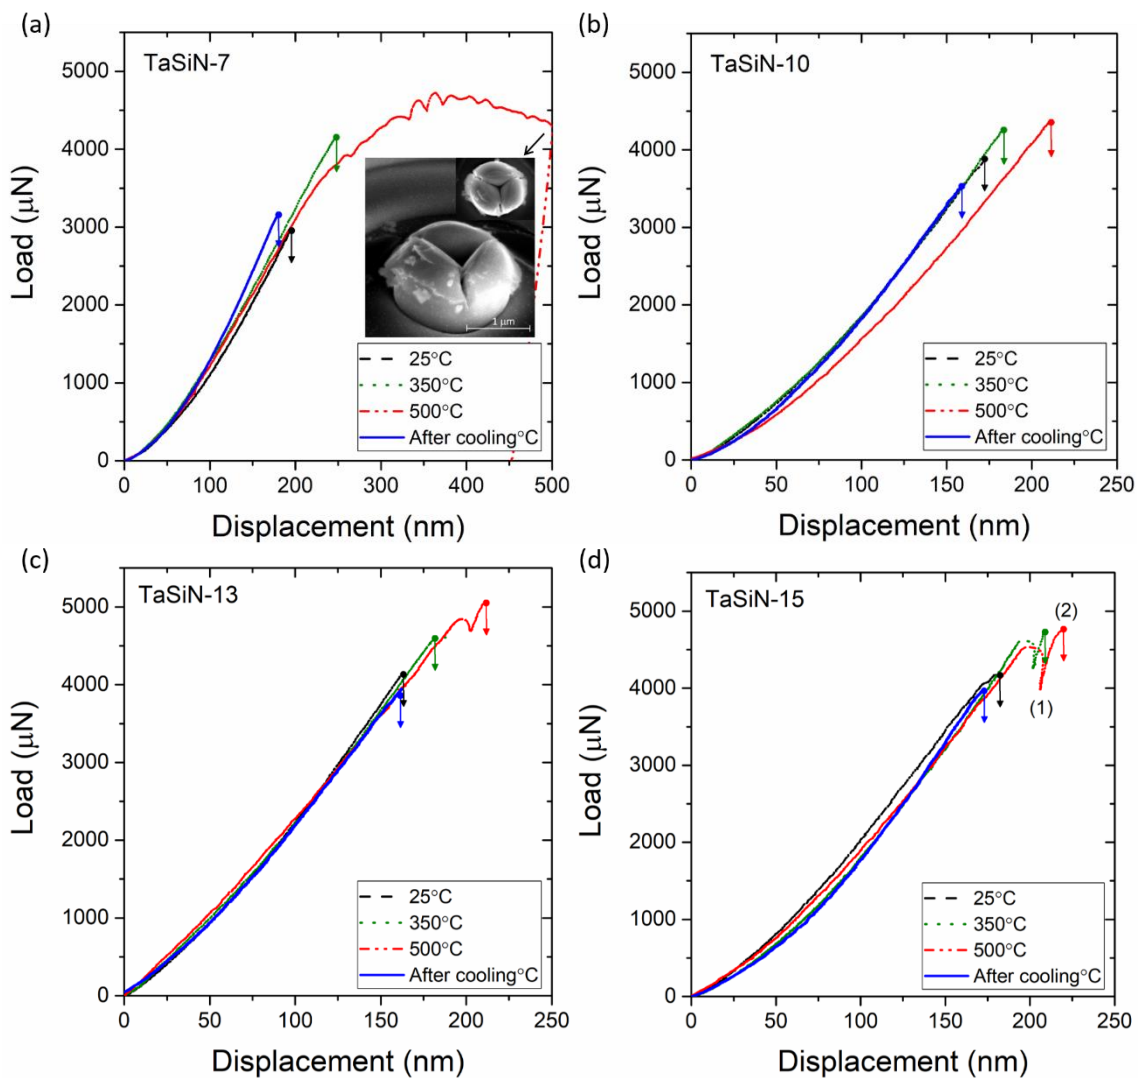
Fig. 6. Representative force-displacement curves showing critical loads for micropillar splitting tests performed at 25, 350, 500°C and after cooling for all four TaSiN coatings: (a) TaSiN-7 (the

inset shows an SEM micrograph for TaSiN-7 after testing where no catastrophic fracture occurred), (b) TaSiN-10; (c) TaSiN-13; (d) TaSiN-15.

Some of the TaSiN-13 and TaSiN-15 coatings tested at 350 and 500 °C exhibited a load drop (marked as (1) in the load-displacement curves of Fig. 6d) prior to the critical load. At this point, one of the tests was stopped for TaSiN-15 and the micropillar imaged by SEM, as shown in Fig. 8b. A crack can be observed at the top of the micropillar (inset of Fig. 8b) extending from one of the corners of the residual imprint to the outer radius of the micropillar. Figs 8a and 8c show post-fracture micropillars for TaSiN-15 tested at 350 and 500 °C respectively, which show how the micropillars adopted a mushroom shape in order to accommodate the pile-up formed around the indentation imprint, indicating a large increase in plasticity with temperature.

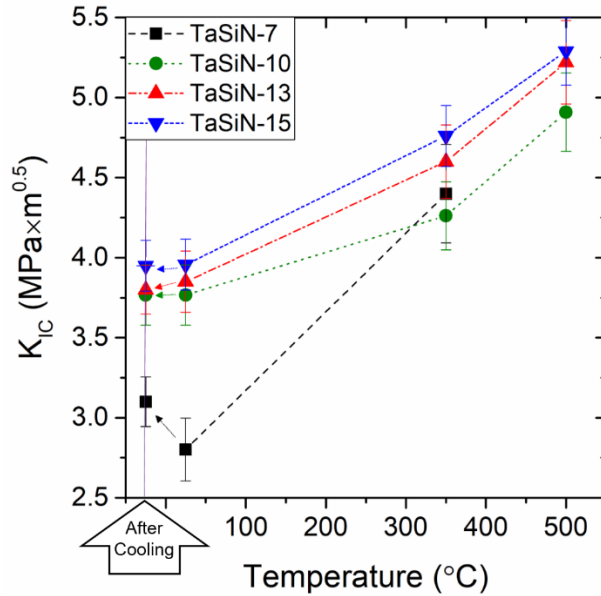
Fig. 7. Fracture toughness as a function of temperature for all TaSiN coatings.

of temperature are presented in Fig. 7. The toughness for all coatings increased with temperature, consistently with the hardness drop with temperature, which indicates enhanced plasticity with temperature. The increase in fracture toughness with temperature was particularly steep for TaSiN-7, to the point that no micropillar splitting took place for this coating at 500 °C. In this case, the tip penetrated continuously into the top of the micropillar while cracks extended from the corners of the indentation imprint, as shown in the inset of Fig. 6a, without inducing the splitting of the micropillar. Therefore, no fracture toughness could be determined for this coating at 500 °C. Finally, and contrary to the hardness changes observed, repeating the splitting tests after cooling down to room temperature (Figs. 6a-d) provided similar critical loads, and hence, similar toughness results to those obtained at room temperature before heating (Fig. 7).

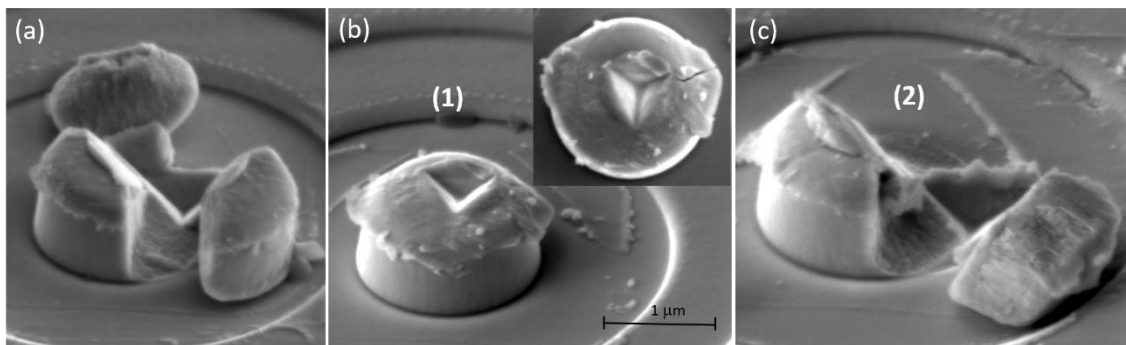
Fig. 8. SEM images of tested micropillars for the TaSiN-15 coating: (a) after splitting test performed at 350°C; (b) after splitting test at 500°C up to point (1) in Fig. 6(c) (the inset is a top

view of the same micropillar); and (c) after splitting test performed at 500 °C - point (2) in Fig. 6(d), after total fracture.

All coatings retained a good combination of hardness and fracture toughness at 500°C, with the hardness decreasing by 15% and the fracture toughness increasing by 30%, due to enhanced plasticity of the coatings. No evidence of significant microstructural changes or grain size enlargement were found from the XRD and TEM studies after high temperature testing. Therefore, the coatings presented high temperature stability and the reported high temperature hardness and fracture toughness values were not a consequence of microstructural changes suffered during high temperature testing. On the contrary, the observed hardness trend as a function of temperature is attributed to thermally activated plastic deformation, as has been observed in other hard nitride coatings [19]. In our case, the hardness decreased by only $\approx 5\%$ at 350°C while a larger drop ($\approx 15\%$) was observed at 500 °C. This increase in plasticity with temperature was even more evident on the micropillar splitting tests performed at 500 °C, where the cube corner tip induced massive pile-ups, as observed in Fig. 8b.

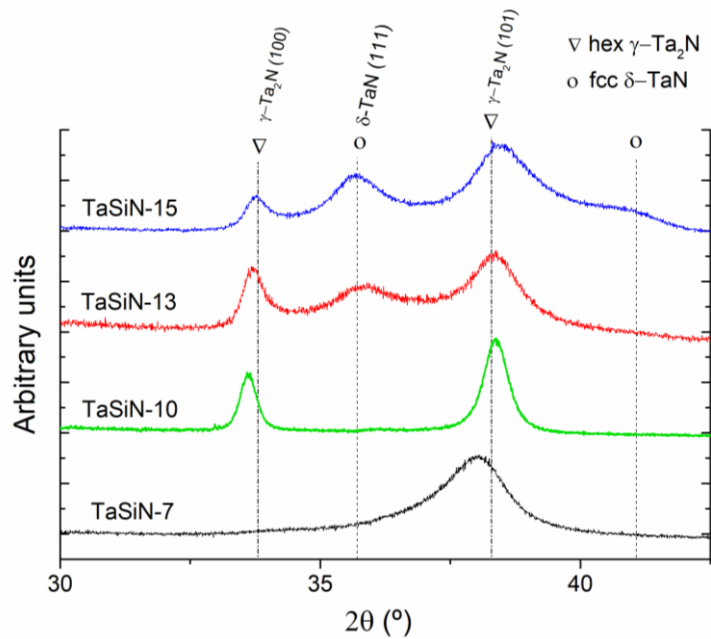
Fig. 9. XRD spectra of the TaSiN coatings after nanoindentation at 500 °C.

It is important to elucidate the potential microstructural changes that might occur during the high temperature nanoindentation and micropillar splitting tests. According to the XRD spectra of Fig. 9, the phase composition remained essentially unchanged for all samples after the indentation tests at 500 °C, so the coatings microstructure seemed to be stable up to this temperature.

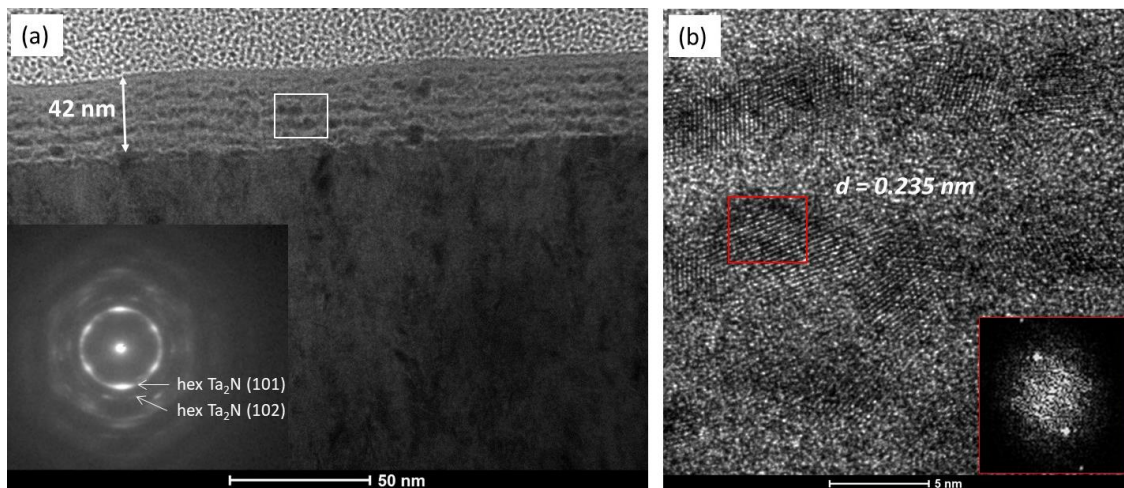
Fig. 10. (a) Cross-sectional bright-field (BF) TEM image of the TaSiN-7 coating. Inset is the selected-area diffraction (SAD) pattern of the area beneath the surface layer; (b) Cross-sectional high-resolution TEM image of the oxide-rich surface layer area enclosed by the white square in (a). The inset is a Fourier transform of the crystalline region delimited by the red square.

Fig. 10 shows a cross-sectional TEM image of the TaSiN-7 coating after nanoindentation testing at 500 °C, where a distinct oxide surface layer with a thickness of ≈ 42 nm can be observed. This is not surprising since residual oxygen is always present (and subsequently uptaken during high temperature testing), even when the coatings were tested in a closed environment under a low flow of Ar. The oxide layer presented a multi-layered morphology. A compositional map for N and O across the top surface layer is shown in Fig. 11a. The oxide-rich surface layer was partially crystalline, as can be observed in the high-resolution TEM image of Fig. 10b, where the multilayer structure alternated amorphous and crystalline regions. The crystalline domains exhibited a lattice spacing of 0.235 nm, correlating to the period of hexagonal Ta_2N (101) planes, which occupied $\approx 50\%$ of the area, and were embedded in irregular Si-oxide dominated amorphous layers (see Fig. 10b). Apart from the surface oxide, no microstructural changes were observed for the rest of the coating thickness, which exhibited the same dense as-deposited nanocrystalline columnar microstructure, with lateral sizes of the order of 5-10 nm (see Fig. 11c). The selected-area

diffraction (SAD) pattern for TaSiN-7 (inset of Fig. 10a) shows a discontinuous ring pattern, indicating that the coating had a noticeable texture, with the main reflection assigned to hexagonal γ -Ta₂N (101), in agreement with XRD observations.

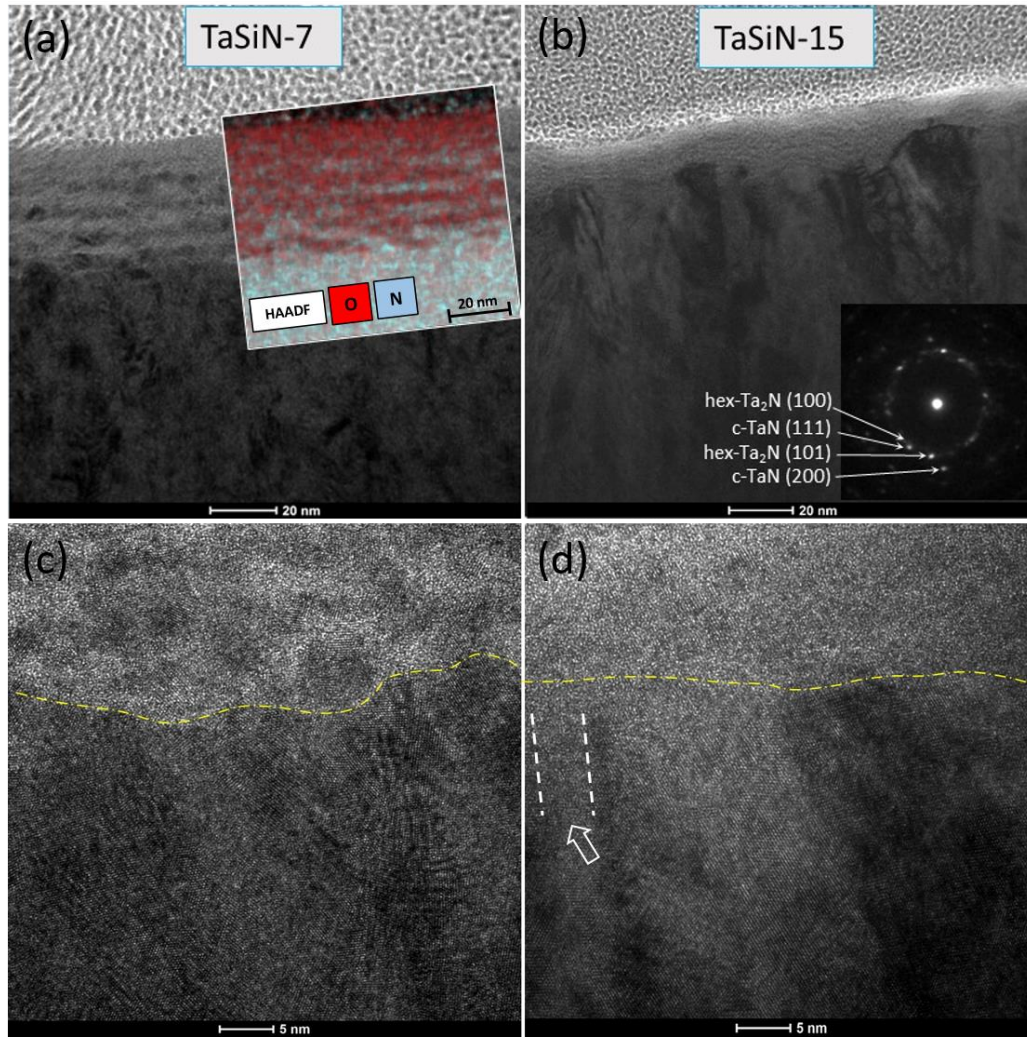
Fig. 11. (a) Cross-sectional BF TEM image of the TaSiN-7 coating. The inset is the EDX map of the near surface layer where red corresponds to O and blue to N; (b) Cross-sectional BF TEM image of the TaSiN-15. Inset is the SAD pattern; (c) and (d) are cross-sectional HR-TEM image of the TaSiN-7 and TaSiN-15 respectively. The dashed yellow line is the interface between the oxide-rich surface layer and the bulk of the coating; the white arrow in (d) points to an amorphous region.

Similar observations were made with increasing the N content, with the only difference being the morphology and thickness of the surface oxide layer: the surface layer was more amorphous with a total thickness of only 15 nm for TaSiN-13 and TaSiN-15, as observed in Fig. 11b. Apart from the surface oxide layer, the microstructure of the coatings remained unchanged, showing columnar grains with an average grain size in the range 25-40 nm for TaSiN-15, composed of cubic δ -TaN and hexagonal γ -Ta₂N phases, as revealed by the SAD patterns and in agreement with the XRD results, which were separated by amorphous regions, presumably Si-N rich (as pointed by the arrow in Fig. 11d).
