# AUTOMATIC JOINT DAMAGE QUANTIFICATION USING COMPUTER VISION AND DEEP LEARNING

## ABSTRACT

**Keywords:** Contraction joint, automatic detection, joint damage quantification, computer vision, deep learning.

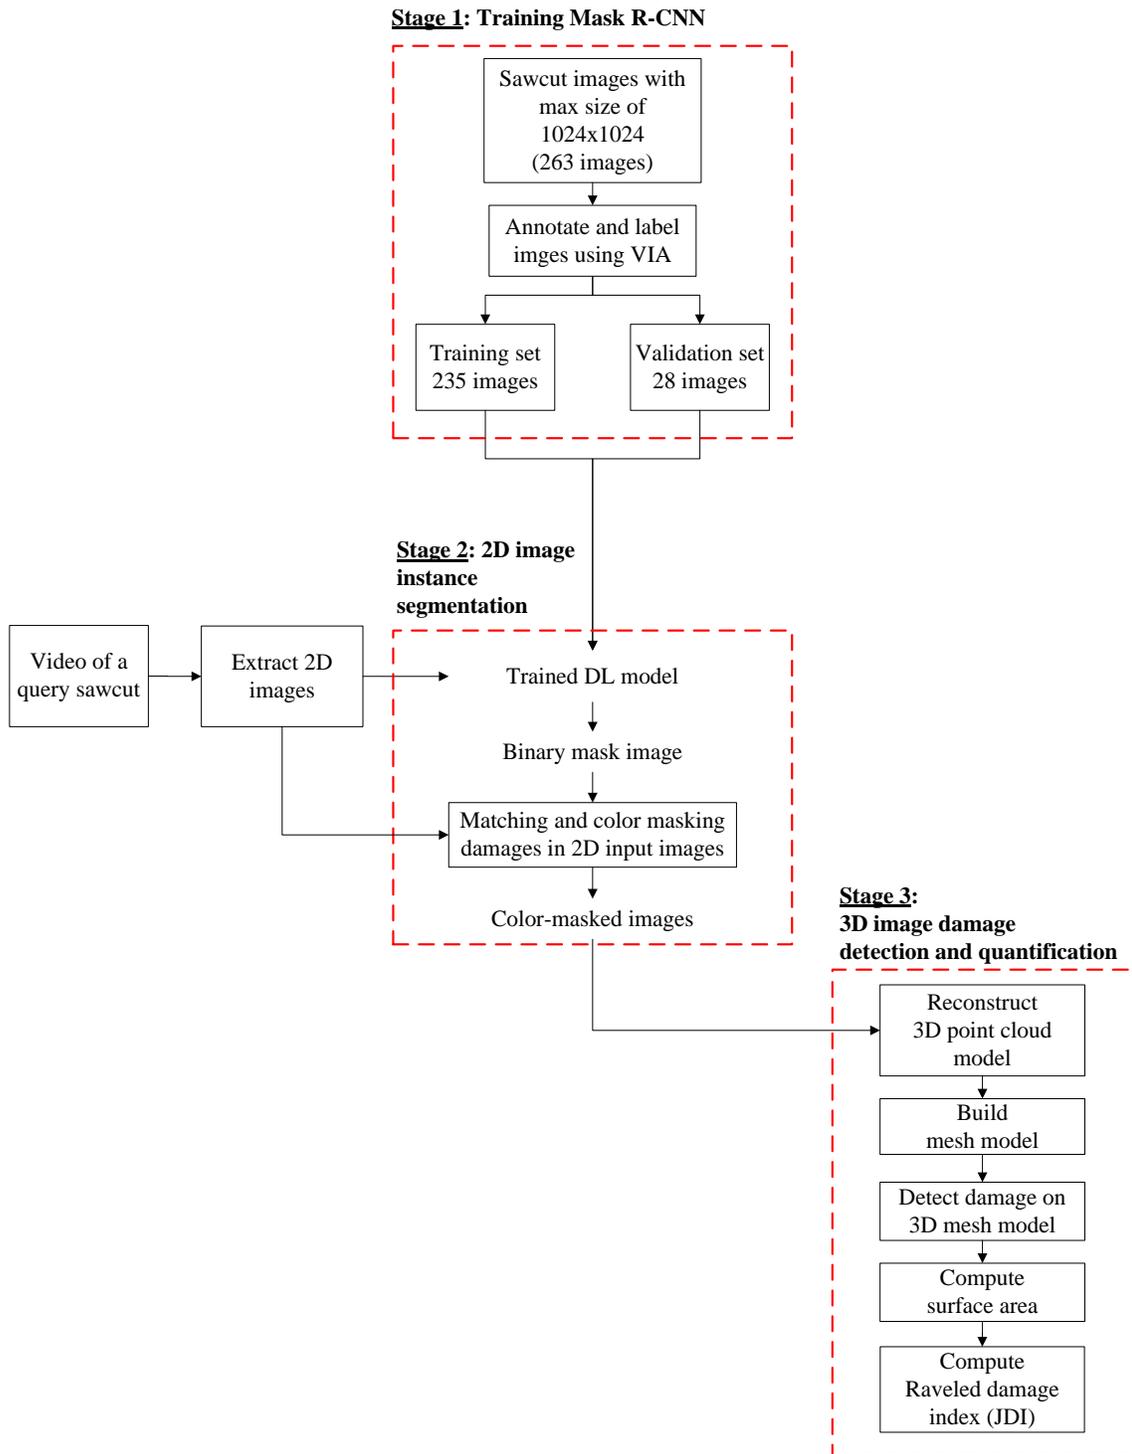
**Fig. 1** – Overall framework of the DL model for joint raveling and spalling damage detection and quantification.

(e.g., tining, sawcut groove, fibers, and texturing) will prolong the processing time by increasing 3D image reconstruction time as well as reduce its accuracy. To improve automation and accuracy of damage detection and quantification, a DL model [26] is embedded in DQA as a pre-processing step for autonomously detecting contraction joints with varying levels of damage. A proposed hierarchical approach is shown in Fig. 1. The approach has three main stages including:

- Stage 1: Train DL model to detect the joint damage in 2D images which contain unnecessary background information;
- Stage 2: Implement the post-trained DL model on query or new 2D images to output 2D images containing detected joint damage areas;
- Stage 3: Reconstruct a 3D image using the 2D images in stage 2. Finally, a quantification algorithm localizes the 3D joint damage and computes the damage surface area and JDI.

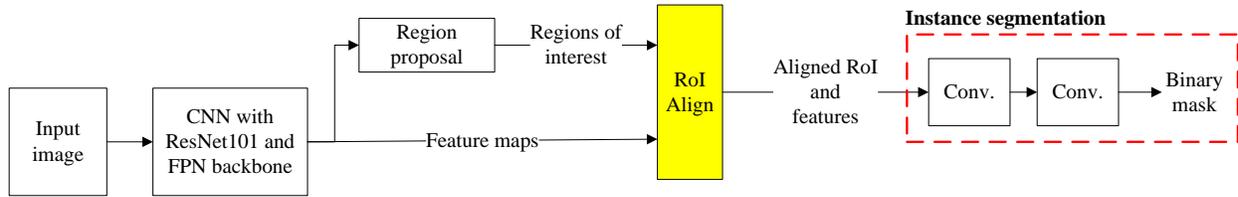
**Nomenclatures:**  
Conv. = Convolutional layer

**Fig. 2** – Schematic of Mask R-CNN using FPN-ResNet101 backbone for 2D damage segmentation [26].

The first step in the overall framework is to train a model for pixel-level detection of joint damage. A DL model, Mask R-CNN using the backbone of ResNet-101 [27] and feature pyramid network (FPN) [28], was chosen to train a dataset of concrete joint images because it is state-of-the-art in pixel-wise object detection [26]. Fig. 2 shows the schematic of Mask R-CNN. It is proven to be a simple and fast system and it outperformed previous single model entries on every task in the 2016 COCO challenge [29]. As shown in Fig. 2, a concrete input image is fed into a convolution neural network (CNN) layer with ResNet-101, which is really a DL network with 101 layers and FPN backbone for feature extraction. The region proposal network takes feature map output from the last shared CNN layer as input, slides a small network over the feature map, and outputs the Region of Interest (RoI). RoI-Align properly aligns the extracted features with the input image pixel-to-pixel and feeds into the new convolution layer for instance segmentation, outputting a binary mask layer indicating joint damage locations (see Fig. 5).

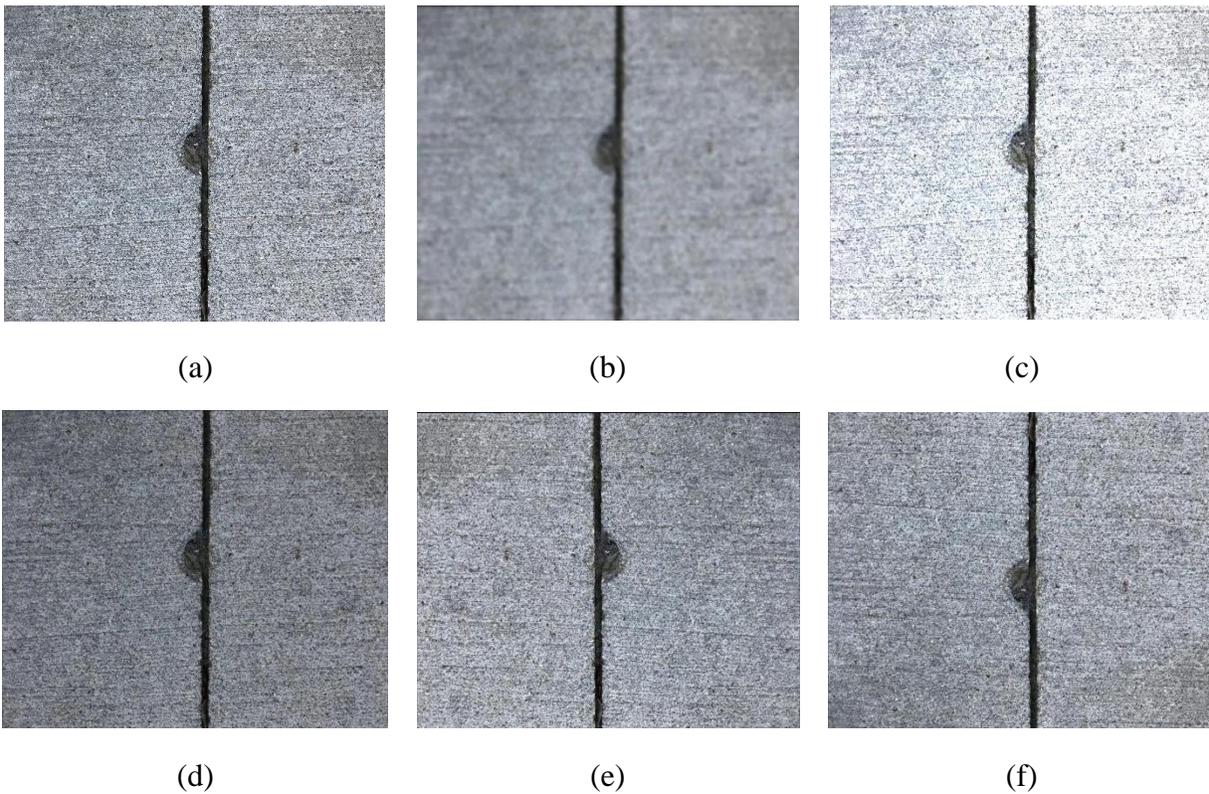
**Fig. 3** – Augmentation methods: (a) original image (none), (b) Gaussian blurring with a sigma of 0.25, (c) brightening, (d) darkening, (e) vertical flip, and (f) horizontal flip.

providing good performance, improving generalization, and reducing overfitting [31-34]. In this study, multiple augmentation techniques were applied randomly on the training images to expand the dataset. Fig. 3 demonstrates an example training image augmented by the different augmentation techniques, such as Gaussian blurring, brightening or darkening images, vertical or horizontal flipping. These image augmentations significantly increased the size of the training set from 263 to 1578 images.

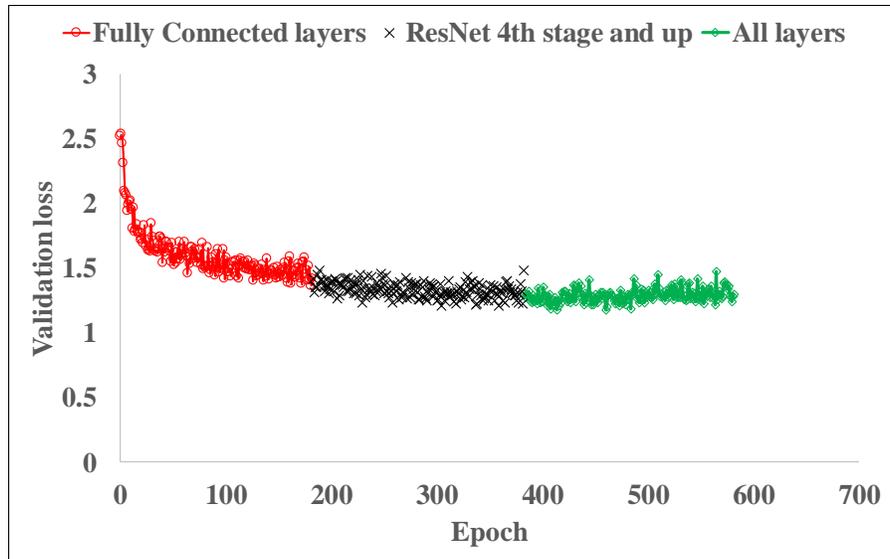
**Fig. 4** – Traces of validation total loss during training the DL model with initial COCO pre-trained weights [29] for joint damage instance segmentation.

The DL model is trained using a workstation with an Intel Core i7-7700 @ 3.6GHz CPU, 32GB Ram, and NVIDIA 1080 Ti GPU. It took approximately 12 hours for training the model until the validation loss was convergent (e.g., 1.29). The trained weights were saved for pixel-wise damage detection of query or new joint images.

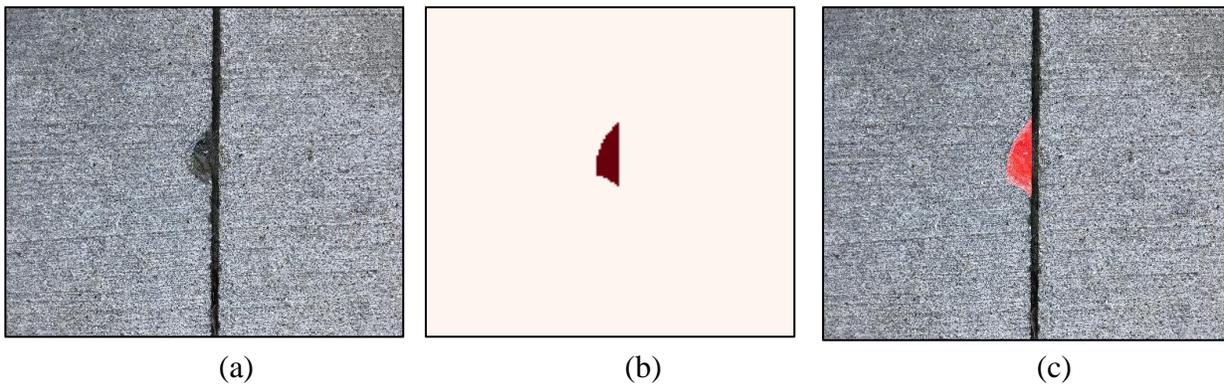
**Fig. 5** – (a) Input image, (b) binary mask image, and (c) color-masked image of joint damage.

From a recorded video of a 500 mm portion of a sawcut joint, more than 50 high-resolution images ( $1080 \times 1920$  pixels) were extracted in order to have sufficient overlap between adjacent images for feature matching during 3D image reconstruction. The images were input into the post-trained DL model to output a binary mask image indicating pixels with joint damage as shown in Fig. 5. The identifying pixels encompassing the damage area were set to an arbitrary RGB value (e.g., RGB = 255, 0, 0).

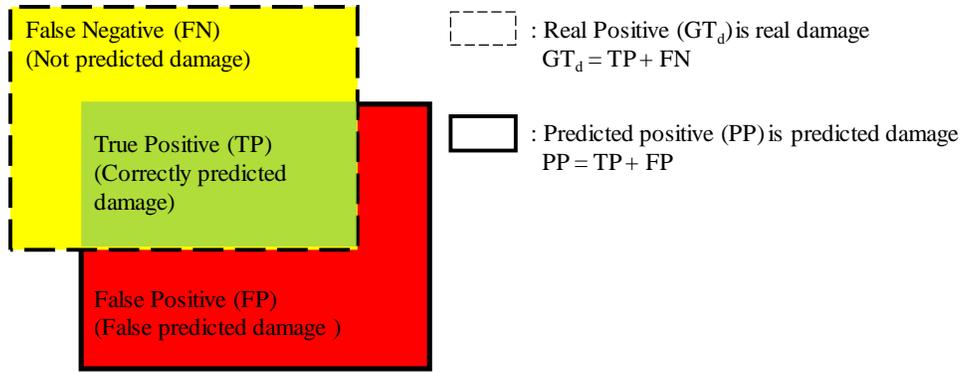
**Fig. 6** – Illustration showing ground truth  $GT_d$  (real damage or positive), false positive FP (incorrectly predicted damage) in red, false negative FN (not predicted damage) in yellow, and true positive TP (correct predicted damage) in green, which is part of the real damage.

where TP and FP (see Fig. 6) are the area of the correctly and false predicted regions, respectively.

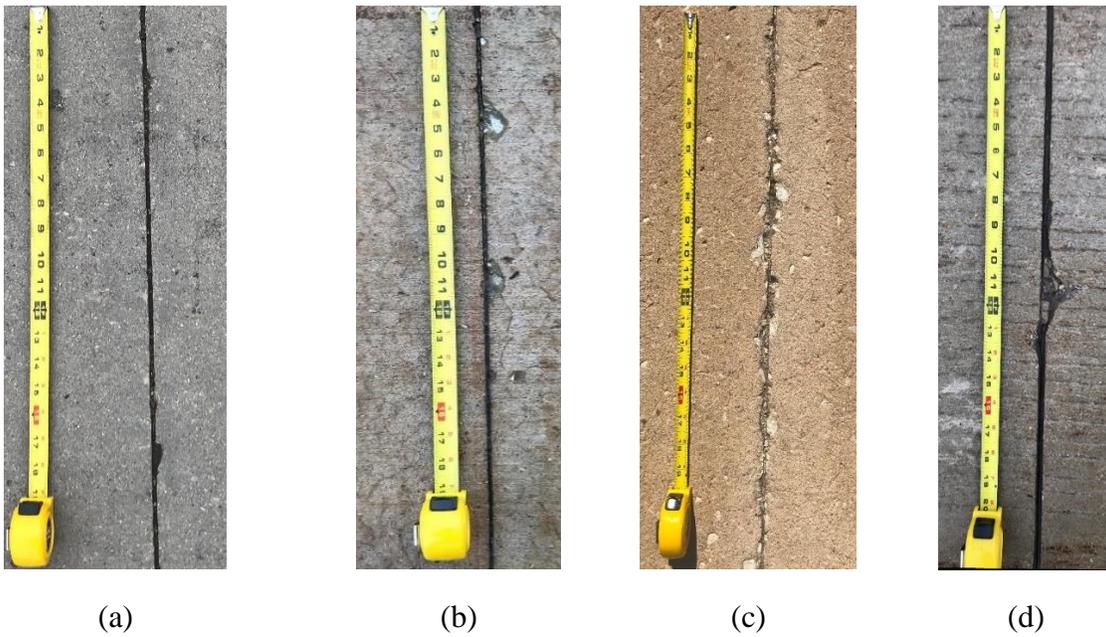
**Fig. 8.7:** Overview images of four sawcut contraction joints (a) sidewalk SW, (b) parking lot#1, (c) parking lot#2, and (d) JPCP captured under different weather conditions. The pavement surfaces have various surface textures and appearances.

The proposed framework was field implemented on four completely new 500-mm long transverse contraction joints belonging to separate construction sites. The joints are video captured under various weather conditions: a sidewalk (SW) on Wright Street in Champaign, IL, two parking lots (Parking lot #1 and #2) in Urbana, IL, and a tollway jointed plain concrete pavement (JPCP) near Itasca, IL (USA). The concrete sections were selected because they had various surface textures and appearances. Specifically, the sidewalk has a smooth surface, the parking lots showed a higher textured surface with macrofibers and slight scaling, and the JPCP section had longitudinal tining and texture. All of these various surface features act as noise and increase the difficulty in detecting the joint damage accurately. The sawn joints introduced in Fig. 8.7 consist of a variety of joint damage sizes with the smallest length approximately 13 mm. Of the four contraction joints, only one is rated visually as unacceptable while the other three are acceptable. A 12MP smartphone camera (e.g., iPhone 7) was used to video record the sawcuts to increase the number of images at different viewpoints. The next sub-sections explain the 2D and 3D damage analysis and the effect of color threshold on joint damage quantification.

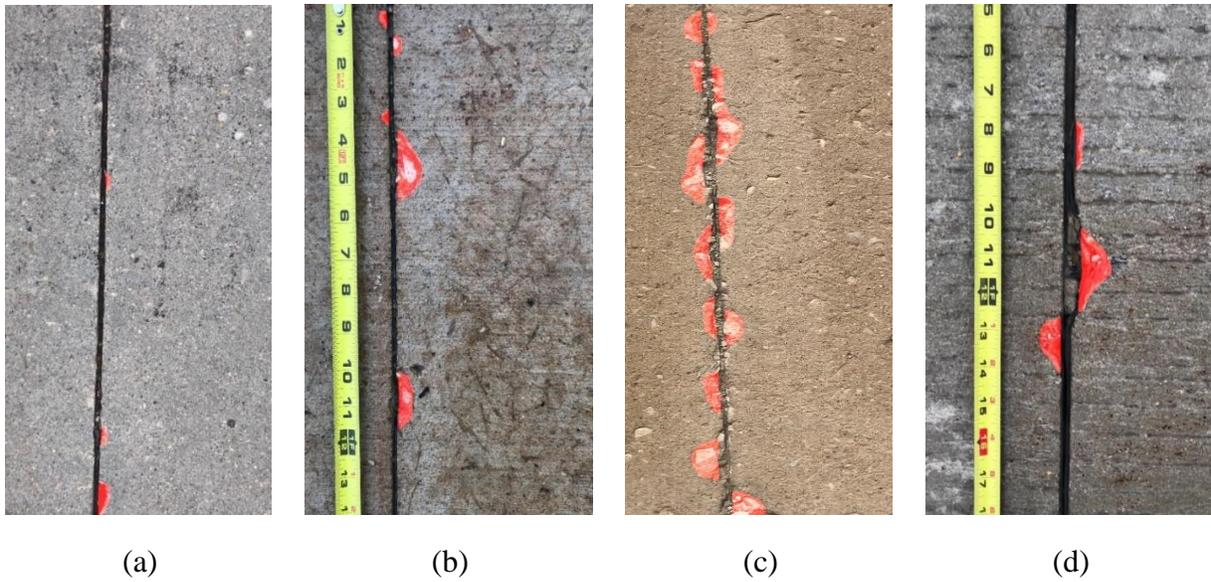
**Fig. 8** – Examples of color-masked 2D images at contraction joints at four project locations: (a) sidewalk, (b) parking lot#1, (c) parking lot#2, and (d) JPCP.

The post-trained DL model detected joint damages in the 2D images of the sawcuts shown in Fig. 8. To examine the performance of damage detection in 2D images, 10% of 2D images from the field sections were selected randomly and manually annotated using VIA VGG annotation software [30]. The mean recall and error for 2D damage segmentation results are shown in Table 1. The results show that the recall of damage detection of the post-trained model is high but so is the error. This indicates the model was able to detect the true joint damages but also it overestimated its extent. In addition, Fig. 9 shows examples of high false detections in 2D images by the post-trained DL model.

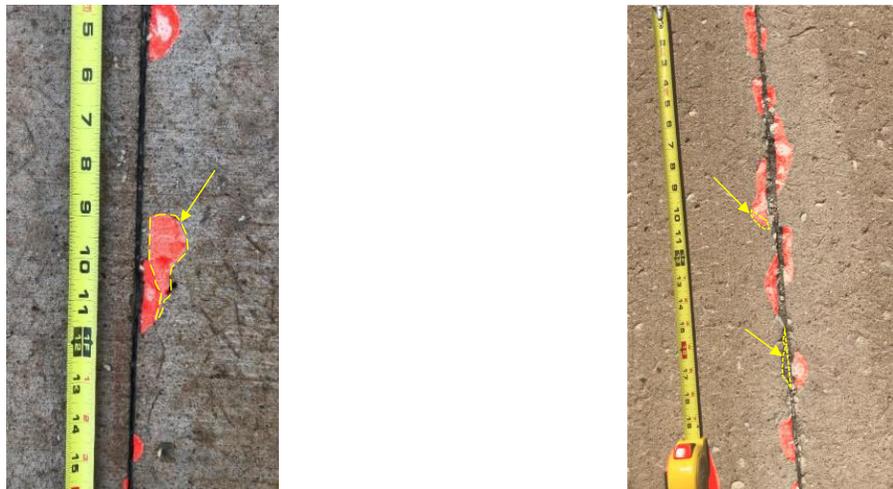
**Fig. 9** – Typical false positives (area bounded by the dashed yellow line) by trained DL at joints on (a) parking lot#1 and (b) parking lot#2.

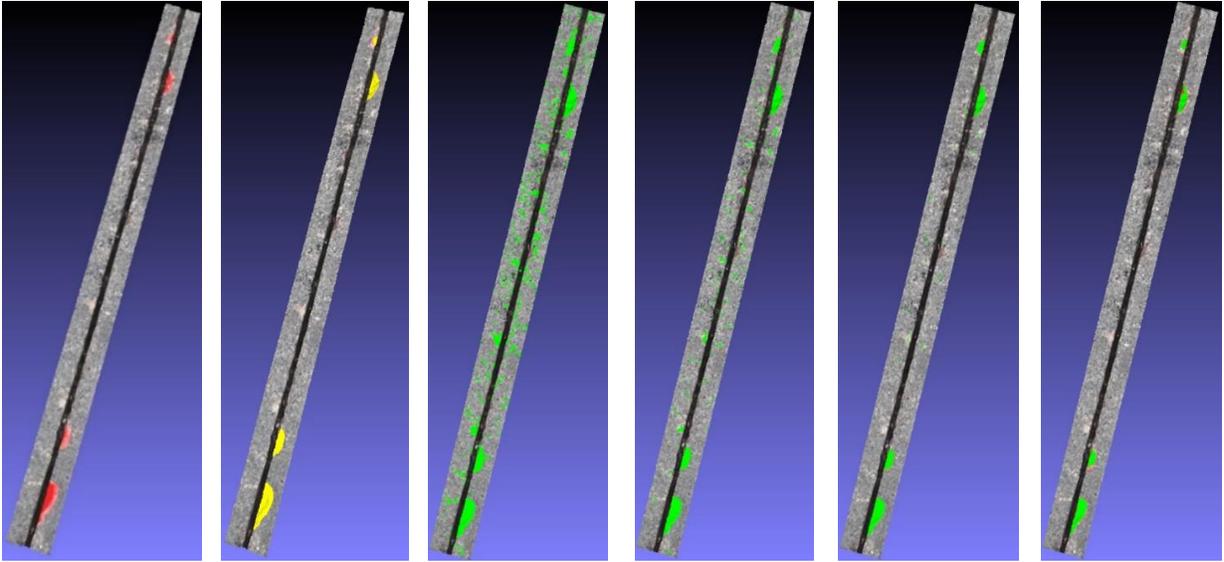
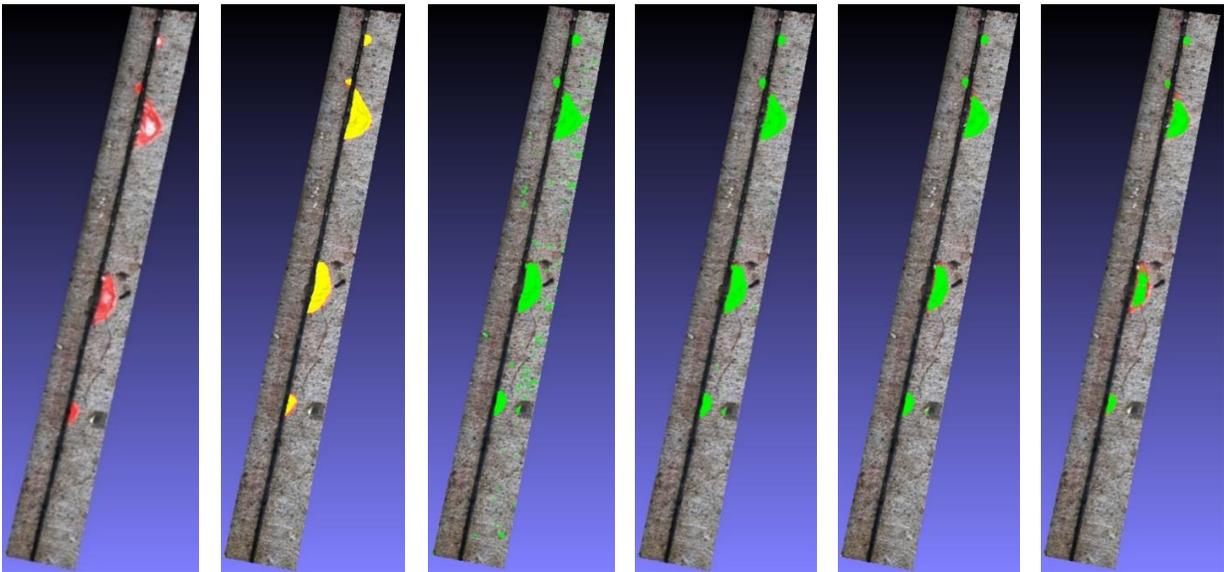
**Fig. 10** – Influence of color thresholds on joint damage detection for (a) sidewalk and (b) parking lot#1. From left to right, 3D reconstructed image with spall damages in red, the image having ground truth damage (yellow), and next 4 images showing damage detected by color thresholds (green) of 190, 210, 230, and 250, respectively.

damages color-masked in 2D images (see second image from the left in Fig. 10 and Fig. 11). However, the red color intensity of 3D damage areas does not remain at 255 as in the input 2D color-masked images due to the process of averaging pixel colors [38-40].

Fig. 10 and Fig. 11 introduces the 3D reconstructed images of the four sawcut joints with the red color indicating the spalling damage (first image on the left), the image containing the ground truth damage (yellow), and next four images showing damage detected by color thresholds (green) of 190, 210, 230, and 250, respectively. Similar to evaluating the performance of damage detection in 2D images, the performance of damage quantification in 3D images is examined by recall and error in equations 4-2 and 4-3. The recall, error, and JDI for the four sawn joints are summarized in Table 2. To calculate the ground truth, the damage (indicated as green yellow) is segmented out manually from the 3D images and compute JDI by summing all the surface area within the segmented damage.

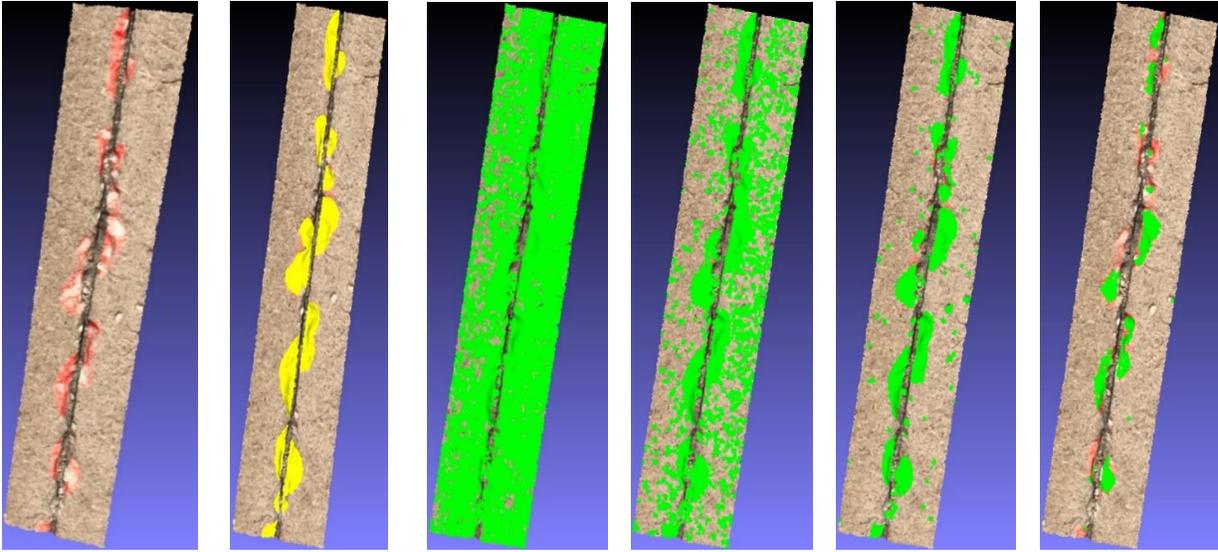
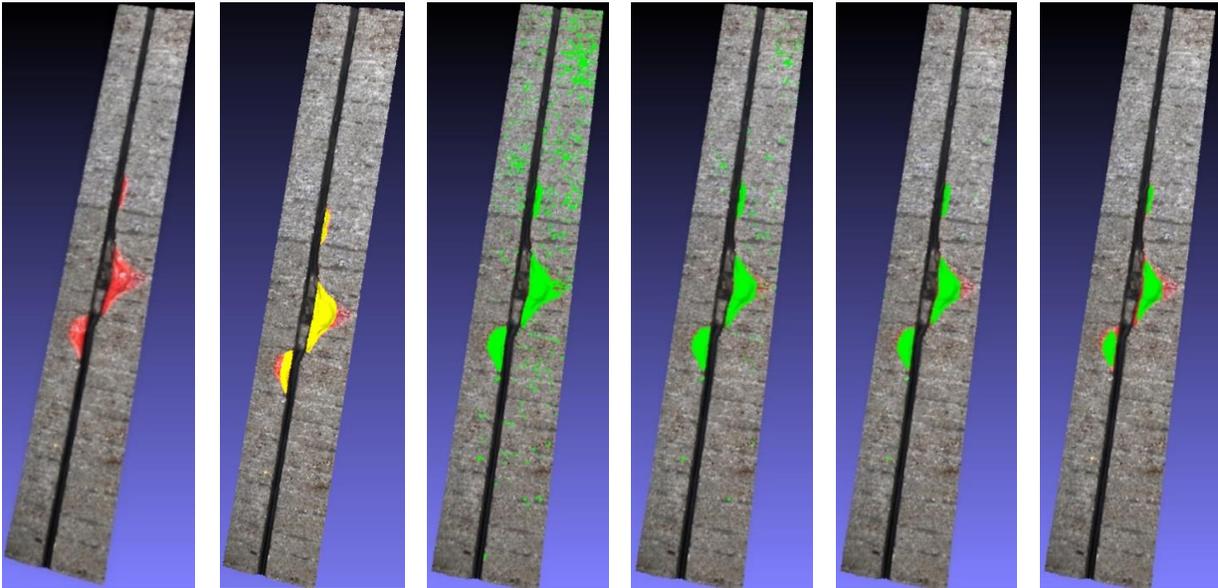
**Fig. 11** – Influence of color thresholds on joint damage detection for (a) parking lot#2 and (b) JPCP. From left to right, 3D reconstructed image with spall damages in red, the image having ground truth damage (yellow), and next 4 images showing damage detected by color thresholds (green) of 190, 210, 230, and 250, respectively.

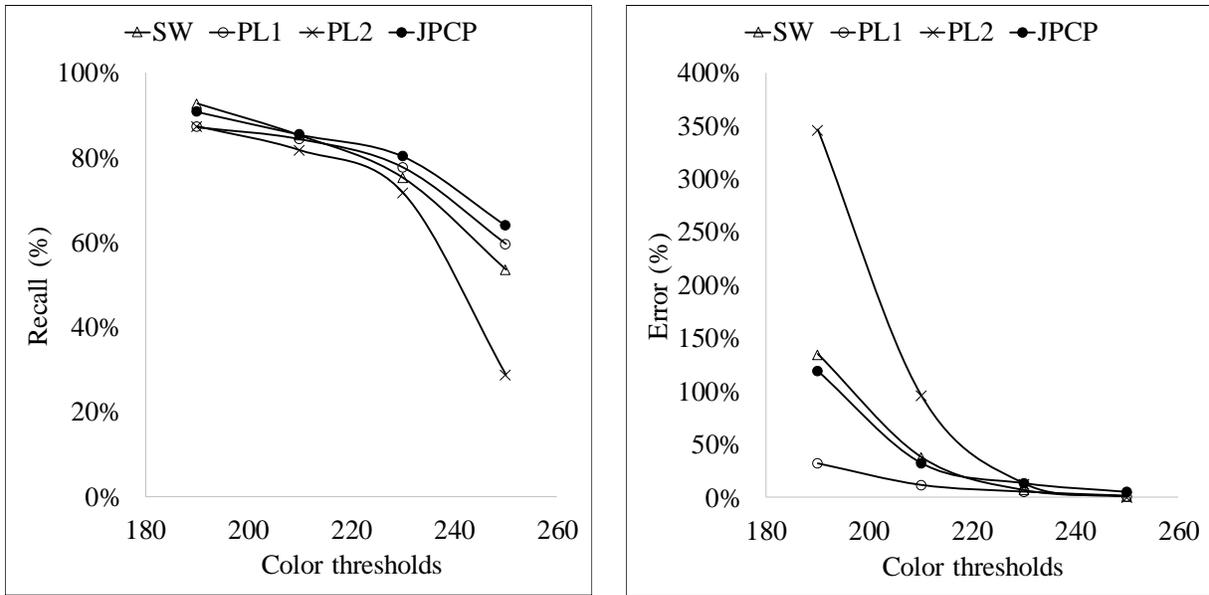
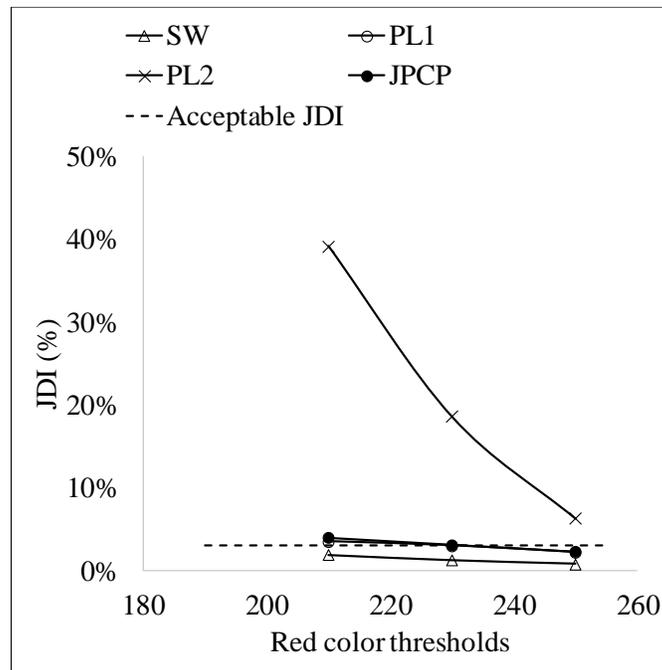
**Fig. 12** – (a) Recall, (b) error, and (c) JDI at different color thresholds for the four contraction joints (Sidewalk-SW, parking lot#1-PL1, parking lot#2-PL2, JPCP). The dashed line represents the acceptable damage index [41].

Fig. 12 shows the relationship between the recall and error of the damage detections for a range of color thresholds. The highest and lowest recall of 93% and 29% correspond to the color threshold of 190 and 250, respectively. Color thresholds equal to or less than 230 provide comparable recall for the four sites. The highest and lowest error values of 135% and almost 0% correspond to the color thresholds of 190 and 250, respectively. For all field sites, low error is for thresholds of 230 and 250. Based on the fact that the JDI of sawn joints accepted by pavement engineers is less than 3% [41], the JDI results at the thresholds 190 and 210 especially for PL1 and JPCP are not in good agreement with the visual inspection. The color threshold of 230 was chosen as a balance between recall and error and provides the JDI in good agreement with the observed joint damage of all sawn joints on each of the 4 project sites.

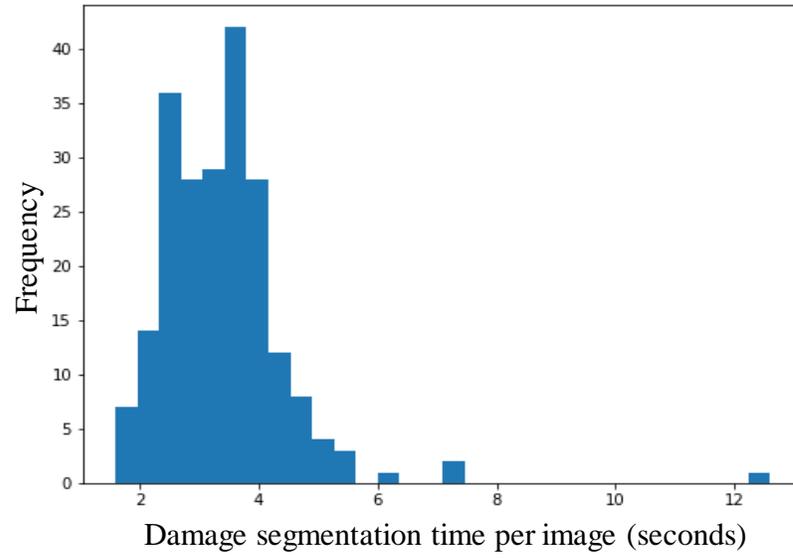
**Fig. 13** – Processing time histogram of 2D damage segmentation.

The amount of processing time for the entire 3D damage quantification process including each step is summarized in Table 3. The initial 12 hours for training the DL model was excluded. The total processing time varied from 33 to 64 minutes mainly from the 3D image reconstruction step. Meshing from a dense point cloud is a time-consuming step in the 3D reconstruction and it is affected by many parameters [44]. Pixel-wise detecting and color-masking joint damage in 2D images take 3.3 seconds per image on average (see Fig. 13) and 3D damage recognition and quantification takes less than a minute using Intel Core i7-7700 @ 3.6GHz CPU with 32GB Ram and NVIDIA 1080 Ti GPU.
