EFFECT OF ELECTROPOLISHING ON NITROGEN DOPED AND UN-DOPED NIOBIUM SURFACES*

Abstract

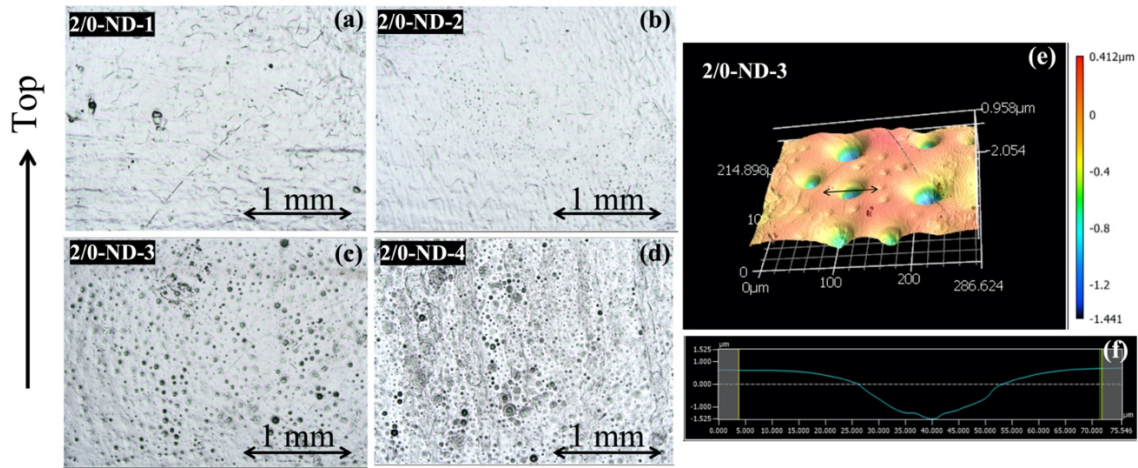
Figure 1: N-doped samples after 5 μm removal in EP performed at maximum temperatures of (a) 3 $^{\circ}\text{C}$, (b) 16 $^{\circ}\text{C}$, (c) 24 $^{\circ}\text{C}$, and (d) 42 $^{\circ}\text{C}$. The arrow shows the orientation of the samples in the EP bath. (e) 3D image of the surface shown in (c). (f) Surface profile along the line over a pit shown in (e).

Microscope images of the N-doped samples listed in Table 1 are shown in Fig. 1. The orientation of the sample in the EP bath is illustrated with the images. The images showed that the surface contained many pits after removal of 5 μm . The number density of the pits was increasing with increase in the surface temperature during EP. Many pits were found after EP performed even at a low temperature $\sim 16^{\circ}\text{C}$. However, the pits were not as wide as at higher temperatures. The depth of pits was measured to be $> 2 \mu\text{m}$ as shown by a profile in Fig. 1. The surface of the samples, mainly 2/0-ND-4, electropolished at higher temperatures were also found to have traces of gas bubbles originating from the pit positions. The bubble traces were heading from the bottom to top direction of the samples set

EP of N-doped and undoped samples was performed at different temperatures. The varying surface temperatures in the EP process affected the surface features. A higher temperature resulted in the formation of the high number density of pits which were more than 2 μm in depth. The number of pits decreased with the decrease in the sample surface temperature. Only a few pits were seen in 1x1 cm^2 area of the 2/0-ND-1 which was electropolished at ~0 °C. The pits with bubble traces were found even on the electropolished sample 800C-UD-1 that was heat-treated at 800 °C for 3 hours. This showed that furnace impurities incorporated in the Nb sample during the heat treatment. The cavity surface also showed pits which were less in the density and with smaller depth. Gas evolution from the surface was supposed to be the cause of the pit formation on the surface electropolished at higher temperatures.

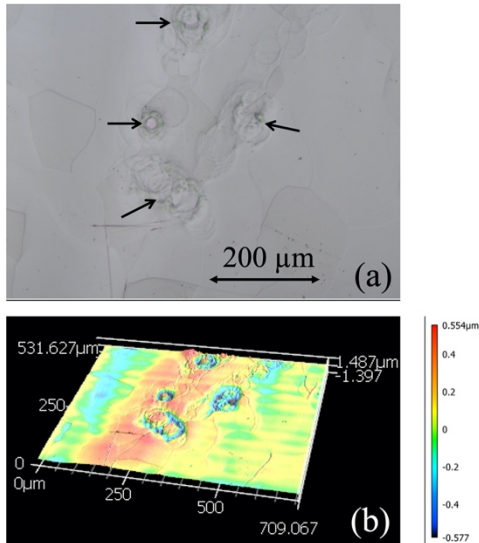
Figure 2: Traces of bubbles originating from a pit-like feature on the surface electropolished after 800 $^{\circ}\text{C}$ /3hrs heat treatment (Sample 800C_UD-1). The arrows in (a) show the positions where the bubbles were supposed to be generated.

The samples heat-treated (HT) at 800 $^{\circ}\text{C}$ for 3 hours were usually not having pits except a few spots showing pit-like feature with bubble traces in a 1x1 cm^2 area. Figure 2 shows a spot with pit-like feature associated with bubble traces on the undoped sample (800C_UD-1). However, the pits were not as deep as observed in the case of N-doped samples. The undoped sample (UD-2), which was not subjected to any furnace treatment, have not shown any pit or bubble traces on the surface.

The pitting on the N-doped surface was not formed after acid soaking for 2 hours. This test confirmed that the pitting was not formed due to the etching by the acid in absence of applied voltage. The pit-like feature with bubble traces on the samples suggested that gas evolution started from the spot which supposed to contain impurities. These impurities might be NbN and NbC. The generated gas bubbles were supposed to be responsible for the pits formed on the surface. The bubbles which stayed on the surface can enhance local reaction on the bubble positions [5]. The bubble traces were the signature of presence of gas bubbles.

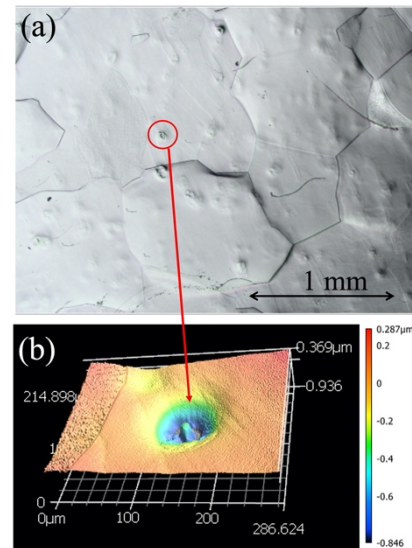
Figure 3: (a) Optical image of the cutout from cell-2 of the 9-cell cavity (b) 3D image of one of the pits on the surface.

In order to see the effect on cavities, cutout samples from a N-doped 9-cell cavity (CAV0018) electropolished for 7 μm removal were observed. EP was performed at 14 V and a cavity temperature of 24 $^{\circ}\text{C}$. The surface of the cutout from cell-2 of the cavity is shown in Fig. 3. The pits were

also found on the cavity surface. However, the number density of pits was lower than that found on the Nb samples after EP at similar temperature. The equator surface in the end cells, which showed a rough surface due to grain etching [4], were not having pits.
