Draenert G.F.*†, Mitov G.**

Lack of corundum, carbon residues and revealing gaps on dental implants

* Prof.Dr.Dr.Dr. Guy F. Draenert, MD DMD PhD, University of Marburg and Implant Institute, Tal 4, 80331 Munich, Germany

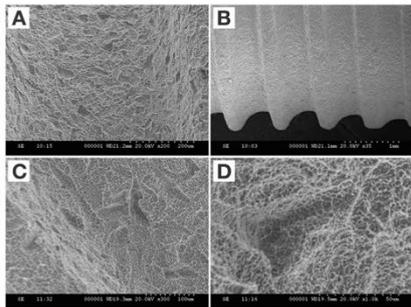
nearly corundum-free surface

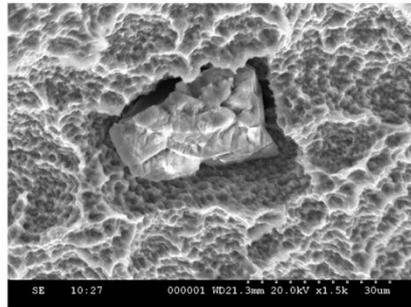
gaps indicate disappeared mater

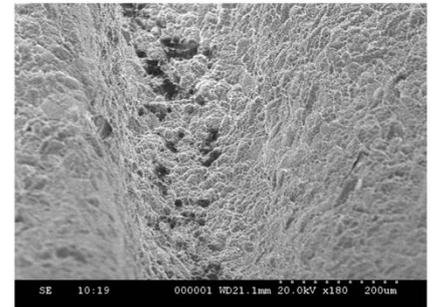
unclear dirt with high carbon levels

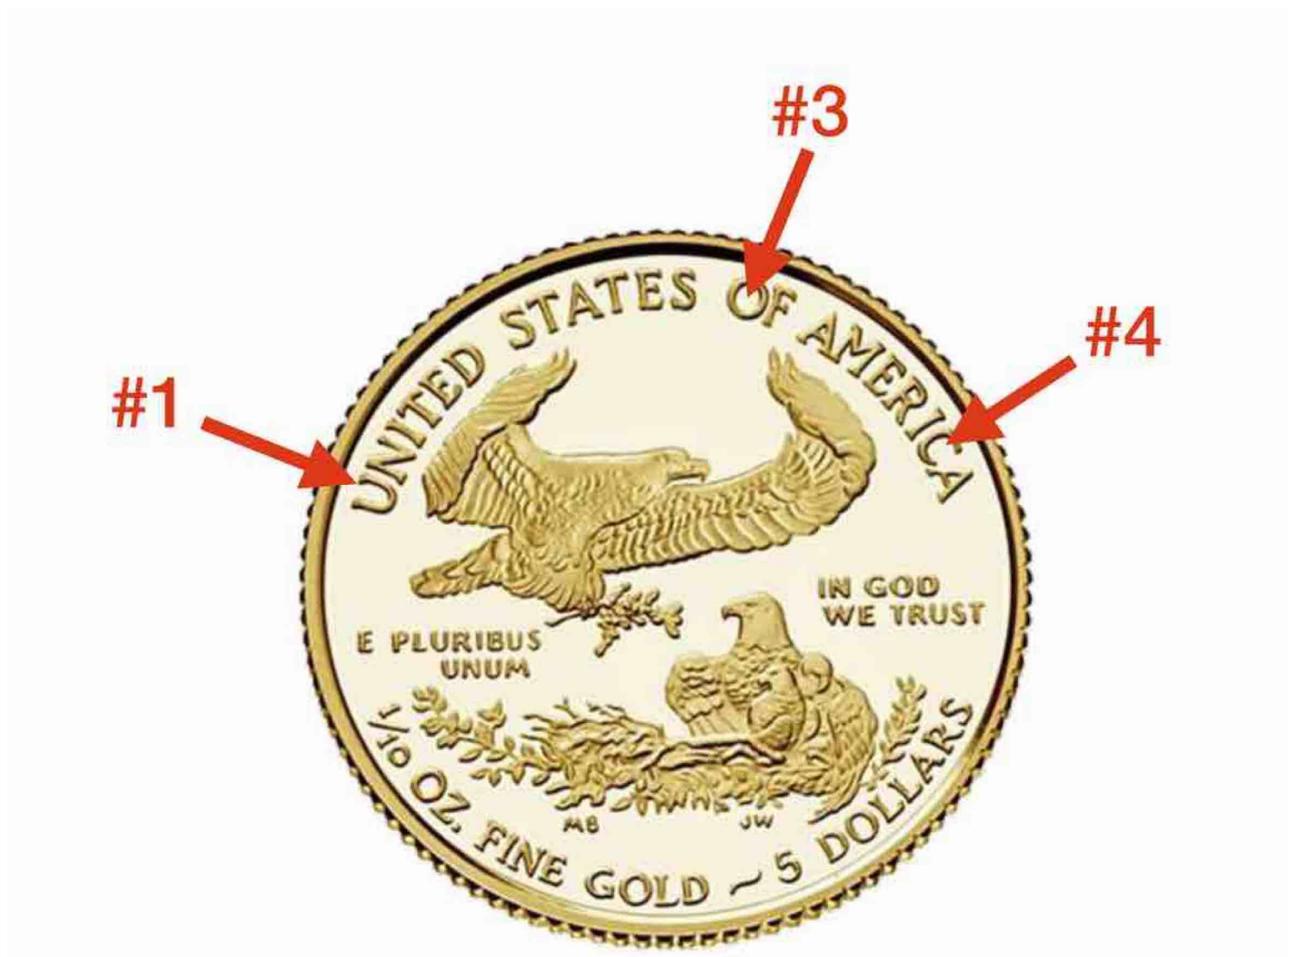
The coin model used to allow EDX analysis of the storage liquid in the EDX. The 3 positions of the 3 SLActive samples are: #1: Sample #1 (LOT RA939); #3: Sample #3 (LOT NX064); #4: Sample #4 (LOT KY861).

We applied the EDX in order to qualitatively analyze the storage liquid of the implants. SLActive implants are stored in a liquid in their vials and not dry. Any residues on the implant surface are subject to mixing into the this liquid. We applied EDX examination to evaluate this liquid in order to solve the problems associated with other methods. All other methods required larger volumes or more complex procedures providing quantitative data also. The desired method of choice would have been mass spectrometry of the storage liquid. However, the necessary volume required by certified environmental analysis institutes in Germany are 5 ml or more, exceeding the given storage liquid volumes as mentioned above. We therefore applied an electron-reflecting carrier (gold) and placed microliter volumes to apply the EDX-device for this analysis. An United States Gold Eagle 1/10 oz. coin was cleaned with acetone and placed on the SEM carrier module under clean conditions. 20 μ l Storage liquid were applied at the designated sample positions as described below with a Gilson pipetman 200. The samples were dried in a vacuum chamber as usual and then transferred in the SEM device.

Fig.1:

The coin model used to allow EDX analysis of the storage liquid in the EDX. The 3 positions of the 3 SLActive samples are: #1: Sample #1 (LOT RA939); #3: Sample #3 (LOT NX064); #4: Sample #4 (LOT KY861).

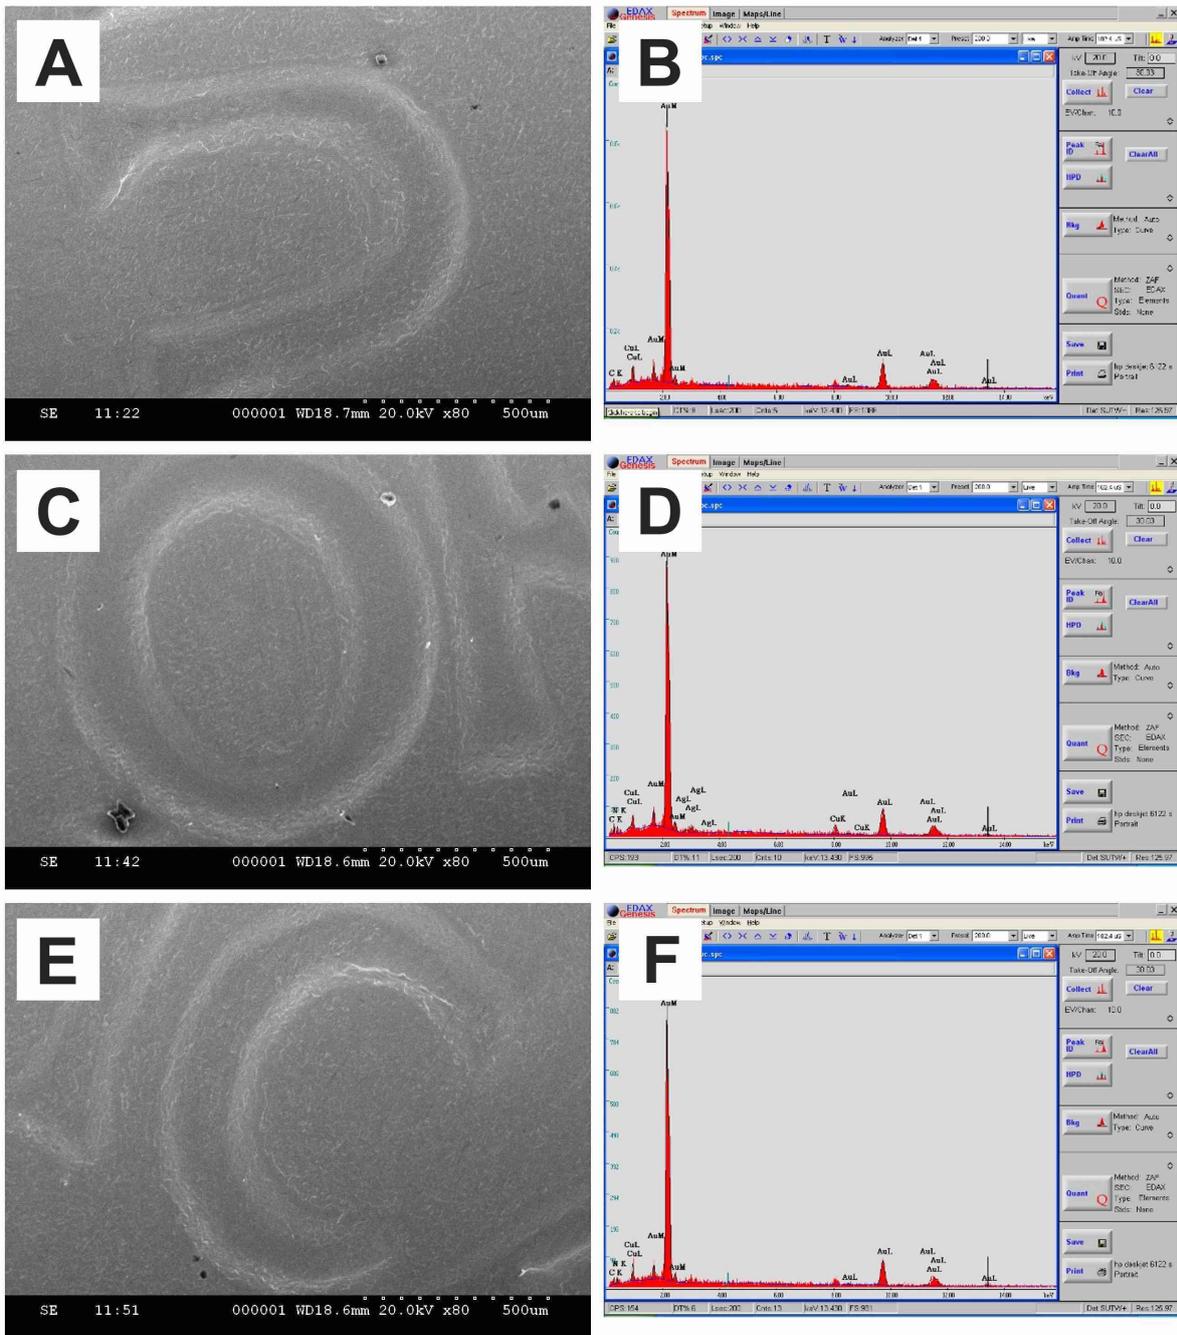
Energy dispersive x-ray (EDX) analysis without SLActive storage solution as described in detail in the results. The sample positions refer to the described letters in “United States of America” on the 1/10 oz. golden eagle coin.

The EDX examination of the samples as shown in fig. 2 and 3 showed the following difference between the empty control run and the samples:

Fig.2:

Energy dispersive x-ray (EDX) analysis without SLActive storage solution as described in detail in the results. The sample positions refer to the described letters in "Unite States of America" on the 1/10 oz. golden eagle coin.

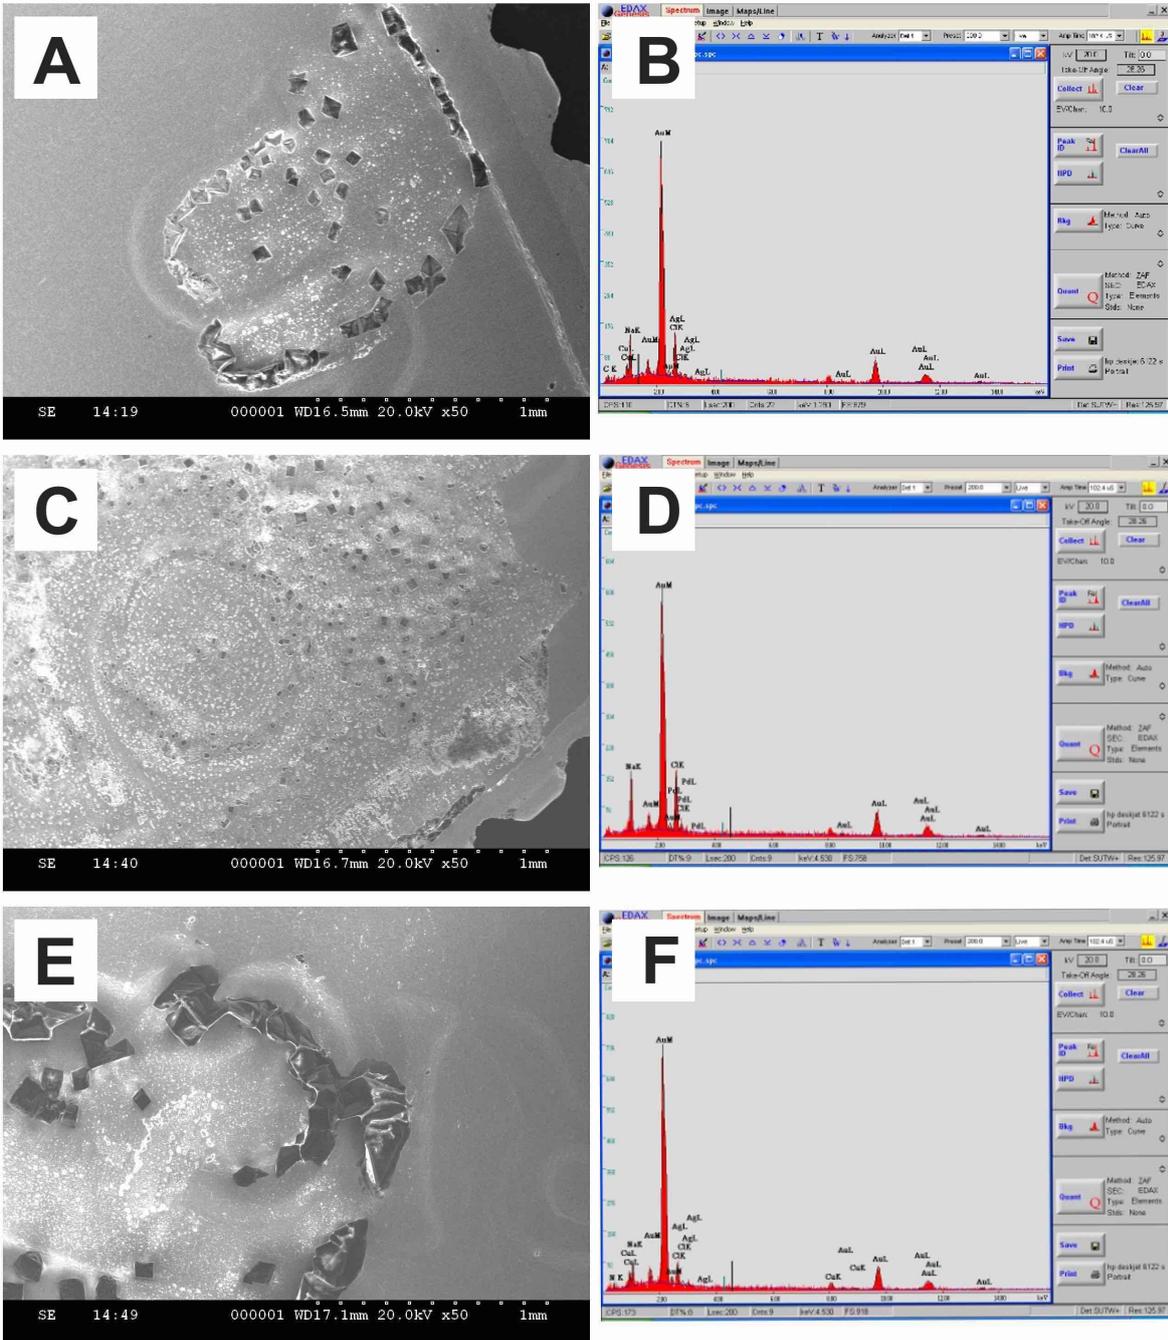
Energy dispersive x-ray (EDX) analysis with SLActive storage solution as described in detail in the results. The sample positions refer to the described letters in “United States of America” on the 1/10 oz. golden eagle coin.

Sample #1 (LOT RA939): C (carbon) 50.25 Wt%/ 70.28 At%; Na (sodium) 23.97 Wt%/ 17.51 At%; Cl (chloride) 25.77 Wt%/ 12.21 At%.

Sample #3 (LOT NX064): C (carbon) none; Na (sodium) 8.67 Wt%/ 35.28 At%; Cl (chloride) 9.73 Wt%/ 25.67.

Sample #4 (LOT KY861): C (carbon) none; Na (sodium) 4.15 Wt%/ 16.35 At%; Cl (chloride) 3.70 Wt%/ 9.45 At%. Values below 1 Wt% or At% are excluded and considered not relevant. There was no aluminum whatsoever in any specimen, not even in percentages below 1%.

Fig.3:

Energy dispersive x-ray (EDX) analysis with SLActive storage solution as described in detail in the results. The sample positions refer to the described letters in "Unite States of America" on the 1/10 oz. golden eagle coin.

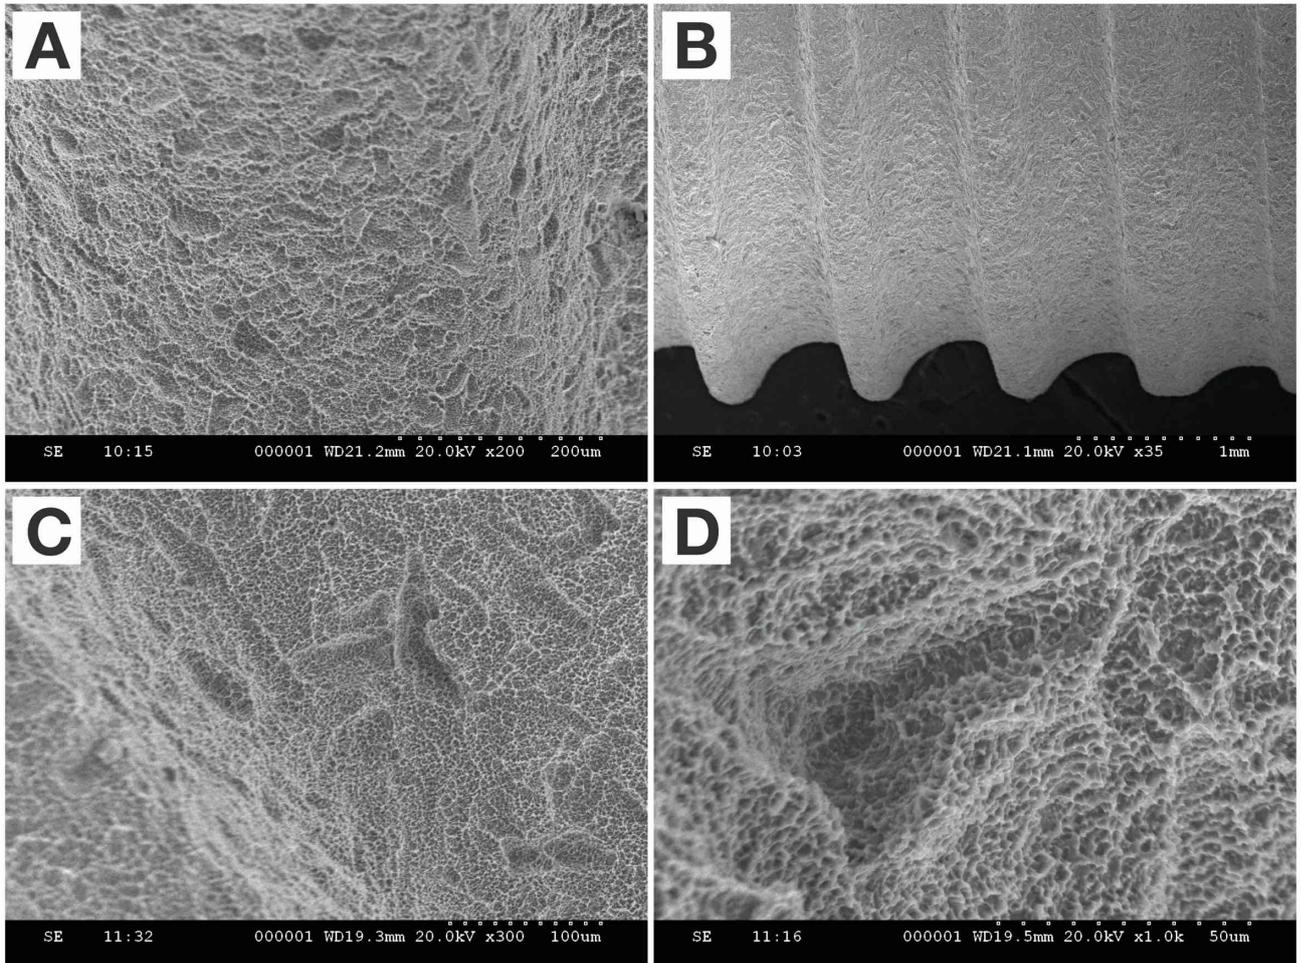
Fig.4: Predominantly morphologically clean surface with typical corundum blasting pattern including disseminated deep bumps and almost no corundum residues: A: sample #1 (200x); B: sample #1 (35x); C: sample #2 (300x); D: sample #2 (1000x).

Corundum blasting results in a specific surface macrostructure (see fig.4). However the typical and physics-based corundum residues, that are struck in the titanium surface with a sharp and gap-free interface to the titanium, can only be found rarely (see fig.5). Unusual cave-shaped defects with high carbon surface values of 25.65 Wt%/ 50.49 At% can be found also (see fig.6).

Fig.4: Predominantly morphologically clean surface with typical corundum blasting pattern including disseminated deep bumps and almost no corundum residues: A: sample #1 (200x); B: sample #1 (35x); C: sample #2 (300x); D: sample #2 (1000x).

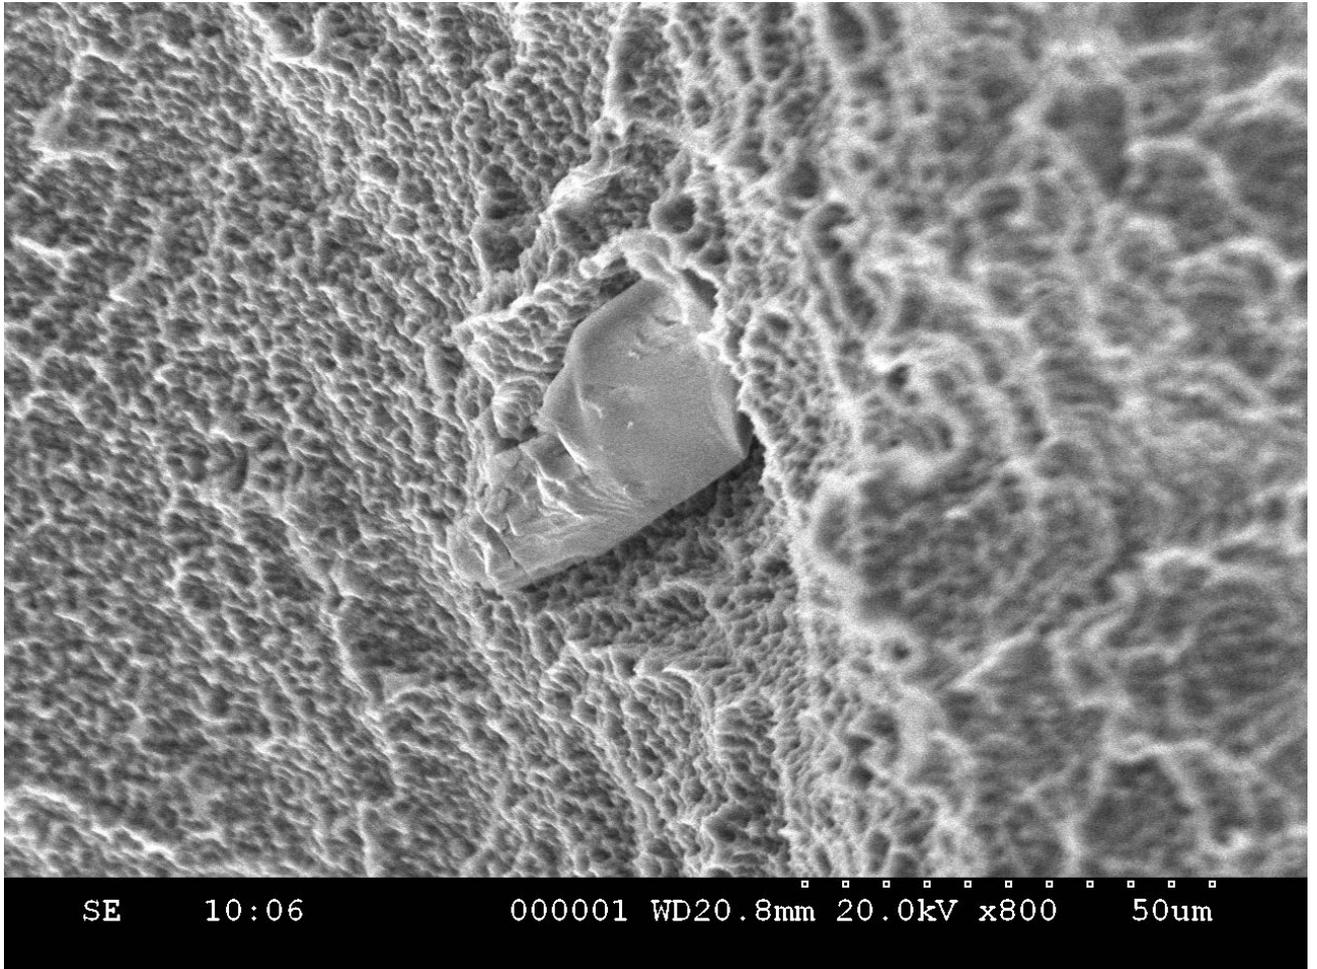
Fig.5: Typical corundum particle struck in the titanium surface without gap (sample #1; 800x).

Fig.5: Typical corundum particle struck in the titanium surface without gap (sample #1; 800x).

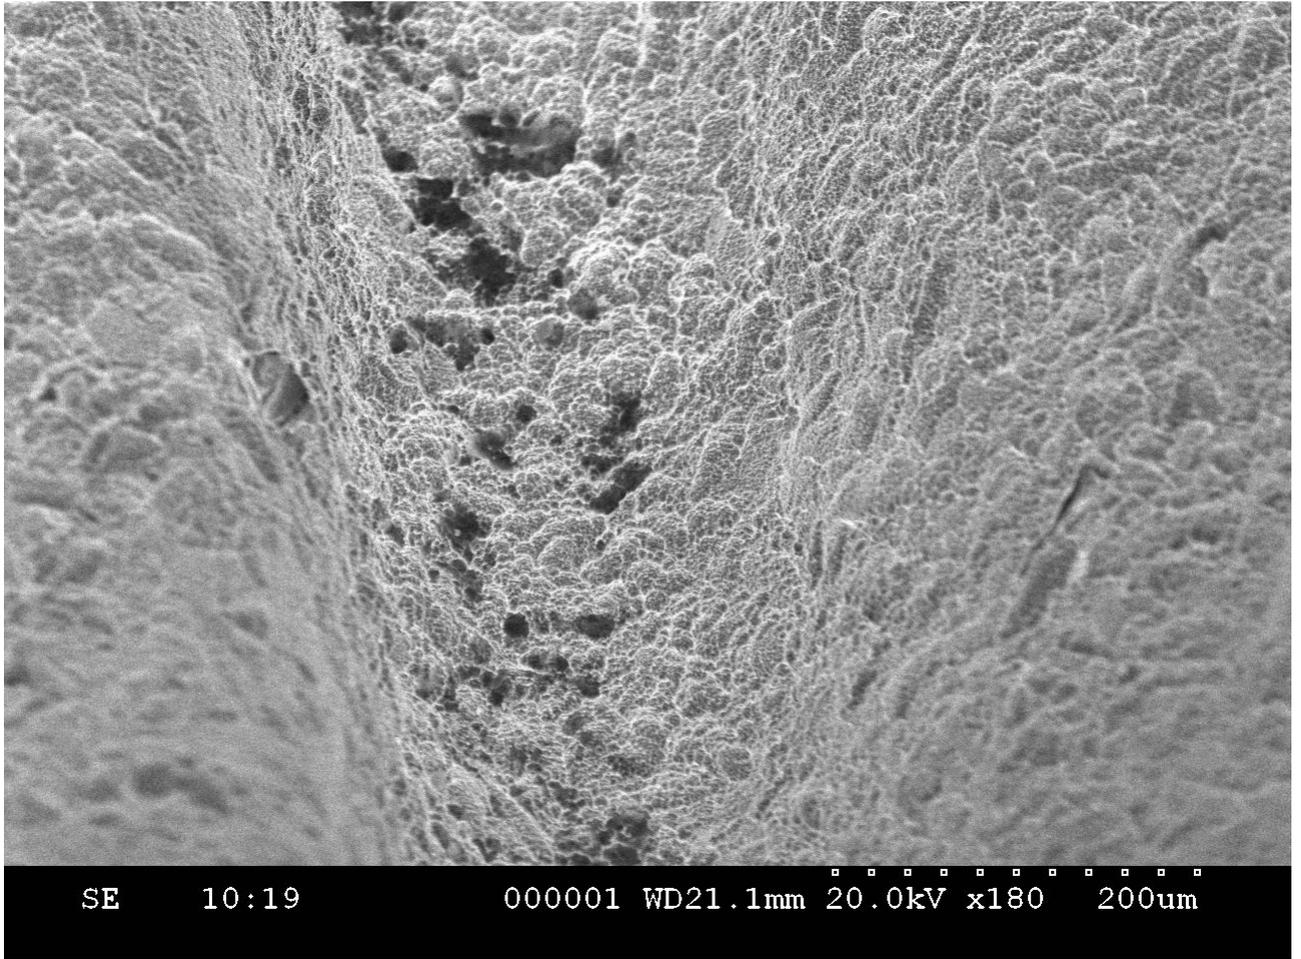
Fig.6: Unusual surface excavations with high carbon levels (sample #1; 180x).

Fig.6: Unusual surface excavations with high carbon levels (sample #1; 180x).

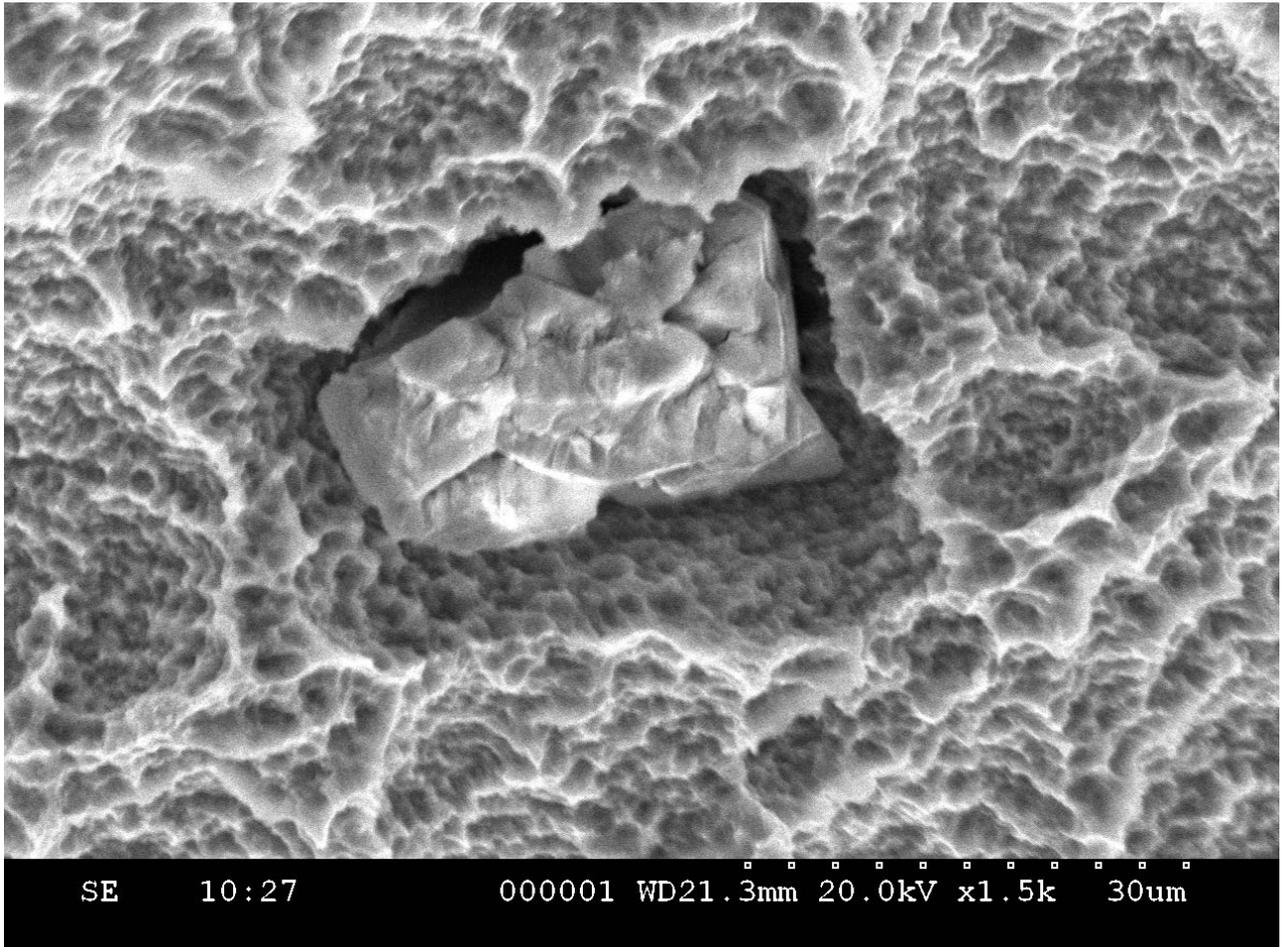
Fig.7: Typical corundum particle struck in the titanium surface with a gap indicating the removal of any material that was located there at the time of blasting (sample #1; 800x).

Particles of various shape with aluminum and carbon loading can be found. All of these particles show a gap at the interface between the particle and the titanium surface. Some of these particles show a corundum-typical structure (see fig.7). Some particles are more smooth morphologically (see fig.8).

Solid particles do not shrink and titanium surface defects do not expand after blasting and under the processing and examinations done in this study. Therefore, the images fig. 7 and 8 are utmost important to understand the conclusion of the results. The only explanation that is sound concerning these morphological results is that there was a material present during the blasting process between titanium surface and particle that was removed later.

Fig.7: Typical corundum particle struck in the titanium surface with a gap indicating the removal of any material that was located there at the time of blasting (sample #1; 800x).

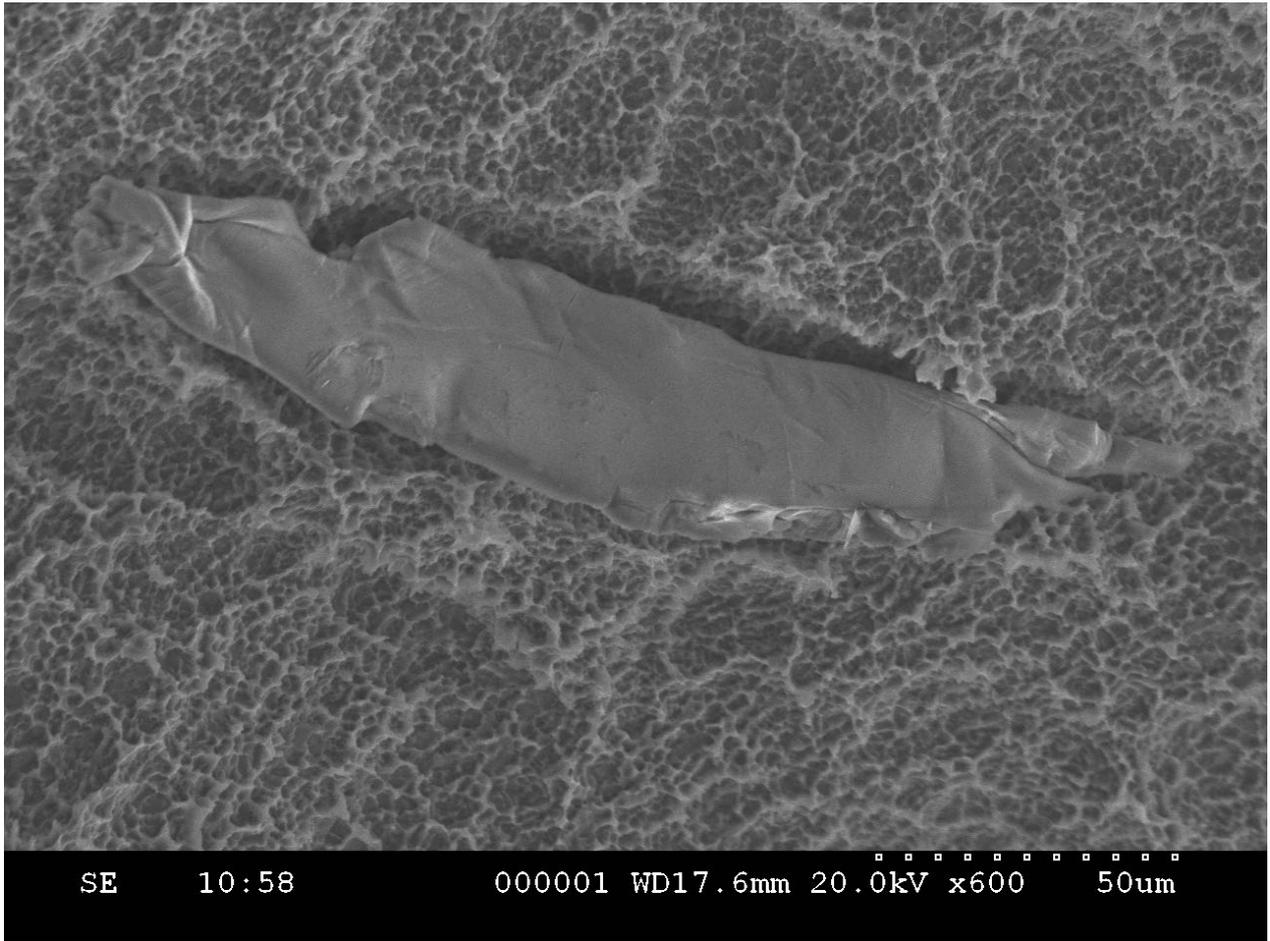
Fig.8: Untypical particle with aluminum content indicating corundum struck in the titanium surface with a gap indicating the removal of any material that was located there at the time of blasting (sample #4; 600x).

Fig.8: Untypical particle with aluminum content indicating corundum struck in the titanium surface with a gap indicating the removal of any material that was located there at the time of blasting (sample #4; 600x).
