Influence of the coating brittleness on the thermomechanical fatigue behavior of a β -NiAl coated R125 Ni-based superalloy

Keywords: Coated superalloy; Brittle-to-ductile transition; Cyclic oxidation; Thermomechanical fatigue testing; Coating cracking.

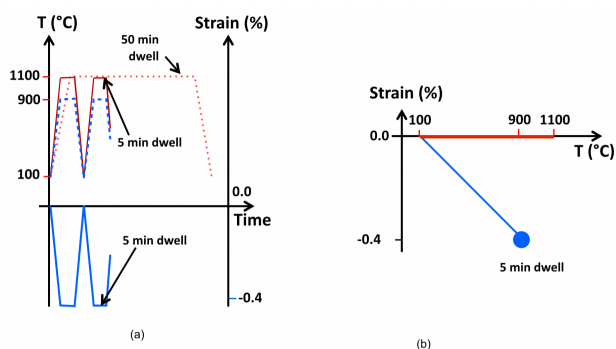
Figure 1: Applied (a) thermal cycling with different hold times and strain controlled TMF testing (b) resulting strain to temperature OP-TMF cycle (in blue) compared to pure thermal cycle (in red)

A schematic illustration of the thermal cycle is depicted in Figure 1(a).

In order to get a clearer picture of the global behavior of NiAl coated R125, out-of-phase strain controlled thermomechanical fatigue (OP-TMF) cycles were performed. This OP-TMF loading combines a thermal cycle with a 5 min dwell at the maximum temperature set to 900 °C, with a strain cycle from 0 to -0.4 %, with a dwell time at -0.4 % corresponding to the dwell at the maximum temperature, Figures 1(a) and (b).

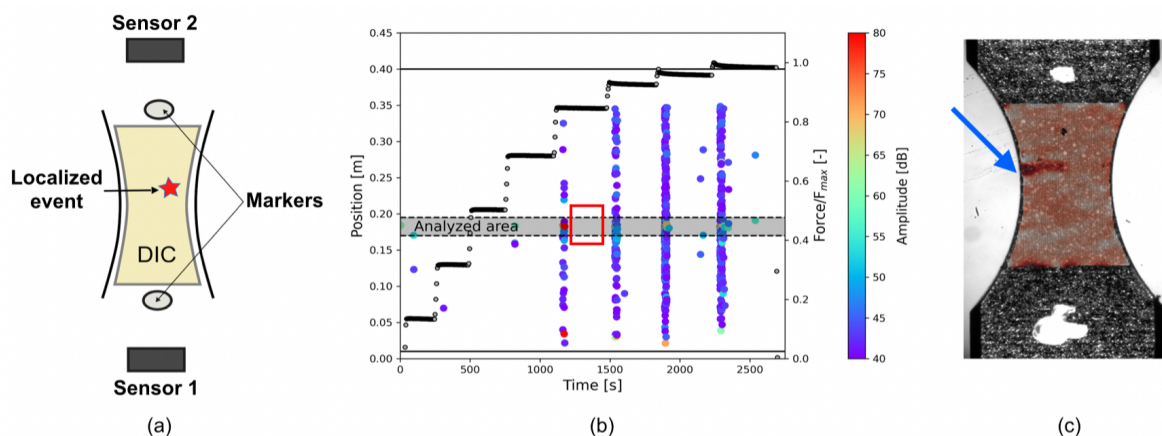
Figure 2: Mesoscale set-up (a) sketch of markers and AE sensors (b) evolution of force and acoustic events as a function of time (c) DIC analysis of strain component in the loading direction

arrow Figure 2(c). For temperature equal or higher than 700 °C, the ductility increase is obvious, for test carried out at 900 °C no crack was observed, this maximum strain being used to rationalize the experimental strain values for each test ($\epsilon_{c,max}$ 900 °C).

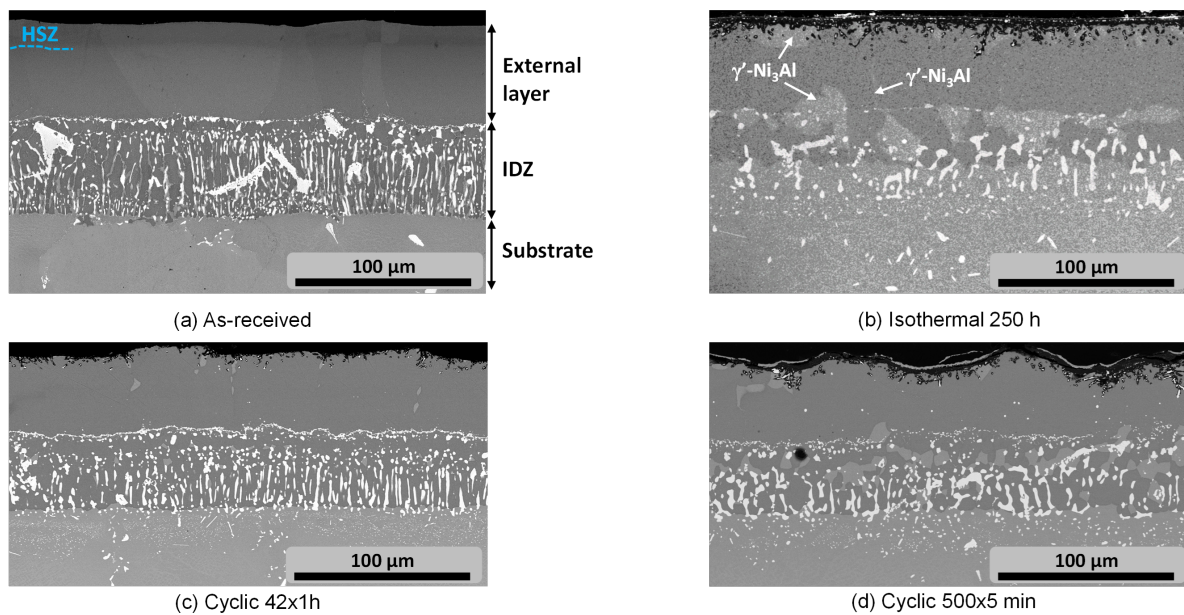
Figure 3: Microstructure for different aging conditions observed in BSE mode (a) AR state, (b) isothermal oxidation for 250 h at 1100 °C (c) thermal cycling 1 h dwell at 1100 °C and N=42 and (d) thermal cycling 5 min dwell at 1100 °C and N=500

As a first intent, the evolution of microstructure from as-received (AR) state to different agings was herein described (see Fig. 3).

The microstructure in the AR condition is typical of a diffusion coating, Figure 3(a), showing (i) an external layer composed mainly of β -NiAl (dark gray), with the darkest contrast showing the hyper stoichiometric zone (HSZ in blue) closer to the coating surface, (ii) an interdiffusion zone (IDZ), with a matrix composed of β -NiAl and a rather high density of precipitates presumed to be TCP (light particles), and then (iii) the superalloy with a few TCP precipitates, eutectic particles and the well known γ/γ' microstructure.

After isothermal oxidation, the surface of the coating shows complex oxidation patterns and fine precipitation in the vicinity of initial β grain boundaries (Figure 3(b)). Bright particles and light gray particles are observed, the latter being associated with γ' phases. The same contrast is observed closer to the coating surface and near or at the outer coating/IDZ interface. The surface roughness remained similar to the one of the AR state. Within the IDZ, a large amount of γ' phase is observed with equiaxed grains close to the outer coating/IDZ interface and a sort of diffusion front in the region of elongated TCPs. The substrate exhibits elongated TCPs that are very numerous compared to the AR state.

For 1 h dwell at high temperature, the surface roughness slightly increased compared to the AR state, which could be related to the so-called rumpling phenomenon, Figure 3(c) and (d). In addition, oxide pegs with sizes similar to the isothermal state are observed, although the accumulated time at high temperature is lower for the observed cyclic case. Some γ' precipitates are observed close to the surface, and at the β grain boundaries, but the bright particles are not observed in the outer layer.

For tests with a 5-min. dwell at high temperature, the outer surface becomes rougher than in any other case, while the time accumulated at high temperature is relatively low (about 42 h of exposure at 1100 $^{\circ}\text{C}$), Figure 3(d).

Thermal aging, in an isothermal or cyclic way, lead to microstructural evolutions of the coated system due to the combined effect of the oxidation and diffusion with the Ni-based superalloy substrate (See Figure 3). The main evolutions consisted in β to γ' transformation in both the external coating and in the IDZ matrix. In the external coating, γ' precipitation is mainly localized at grain boundaries, promoted by thermal cycling. These microstructural evolutions are controlled by the diffusion front related to the accumulated time spent at maximum temperature. In addition, thermal cycling promotes surface undulation, the so-called rumpling phenomenon, and damage associated with oxide pegs, that are potential sites for crack initiation. Repetitive short-dwell thermal cycling was found to be particularly detrimental for the coated systems due to the occurrence of short cracks within the external coating system. Such microstructural evolutions are in good agreement with the literature on aluminide coating systems [21, 12, 22]. The major difference

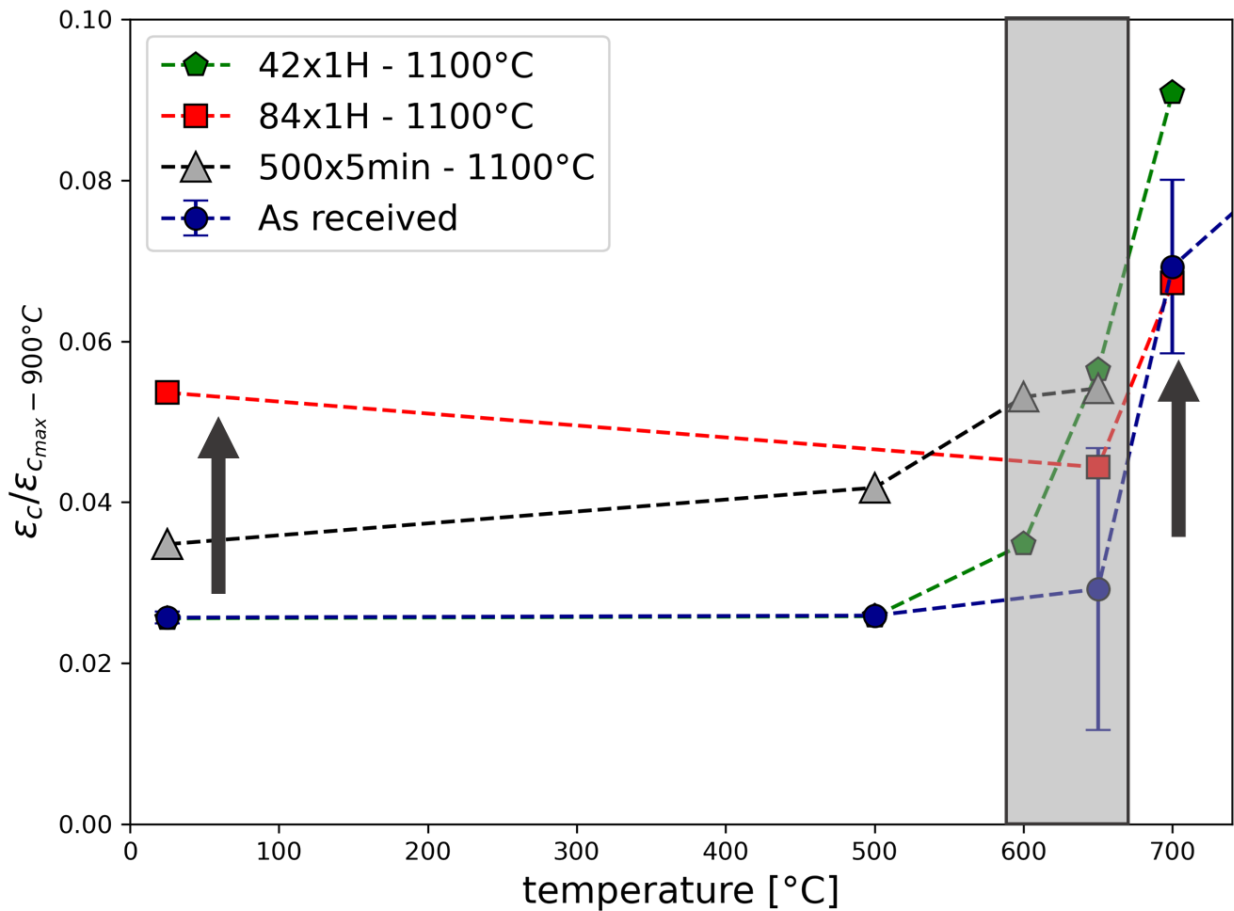
Figure 4: Strain-to-failure evolution with temperature and aging

The as-received coating was found to be particularly brittle from room temperature to 700 °C, Figure 4. The associated cracks were observed to reach the whole width of the specimen in a single step of loading. This is evidenced by strain localization patterns observed by DIC, see the

After thermal aging, a low number of thermal cycles with long dwell time at maximum temperature does not impact the room temperature ductility (see green curve corresponding to 42 cycles for 1-h dwell at 1100 °C in Figure 4). However, a slight gain in ductility is observed for this condition of aging for temperature of 600 °C and higher.

For longer high temperature exposure at maximum temperature or shorter dwell time, the ductility at room temperature has been clearly increased, as illustrated in Figure 4 (gray and red curves, corresponding to 500 cycles for 5-min dwell and 84 cycles for 1-h dwell at 1100 °C, respectively). It is noteworthy that the time spent at maximum temperature is of about 42-h for 500 cycles of 5-minutes, that is to say that the dwell time impacts the ductility of the considered material.

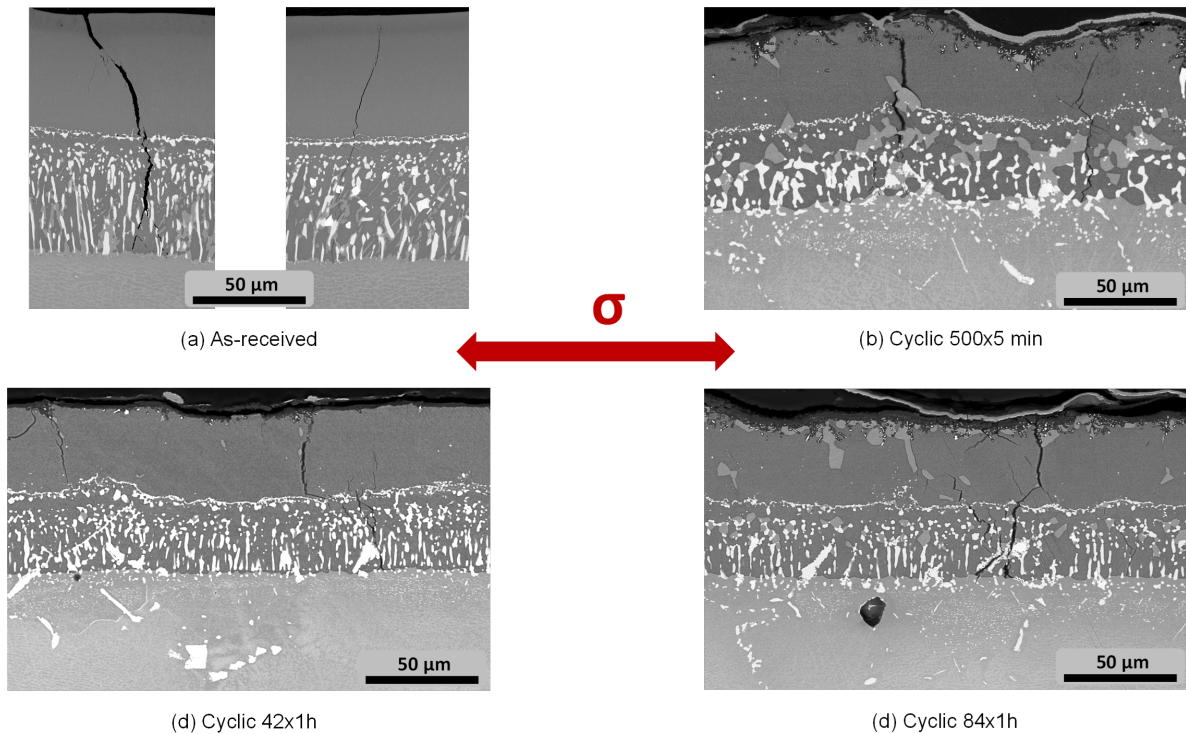
Figure 5: Microstructure and crack after room temperature tensile test for different aging conditions (a) AR state, (b) thermal cycling of 5-min dwell at 1100 °C and N=500, (c) thermal cycling 1-h dwell at 1100 °C and N=42 and (d) thermal cycling 1-h dwell at 1100 °C and N=84

Thermal aging alters the microstructure of the outer layer of the coating, resulting in a significant increase in strain to failure in room temperature tensile tests. In order to gain insight into the crack evolution within the coating and its relationship to the microstructure, *i.e.*, virgin or aged, *postmortem* sections were observed using SEM after discontinuous tensile tests at room temperature. These micrographs allow a direct comparison between the as-received and thermally aged systems. It is important to note that the cracks are modified by the microstructure.

For AR state, the cracks easily join the substrate to IDZ interface despite some local deviations (two cracks are shown in Figure 5(a)). In addition to very limited ductility, the through "coating plus IDZ" thickness cracking are very detrimental for the integrity of the system, directly impacting the failure of the substrate. For 42 cycles of 1 h, crack opening is more limited, and the crack path is clearly more tortuous (Figure 5(c)). Furthermore, crack deviations are observed at the external coating/IDZ interface. This could impede the crack growth even though in the given observation, the crack in the IDZ reaches again the IDZ/substrate interface. For 84 cycles of 1 h, the crack path seems to be connected to β/γ interfaces in the external coating (Figure 5(d)). Again this should limit the crack extension even though the density of crack is higher for 84 cycles of 1 h aging than for 42 cycles of 1 h aging. For 500 cycles of 5 min, crack paths are also driven by β/γ interfaces, but could also be observed in a pure β region, associated with both β grain boundaries and not (Figure 5(b)). However, cracks are tortuous for both cases. The brightest particles in the external coating do not seem to impact cracking. The role of surface roughness associated with rumpling on the coating cracking is not obvious from these observations. This point will be addressed in a follow-on paper.

As far as the brittleness of the coating is concerned, cross-sectional observations (Figure 5) and microscale DIC techniques aimed at evaluating differences in crack path depending on the thermal aging condition (Figure 6). It is worth mentioning that long-term isothermal oxidation can significantly improve the cracking resistance of the coating system (here 308 h at 1100 °C). This is in line with in-depth study of NiAl evolution with aging as developed for example in [16]. Indeed, the coated system experienced cracking at 250 MPa in its as-received state compared to 600 MPa for the long-term isothermal state. In addition to the onset of crack development, the crack pattern also sheds light on the coating brittleness. Through coating plus IDZ cracking and fully transverse cracking are signs of high brittleness. Shorter cracks and crack arrests/bifurcations within the IDZ testify to the influence of microstructural change on improving the ductility of the coated system. It is worth noting that the surface crack pattern observed with OHR-DIC (Figure 6) is fully consistent with the thermal cycling crack observed through the cross-section (Figure 5): the cracks are mostly limited by either β/γ' interfaces or β grain boundaries.

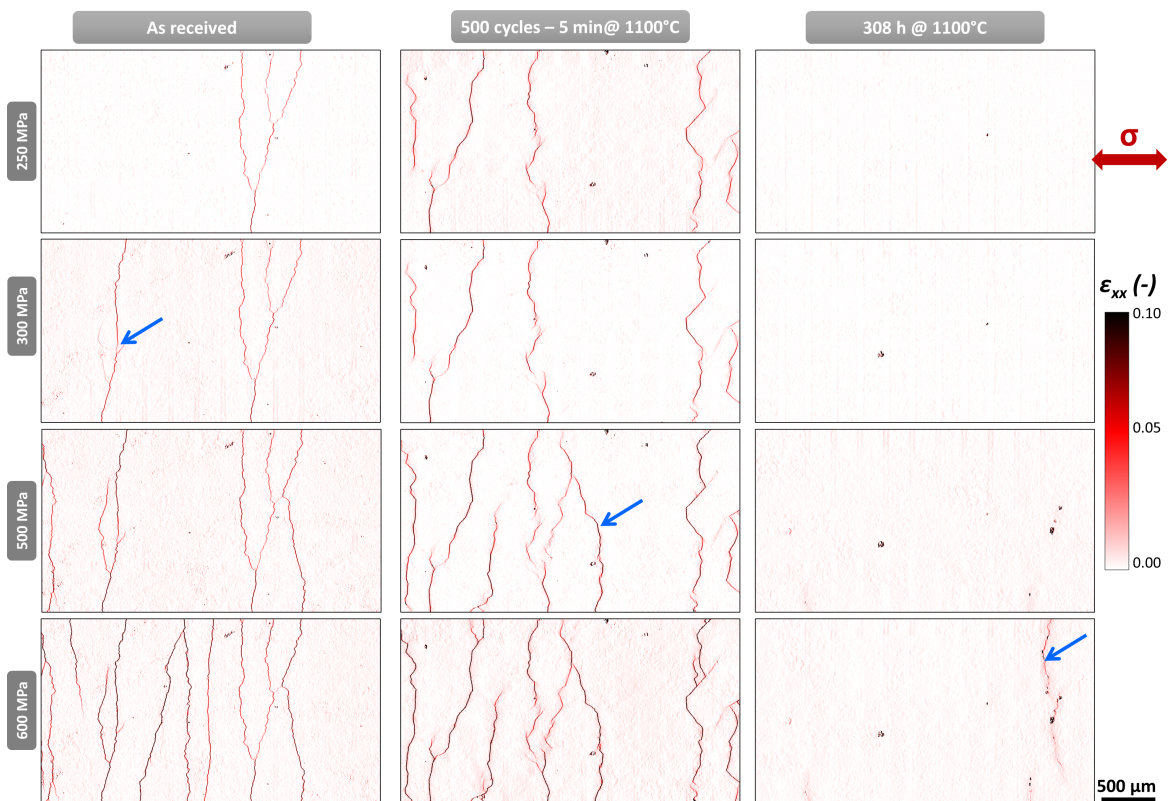
Figure 6: Strain maps along the macroscopic tensile direction for the different loading conditions, for the different aging conditions.

OHR-DIC was carried out on rough original surfaces using LSCM in AR and aged states, using a specimen of uniform section within the gauge length. The strain observations correspond to the total width of the gauge length, Figure 6.

In the AR state, cracks developed across the gauge width for macroscopic stresses as low as 250 MPa (related to a strain of 0.13 %), as shown in Figure 6. New cracks continuously developed with the macroscopic deformation, with the first significant crack event highlighted with blue arrows.

For the 5-min dwell thermal cycling condition, short cracks were found for stress as low as 250 MPa (related to strain of 0.13 %). The cracks did not propagate across the full gauge width as compared to the AR condition. The crack pattern associated with this short dwell time is denser than that observed for the AR state, but also exhibits crack branches that are more limited in length and more tortuous. Further crack growth was observed as the deformation increased up to 500 MPa.

For the 308 h isothermal oxidation condition, coating cracking was only observed at 600 MPa. Therefore, the aging not only changed the ductility of the coating system but also its fracture mechanism.

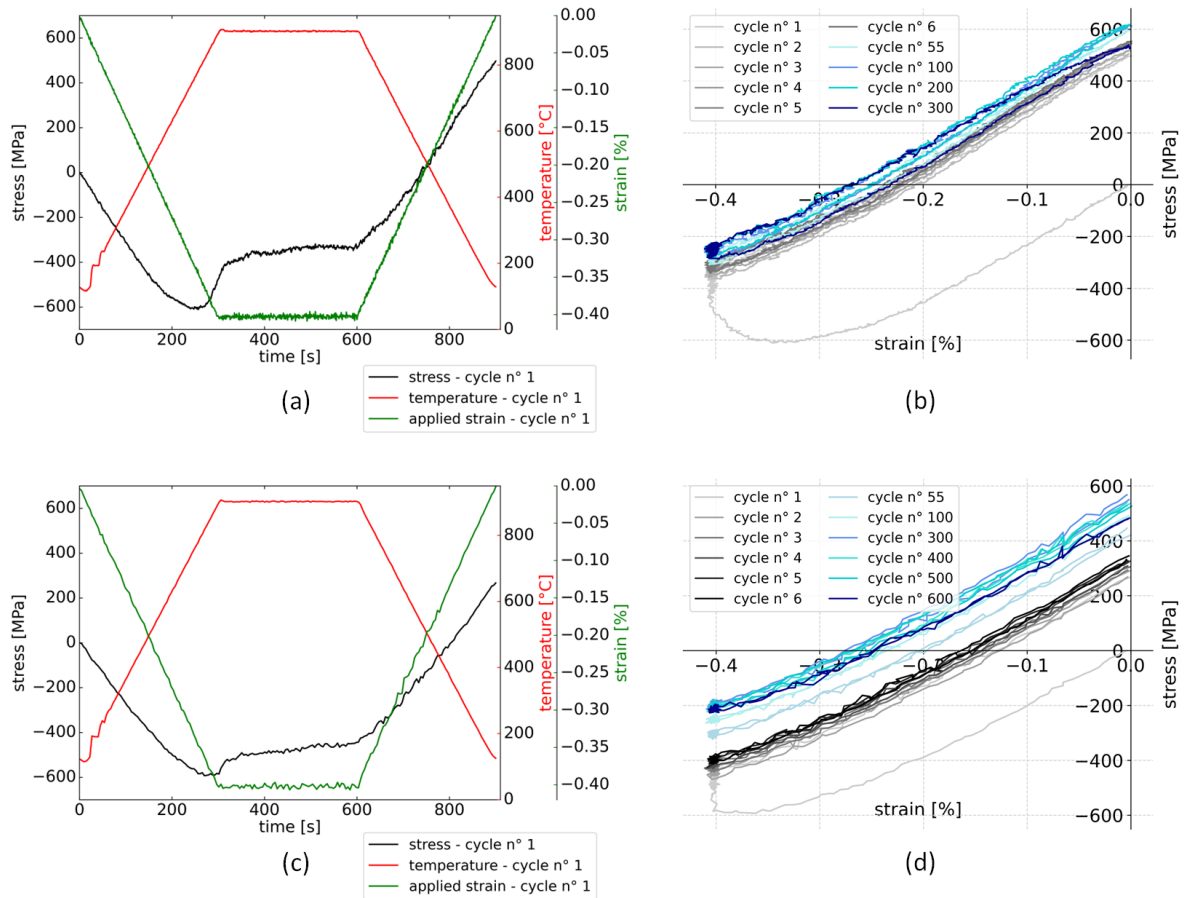
Figure 7: TMF temperature-strain-stress evolutions for both as received state (AR) and pre-aging, corresponding to 42 cycles of 1 h dwell at 1100°C (a) function of time for AR specimen, (b) stress-strain function of the number of cycles for AR specimen, (c) function of time for pre-aged specimen, (d) stress-strain function of the number of cycles for pre-aged specimen.

gain from improved oxidation performance can be largely impaired by the brittle behavior of the coating. Therefore, the detection and prediction of crack initiation under experimental conditions close to those in service is essential for estimating the lifetime of the entire system. For high temperature loading, typical of thermomechanical fatigue (TMF) loading, early damage is critical due to the way stress can occur at a low temperature range, especially when considering out-of-phase thermomechanical fatigue (OP-TMF) conditions [8, 9], Figure 7.

Stress-strain hysteresis was plotted in Figure 7(c) for the first cycle. The stress-strain-temperature evolution is very close to the AR condition, an increase of the compressive stress is found as a function of the temperature increase. However, less pronounced stress-relaxation during the strain dwell led to moderate tensile stresses at the lowest temperature (200 MPa lower than AR condition). The Bauschinger effect is yet more pronounced between the #6 and #55 cycles for the aged specimen, but the maximum tensile stress after #300 cycles (and even #600 cycles) is lower than the maximum tensile stress experienced during the OP-TMF test in the AR condition. Interestingly, the aged specimen had a two times greater lifetime under the same OP-TMF conditions compared to the AR specimen.
