Surface Analysis of OFE-Copper X-Band Accelerating Structures and Possible Correlation to RF Breakdown Events

S.E. Harvey*, F. Le Pimpec, R.E. Kirby, F. Marcelja, K. Adamson, E.L. Garwin
SLAC, 2575 Sand Hill Rd, Menlo Park, CA, 94025

Abstract

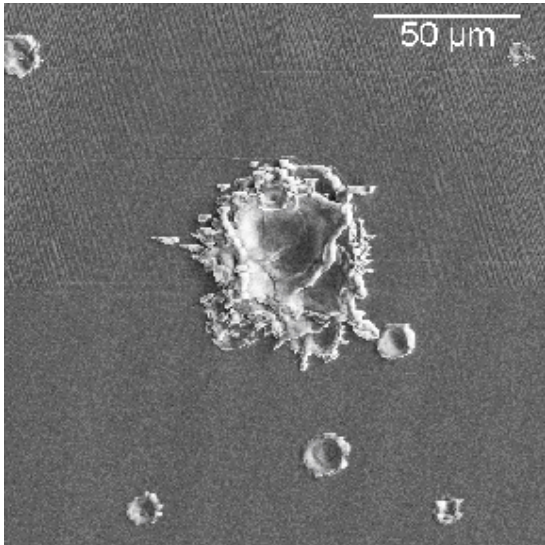
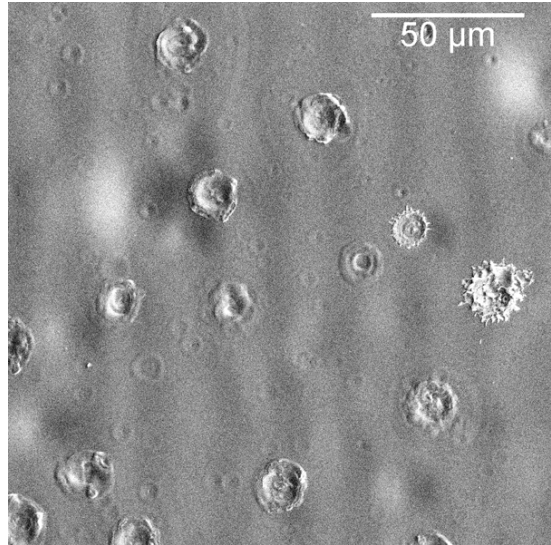
Figure 1: (a) sharp-edged craters (left); (b) smoothed-edged craters (right)

The defect dissipates some of the RF energy. Melting at the breakdown site creates craters that, due to their irregular geometry, can act as further sites for enhanced field emission and breakdown. The observed physical morphology of the craters falls into two distinct groups: irregular edges and softened edges. Fig.1(a) shows a crater with irreg-

ular edges; in Fig.1(b) a second type of crater is observed where there are few sharp edges and repeated melting appears to have taken place. The softened-edge craters often appear in close proximity with one another; irregularly edged craters are frequently spaced further apart. This suggests that the softened-edged craters may have started out irregularly edged, but have changed morphology due to repeated melting or plasma-ion bombardment.

This paper explores the possible correlation between the location and frequency of occurrence of breakdown events (Fig.1(a and b) and Fig.2) and their connection to copper surface morphology or contamination in travelling wave structures. The goal of this ongoing work is to identify the cause of the breakdown events and to diminish their occurrence, hence reducing operational variation among structures.

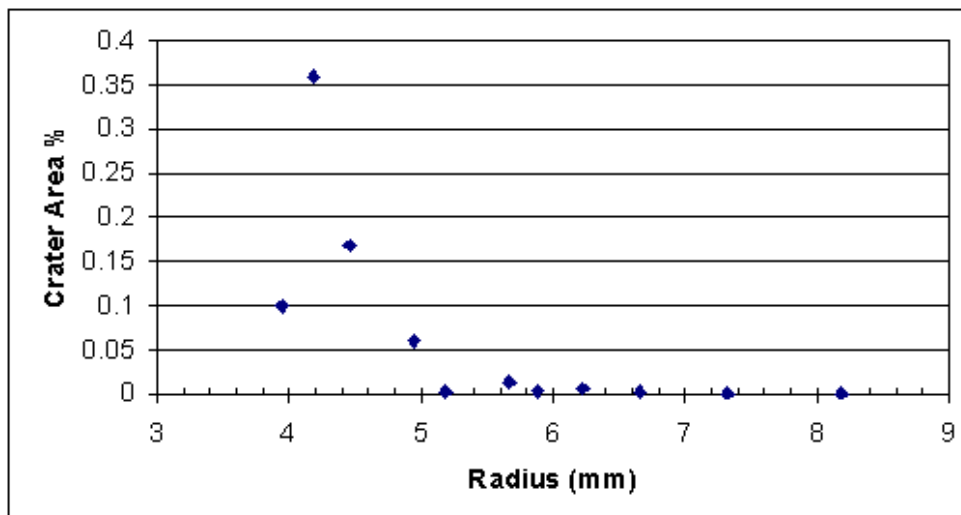
Figure 2: Average percentage area damaged by craters versus radial distance from center of aperture (30th Cell T53VG3RA)

In general the density of craters increases along the cell radius toward the center, where electric fields (\mathbf{E}) are highest, Fig.2. It is important to note that not every grain near the aperture exhibited craters and that the crater density varied substantially from grain to grain.

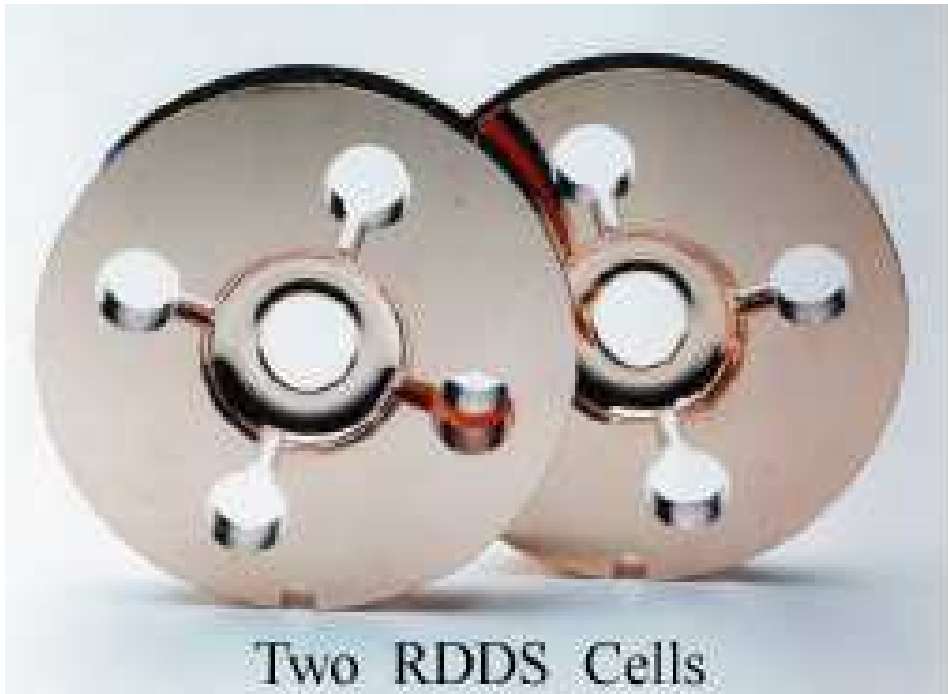
Figure 3: Damped Round and Detuned Structure Cells

The accelerator structure is manufactured from 99.99% pure OFE copper that has been evaluated as Class 1 material per ASTM-B66. To form a cell, Fig.3, the copper is machined either with a poly- or a mono-crystal diamond tool. Chemical cleaning and etching is performed after the final machining step to remove machining-related damaged material from the surface. An iris and a half cup side forms a half cell, Fig.3. After cleaning, the two half cells are diffusion bonded together in a dry hydrogen furnace to form a full accelerator cell. Several braze cycles are required for RF couplers and water lines and a wet/dry hydrogen cleanup furnace cycle follows the brazing steps. The structure is then vacuum fired at 650°C for two weeks to outgas dissolved dissolved gases, primarily hydrogen, which can be available for breakdown plasma formation. Vacuum-firing also reduces contaminant concentration on the structure surface. Desorption of surface/bulk gas contributes to the RF breakdown mechanism [5].

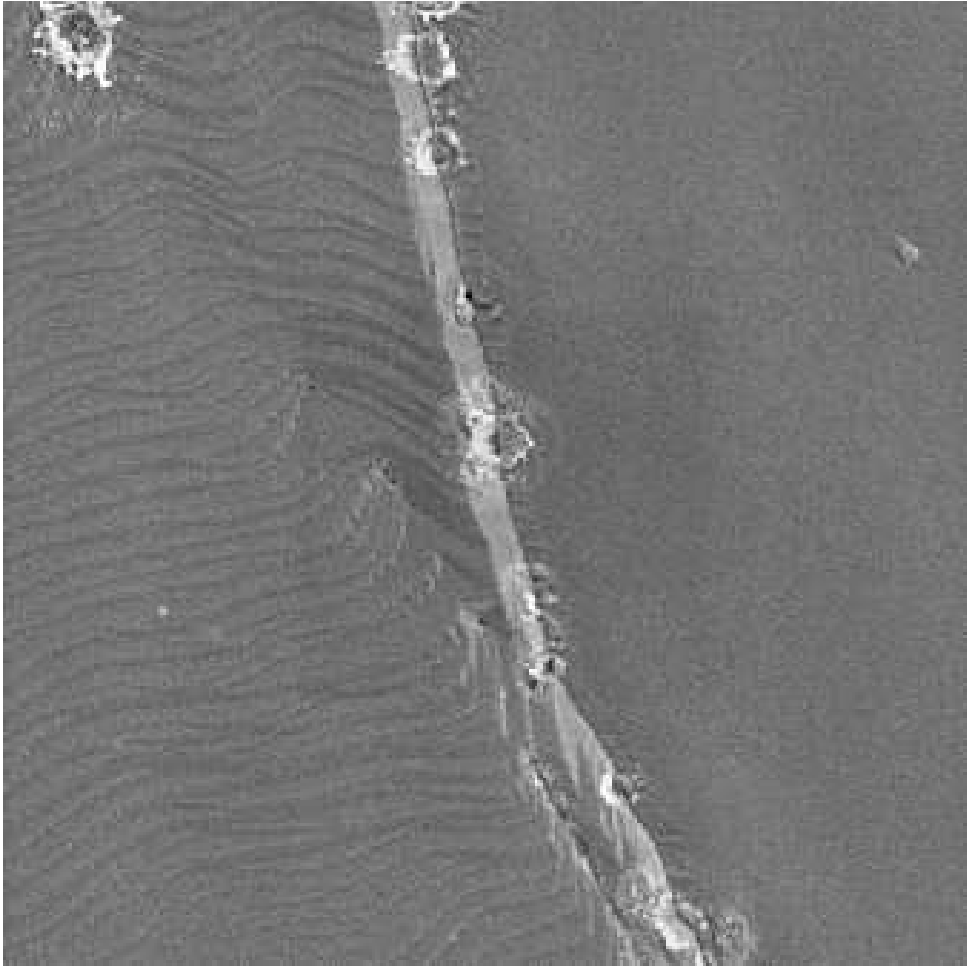
Figure 4: Breakdown on Grain Boundary

Craters were also seen at grain boundaries and at inclusions, Fig.4. Grain boundaries and inclusions are logical field emitters considering a Fowler-Nordheim model, equation.1. Both of these defect types have irregular geometries that increase the value of β (field-enhancement factor); simultaneously these defects indicate an area of high stress within the material, which could decrease the work function Φ , increasing the field emission:

Of particular interest is the role of copper surface plasticity in RF breakdown. Local heating, as well as the presence of high magnetic and electric fields, are known to create mass movement in copper [9]. Inclusions emerging at grain boundaries and microprotrusions (slip lines), created by local stresses due to mass movement, can act as field emitters. So, there can be a sufficiently high field or local heating that could induce mass movement in copper, thus resulting in RF breakdown. Fig.4 does present mass move-

ment inside a grain, and a crater with no traces of contaminant. However, we have not correlated systematic mass movement in a grain with breakdown events.

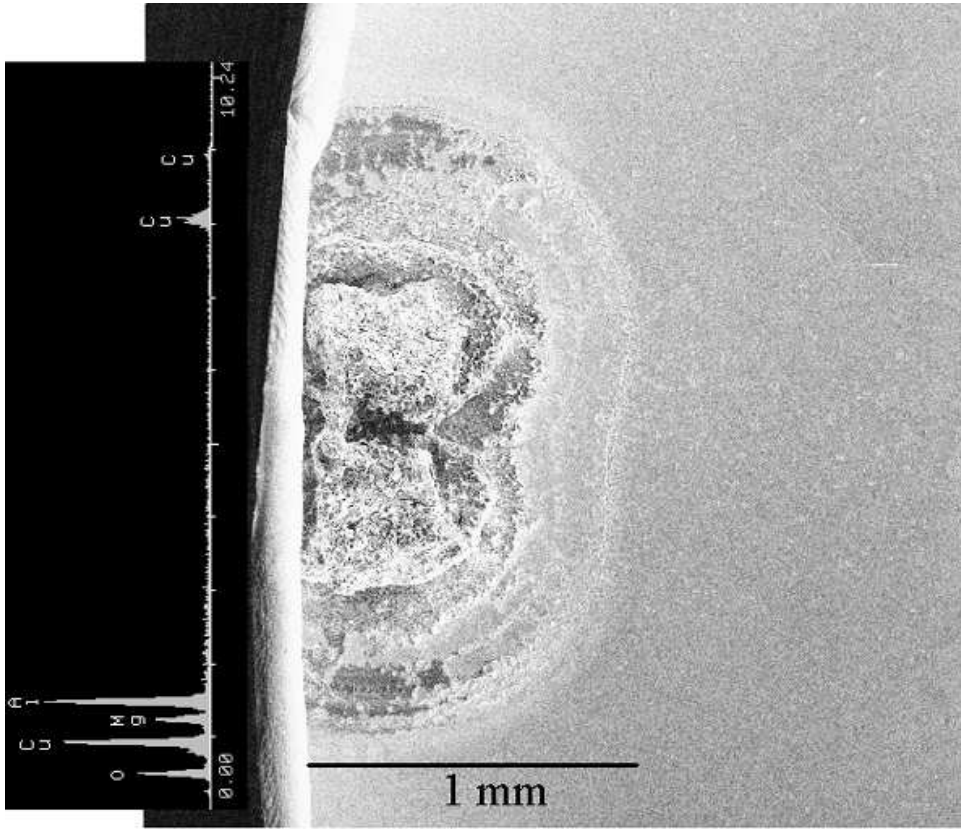
Figure 5: Aluminum particle (melted due to RF breakdown?) found on cell 13 of H90VG5

Two processed structures, H90VG5 and H90VG3N, did exhibit high RF breakdown in a localized region within the structure. At the bottom of the cell 13, between iris 12 and iris 13, of H90VG5, an aluminum sliver (mm length) was found, Fig.5. In cell 35-36 of H90VG3N a large (> 100 microns) stainless steel (S/S) particle, Fig.6 was found embedded in the sidewall of the cell. A high density of craters was found near the S/S particle, Fig.7. The aluminium sliver was likely introduced to the structure during assembly in the NLTCA. The process by which the S/S particle was introduced inside the structure is not so clear because the particle is now actually embedded into the copper.

Using RF design simulation software the intensity of the magnetic or electric field inside a structure or a cell can be determined. At the location of the cup side the magnetic field (\mathbf{H}) of the RF wave is maximal 0.3 MA/m , on the iris it can be up to 5 times less. The surface electric field on the iris is 150 MV/m and is 7 MV/m at the location of the S/S particle. The pattern of the melting at the base of this particle is consistent with a high current induced by \mathbf{H} [13].
