# Effect of Optical Coating and Surface Treatments on Mechanical Loss in Fused Silica

Andri M. Gretarsson, Gregory M. Harry, Steven D. Penn, Peter R. Saulson, John J. Schiller, and William J. Startin

*Department of Physics, Syracuse University, Syracuse, NY 13244-1130, U.S.A.*

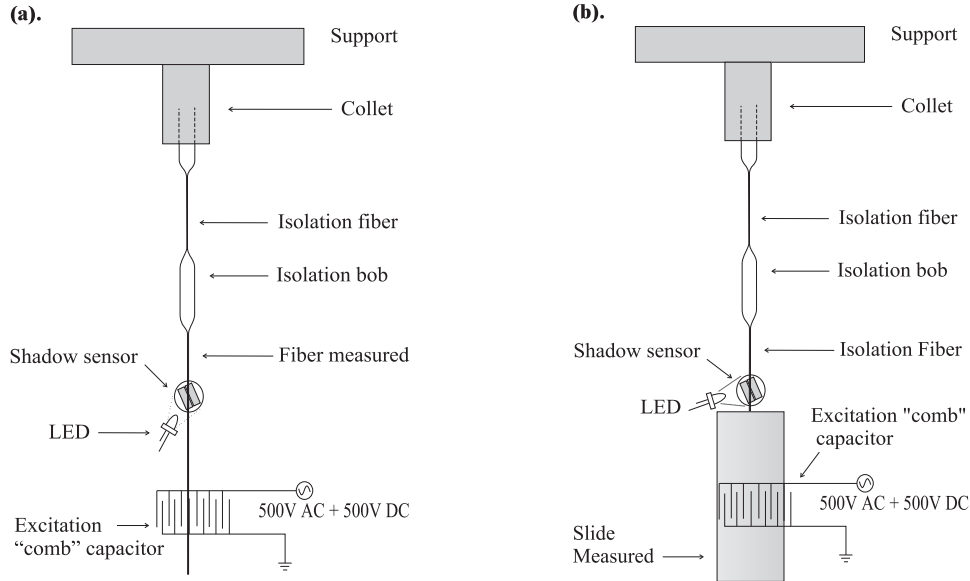
**FIGURE 1.** Schematic diagram of the experimental setups. (a). Setup for measuring fiber  $Q_s$ . (b). Setup for measuring slide  $Q_s$ . The isolation bobs and fibers prevent the measured sample  $Q$  from being degraded by rubbing in the clamp and from recoil in the lower  $Q$  support structure.

The surface loss due to optical coatings was investigated by measuring the quality factors of the modes of fused silica slides. We measured the  $Q$ s for three slides of dimensions  $76 \text{ mm} \times 25 \text{ mm} \times 1 \text{ mm}$ . The slides were suspended below a monolithic, fused-silica isolation system, as shown in Fig. 1b. The slides' vibration was monitored by positioning the LED and shadow sensor around the suspending fiber directly above the slide.

The coated Slide B was suspended from the center of one of its short edges, as shown in Fig. 1b. When the supporting fiber was connected to the slide using a hydrogen-oxygen torch the coating became visibly damaged. Where the flame from the torch contacted the coating, the coating took on a milky appearance. This occurred in a crescent shape approximately 3 mm across at the top of the slide. The high value of  $d_s$  for the second mode is believed to be due to this damage. To test this, the top 5 mm of this slide were immersed in a 50% solution (by weight) of HF

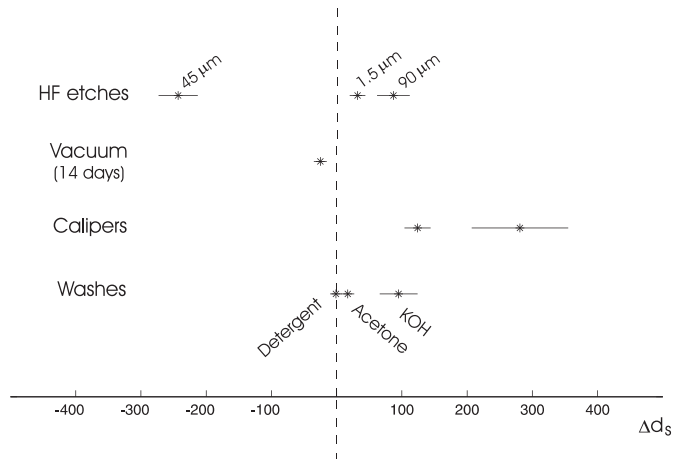
Figure 2 shows how strongly different treatments affected the surface of fibers. Most of the treatments either produced no change in the condition of the surface or they made it only slightly worse. However, pinching the surface at regular (1 cm) intervals with calipers significantly increased the dissipation depth, possibly due to small cracks formed by the mechanical contact. Similarly, the mechanically polished microscope slide had the highest measured  $d_s$ . It is interesting to note that the surface of Fiber I, after being significantly damaged by calipers, was restored to a condition better than as drawn (or perhaps more appropriately better than “as stored and handled”) by the  $45 \mu\text{m}$  HF etch. The resulting dissipation depth agrees with the best as drawn case, having a value of about  $100 \mu\text{m}$ .

**FIGURE 2.** Change in the condition of fiber surfaces as compared to the initial surface as drawn,  $\Delta d_s$  vs treatment. Horizontal lines mark the uncertainty in  $\Delta d_s$ .
