# Aging Study of RPC's for the SiD Hcal and Muon System

Preliminary test results on microscope investigation and BESIII-type RPC aging performance have revealed interesting aging phenomena that had not been seen before in Linseed oil coated Italian-type RPC. We report here on the aging performance of BESIII-type and its variant RPC, and on microscopic surface characterization of BESIII-type Bakelite electrodes.

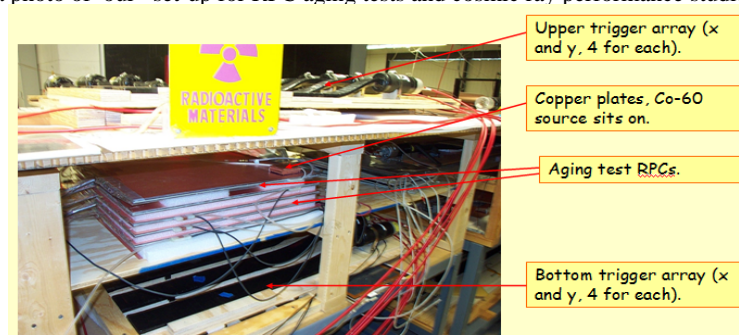
Figure 1 shows a photo of our set-up for RPC aging tests and cosmic ray performance studies.

**Fig. 1. RPC aging test set-up.**

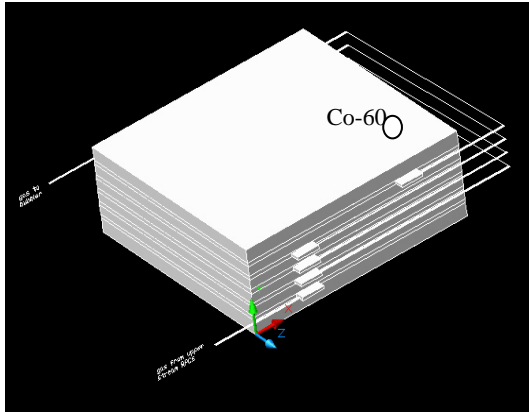
The gas inter-connection among five RPCs is shown in Fig. 2, and figure 3 shows the scintillation counter array used for cosmic ray trigger. It sandwiches the stack of test RPCs, and divides the test RPCs into 16 regions (#1 to #16 from lower-right to upper-left) in a 4×4 array.

Fig. 2. Gas inter-connection among five RPCs and the source position.

A 0.1mCi Co-60 source is placed on top of the RPCs through an 18mm thick stack of copper plates (region #1, see Fig. 2). The singles rates with and without the source are quite different among 5 RPCs. RPC #4 is the noisiest, ~6kHz for strip #2. RPC #8 is the quietest, ~0.8kHz for strip #2. See figure 4 for details.

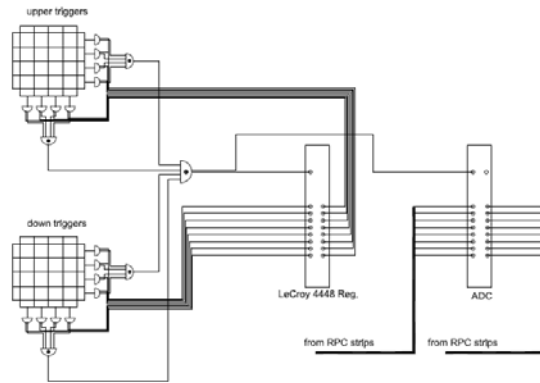
Fig. 3. Scintillation telescope array.

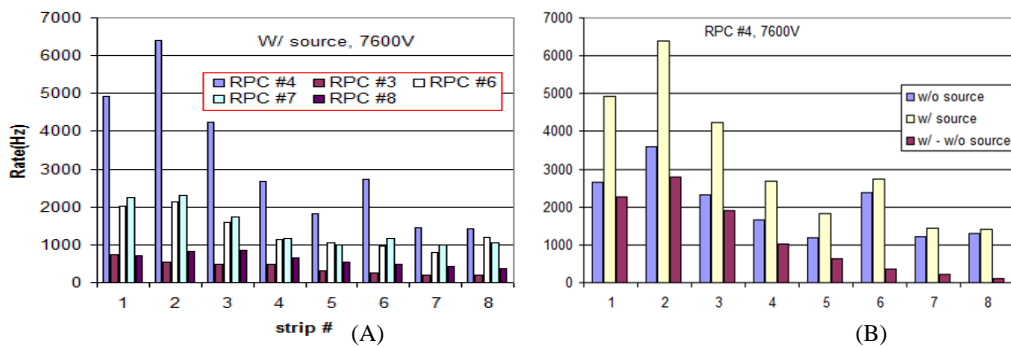
Fig. 4. Singles rate of the test RPCs. (A) Rate for all five RPCs with source; (B) Rate for RPC#4 with and without source.

Because of the geometry and the intrinsic noise rate difference the aging dose rate is different among these RPCs, with their ratio is (#8): (#6, #7): (#4) ~ 1: 2.5: 7.5. The equivalent aging dose is based on the following assumptions: (1) The background noise rate for a running RPC is 0.4Hz/cm<sup>2</sup>; and (2) A simple Monte Carlo calculation shows 40% of the total rate detected by 8 6cm-width strips over a 50cm×50cm RPC by a Co-60 source that is concentrated in a 10cm radius circle in region #1 [2].

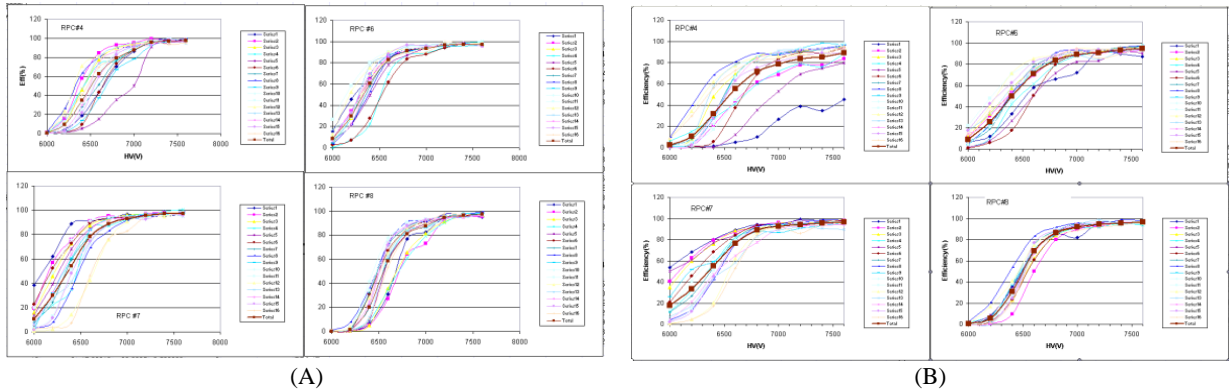
For the aging test the source is placed on top of the RPC stack. We measured the initial efficiency for the test RPCs, monitored their dark current in the course of aging test. By comparing the efficiency degradation with time the aging effect can be clearly revealed. Figure 5 shows the efficiency before and after 23 days aging. The equivalent aging dose for RPC#4 equals to 7.6 years. By that time serious aging has already shown up. The other three RPCs have much less degradation because their equivalent aging dose is smaller.

Fig. 5(A) Initial efficiency; (B) After 23 days efficiency.

To simplify the plateau plots instead of all 16 regions we only draw three regions for each RPC: region #1, #2 and #5, which are the direct radiated regions and their immediate neighboring regions. The equivalent aging doses are shown in the right yellow text boxes. Surprisingly RPC N5 efficiency is even getting better with time, and the other four RPCs are also showing no aging degradation. At the 74-th day the equivalent aging dose reaches 8.2 years. On other hand for the regular BESIII-type RPC, at equivalent aging dose of 7.6 years serious aging has already taken place, as shown in figure 5.

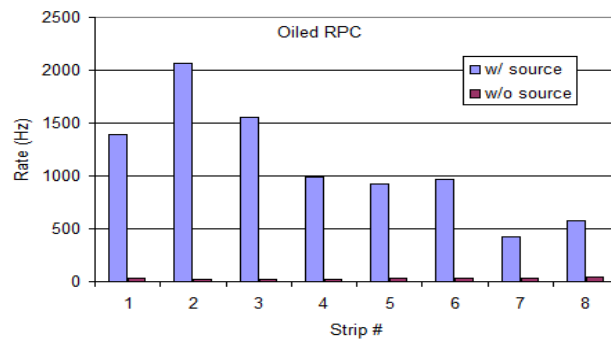
The initial performance of this chamber is extremely good. Its singles rate with and without source is shown in Fig. 6. The noise rate without source is very close to cosmic ray background. The equivalent aging dose ratio to the predefined background rate ( $0.4\text{Hz}/\text{cm}^2$ ) due to the source is estimated as 40:1.

Fig. 6. Initial singles rate of Linseed oil coated RPC.

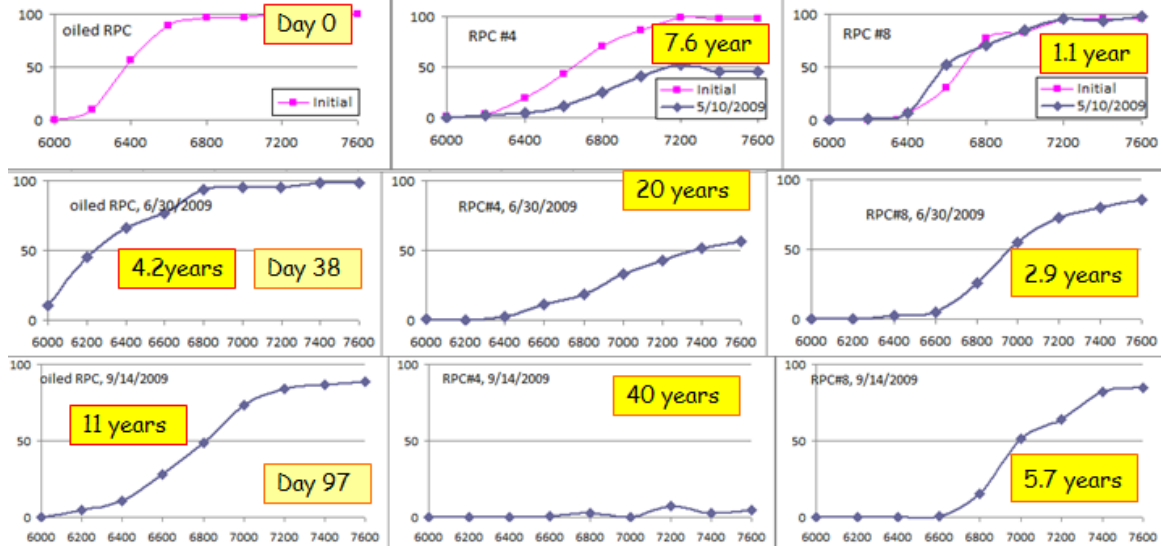
In figure 7 we compare the aging performance for Linseed oil coated RPCs and other two RPCs: RPC#4 and #8. The number in the bright yellow box is the equivalent aging dose. Up to 11 years of the equivalent aging dose the oil coated RPC still has good efficiency curve, although the efficiency plateau's shoulder has

shifted higher by ~ 400V. For other two regular RPCs without oil coating (7.6 and 5.7 years, respectively) the efficiency plateaus already degraded profoundly in spite of significantly less aging dose.

**Fig. 7. Comparison between oil coated BESIII RPC and regular BESIII RPC.**

A month after the Day 97 of the efficiency test, when we tested the efficiency again we found drastic efficiency drop for the radiated region of the oil coated RPC. An “autopsy” revealed that the Linseed oil coating had not been cured completely, causing several big oil stalagmites to form in the gap of the radiated region, similarly to the serious failure of the first generation of BaBar RPCs. [4]. We believe if we improve the curing process, this problem can be avoided as demonstrated by second generation of BaBar RPC’s [5, 6]. The advantage of the Linseed oil coating is clear: lower noise rates and better aging performance.

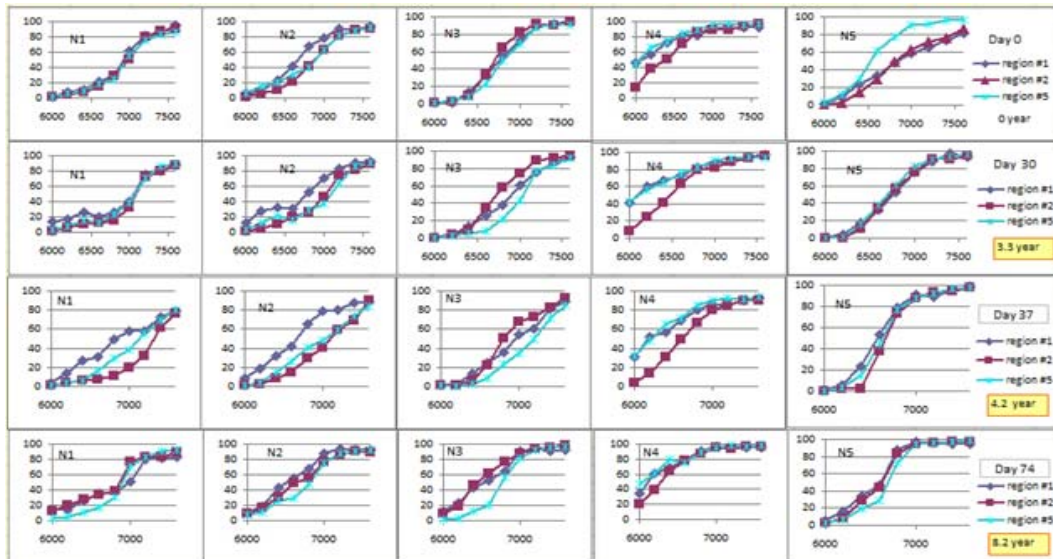
Based on our test results our Chinese collaborator, Xianghu Construction Material, Inc. has developed a new variant of Bakelite with embedded Linseed oil. Five RPCs with this Bakelite have been constructed and put into aging test for more than 75 days, an aging dose equivalent to more than 9 years. The most recent test results are summarized in figure 7.

Fig. 7. Summary of the Linseed oil embedded Bakelite RPC aging test.

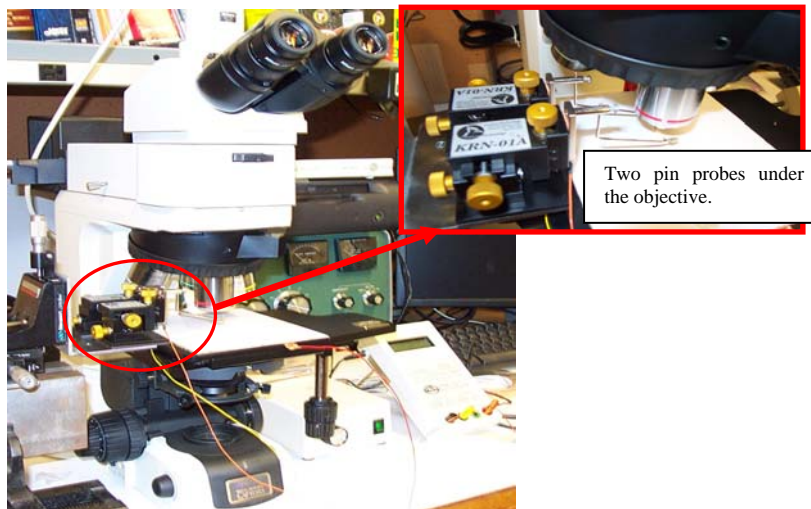
A Nikon LV100D microscope has been used for this study to search for the cause of the aging. We have set up a microscope/pin-probe station aimed the resistance measurement that has revealed tiny sparking marks on the electrode surface, as shown in figure 8.

Fig. 8. Nikon microscope and two pin-probes with their 3D micrometer stages (the insert shows two pin-probes).

Using the microscope/pin probe station we can measure the volume resistance for any interested region on the electrode surface. We can move the probes to the sparking region, place the pins right on the interested region, and lower the probes to touch the surface as shown in figure 10 and 11. Two pin probes are connected together and form one input to the high resistance meter. The other input of the resistance meter is connected to a copper tape that sticks to the graphite coating on the back side of the test sample. Two categories of the interested region are selected: sparking

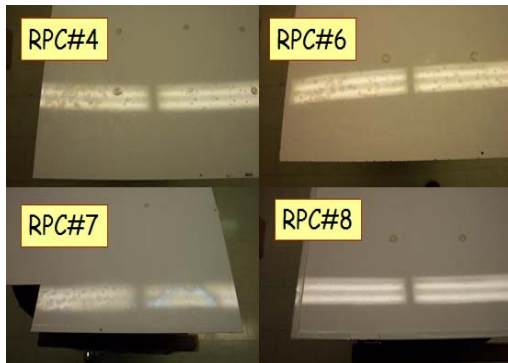
After opening the aged RPCs we found a lot of sparking marks all over the surface for both anode and cathode. Figure 9 shows some typical images. The distribution density of the marks varies; and shows a correlation between the degree of efficiency drop and the density of the sparking marks. RPC #4 has suffered the highest aging dose, and the highest sparking density. RPC #8 has the least aging dose and lowest aging mark density. Under the microscope the sparking marks show varied appearances that may be related to the degree of the electric energy released in the sparks.

**Fig. 9.** Sparking marks on the aged RPC electrode surface can be seen in the ceiling lamp's images.

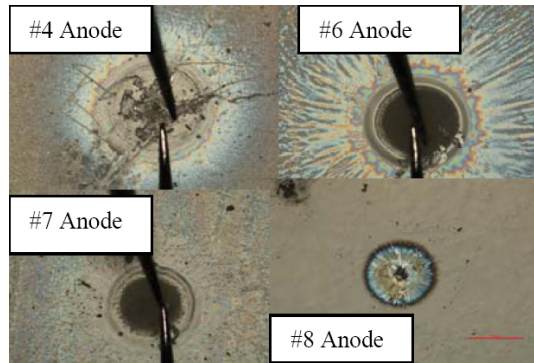
**Fig. 10.** Sparking mark images from four RPCs: #4, #6, #7 and #8. The 0.5mm red microscope scale is shown in #8 image.

In figure 10 we show images of typical sparking mark images for different RPCs. The sharp pins shown in the picture are the pin probes. Scratching the sparking marks with the probe can produce clear scratching traces. By contrast there is very little sparking evidence found on the Linseed oil coated RPC electrodes. In Fig. 11 we show images of spark-like spots, but their different appearance may indicate that the Linseed oil coating plays a big role in suppressing large sparking.

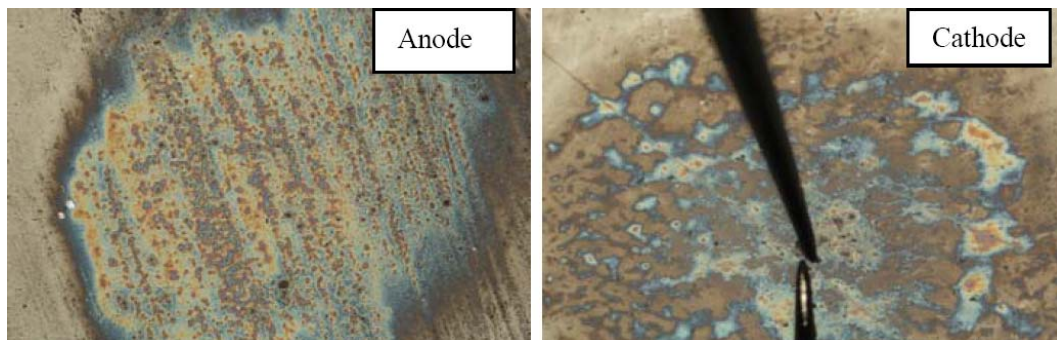
**Fig. 1.** Spark-like marks observed on Linseed oil coated surface.

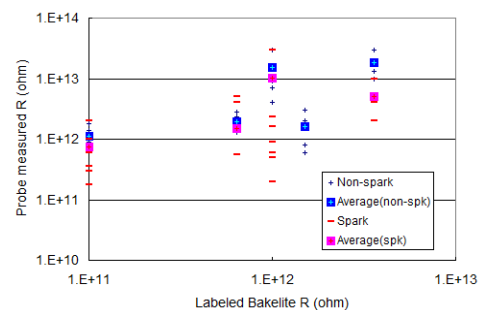
**Fig. 12.** Pin probe measured volume resistance for various aged electrodes.

and non-sparking areas. The test chambers have their original Bakelite volume resistance measured and labeled. We summarize all of the test results in figure 12. There is some small resistance difference between sparking and non-sparking areas, the former is somewhat smaller than the later, but it is not dramatic and whether or not it is related to the efficiency degradation is still unknown.

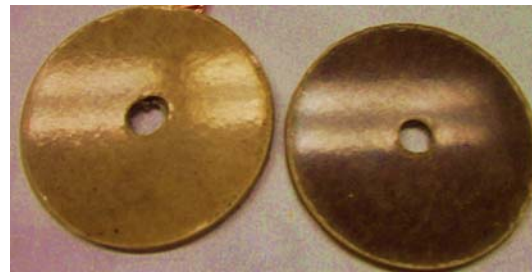
The sample disc from the high flux central region shows a highly discolored surface with an “orange peel” looking texture. The disc from the lower flux region is less discolored, its Linseed oil coating film looks smooth, and a cotton tip with ethanol easily removes the oil film, revealing a shiny Bakelite surface. It seems that the high dose of radiation and resulted erosion from high concentration of HF caused the dye in the surface layer paper to discolor; and also caused the “orange peel” look on the surface. Figure 14 shows a comparison between high dose and low dose BaBar samples.

**Fig. 14. The left disc is high dose sample, it shows discolored “orange peel” like surface, the right disc is low dose sample, its surface looks reasonably smooth and darker.**

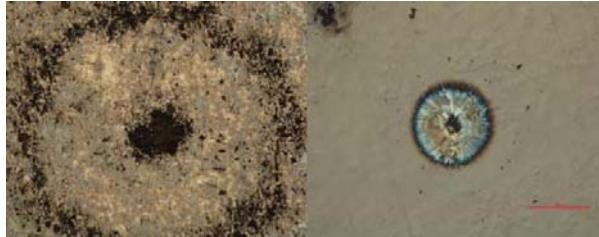
Compared to the BESIII RPC we notice that sparking marks are very rare on our BaBar RPC samples. We did find one and its microscope image is shown in figure 15, quite different looking from BESIII-type RPC.

**Fig. 15. Sparking mark, (A) BaBar sample; (B) BESIII-type aging test chamber #8 sample. The red microscope scale (0.5mm) is shown in (B), it should be same for (A).**

The different appearance of the sparking marks for Linseed oil coated BaBar RPCs and oil-free BESIII-type RPCs might be related to their different surface material. The Linseed oil coating, when it is completely cured, has a long carbon chain, as shown in figure 16(A) [7], and the melamine structure, which is the surface material of BESIII Bakelite, is shown in figure 16(B) [8].

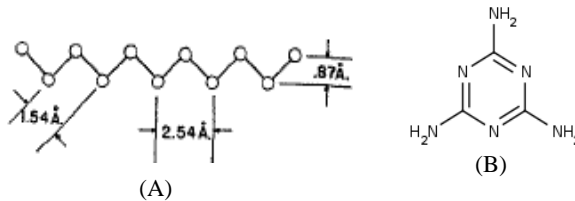
**Fig. 16. Chemical structure of Bakelite surface material. (A) cured Linseed oil film; (B) Melamine resin.**
