# Erosion of Copper Target Irradiated by Ion Beam

**Abstract – Erosion of copper target irradiated by deuterium ion beam with ultimate fluence is studied. The target originally destined for neutron generation represents bulk copper substrate covered by 3-mm titanium layer. The target was irradiated by deuterium ion beam generated in Bayard-Alpert type ion source with energy of ions 17.5 keV/nuclear. Maximal fluence in the center of the target achieves  $2.5 \cdot 10^{23}$  atoms/cm<sup>2</sup>. Measurements of the profile of irradiated target and estimation of fluence shows that physical sputtering is a dominating process that determines the target erosion. Most interesting feature is growth of mm-size tadpole-shaped structures, localized in the cracks of the surface. RFA analysis of these structures showed extremely large (up to 60%at.) carbon content.**

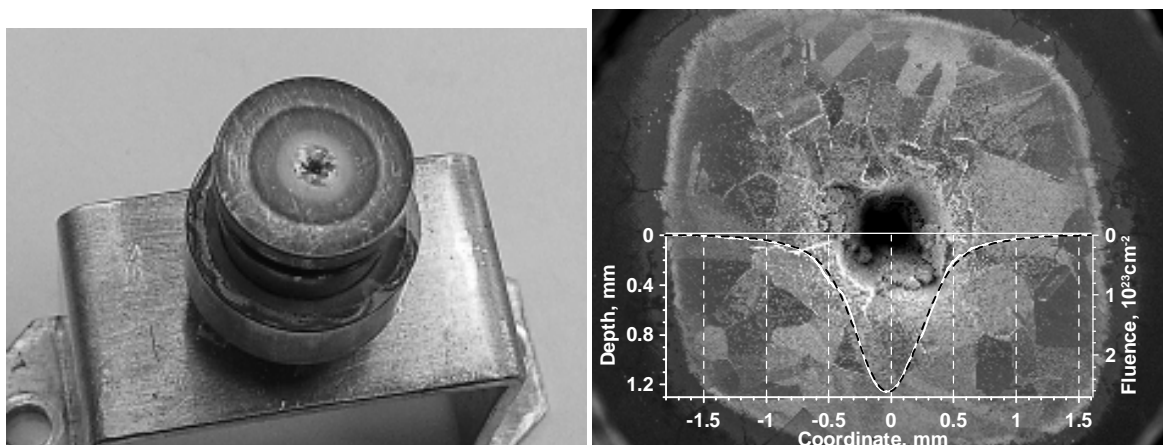
Fig.1 Photo of the target after durability test (a) and SEM image of the central part of the targets (b)

A value of fluence achievable in experiment is restricted by tube operation current (50  $\mu A$ ) and reasonable experiment duration. For increasing of this value we focuses ion beam with a spot size on the target 0.5 mm (Fig. 1a). In the 600-operation-hours durability test the fluence in the beam spot exceeds  $10^{23} \text{ cm}^{-2}$ .

Profile of the target surface after irradiation is shown on Fig.1b (white solid curve). Erosion depth achieves 1.2 mm in the center of the target. The profile can be approximated by the sum of two Gaussians with characteristic diameters 0.25 and 0.52 mm and practically equal 2D integrals over target surface (black dashed curve on the Fig.2b). Possible reason for such profile is a presence of hydrogen (protium) in the ion beam. Particle tracing calculations show that difference in focusing lengths for  $D_2^+$  and  $DH^+$  ions can explain the observed two-component profile. Assuming linear dependence of erosion depth from a local value of fluence and taking into account full number of atoms hit to the target ( $1.35 \times 10^{21}$  atoms) we can estimate spatial distribution of the fluence (right axis of Fig.2b). Maximal fluence in the center of the target achieves  $2.5 \times 10^{23} \text{ atoms/cm}^2$ . Physical sputtering under such fluence with the yield value 0.03 [4] would cause erosion depth 0.9 mm. Accordingly exactly physical sputtering is a

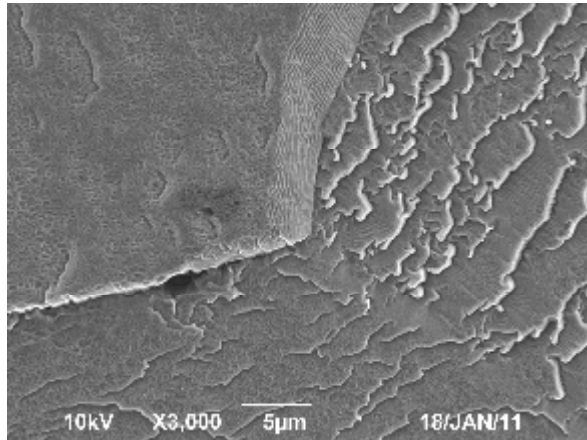
Fig.2 Flacks and open blisters on the target surface, distance 1.5 mm from the target center

Note that the estimated fluence is far above the threshold of blistering that is in order of  $10^{18} \text{ cm}^{-2}$  [1], and signs of blisters and flacks are observed on the hole enclosure (Fig.2). Appearance of such structures strongly depends on crystal structure of the surface. Several hundreds microns grains observed in this area have sufficiently different relief of the structures on the surface.

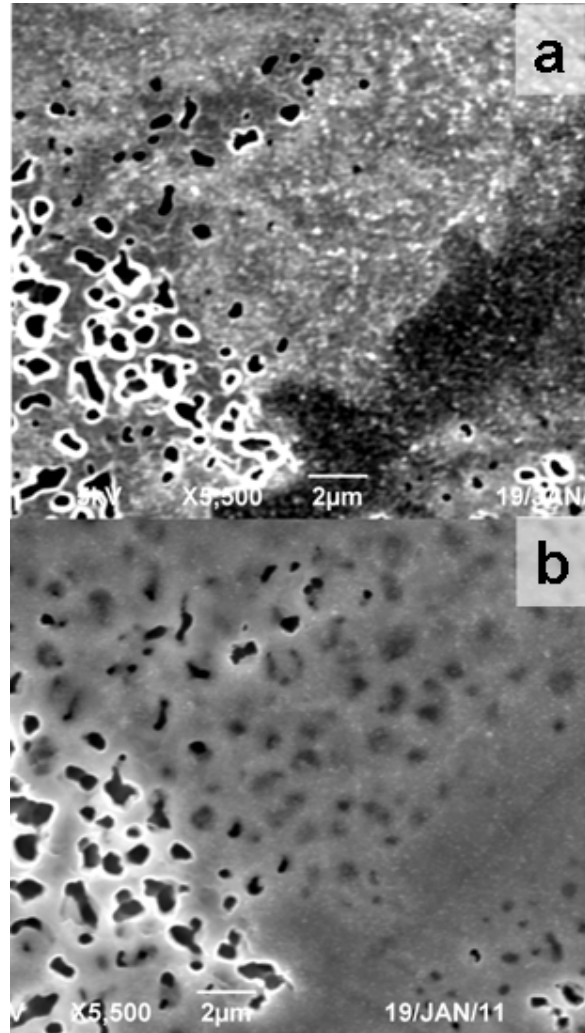
Fig.3 SEM images of intermediate zone taken with the energies of scanning electron beam 5 (top image) and 20 (bottom image) keV

appearance of cavities under surface layer. The cavities are discovered by comparison of SEM images with energies of electrons 5 and 20 keV (Fig.3). Holes in the upper right corner clearly seen on the Fig.3b ( $E_e=20$  keV) and hidden on Fig.3a ( $E_e=5$  keV). It follows that the holes in copper target are covered by the layer with the thickness more than 100 nm (the range of 5 keV electrons). Since the range of ions less than 100 nm that means that hydrogen accumulated in the surface layer diffuses to the bulk of target and cause cavities formation.

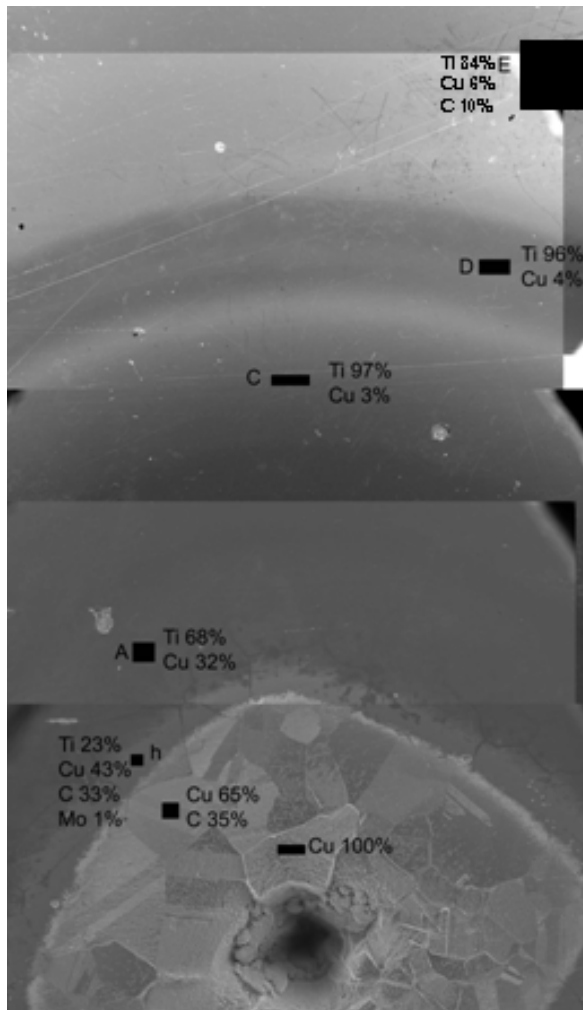
Fig.4 Elemental content of the target surface

Elemental content of surface is measured in several points of the target by SEM RFA add-on. The target image composed from several SEM scans with denoted zones of RFA measurements and resulted elemental content is shown on Fig.5. Apart of original target elements –titanium, copper, and molybdenum the one observed impurity is carbon. According to our view origin of 10%at. carbon content on the target border is surface contamination. A surface of a zone

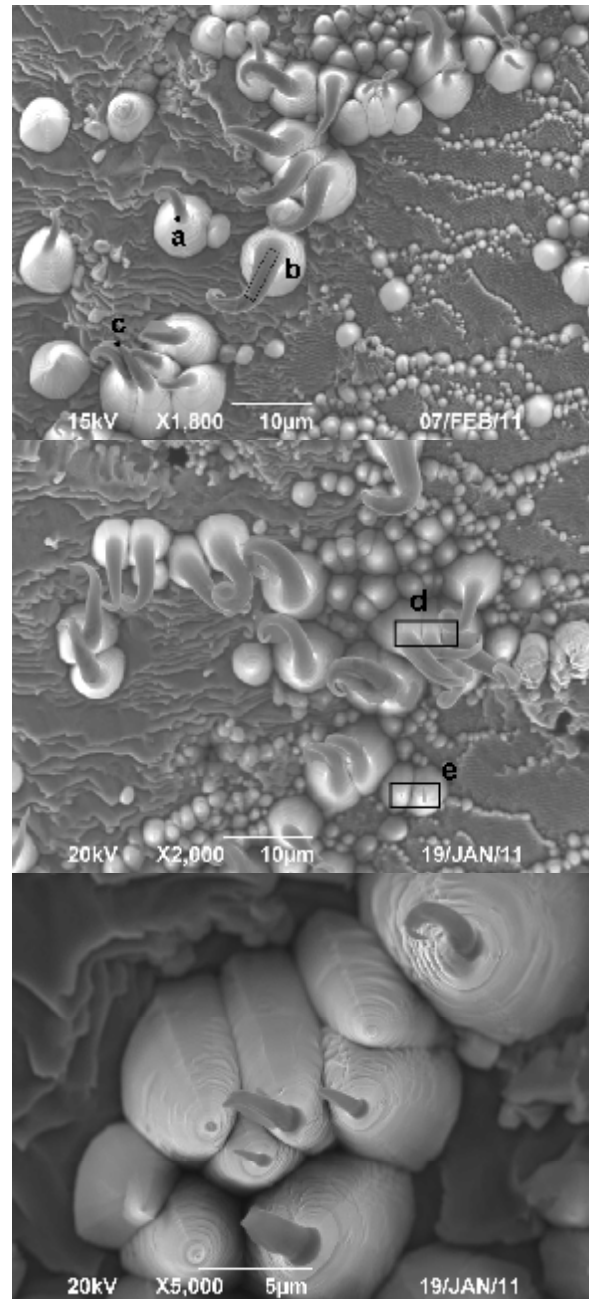
Fig.5 Freak patterns on the surface near central hole; letters marks the areas of RFA elemental content measurements, **a**- C 16% Cu 84%, **b** – C 38% Cu 62%, **c** – C 42% Cu 58%, **d** – C 60% Cu 40%, **e**- C 35% Cu 65%

Most intriguing effect of target irradiation is growth of freak tadpole-shaped patterns (Fig.6) consisted of bell basement and spin tail. These patterns predominantly appeared on the grain borders close to central hole. Several groups of the patterns with different ages are observed on the target. Brightness of SEM images of the structures indicates good conductivity of surface. Thereat RFA analysis registers increased carbon content in the patterns. This content sufficiently varies for different patterns and achieves 40% at. for tails and 60% at. for basements with remaining copper and absence of any other impurities. At the same time RFA measurement integrated over 50x150  $\mu\text{m}$  area included patterns result 100% copper content. Certainly the patterns forms by extrusion from intergranular space but specific mechanism and chemical structure of the patterns are unclear.
