EVIDENCE OF DAMAGE IN CARBON FIBRE COMPOSITE TILES JOINED TO A METALLIC HEAT SINK UNDER HIGH HEAT FLUX FATIGUE

Association Euratom - CEA sur la Fusion Contrôlée.

Centre d'Etude de Cadarache

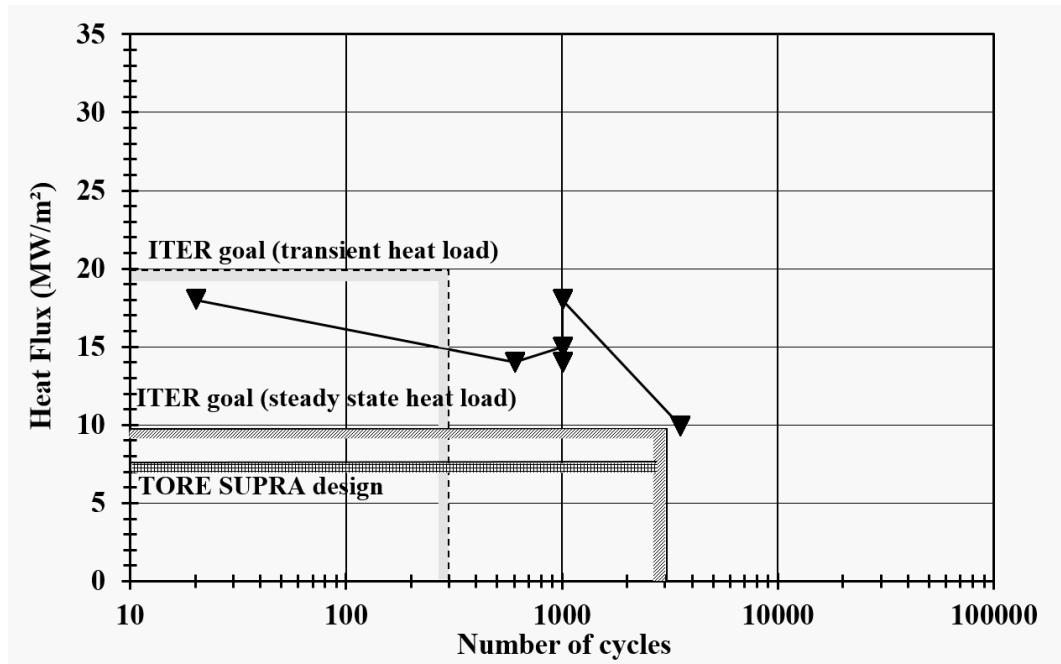
Figure 1 : results of high heat flux tests of CFC armour to Cu heat sink joints.

With NS31 from SEP and Dunlop concept 2, SMS 2B and 3B were cycled during 1000 cycles at 18 MW/m², showing an evolution of the surface temperature, and intense erosion but no tile detachment. Those tests compare well with the literature (figure 1, see also [10]).

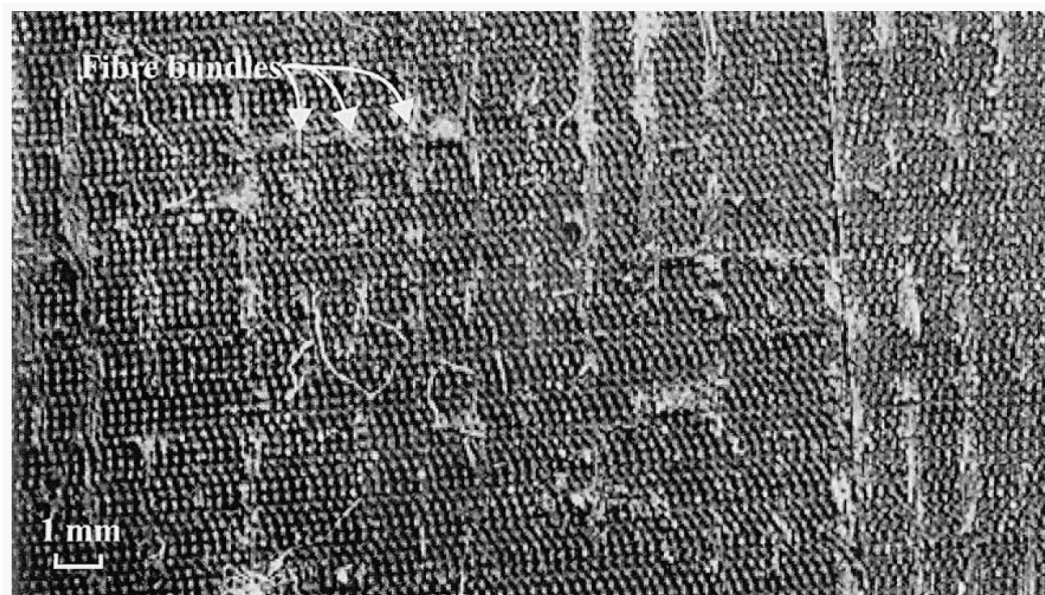
Figure 5 : Macrography of the heat sink after tests at 18 MW/m^2 (the defective tile was removed in laboratory)

On broken tiles removed from the mock-up after test at 18 MW/m^2 (figure 5), the copper is mainly black, with many cones visible. The cones are made out of copper that has solidified in the laser - machined holes in the CFC during the AMC process. Fibre bundles often remain attached to the copper. Very few copper is visible on the fractured area of the tile. These elements indicate that such cracks propagate mainly in the CFC or just beneath. Moreover, some black dust falls from the tile, suggesting a disintegration of the CFC material in the vicinity of the bond.
