# Experience gained about Resistive Plate Chambers ageing from the ALICE Muon TRigger/IDentifier detector

A. Ferretti<sup>1,a</sup>, for the ALICE Collaboration

The ALICE Muon Identifier is composed of 72 single-gap bakelite Resistive Plate Chambers, which have been operational since 2009 in maxi-avalanche mode (discrimination threshold: 7 mV without amplification) with a Tetrafluoroethane/Isobutane/Sulfur Hexafluoride gas mixture, undergoing counting rates of the order of tens of Hz/cm<sup>2</sup>.

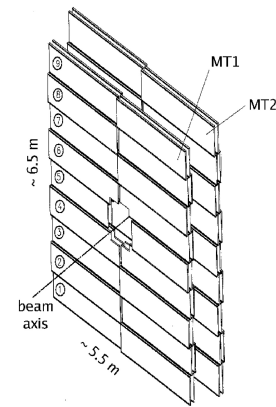
Figure 1: Layout of the ALICE Muon TRigger/Identifier. Each slat is one RPC

The Muon Trigger[2] (renamed since 2020 as Muon Identifier, MID) is placed downstream of the FMS, starting  $\sim 16$  m from the Interaction Point and is made of 72 Resistive Plate Chambers (RPCs), arranged in two stations of two planes each (see Figure 1). Each detection plane is  $\sim 5.5$  m wide and  $\sim 6.5$  m tall and it is made of 18 chambers, which come in two sizes: sixteen in each plane are  $\sim 270 \times 70$  cm<sup>2</sup>, while the remaining two are shorter ( $\sim 210 \times 70$  cm<sup>2</sup>) in order to accommodate the beam pipe shielding in the middle of the plane. MID RPCs are equipped with orthogonal readout strips to provide spatial information along both X and Y directions, for a total of 21k readout channels.

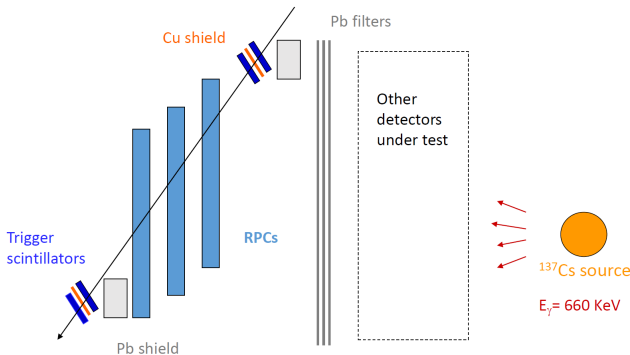
Figure 2: Schematic layout of the GIF ageing test

After successful tests, the Muon Trigger group started an R&D campaign to evaluate the ageing characteristics of the detectors in order to estimate their lifetime. To this end, in February 2001, we installed two  $50\times 50\text{ cm}^2$  prototypes in the GIF, and we exposed it to a  $\gamma$ -induced counting rate in the  $70\text{--}150\text{ Hz/cm}^2$  range[7]. Efficiency was monitored on a small area ( $\sim 30\times 10\text{ cm}^2$ ) using a scintillator telescope selecting cosmic rays crossing the upper-central zone of the detectors (see Figure 2). Unlike the RPCs used in previous tests, one of these prototypes was coated with a much thinner layer of linseed oil because of the experience of the BaBar IFR RPCs[6], which underwent major efficiency problems due to an excess of linseed oil. The proportions between oil and pentane were then changed to 30/70, resulting in a oil layer  $\sim 3\text{ }\mu\text{m}$  thick. The other RPC was without oil coating at all.

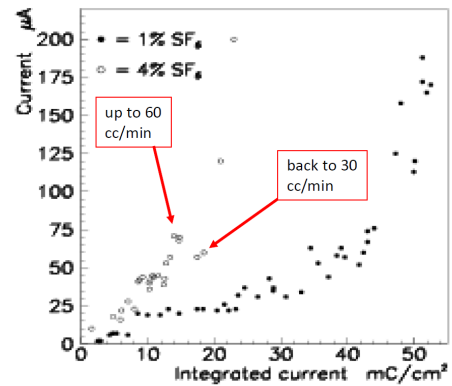
Figure 3: Dark current drawn by RPCs as a function of integrated current. Black dots refer to an RPC flowing with a mixture of 1%  $\text{SF}_6$ , while white dots refer to a RPC flowing with a mixture of 4%  $\text{SF}_6$ . The temporary decrease of the dark current in the RPC with 1%  $\text{SF}_6$  is correlated with an increase in the gas flow rate.

Results of the first test (see Figure 3) showed that operating the gas mixture with 1% of  $\text{SF}_6$  caused a strong reduction of the dark current increase: even if the chamber flowed with 1% was exposed to a counting rate double of the one of the 4% chamber, ( $100\text{ Hz/cm}^2$  vs.  $50\text{ Hz/cm}^2$ ), the dark current stayed under  $200\text{ }\mu\text{A}$  up to  $60\text{ mC/cm}^2$ , while the 4% chamber reached the same value before integrating  $30\text{ mC/cm}^2$ .

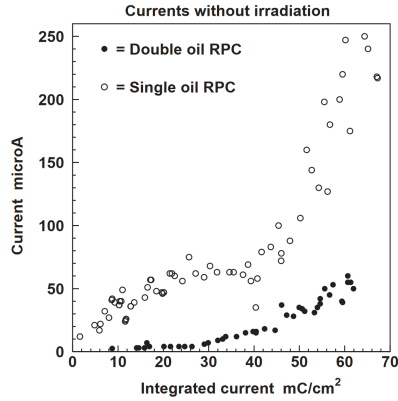
Figure 4: Dark current drawn by RPCs as a function of integrated current. Black dots refer to an RPC internally coated with a double linseed oil layer, while white dots refer to an RPC coated with only one oil layer.

After this outcome, for the second comparison, we flowed the RPCs with the “1%  $\text{SF}_6$ ” mixture and the results showed that the RPC with a double oil layer performed better than the one with a single layer. After integrating a current of  $60\text{ mC/cm}^2$ , the “double oiled” RPC absorbed a dark current of about  $50\text{ }\mu\text{A}$  (see Figure 4) while the “single oiled” one reached values above  $200\text{ }\mu\text{A}$ . A test with chambers oiled thrice did not show significant improvements with respect to the twice-oiled’ one[8].

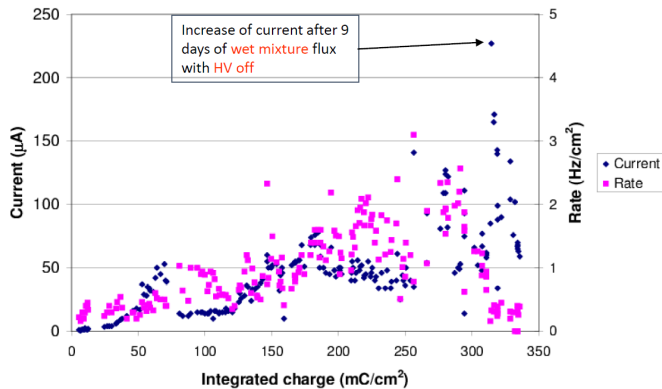
Figure 5: Dark current (lozenges, left vertical axis) and dark counting rate (squares, right vertical axis) drawn by an RPC as a function of integrated current.

The outcome of the tests reported above led us to a year-long test at GIF on an RPC with a double oil layer and flowing with 1% SF<sub>6</sub> streamer mixture, with the same setup mentioned above (with the addition of scalers to measure the dark hit rate), in order to ascertain if the RPC was able to withstand an integrated current comparable with the one required in the first 10 years of ALICE data-taking. The efficiency, measured only partially on the detector's active area, stayed at 90% until the end of the test (i.e. after 340 mC/cm<sup>2</sup>). As shown in Figure 5, the dark current remained around 50  $\mu$ A up to an integrated charge of 250 mC/cm<sup>2</sup> (with drops observed after GIF source shut-off periods) while the dark rate remained under 100 Hz/cm<sup>2</sup>. Then, the dark current started to increase while the dark rate started to decrease.

This behaviour was puzzling because, before that point, we thought the dark current was correlated to the dark hits. We decided to stop the test and study the efficiency of the RPC all over the surface with the help of the Cosmic Rays Tracking Station in the INFN Torino lab and discovered (Figure 6, left) that a large part of the detector outside the area in which we

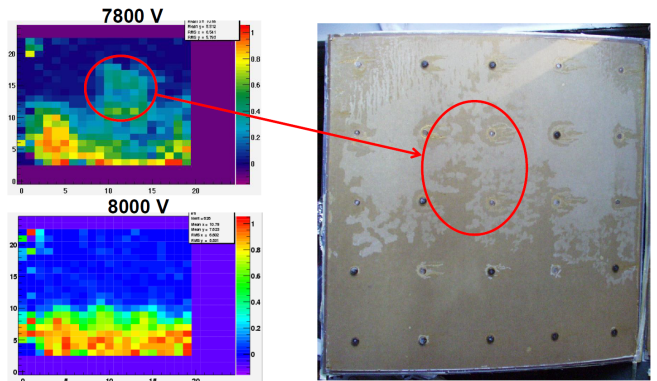
Figure 6: Top left: map of efficiency of an aged 50x50 cm<sup>2</sup> RPC working with an H.V. of 7.8 kV. Each small square represents a 2.5 x 2.5 cm<sup>2</sup> detector area. Bottom left: same as top, but with an H.V. of 8.0 kV. Right: picture of the internal surface of the aged chamber. Brighter areas are the ones where the linseed oil layer has been removed.

measured the efficiency at GIF was inefficient, and that in the inefficient zone the RPC single rate was zero: the behaviour of the detector was then similar to the one when it is filled with Argon and operated above 2.5 kV, i.e. large currents but with zero hit rate.

To understand the cause of the hypothesized electron emission, we opened the detector in order to examine the internal electrode surface and we discovered that in the inefficient zones, the linseed oil layer was no longer there (Figure 6, right). Since the oil layer's role is to smooth out the cathode surface to minimize field electron emission, it is plausible that the removal of the layer would trigger a large emission of electrons from the cathode with the consequences mentioned above. But why the linseed oil disappeared? A possible explanation was that the removal was due to the production of chemically active fragments from collisions between the fluorinated gas molecules present in the gas mixture and the avalanche electrons, which then reacted with the oil layer corroding it.

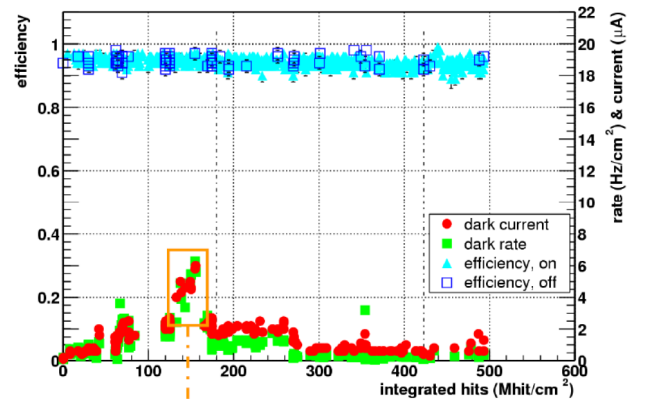
Figure 7: Efficiency (left vertical axis), dark current and dark hit rate (right vertical axis) as a function of integrated charge measured in the final ageing test in 2004-2005. The temporary increase in current and rate at 150 Mhits/cm<sup>2</sup> highlighted in the orange box was due to a failure of the refrigerator, where the water bubbler used to humidify the gas mixture was kept.

The fundamental result of the tests was the correlation of ageing to the integrated charge. In ALICE, 100 Mhits/cm<sup>2</sup>. year were expected on the RPC detectors placed in the most exposed areas. To reach this goal, a strong reduction of the charge-per-hit was necessary. To minimize the signal charge, we adopted an “avalanche-like” (i.e. strongly quenched) gas mixture made of 89.7%  $C_2H_2F_4$ , 10%  $i-C_4H_{10}$  and 0.3%  $SF_6$  (50% relative humidity). However, since our readout electronics did not include a pre-amplification stage, we could not switch to the standard avalanche mode (the signal discrimination threshold is smaller than 1 mV). We decided to set the signal discrimination threshold to 10 mV, resulting in the so-called “maxi-avalanche” operation mode [9]. To verify if a RPC could withstand years of operation in ALICE, in 2004-2005 we performed a long-ageing test at GIF on a real-size RPC ( $270 \times 70 \text{ cm}^2$ )[10]. After accumulating 500 Mhits/cm<sup>2</sup> (corresponding to 100 mC/cm<sup>2</sup>), the dark current was less than  $1 \mu A$  and the dark-hit rate was less than  $0.1 \text{ Hz/cm}^2$  (see Figure 7).

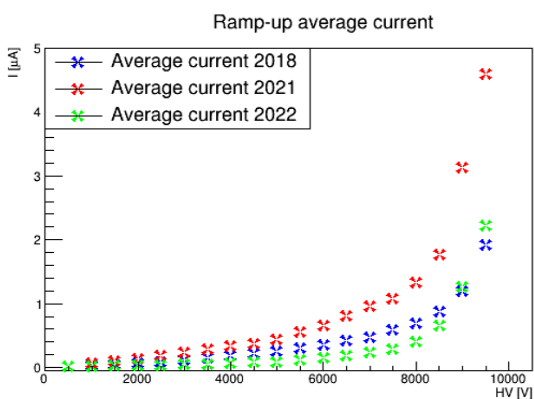
Figure 8: Average currents measured during the HV ramp up of the Muon Identifier. An increase can be noted in 2021 compared to 2018, even if the chambers were not operated during this period. After changing 10 HV cables, the average dark current at HV working point decreased from ~5µA to ~2µA

0.3% SF<sub>6</sub> and a detection threshold of 7 mV, in order to reduce as much as possible the charge per hit. In this configuration, the RPCs have been operating successfully since 2010. The most exposed detectors cumulated an integrated charge of ~20 mC/cm<sup>2</sup>. The efficiency has been constantly above 95% all over the detector area. The main ageing issue has been due to the Polycarbonate gas outlets: some (about 10%) broke and had to be replaced. In one case, a chamber had to be replaced because of an extended leak, probably due to bad gluing. Another issue was discovered in 2021 after the second LHC Long Shutdown (2018-2021). It was found that in some detectors, the dark currents were higher than at the beginning of the shutdown, despite the RPCs not being operated at all. The cause was in some HV cables and/or connectors leaking a small amount of current due to bad insulation. These cables were replaced during the 2021-2022 winter shutdown. In Figure 8 the average dark currents measured during ramp-up before and after the replacement of cables are shown.
