A Thought of Wrapping Space Shuttle External Tank with Ceramic Fiber Fishnet Stockings

Sun Hong Rhie

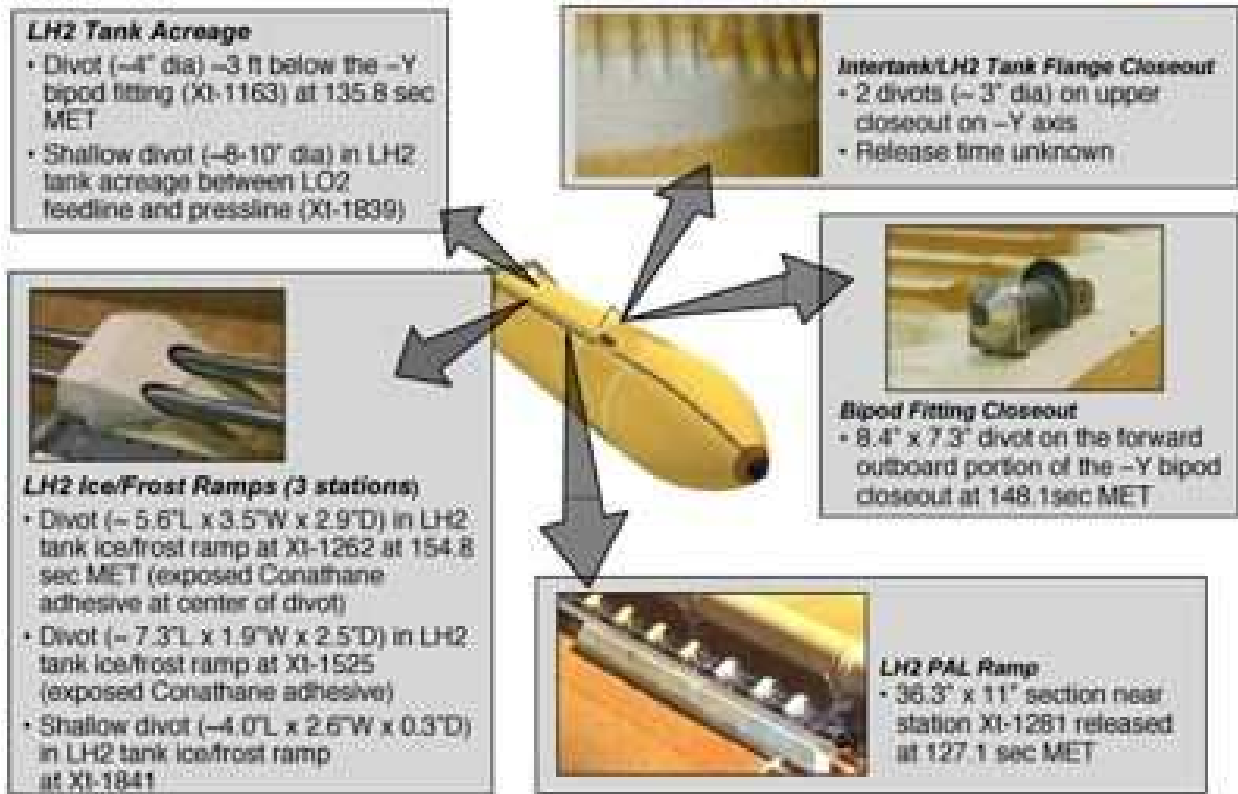
Foam Loss Locations

Fig. 1.— Foam loss locations on STS-114 external fuel tank publicly released by NASA: <http://www.nasa.gov> or <http://www.spaceflightnow.com>.

While HST customers were crossing their fingers, the STS-114 camera system exhibited a spectacular scene of a top-hat shape 0.9lbs insulation foam flying off the external tank. The public release of the foam loss locations by NASA shown in Fig. 1 read as follows.

1. LH2 PAL ramp: $36.3'' \times 11''$ section near station Xt-1281 released at 127.1 sec MET;
2. $8.4'' \times 7.3''$ divot on the forward outboard portion of the $-Y$ bipod closeout at 148.1 sec MET;

3. Divot ($\sim 5.6'' L \times 3.5'' W \times 2.9'' D$) in LH2 tank ice/frost ramp at Xt-1262 at 154.8 sec MET (exposed Conathane adhesive at center of divot);
4. Divot ($\sim 7.3'' L \times 1.9'' W \times 2.5'' D$) in LH2 tank ice/frost ramp at Xt-1525 (exposed Conathane adhesive);
5. Shallow divot ($\sim 4.0'' L \times 2.6'' W \times 0.3'' D$) in LH2 tank ice/frost ramp at Xt-1841;
6. Divot ($\sim 4''$ dia) \sim 3ft below the -Y bipod fitting (Xt-1163) at 135.8 sec MET;
7. Shallow divot ($\sim 8'' - 10''$ dia) in LH2 tank acreage between LO2 feedline and pressline (Xt-1839);
8. 2 divots ($\sim 3''$ dia) on upper intertank/LH2 tank flange closeout on -Y axis (release time unknown).

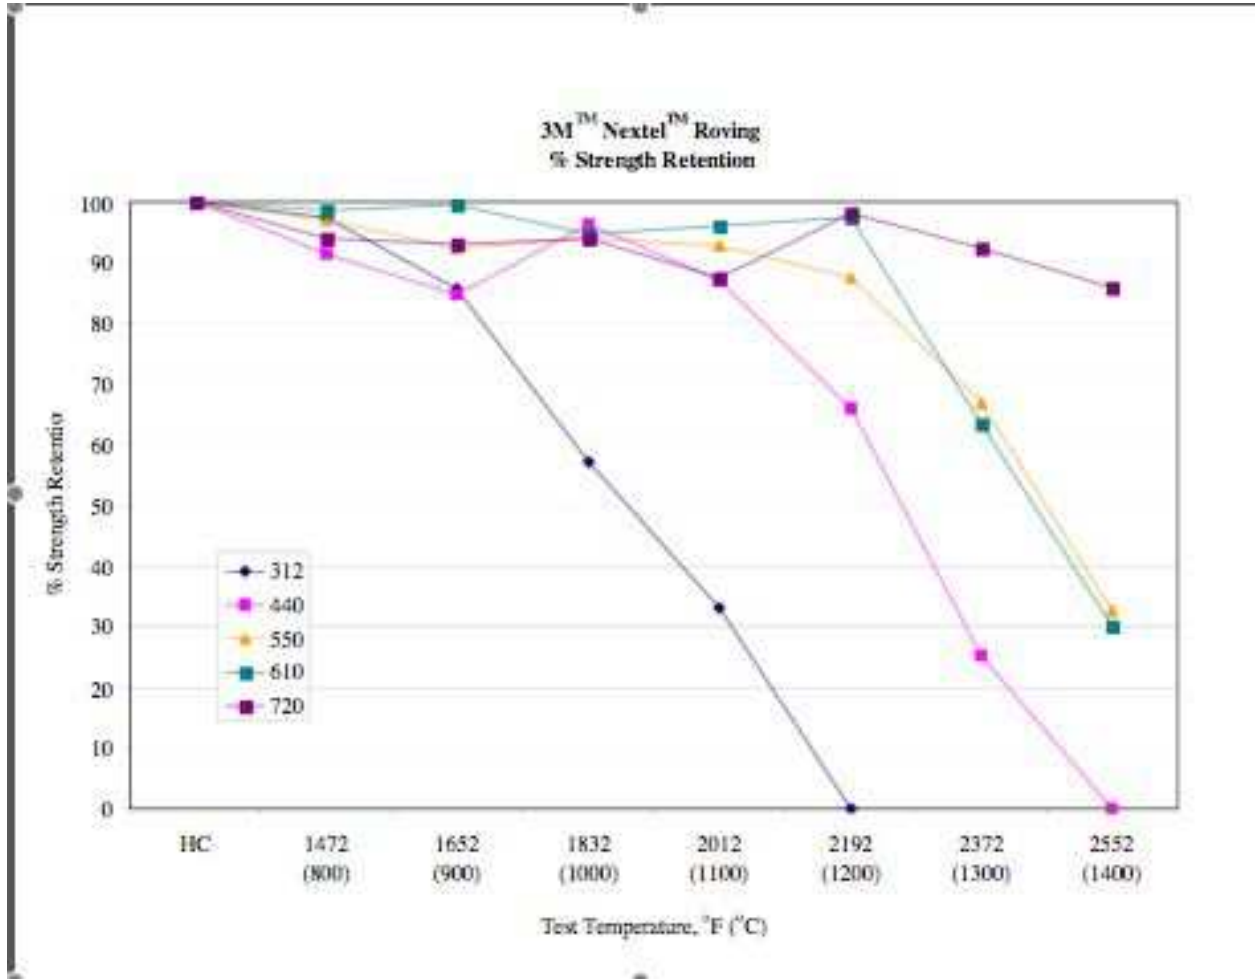
Fig. 2.— 3M Nextel 720 tow shows relatively high stability in high temperatures. Fiber 610 shows sudden drop in strength at 1200°C . (The figure is from 3MTTN.)

Figure 2 shows the stable strength of fiber 720 tow in high temperatures. (3M Nextel oxide fiber tows come in fiber counts of 400 or 750.) Figures 3 and 4 show the single fiber tensile strengths of the fibers 610 and 720 in room temperature and high temperatures where the high temperature heatings lasted about 90 seconds. (Note that the maximum aerodynamic friction and heating occurs around 80 seconds after the launch.) The fiber 610 is stronger at room temperature, but fiber 720 is preferred because of the stability of the strength in high temperatures. Comparison of figures 2 and 4 shows that the fiber 720 tow performs better than single fiber at higher temperatures ($> 1150^\circ\text{C}$) consistently with the report by DY.

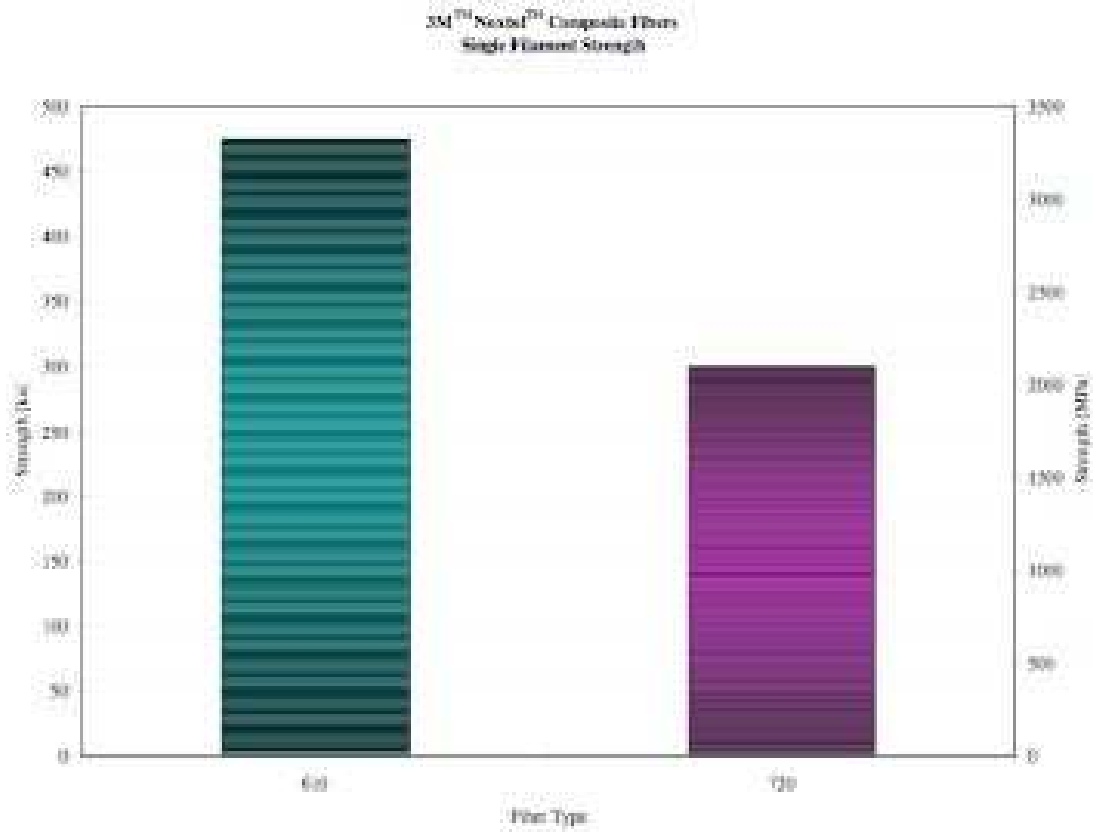
Outline of Test:
Sample Number: 10
Gage Length: 1 inch (25.4 mm)
Extension Rate: 0.2 inch/min (5.1 mm/min)

Fig. 3.— Room temperature single fiber tensile strengths of fiber 610 and fiber 720. (The figure is from 3MTTN.)

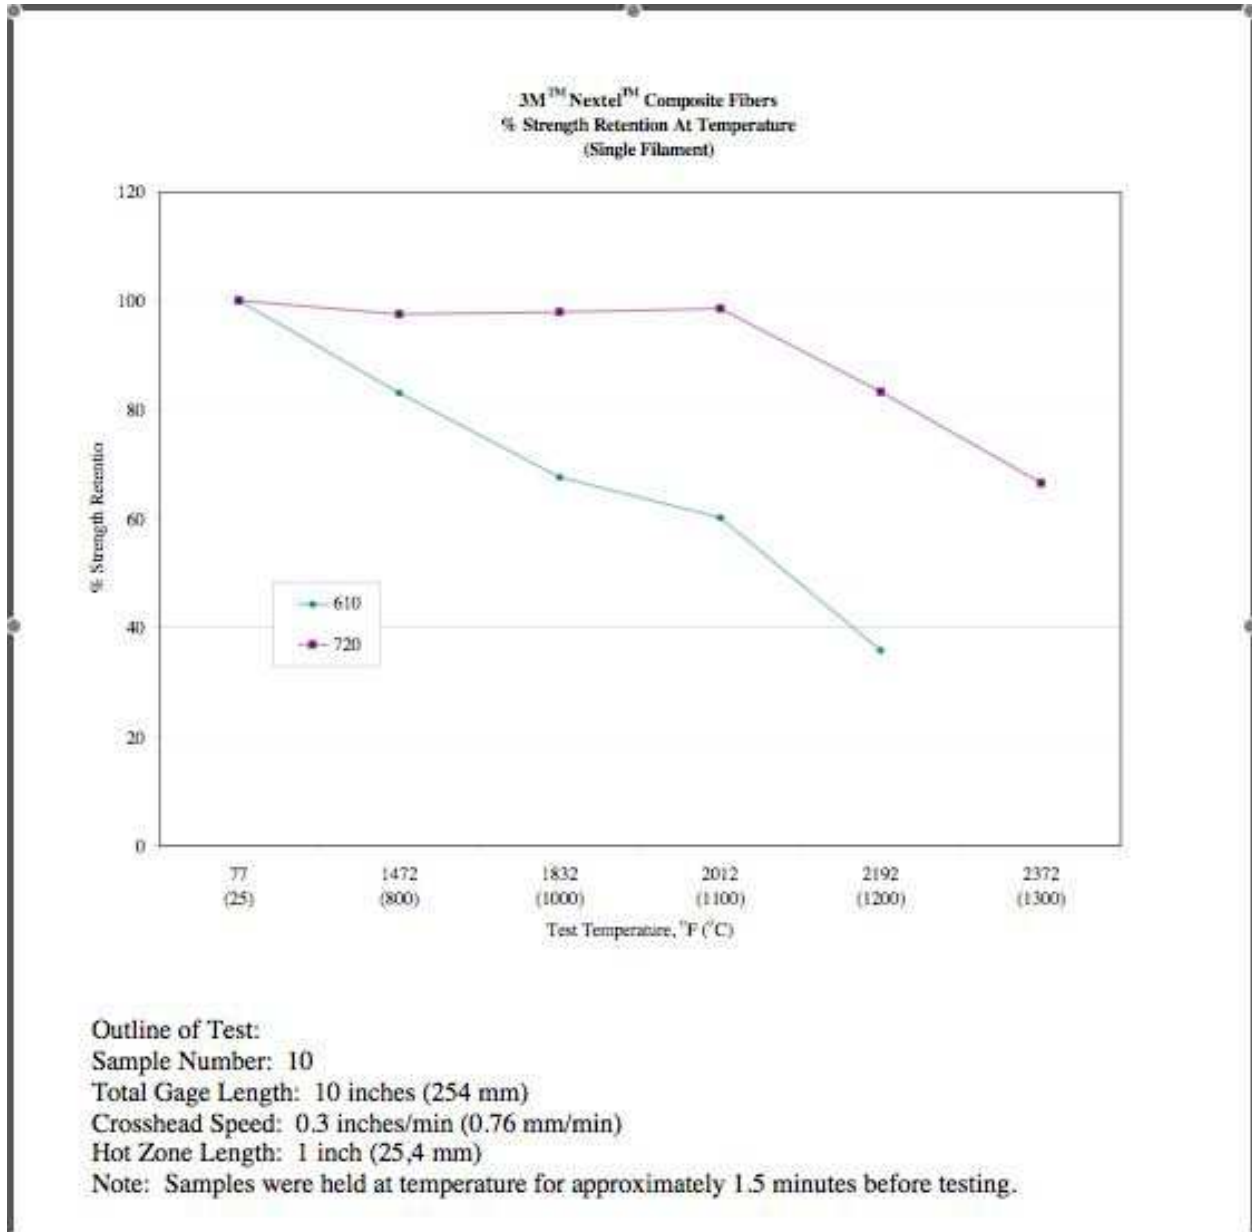
Fig. 4.— Fiber 720 shows a relatively stable strength at high temperature heating for $\sim 90sec$. The maximum aerodynamic heating of the external tank occurs at $\sim 80sec$ after the launch. (The figure is from 3MTTN.)

The concern of foam shedding is on the area where the aerodynamic stress is high, and the design requirement⁸ of the temperature tolerance due to aerodynamic heating is 1200°C . Within the temperature range, fiber 720 shows excellent strength behavior and also very slight difference in the strengths between a tow and an average single fiber. The temperature tolerance requirements for the areas with heating from solid rocket booster and from main engine are very high with 1650°C and 3300°C . Foam shedding or ablation from those areas (aft dome and lower part of the acreage) is not a concern in regard to the potential damage to the thermal protection systems (TPS), and reinforcement fibers should not be used to avoid generating unnecessary potential hazard of loose fiber fragments or melts.
