Effect of Deck Deterioration on Overall System Behavior, Resilience and Remaining Life of Composite Steel Girder Bridges

Amir Gheitasi¹ and Devin K. Harris²

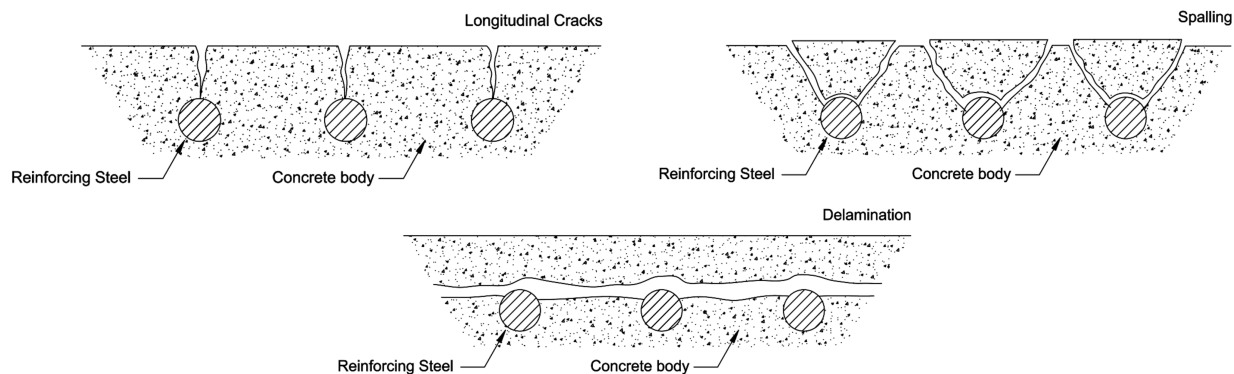
Figure 1. Possible damage scenarios as a result of rebar corrosion.

Delamination usually occurs as a result of separation in the concrete layers parallel and close to the surface at or near the outermost layer of reinforcing rebars (ACI 2003). Separation of the concrete layer happens when corrosion induced cracks in the vicinity of adjacent rebars join together to form a fracture plane. With a random and irregular pattern, delamination is

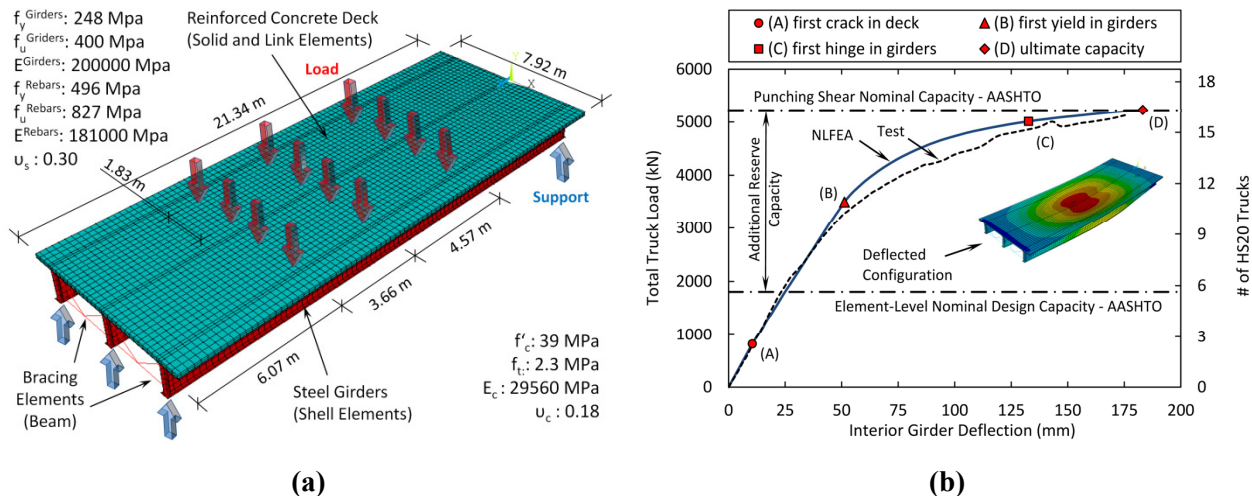
Figure 2: Nebraska laboratory test: (a) FE model development, (b) model validation

Interior girder deflection at mid-span of the bridge was used to validate the proposed numerical model. As illustrated in Figure 2b, results obtained via non-linear FE analysis correlate well with experimental outcome within the elastic range of the behavior (up to 3500 kN of the applied loads). As the bridge system behaves in a non-linear fashion, numerical and experimental results start to deviate with maximum error of 8%. With further application of the loads, the numerical model again begins to mimic the experimental data. Based on the validated numerical analysis, the general behavior of investigated bridge was classified into four different stages (see Figure 2b). The bridge system behaves linearly elastic prior to the formation of first flexural cracks in the concrete deck (stage A). Beyond first cracking point, it continues to carry

more loads until plasticity initiates in steel girders (stage B). With further increment in the external loading, the structural stiffness drops off significantly and plastic hinges are formed in steel girders at the location of maximum moment (stage C).

The laboratory experiment on this bridge model was terminated due to punching shear failure occurred under one of the patch loadings. In FE analysis, the model was loaded until it reached to the level of nominal punching shear capacity calculated based on AASHTO specifications (stage D). The ultimate load capacity and the corresponding maximum deflection predicted by the FE model were 5235 kN and 183.2 mm, respectively, as opposed to the corresponding experimental values of 5124.3 kN and 175.3 mm. In addition, Figure 3b demonstrates that the bridge system provides a significant amount of additional reserve capacity over the theoretical nominal design capacity based on AASHTO LRFD (2012) design methodology. This would validate the existence of a high level of redundancy in the system; which cannot be predicted based on the element-level design behavior of the bridge superstructure.

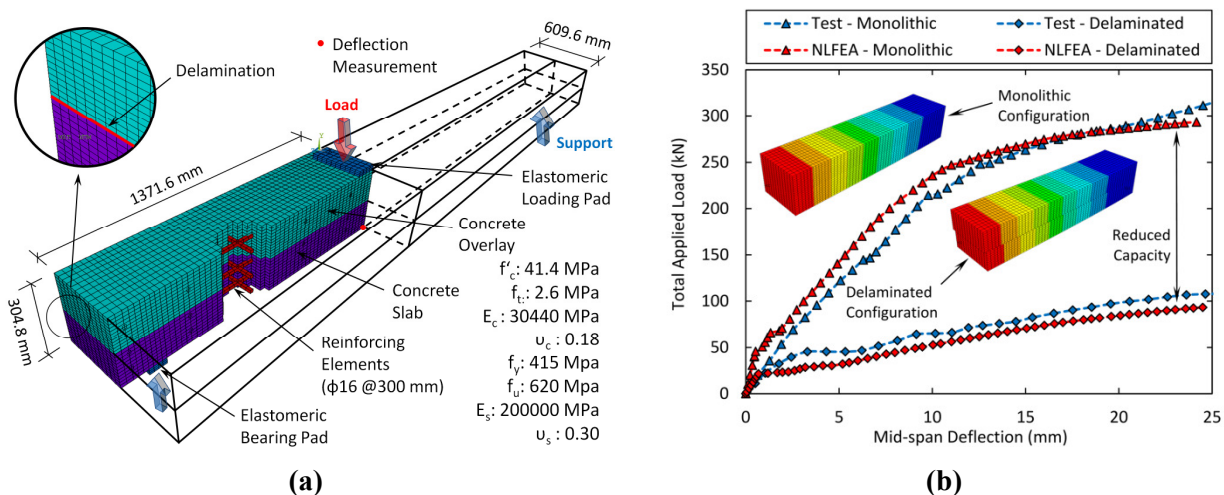
Figure 3: Delaminated reinforced concrete slab: (a) FE model development, (b) model validation

upper bound or the worst case scenario of the magnitude of delamination that could exist in concrete decks. Figure 3a illustrates the geometrical configurations of selected slab panel. In the test setup, this slab was supported by polished and greased steel slip plates to allow horizontal translation and elastomeric bearing pads to allow rotation. A concentrated load was applied at the center of the span through a MTS actuator reacted against a structural steel load frame.

The load-deflection behavior at the mid-span of the simulated slabs were derived from the non-linear FE analysis and compared to the corresponding experimental result (Seible 1998) for validation purposes. Figure 3b illustrates this comparison for both the intact and deteriorated numerical models. The observed discrepancies exist between the results can be mainly attributed to the unknown material properties of the elastomeric loading pads used in the experiment. Despite the relevant numerical errors, the proposed FE models were able to predict the general non-linear behavior of both intact and damaged configurations. Moreover, comparing the results of intact and damaged models demonstrated the influence of delamination mechanism in reducing the load-carrying capacity of these slab members. This would indicate that the

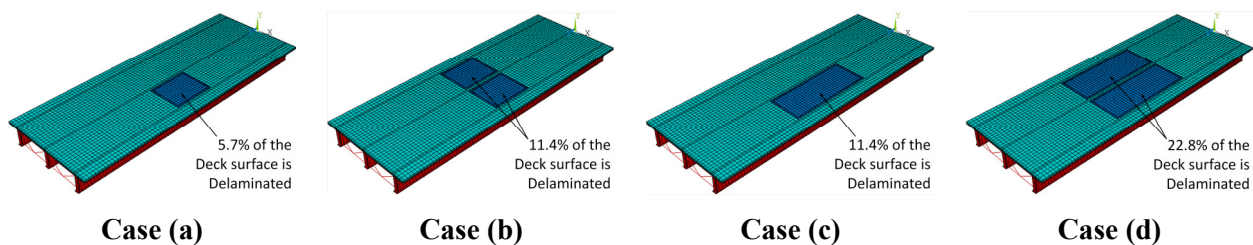
Figure 4: Integrated damage scenarios (subsurface delamination)

The validated damage modeling approach that has been used to simulate the subsurface delamination in concrete slabs can be integrated into the calibrated numerical model of the intact bridge system to identify the effect of this damage mechanism on the system-level behavior. Four different cases of delamination with respect to their level of propagation were considered in this study to update the bridge model. According to historical inspection data, delaminations in concrete decks do not usually occur in concentrated areas, but instead they are distributed randomly across the bridge deck surface area and typically occur at or above the upper layers of reinforcement. In this study, however, the delaminated area shapes and extents were assumed and positioned near midspan to induce a worst case damage configuration at this location in the simulated bridge model. As depicted in Figure 4, the assumed delaminated areas cover almost 6% to 23% of the total concrete slab area. In all cases, it was assumed that the delamination occurred at the depth of 76.2 mm (3 in.) from the top surface of the slab, as a result of corrosion in the top layer of the deck reinforcement. The fracture plane was modeled with a coupled symmetric contact elements. Only compressive stresses can be transferred towards the cracked surface, while the shear and tensile resistance at the plane of fracture have been released.

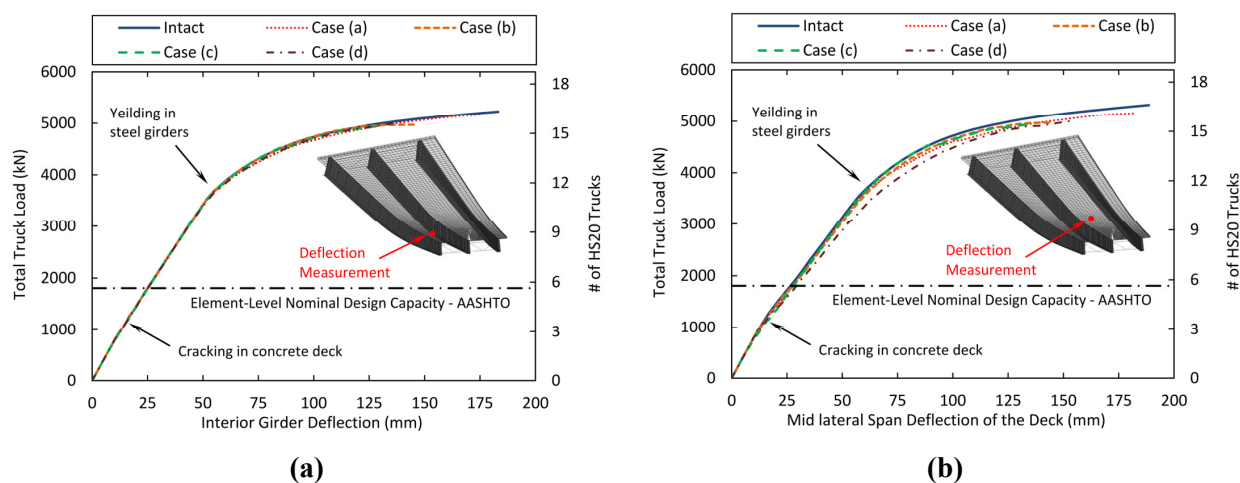
Figure 5: Impact of damage on system-level behavior: (a) girder deflection (b) deck deflection

Under the same loading and boundary conditions applied to the intact bridge system, the updated models were numerically analyzed to evaluate the effect of integrated damage mechanisms on the system-level behavior. Figure 5a illustrates the variations in the system-level response based on the deflection of the interior girder at mid-span of the structure. It is clear that the assumed damage configurations have negligible effects on the overall behavior and ultimate capacity of the system. In addition, the load-deflection response of the system was captured at the bottom surface of the concrete slab at the mid lateral span between the girders, see Figure 5b. Despite the local effects of the assumed damage scenarios on the deck behavior, the overall response of the deck also highlights the minor impacts of subsurface delamination on the system-level performance and maximum capacity.

As shown, all the numerical models including the intact system, demonstrated additional reserve capacity over the AASHTO LRFD element-level nominal design capacity, which would indicate the high level of system redundancy even in the presence of simulated damage mechanisms. This inherent redundancy can be attributed to the complex interaction between structural members in this type of bridge superstructures. Moreover, the behavioral stages and performance characteristics of the system, including the formation of the flexural cracks in the concrete slab and initiation of the material yielding in steel girders, appear to be unchanged for the updated models with the integrated damage scenarios. With the limited level of impact, it can be concluded that the delamination type of damage has a minimal effect on the system resiliency and remaining service life of the composite steel girder bridges. However, the assumed damage scenarios reduced the ductility of the system (ratio of maximum deflection to deflection at the first yield in girders) at the high levels of material non-linearity, due to localized failure mechanisms (concrete crushing) on the top surface of the deck in the vicinity of the delaminated regions.

Comparing Figures 5a and 5b demonstrates the fact that the overall behavior of the bridge system is highly governed by the behavior of the main load-carrying elements (i.e. girders), while the concrete deck solely distributes the lateral loads among the girders. In order to investigate the effect of subsurface delamination on the lateral load distribution mechanism in the bridge system, the principal stress vectors at the mid-span of the structure were derived from the numerical analysis for the intact and a representative damaged system (case b), and plotted in Figure 6. As demonstrated, the stress vectors in both cases have the high intensity on the top layer of the concrete slab as well as in the surrounding area of the girders, while they have a low intensity at the bottom layer of the deck between girders. This would indicate the existence of an arching action that governs the lateral load distribution mechanism in the slab on girder bridges. Moreover, the integrated damage scenario has no major effects on the load distributing mechanism of the deck system. This can be attributed to the fact that the fracture plane under the applied external loadings is subjected to compressive stresses, which are able to be fully transferred among the implemented contact elements.

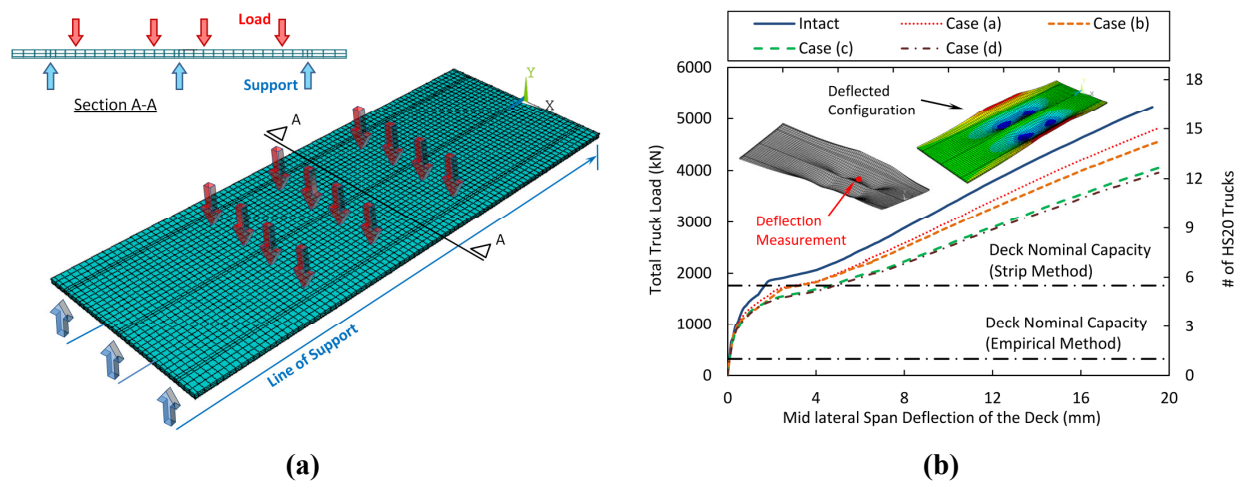
Figure 7: Concrete deck design capacity: (a) model development, (b) influence of damage

The last part of this study focuses on the impact of delamination on the deck behavior itself and the correlation of this impact to the nominal design capacities of the deck system based on the current design methodologies. According to the AASHTO LRFD (2012), the concrete decks can be designed using either Empirical or Traditional (Strip) method. In these methods, the lateral loads are assumed to be transferred among girders via arching action or flexural behavior of the deck, respectively. From the design perspective, it is assumed that the slab is vertically supported at the location of the girders, which would neglect the deflection of girders along the length of the structure. In order to address this main design assumption, the steel girders were extracted from the developed numerical models with intact and damaged configurations. Instead of girders, the slabs were supported at the location of girders through the length of structure (see Figure 7a). Under the same loading configuration, the developed models were analyzed. The load-deflection curves were derived at the mid lateral span of the deck and plotted in Figure 7b. As illustrated, the capacity of the deck decreased consistently with the expansion of the delaminated area. Regardless of the design methodology, it is clear that the actual capacity of the deck system is higher than the assumed nominal design capacities. This can be attributed to the plate action of the deck in transferring loads to the longitudinal supports and the post-cracking behavior of concrete material, which are not considered in the current design practices.
