# Operational Experience with the CMS Pixel Detector

**János Karacsi**<sup>a,b</sup> on behalf of the CMS Collaboration

**ABSTRACT:** In the first LHC running period the CMS-pixel detector had to face various operational challenges and had to adapt to the rapidly changing beam conditions. In order to maximize the physics potential and the quality of the data, online and offline calibrations were performed on a regular basis. The detector performed excellently with an average hit efficiency above 99% for all layers and disks. In this contribution the operational challenges of the silicon pixel detector in the first LHC run and the current long shutdown are summarized and the expectations for 2015 are discussed.

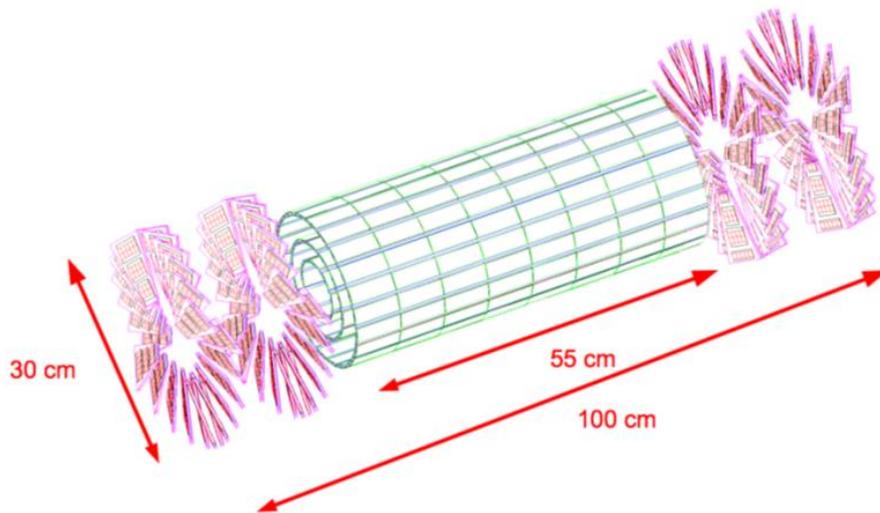
**Figure 1.** Schematic view of the CMS Silicon Pixel detector. The interaction point is surrounded by three cylindrical barrel layers at radii of 4.4, 7.3 and 10.2 cm and two endcap disks on each side with modules between 6 and 15 cm from the beam axis.

The sensors consist of high dose n-implants inserted into a high resistance n-substrate with rectifying pn-junctions on their backside, and are connected with readout chips (ROCs) by indium bump-bonds. The total number of pixels is approximately 66 million, each with a cell size of  $100 \times 150 \mu\text{m}^2$ . There are all together 15840 ROCs located on three barrel layers and two endcap disks (Fig. 1).

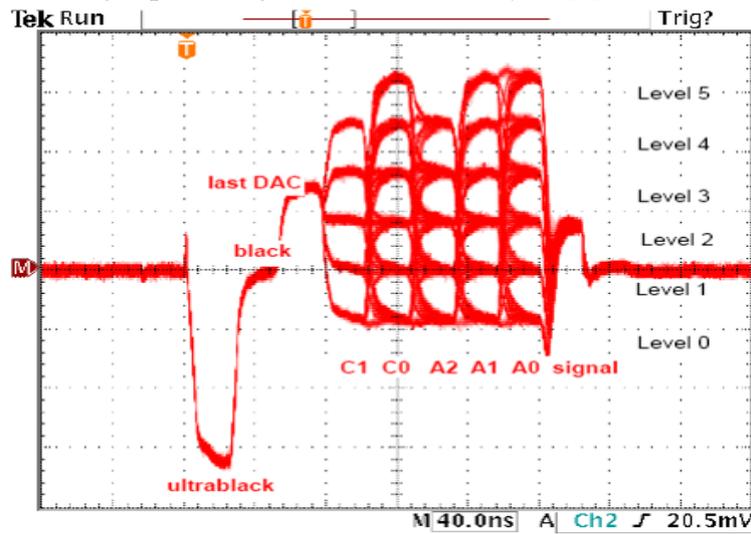
**Figure 2:** Oscilloscope view of the analogue signal for a pixel hit.

In the commissioning period and throughout running the different components of the detector need to be calibrated in order to ensure fully efficient and reliable data collection. The analogue signal (Fig. 2) consists of data packets that contain the information about each pixel hit. The pixel coordinates are encoded by using a six-level address scheme, while the charge information is contained in the analogue pulse height of the last clock cycle [4].

The offset of the optical receiver in the Front End Driver (FED) needs to be set such that the baseline level of the converted analogue signal is at the middle of the ADC range. This calibration is sensitive to temperature changes and needs to be done frequently, but small adjustments are done automatically to correct for small fluctuations. The address level calibration, which is usually done after the baselines are set, ensures that the ADC values corresponding to each address level are well separated and pixel coordinates can be decoded correctly.

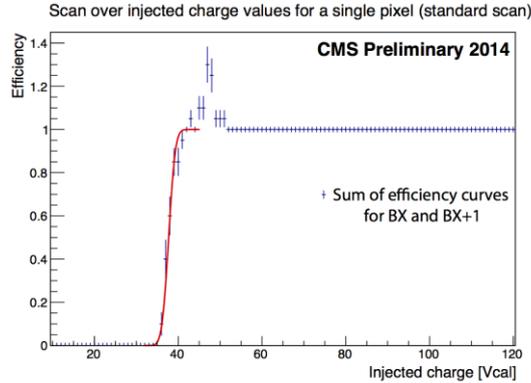
**Figure 3:** Sum of in- and out-of-time charge collection efficiencies as a function of injected charge.

Another set of calibrations needs to be done every few months due to the aging of the detector. One of them is the threshold calibration for which electric charges are injected through a circuit on the readout chip and the efficiency is measured. A scan is done for each pixel in units of  $V_{cal}$  which corresponds to 65.5 electrons. The efficiency is measured and the threshold is derived

from a fitted turn-on curve (Fig 3). The measurement [5] is then repeated in an iterative way for various ROC threshold settings in order to minimise the thresholds.

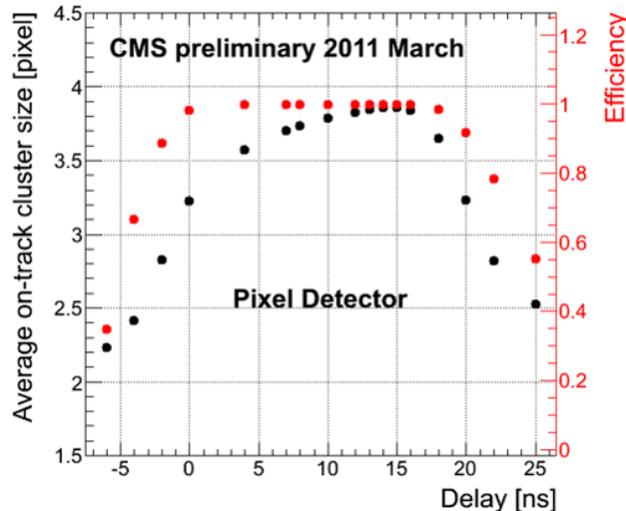
**Figure 4:** Average cluster size and hit efficiency vs. time delay with respect to the LHC clock.

Usually once per year, at the beginning of data taking the timing calibration of the detector is done in which the pixel detector clock is synchronized with the LHC collisions. A scan is done for various settings of the relative phase delay with respect to the LHC clock. A delay is chosen which ensures the collection of both the high pixel charges and giving enough time for most of the smaller charge pulses to cross the readout threshold in the same 25ns readout window. The goal is to maximise both the hit- and the charge collection efficiency (Fig. 4) and to allow the usage of smaller thresholds which then improves the hit resolution. Therefore a point is chosen near the end of the efficiency plateau.

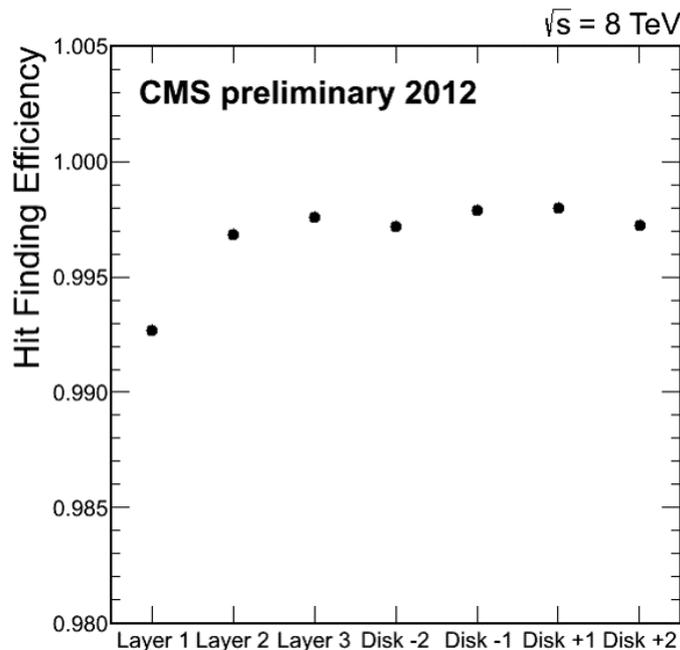
*Figure 5: The average hit efficiency for all barrel layers and endcap disks in 2012.*

The hit efficiency is an important parameter to monitor throughout data taking. It is defined as the probability to find a cluster along a charged particle trajectory. Nonfunctioning modules or those that were affected by a single event upset are excluded from the measurement. The method is explained in more detail in [6]. In 2012 the average efficiency of the detector was above 99% for all layers and disks (Fig. 5). Compared to the outer part of the detector, the innermost layer, which is affected by a larger particle flux, experienced a larger efficiency loss. This is an expected behavior, due to the limited buffer size in the current readout chip [7].
