# Layer-by-Layer Dielectric Breakdown of Hexagonal Boron Nitride

**ABSTRACT:** Hexagonal boron nitride (BN) is widely used as a substrate and gate insulator for two-dimensional (2D) electronic devices. The studies on insulating properties and electrical reliability of BN itself, however, are quite limited. Here, we report a systematic investigation of the dielectric breakdown characteristics of BN using conductive atomic force microscopy. The electric field strength was found to be  $\sim 12$  MV/cm, which is comparable to that of conventional SiO<sub>2</sub> oxides because of the covalent bonding nature of BN. After the hard dielectric breakdown, the BN fractured like a flower into equilateral triangle fragments. However, when the applied voltage was terminated precisely in the middle of the dielectric breakdown, the formation of a hole that did not penetrate to the bottom metal electrode was clearly observed. Subsequent  $I$ - $V$  measurements of the hole indicated that the BN layer remaining in the hole was still electrically inactive. Based on these observations, layer-by-layer breakdown was confirmed for BN with regard to both physical fracture and electrical breakdown. More

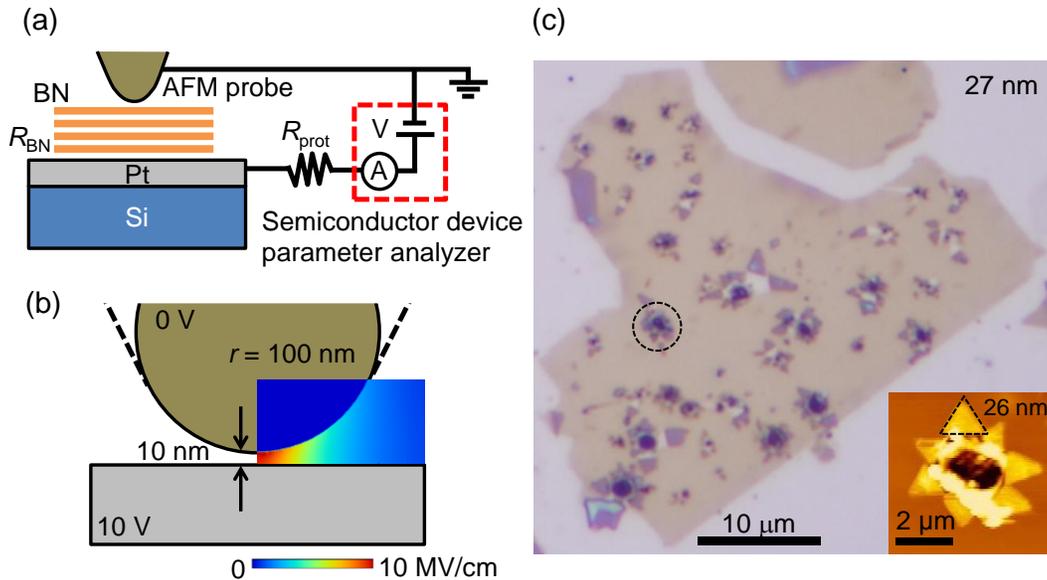
**Figure 1:** (a) Schematic diagram of the measurement setup using the C-AFM system. (b) Intensity profile of the electric field around the AFM probe with a 10-V bias applied. (c) Optical microscopy image of a 27-nm-thick BN flake after a series of breakdown tests. One of the fractured areas is highlighted with the broken circle. The inset presents a typical AFM topographical image of a fractured fragment.

In this study, high-quality BN grown using a temperature-gradient method under a high-pressure and high-temperature atmosphere<sup>5</sup> was used to obtain reliable data. Although other growth techniques are available,<sup>18,26–28</sup> their quality still requires improvement. The BN was transferred to a silicon wafer coated with a 50-nm layer of platinum using the mechanical exfoliation technique. A schematic diagram of the experimental setup is presented in **Figure 1a**. A

**Figure 1b** illustrates the electric field around the AFM tip, which was calculated using a simplified model (details provided in

Supplemental **Figure S1**). The area of  $\sim 40$  nm in diameter below the AFM tip can be treated approximately as a parallel-plate electrode, which is consistent with a previous estimation.<sup>30</sup> It is well known that the surface of SiO<sub>2</sub> is modified during a C-AFM measurement because of the electrochemical reactions catalyzed by the adsorbed water resulting from anodic oxidation.<sup>29,31,32</sup> It is, however, expected that the effect of adsorbed water on electrical measurements may be negligible for BN because BN is hydrophobic<sup>17</sup> and resistant to oxidation.<sup>16</sup> Indeed, our supplemental experiment revealed no evidence of surface modification in BN, unlike SiO<sub>2</sub>/Si (details provided in Supplemental **Figure S2**).

$I$ - $V$  measurements of local areas (*i.e.*, breakdown tests) were performed repeatedly on different areas of the same BN flake. **Figure 1c** presents an optical microscopy image of a BN flake with a 27-nm thickness after the breakdown test. The dielectric breakdown led to the

catastrophic fracture of the BN. The mechanical stress that was abruptly released during the breakdown event resulted in fracture propagation. The fractured fragments often exhibited equilateral triangular shapes, especially for thick BN flakes, as shown in the inset of **Figure 1c**. The thickness of the triangular fragments was equal to that of the original flake. This observation strongly suggests that the preferred fracture directions could be armchair and/or zigzag directions, as expected from the hexagonal lattice structure of BN.<sup>33,34</sup> These unique breakdowns can be also seen in the negative bias voltage stress.

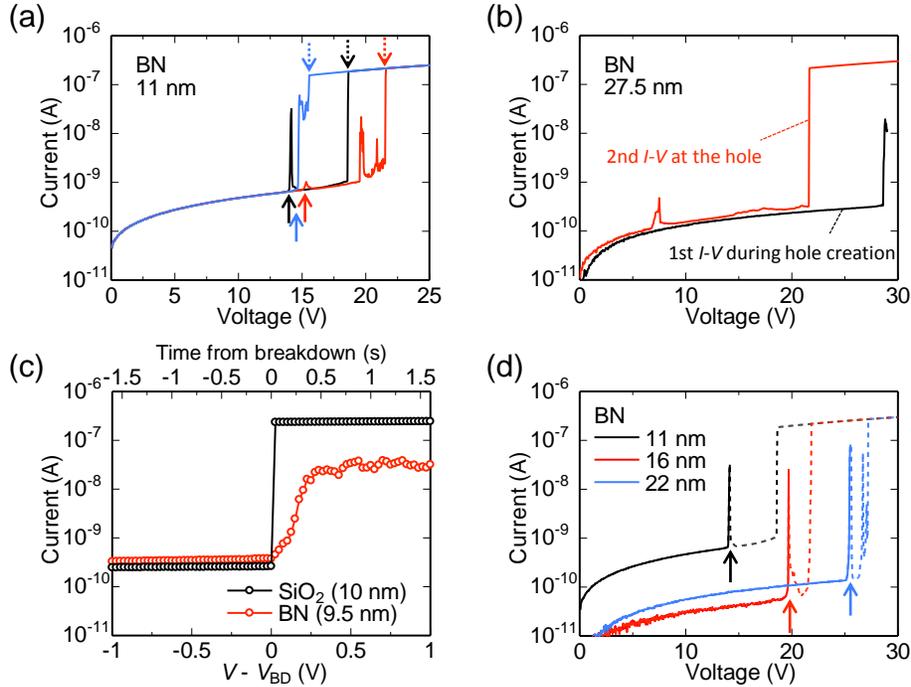
**Figure 2:** (a) Three  $I$ - $V$  curves for the same BN flake with a thickness of 11 nm. The solid and dotted arrows indicate the  $V_{BD}$  values and the short-circuit voltages, respectively. (b)  $I$ - $V$  curves for a fresh BN flake (first  $I$ - $V$  curve) and the BN layers remaining under the hole formed during the first measurement (second  $I$ - $V$  curve). (c) Comparison of  $I$ - $V$  curves for SiO<sub>2</sub> and BN, where the transverse axis represents  $V - V_{BD}$ . The voltage step, ramping rate, and integral time for both experiments were 0.025 V, 0.63 V/s and 20 ms, respectively. (d)  $I$ - $V$  curves for BN samples with different thicknesses. The current curves after the initial peaks are represented by dotted lines because they do not represent the dielectric breakdown of BN samples.

**Figure 2a** presents three sets of  $I$ - $V$  curves for the same BN flake with a thickness of 11 nm. The current increased smoothly with increasing voltage up to approximately 15 V and then increased suddenly at the voltages indicated by solid arrows. In most cases, the current decreased again within a short time, forming sharp peaks. Then, the current fluctuated randomly until the conduction path had completely formed between the two electrodes,

where the current was controlled by  $R_{\text{prot}}$ . This variation in the voltages, indicated by the dotted arrows, was clearly larger than the initial rapid increases in voltage (solid arrows). This finding suggests that the dielectric breakdown character of BN is reflected in these initial rapid increases.

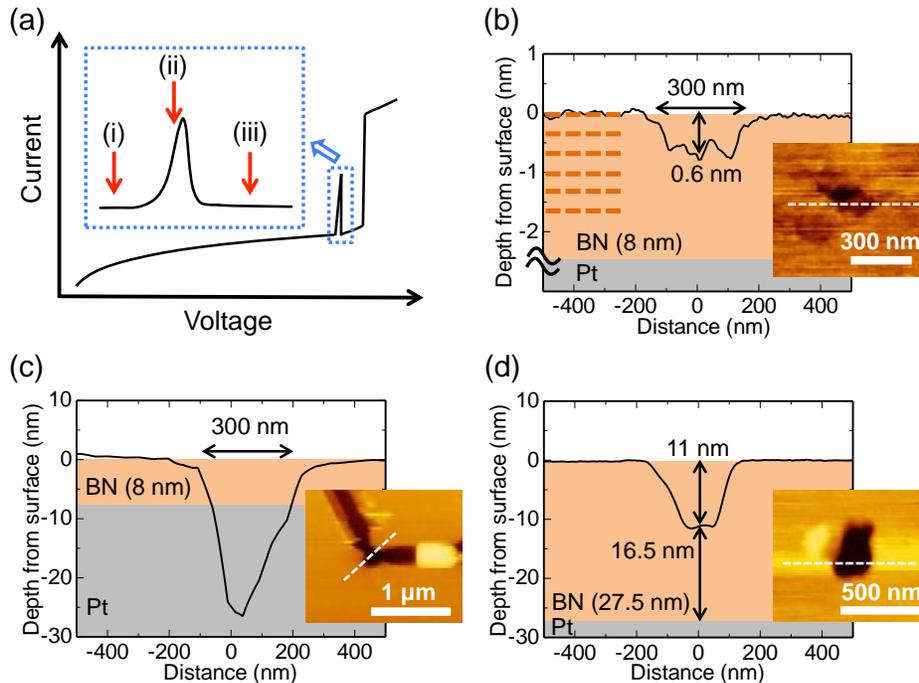
**Figure 3:** (a) Schematic representation of the  $I$ - $V$  curve for BN. The applied voltage was intentionally terminated at three different points, (i-iii). (b),(c) Height profiles and AFM topographical images for BN breakdown terminated at (ii) and (iii), respectively. (d) Height profile and AFM topographical image for thicker BN. Although the AFM topographical image was acquired again using an AFM tip with a smaller radius of  $\sim 10$  nm, the hole shape did not change. Additionally, no additional small hole was detected within the fractured large hole, suggesting that the BN was not completely physically penetrated.

These initial points of rapid increase were investigated in detail. A simplified  $I$ - $V$  curve is illustrated in **Figure 3a**. To observe the topographical changes before and after the initial rapid increase, the applied voltage was intentionally terminated at three different target points. Because the time duration of the initial current increase was relatively long, the voltage could be successfully terminated at the target points. Although there was no detectable change in the AFM topographical image at (i), the formation of a hole with a diameter of  $\sim 300$  nm and a depth of  $\sim 0.6$  nm was observed on the BN surface at (ii), as shown in **Figure 3b**. The hole did not reach the bottom Pt electrode at (ii), but the subsequent catastrophic fracture resulted in a large hole at (iii), as shown in **Figure 3c**. The AFM topographical

image revealed that both the Pt coating and the BN flake were broken, which was confirmed by the detection of the Si wafer underneath the Pt coating in Raman measurements (details provided in Supplemental **Figure S3**).

Now, our greatest interest is in whether the remaining BN layers beneath the hole are still electrically inactive. In the case of thicker BN, the fracturing could be more easily stopped in the middle of the BN, as shown in **Figure 3d**. After the AFM tip was adjusted to precisely the center of the hole,  $I$ - $V$  measurements were performed, and the results are presented in **Figure 2b**. In the low-voltage region, the current was slightly higher than that measured in the first  $I$ - $V$  curve corresponding to the creation of the hole, but the difference was minimal. Then, a peak appeared, suggesting the onset of dielectric breakdown. Therefore, it was clear that the remaining BN layers beneath the hole had not yet broken down electrically.

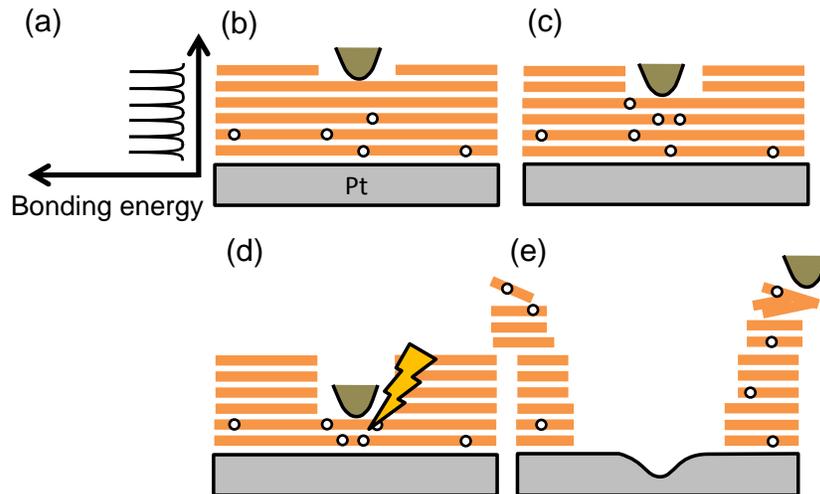
**Figure 4:** A series of schematic illustrations of the layer-by-layer breakdown process. (a) Bonding energy along the direction vertical to the layer surface. The breakdown begins in the top layer (b) and proceeds layer by layer (c). The enhancement of the electric field caused by the thickness reduction (d) induces sudden catastrophic fracture (e). Irreversible defects are drawn as open circles.

**Figure 4** presents a series of schematic illustrations of the breakdown process. The bonding energy along the direction vertical to the BN surface will vary periodically because of  $sp^2$  covalent bonds in the layer and van der Waals bonds in the interlayer, as shown in **Figure 4a**. The breakdown begins in the top layer because of its 2D nature and proceeds layer by layer toward the bottom Pt electrode, as shown in **Figures 4b** and **4c**, respectively. Then, the decrease in the BN thickness beneath the AFM tip enhances the electric field, resulting in sudden catastrophic fracture (**Figure 4d**). The AFM tip is often lifted up into the neighboring region because of the resulting mechanical shock, as shown in **Figure 4e**. This causes the current to decrease sharply, which leads to the formation of the initial sharp peaks observed in **Figures 2a** and **3a**. In fact, when an AFM image was acquired after breakdown, the position of the image was sometimes shifted by a few micrometers with respect to the original image, where the displacement of the tip was larger than the usual drift. Finally, similar behavior repeats until complete conduction is achieved between the two electrodes. Therefore, the initial peak indicates the dielectric breakdown, and the complete conduction observed later is an artificial effect. Hereafter, the voltage corresponding to the onset

that for a fresh BN flake with the same thickness ( $V_{BD} = \sim 20$  V for  $\sim 16.5$  nm) because of the irreversible defect formation in the remaining BN layer under the hole. Thus, it was concluded that irreversible defects must form immediately just prior to dielectric breakdown. Therefore, these irreversible defects are schematically drawn as open circles in **Figure 4**.

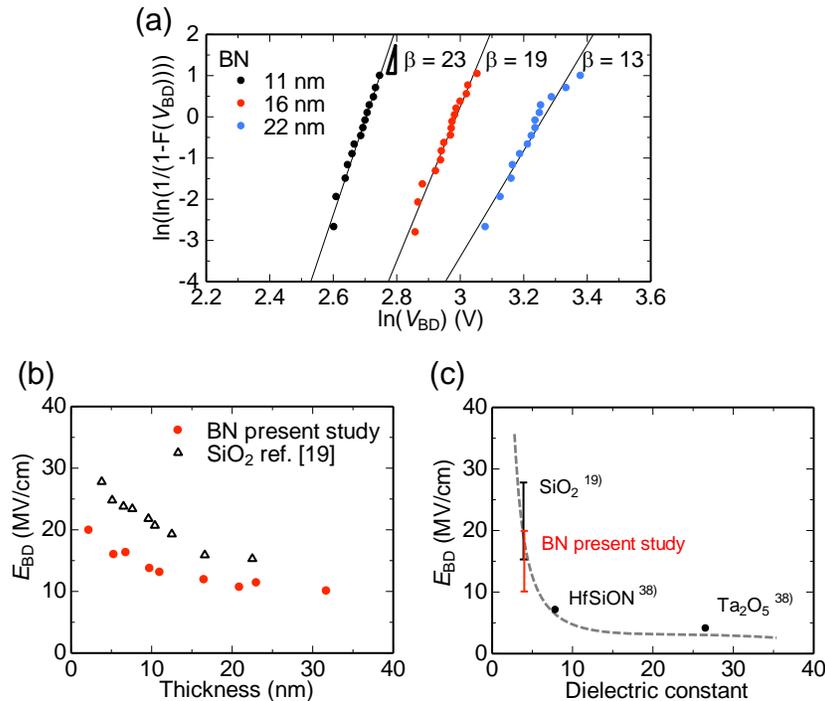
**Figure 5:** (a) Weibull plots of  $V_{BD}$  distributions for different thicknesses of BN. (b)  $E_{BD}$  as a function of thickness for BN for the data measured in this study and for previously reported data. (c) The relation between  $E_{BD}$  and dielectric constant  $k$ .

The variation in  $V_{BD}$  for different thicknesses was investigated to gain further insight into the difference between 2D layered materials and 3D amorphous oxides. **Figure 2d** presents typical  $I$ - $V$  curves for BN flakes with different thicknesses.  $V_{BD}$ , as indicated by the arrows, increased with increasing thickness. The measured  $V_{BD}$  values were sorted in ascending order for statistical analysis, and then the cumulative failure probability ( $F_{BD}$ ) against  $V_{BD}$  was characterized by Weibull plots.<sup>36</sup> Weibull plots of the  $V_{BD}$  distributions for different thickness are presented in **Figure 5a**. The correlation coefficient values of the linear fits for BN with thicknesses of 11 nm, 16 nm, and 22 nm are 0.983 (for 15 samples,  $N = 15$ ), 0.965 ( $N = 17$ ), and 0.945 ( $N = 16$ ), respectively. The good linear fits indicate that the  $V_{BD}$  data can

where  $\alpha$  corresponds to the  $V_{BD}$  at which 63.2% of samples fail, and  $\beta$  is the slope of the line, which characterizes the degree of  $V_{BD}$  variation (uniformity) and determines the failure mode classification that is widely used in reliability engineering. In general,  $\beta < 1$  indicates extrinsic breakdown caused by extrinsic defects (B-mode breakdown) as well as early failure (A-mode breakdown).<sup>25,36</sup> Therefore,  $\beta > 1$  (C-mode breakdown) is required in terms of reliability because this mode represents the intrinsic nature of the dielectric. In this study, the  $\beta$  values for 11-nm, 16-nm, and 22-nm BN were estimated to be 23, 19, and 13, respectively, reflecting intrinsic breakdown. By comparison with the value of  $\beta \approx 8.0$  observed for high- $k$ ,<sup>37</sup> the quality of the present BN crystal is found to be reasonably high, suggesting that the intrinsic breakdown mechanism can be discussed based on these data. As seen in **Figure 5a**, thicker BN samples had smaller  $\beta$  values in the tested range. Interestingly, this result is opposite to that observed in the SiO<sub>2</sub> case, which is well explained by the percolation model.<sup>22</sup> For thicker oxides, many defects are required to create a breakdown path. When the randomness of defect formation in 3D amorphous oxides and the lack of interaction between defects are taken into account, the variation in  $V_{BD}$  becomes small. This is the case for SiO<sub>2</sub>. The opposite results observed for 2D layered BN suggest that the anisotropic formation of defects is the key to understanding the present data; further analysis via simulation is required to investigate this issue.

**Figure 5b** presents the electric field strength ( $E_{BD} = V_{BD} / \text{thickness}$ ) as a function of thickness for BN based on the data measured in this study as well as previously reported data for SiO<sub>2</sub>.<sup>19</sup> Each point represents data averaged from more than 5 measurements of the same flake. The  $E_{BD}$  obtained in this study is in agreement with that reported previously for thin BN.<sup>15</sup> It is interesting that  $E_{BD}$  for BN decreases with increasing the thickness. The similar behavior is also observed for SiO<sub>2</sub>. This could be explained as follows. Because of the very high density of defects formed in thicker BN flakes, the local internal fields may well reach the

Finally, let us discuss the relation between  $E_{BD}$  and the dielectric constant ( $k$ ), which is important in terms of the selection of materials for use as gate insulators in FETs. Empirically,  $E_{BD}$  and  $k$  exhibit an inverse relationship,<sup>37-39</sup> as represented by the dotted line in **Figure 5c**. Materials with ionic bonding exhibit larger  $k$  values because of their higher polarization, whereas those with covalent bonding exhibit smaller  $k$  values. The  $E_{BD}$  values obtained for the present BN flakes are plotted in **Figure 5c** under the assumption that  $k = 4$ . The data lie along the empirical relation. For  $E_{BD}$  values obtained by applying a voltage normal to the layer surface, the anisotropic nature of the covalent bonding in BN is not apparent.  $E_{BD}$  values obtained by applying the voltage parallel to the layer surface are expected to differ considerably.

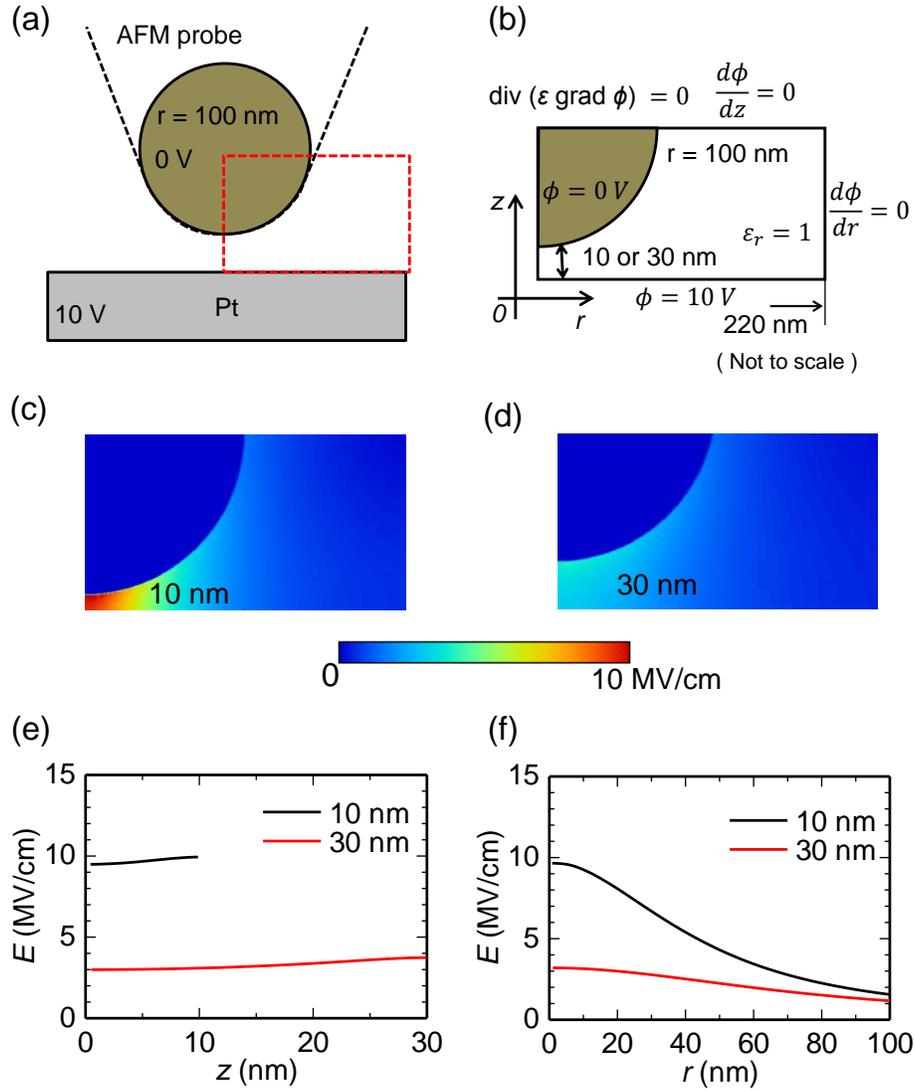
**Supplemental Figure S1:** 2D simulation model (a–b). Electric field around the AFM tip for gap sizes of  $10 \text{ nm}$  (c) and  $30 \text{ nm}$  (d). The color scale indicates the electric field distribution calculated by solving Poisson’s equation. Enlarged views of the electric field at the center of the AFM tip along the  $z$  direction (e) and at the midpoint between the AFM tip and the Pt surface along the  $r$  direction (f).

The electrostatic field around the AFM tip under the application of a bias voltage was calculated. The potential ( $\phi$ ) in the space around the AFM tip, with the exception of the inside of the electrode, satisfies Poisson's equation:

where  $\varepsilon$  is the dielectric constant. The electrostatic field ( $E$ ) is calculated as  $-\text{grad } \phi$ . The governing equation can be solved explicitly using the finite-volume method in a simplified 2D model (**Figure S1a–b**) with a cylindrically symmetric ( $r, z$ ) geometry. The calculation area was divided into  $256 \times 256$  equally sized grids. The boundary conditions were defined to be adiabatic along the right lateral surface and top surface and to be isothermal at the bottom at a constant applied bias voltage. The potential inside the AFM tip was set to zero. The calculation results are presented in Supplemental **Figure S1c–f**.

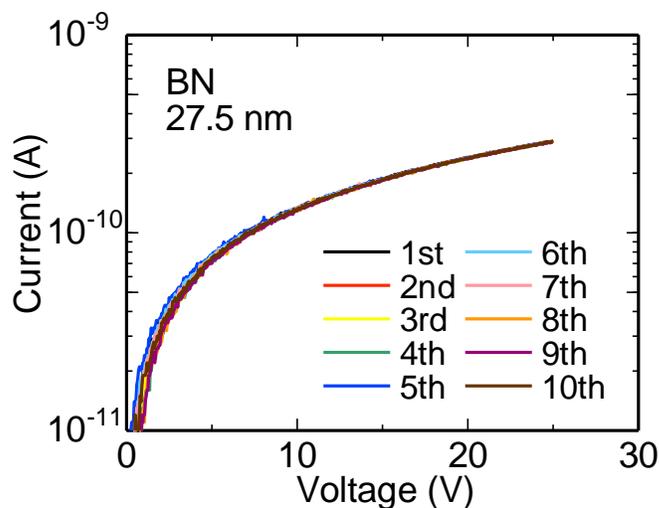
**Supplemental Figure S4:** Ten iterative  $I$ - $V$  measurements from 0 V to 25 V acquired at the same position on BN with a thickness of 27.5 nm. The  $V_{BD}$  values at different positions for the same BN flake fall in the range of 27 – 30 V.

Let us consider the formation of irreversible defects, that is, the soft breakdown before the layer-by-layer hard breakdown. Iterative  $I$ - $V$  measurements for the BN flake with a thickness of 27.5 nm were performed from 0 V to 25 V (a few volts below  $V_{BD}$ ). All measurements clearly overlapped (details provided in Supplemental **Figure S4**), indicating no detectable irreversible defect formation. Now, let us move back to the case of the dielectric breakdown for the remaining BN layer under the hole, as shown in **Figure 2b**. The  $V_{BD}$  value for the remaining 16.5-nm BN layer under the hole was  $\sim 6.7$  V. This is much lower than

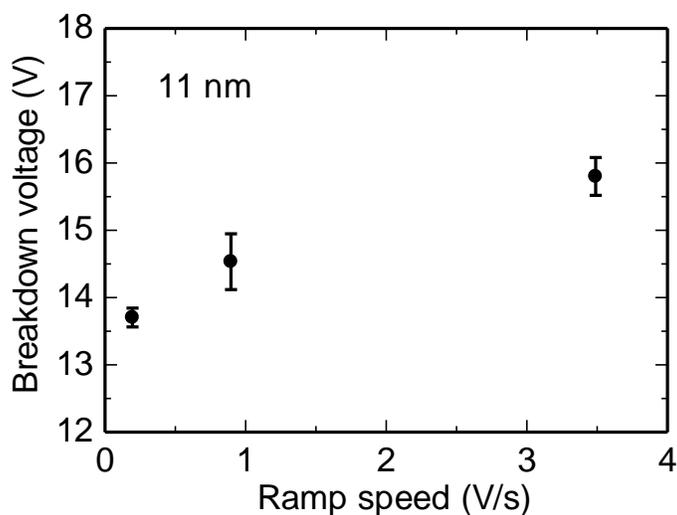
**Supplemental Figure S5:** Breakdown voltage as a function of ramping rate. The breakdown tests were performed on the same BN flake, with a thickness of 11 nm. Solid circles represent average values determined from more than 5 breakdown tests.

magnitudes observed in thin BN flakes. This also explains the lower  $E_{BD}$  values observed for slower ramping rates (details presented in Supplemental **Figure S5**) because more defects are formed in such cases. Although the increase in atomic bonding energy from bulk BN to monolayer BN<sup>13</sup> may contribute to the increase in  $E_{BD}$  observed with decreasing thickness, it does not explain the difference in  $E_{BD}$  observed for different ramping rates.
