Autonomous Repair in Cementitious Material by Combination of Superabsorbent Polymers and Polypropylene Fibres: A Step Towards Sustainable Infrastructure

Souradeep GUPTA^a, KUA Harn-wei^b, PANG Sze-dai^c

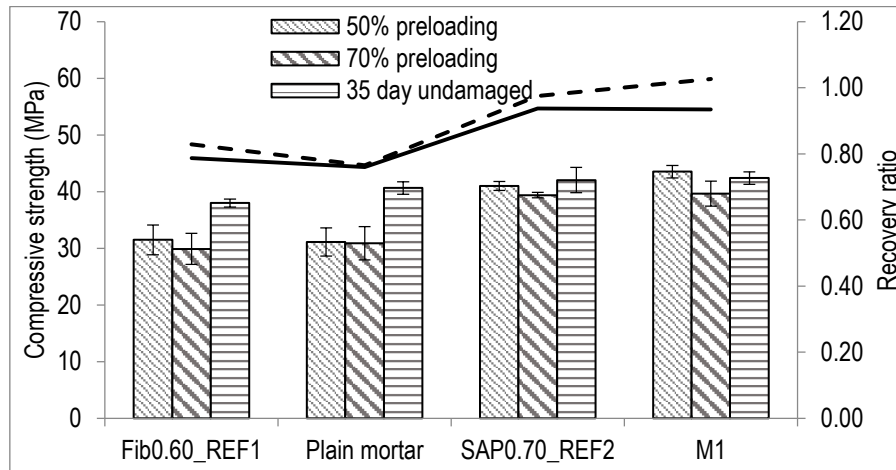
It can be observed from Figure 1 that recovery ratio of strength is considerably higher in M1 at 50% and 70% preloading compared to the reference although 35-day compressive strength of M1 is similar to that of plain mortar and SAP0.70_REF2.

Figure 1: Compressive strength of healed samples, 35day undamaged samples and recovery ratio at 50% and 70% preloading

It can be explained by joint action of fiber and SAP where fibers tend to restrict crack width and SAP particles improve the rate of autogenous healing by supplying moisture to interior of mortar. Generation of hydration products bridge the cracks and impart strength to damaged mortar post healing. Moreover, water desorbed from SAP is rich in calcium ion which reacts with carbon dioxide from surrounding environment resulting in sealing of cracks by precipitation of calcium carbonate at the crack face. Apart from restricting crack width and increasing efficiency of autogenous healing, fibers act as anchors for calcium carbonate crystals. In absence of fibers, the carbonate crystals may not have any anchor to attach to and may be washed away by incoming fluid. SAP0.70_REF2 contained SAP but absence of fibers had little effect on restricting crack propagation which explains its lower compressive strength post-healing.

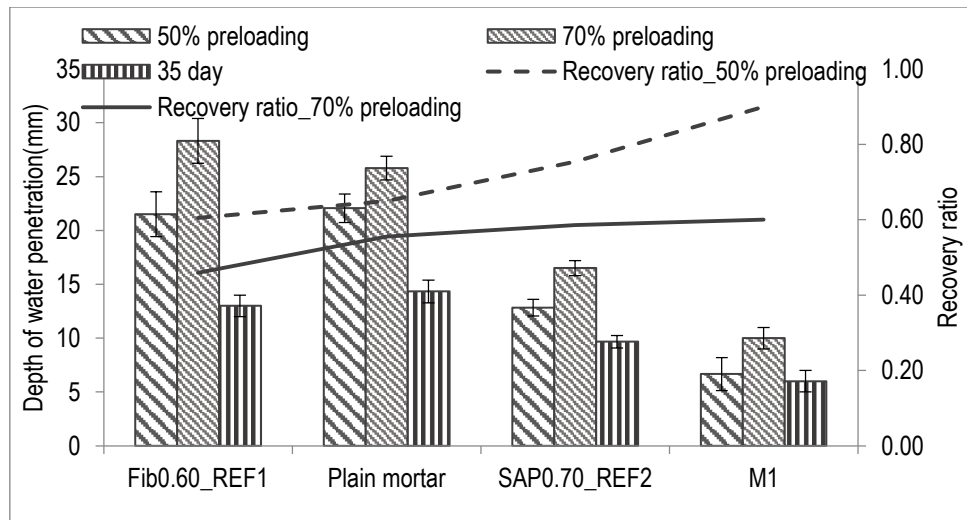
Figure 2 shows samples with SAP and fiber shows higher recovery ratio upon healing. In case of plain mortar and fiber reinforced mortar, healing of microcracks take longer time because of unavailability of moisture in the interior of mortar resulting in partial healing of cracks. Therefore, water under pressure can flow into the concrete without much resistance. In SAP containing samples, healing is more complete because SAP particles can absorb moisture from the moist environment (during curing) and supply for hydration to continue and heal the cracks. Moreover, near the crack faces where there are hydration products calcium carbonate precipitation takes place due to presence of calcium ion (Snoeck and De Belie, 2015).

Figure 2: Water penetration depth in healed samples, 35day undamaged samples and recovery ratio at 50% and 70% preloading

Formation of calcium carbonate bridges and seals the cracks. In presence of fibers across microcracks, calcium carbonate can attach to fibers which prevent them from being washed off from the crack face. This explains higher healing ratio in M1 samples. Moreover, voids containing SAP particles create weak planes which make cracks to cross those voids. SAP s along crack faces swell immediately when it comes in contact with water thus blocking further penetration (Snoeck et al., 2014). However, when preloaded to high stress level localized wider cracks are formed which may not be sufficiently bridged by fibers or blocked by swelled SAP particles. It explains similar recovery ratio in M1 and SAP containing reference samples at 70% preloading level.

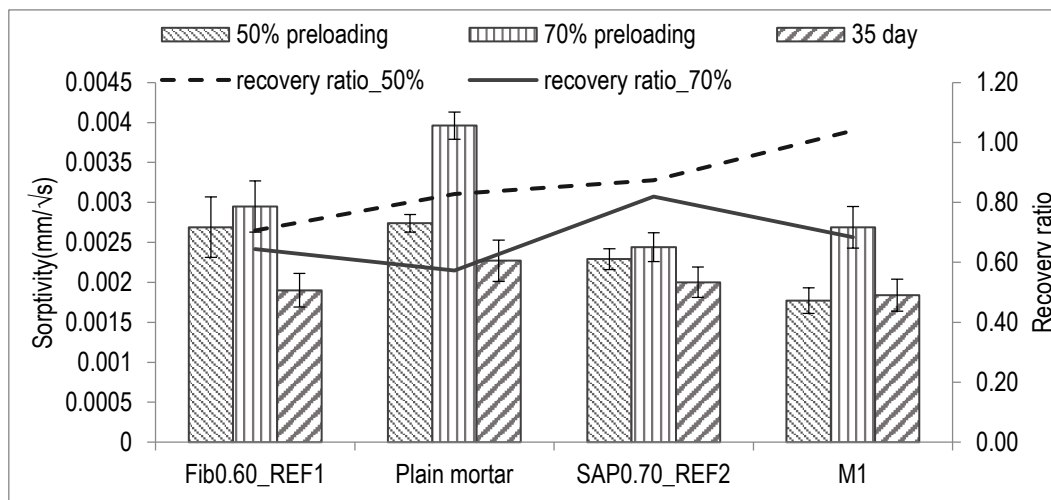
Figure 3: Sorptivity in healed samples, 35day undamaged samples and recovery ratio at 50% and 70% preloading

From Figure 3, one can observe that recovery of sorptivity is highest for M1 samples when subject to 50% preloading although at 70%, the recovery ratio is similar to the reference mortars. This may be attributable to crack profiles created in fiber reinforced mortar under stress. Incorporation of fibers bridge cracks and reduce permeability when the loading is below a certain limit called the threshold level. Above this threshold fibers may cause more localized unrecoverable deformation compared to plain mortar (Hosseini et al., 2009). 70% preloading may have introduced local deformation in the mortar that could not be fully healed or recovered which explains higher sorptivity in M1 samples at 70% preloading.

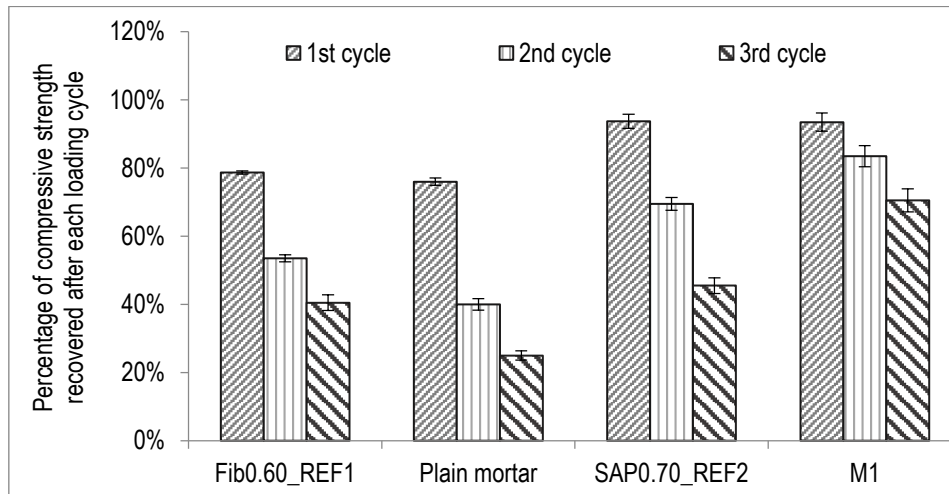
From Figure 4 one can observe that mix M1 retains highest percentage, about 70% of 28-day compressive strength after being subject to three loading cycles.

Figure 4: Recovery percentage of compressive strength of mixes subject to three cycles of loading

It may be justified by the role played by PP fibers in mitigating crack propagation which is also observed when Fib0.6_REF 1 and plain mortar are compared. Plain mortar regained only about 25% of its 28-day strength after three loading cycles compared to 40% in case of Fib0.6_REF1. Addition of SAP also plays an important part in accelerating the healing process. With age the microstructure of mortar becomes denser and therefore less external water tends to reach interior of concrete. Therefore, autogenous healing is mitigated due to lower availability of water. Due to their affinity to water, SAP plays an important role by uptaking moisture from the environment and supplying them for faster autogenous healing in damaged mortar. Therefore, controlled crack width due to addition of fibers and autogenous healing by SAP better performance of M1 samples under cyclical loading.

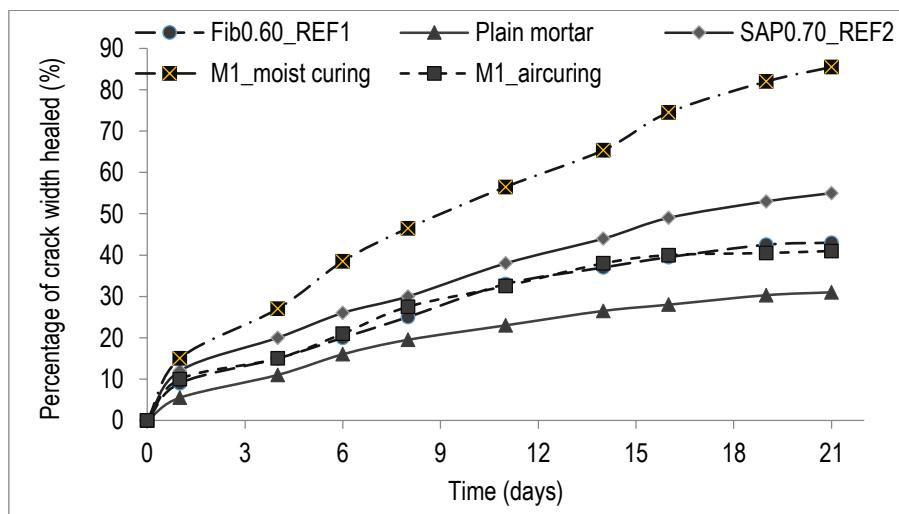
Figure 5 shows that samples with SAP and fiber showed about 85% crack healing compared to only 30-40% healing in reference samples. Figure 6 (b) and (c) shows only partial healing in plain mortar and Fib0.6_REF1 samples which is attributed to limited availability of moisture at the crack site in absence of SAP particles.

Figure 5: Percentage of crack width healed over the healing period in different mixes under moist curing condition and in M1 under moist curing and air curing condition

The unhydrated cement particles near the crack location had ready access to moisture supplied by SAP for further hydration. Moreover, calcium ions at crack face may have reacted with water containing dissolved carbon dioxide or bicarbonate to form calcium carbonate which sealed the cracks. M1 samples placed under air curing also shows similar healing ratio as Fib0.60_REF1 which suggests that presence of SAP particles ensure availability of moisture even under dry condition to seal cracks by further hydration or precipitation of calcium carbonate. However, rate of healing under air-curing dropped beyond 12 days because most of the water absorbed by SAP has been desorbed and utilized for hydration.

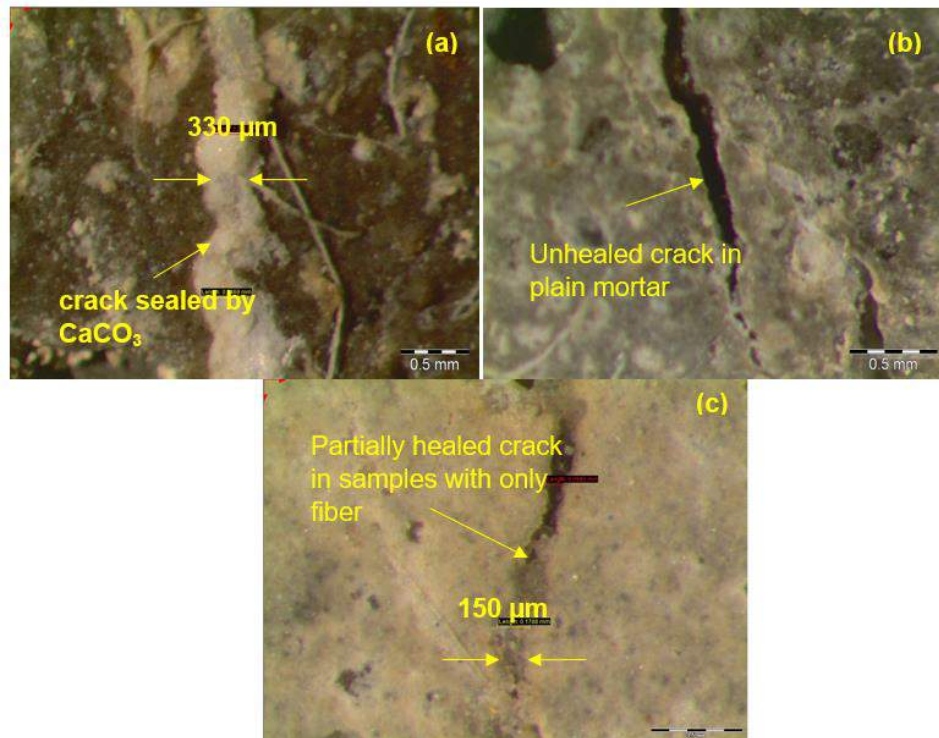
Figure 6: Crack healing in (a)M1 sample (b)Plain mortar samples and (c)Fib0.6_REF1 under moist curing condition

The range of crack width created in M1 samples was 220 – 380 μm at failure while it was in the range of 200 - 300 μm in Fib0.6_REF1. It means that M1 showed slightly higher crack width at failure which may be attributed to weak spots created due to desorption of water from SAP. While complete sealing of cracks up to 330 μm was noted in M1 (Figure 6a), cracks beyond 330 μm were healed partially.
