Fluorescent thermal imaging of a non-insulated pancake coil wound from high temperature superconductor tape

R. Gyuráki, T. Benkel, F. Schreiner, and F. Grilli

The authors are with the Karlsruhe Institute of Technology, Eggenstein-Leopoldshafen, Germany

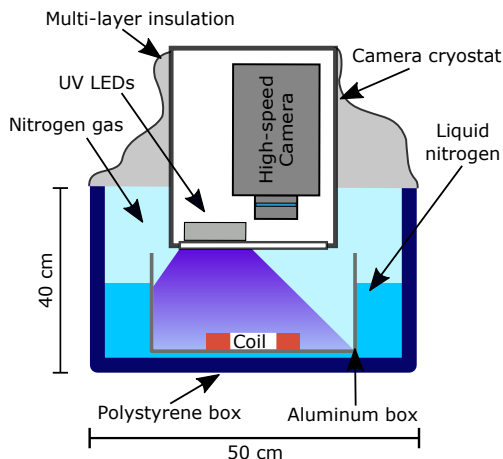
FIG. 1: Cross-section view of the experimental setup.

To avoid complex and expensive vacuum and cryocooler setups with optical windows – and since the aim was to test the coil only at 77 K – a simple, 2-component cryostat was constructed, as shown in Figure 1. An aluminum container was placed inside a larger polystyrene container, and the space between the two was filled up with liquid nitrogen. The coil was then placed into the aluminum box and a good thermal contact was made between the two with the help of a thin layer of thermal paste. This allowed the coil to be conduction-cooled to 77 K via the aluminum container’s walls. The remaining space in the containers was filled with evaporated, cold nitrogen gas, providing a cold and clear atmosphere, ideal for optical measurements. The high-speed camera was then positioned above the setup and lowered close to

the coil inside a separate optical cryostat that kept the camera at room temperature. The UV excitation light was also placed in the camera’s cryostat. The setup was finally surrounded by multi-layer insulation from the top to shield the sample from radiation heat sources, and to prevent air movement and mixing with the cold nitrogen gas, and also to block out ambient light. The result was a conduction-cooled NI-coil in a pure, cold, nitrogen atmosphere. The high-speed camera, despite having been used in the past at several thousand frames per second (fps) to measure quenches in single HTS tapes [14], was used here at the slowest speed setting of 50 fps, which was found sufficient for measuring the heating in the NI coil. This allowed a maximum recording time of about 10-12 minutes per experiment.

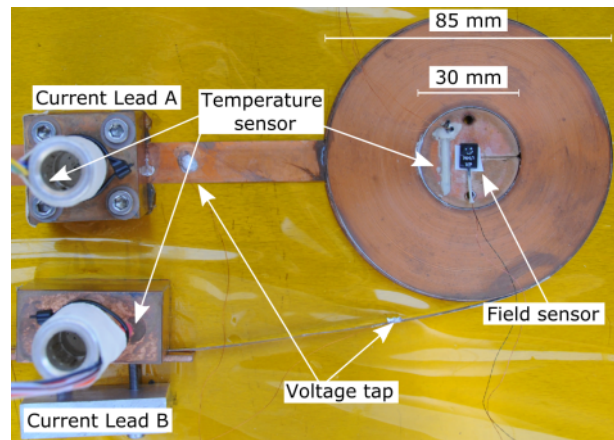
FIG. 2: HTS non-insulated coil placed at the bottom of an aluminium box. A Kapton sheet served as electrical insulation in between.

A picture of the coil and the electrical instrumentation is shown in Figure 2. The magnetic field was measured with a Hall sensor and the temperature with a Pt100 thermometer, both located at the center of the coil. The voltage was measured across two superconducting current leads. However, this path includes the resistive soldered joint between the 12-mm HTS current lead and the coil former, as well as between the coil former and the first turn. Since the current leads were also conduction-cooled, their temperatures were also recorded with a Pt100 sensor each. The current was measured with a shunt resistor inserted in the circuit. This resulted in seven data acquisition channels, which were recorded using an NI-USB 6289 DAQ, at a rate of 1000 samples per second, and several Dataforth and Dewetron pre-amplifiers for acquiring low voltages. In parallel, the coil voltage was also measured with a nanovoltmeter at a slower rate of 1 sample per second for higher accuracy.

- [14] R. Gyuráki, F. Sirois, and F. Grilli, *Superconductor Science and Technology* **31**, 34003 (2018).
- [15] The attached video shows the thermal imaging as well as the electrical signals. This latter includes the current, magnetic field, voltage across the coil and the temperature measured by the Pt100 sensor as shown in Figure 2.

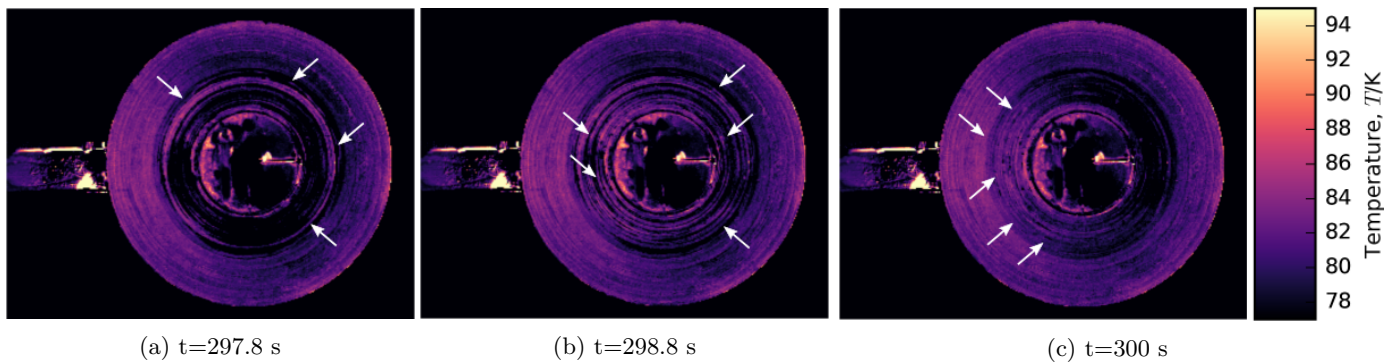
FIG. 4: Thermal images of the coil during the 72 A over-current test showing different time points just before and right after the “self-recovery”. The white arrows indicate features, as described in the text.

Since the magnetic field also reduced with the increasing voltage, the current must have been changing from the spiral to the radial path. This is also supported by the quasi-linear voltage rise observed, as expected with increasingly more current flowing through a resistor. In Figure 4a one can see that the outer turns of the coil are initially at a higher temperature, presumably due to slightly worse cooling than in other parts of the coil. At the same time, distinct heating is visible in the form of circles with varying width, as can be seen in Figure 4a and Figure 4b highlighted by the white arrows. This indicates that at particular locations in the coil, the current flows through the turn-to-turn contact resistance and generate losses. At about 298 seconds into the measurement, the voltage dropped and the magnetic field increased sharply, indicating that the current reverted back into the spiral path quite abruptly. Simultaneously, the center windings of the coil have heated up, as indicated

by the white arrows in Figure 4c, where the ring-like hot areas have been replaced by an uniformly warmer zone, mostly on the left hand side of the coil. Hence the current flowing through the turn-to-turn contact resistances of the coil can be seen on the thermal image as heating over possibly several turns, which is most likely a function of the cooling performance and the distribution of local fluctuations of I_c along the length of the wound conductor.

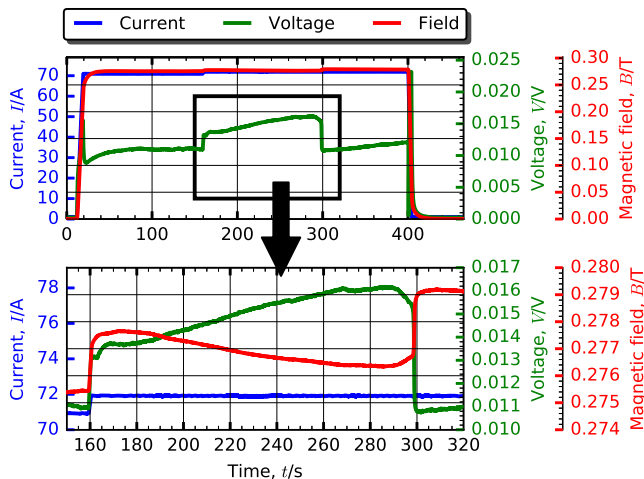
FIG. 3: Electrical measurements of the coil during the 72 A over-current test. The bottom plot shows a zoomed area marked by the black rectangle. Note that the axes ranges are changed on the zoomed plot.

The coil current was first ramped up to 71 A at a rate of 10 A/s and the voltage was monitored, as shown in Figure 3. It eventually stabilized and so the current was increased to 72 A, this time at a slower 1 A/s rate, as shown at time 160 s. At this current level, a slow yet steady voltage shift was observed, and the coil was held at this level.

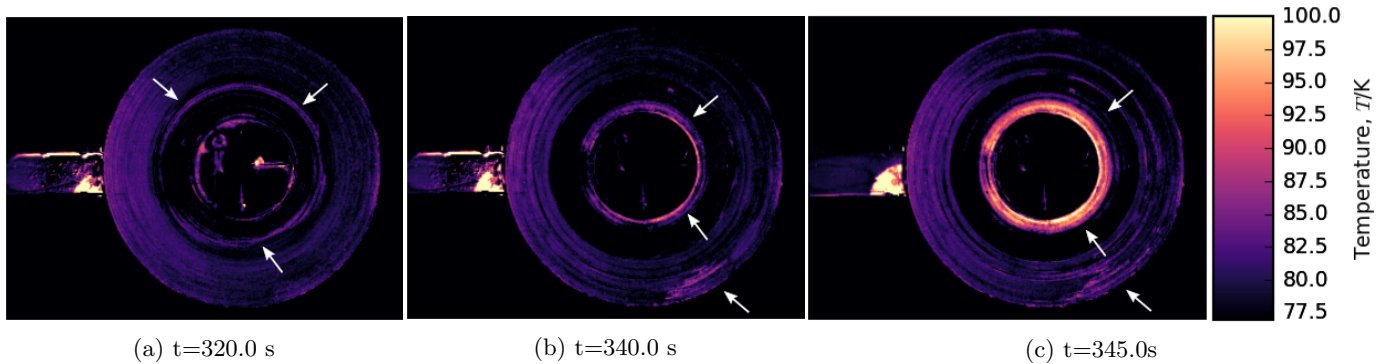
FIG. 6: Thermal images of the coil during the 74 A over-current test showing different time points just before and at the moment of thermal runaway and ramping down. The white arrows indicate features, as described in the text.

windings of the coil. When looking at the dynamic development (see attached video [15]) one can identify a stage between Figure 6a and Figure 6b. Between these times the middle turns of the coil actually cooled down, and when the voltage continued to rise, the central windings started heating up instead. A possible explanation is that when the coil voltage is low, only the “major” defects in the coil can be bypassed. However, at higher voltages, more current can be forced through the turn-to-turn contact resistances, thereby reducing the current in the superconductor as well as the local heating. Due to the fact that the energy is dissipated over a larger volume, this could then manifest in a form of a local cooling effect. Then in Figure 6c, the center windings see the combined effect of superconducting to resistive transition of the HTS due to the reduced temperature margin and high magnetic field, combined with the current bypass and joule heating due to the resistive joints. To check

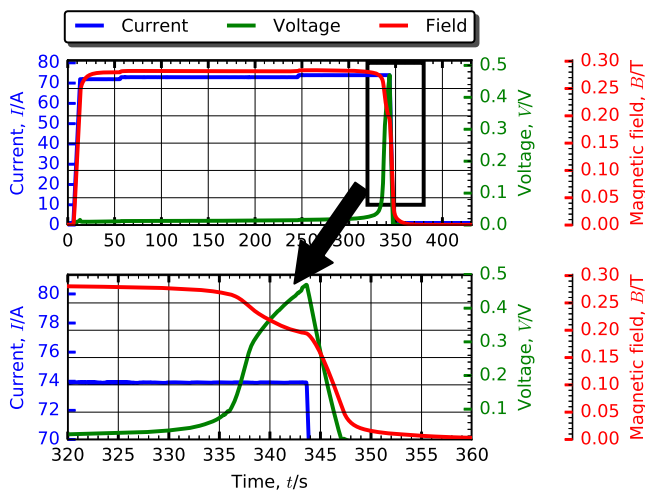
FIG. 5: Electrical measurements of the coil during the 74 A over-current test. The bottom plot shows a zoomed area marked by the black rectangle.

To reproduce previous results and observe the same behavior again, the coil current was ramped up in a subsequent measurement directly to 72 A at a rate of 10 A/s, as shown in Figure 5. However, in this case, no voltage drift was observed. The current was therefore ramped up to 73 A, and finally 74 A, at a slower 1 A/s rate, where the coil voltage became unstable and started increasing once again. Over the course of two minutes at a steady current of 74 A, the coil voltage rose up continuously until its final value of 0.47 V, at which the coil current was ramped down quickly. The field started decaying with the developing voltage, indicating a slow current transfer into a radial path. Then, after 336 s, a much sharper voltage rise and accompanying field drop became visible, likely due to (some of) the HTS tapes becoming resistive. Figure 6 shows excerpts of the thermal imaging recording at three different time instants. In Figure 6a, one can see that the outside of the coil is again at a higher temperature, however still cryostable. Warmer zones are still visible around the center and middle layer of the coil (shown by the white arrows), indicating heating due to currents flowing through the turn-to-turn contact resistances. Figure 6b shows that the middle layers seem to have mostly cooled down, and at the same time – due to the voltage rise of the coil – the innermost windings started heating up. At the bottom of the image, where the outer current lead arrives at the coil, a hot spot is also visible. Then in Figure 6c, just before the current was ramped down to protect the coil, the hottest temperature of around 100 K was reached at the few innermost
