# Structural study of the Notre-Dame ancient *charpente*

The timber roofing structure (*charpente* or *combles*, in French) of the cathedral Notre-Dame, destroyed by the fire of April 15th, 2019, is studied. The aim is twofold: on the one hand, it is interesting to evaluate the structural behavior of the original wooden structure in view of the reconstruction of the cathedral's roof. On the other hand, its structural analysis, never done before, can help to shed a light on the design process used by the masterbuilders of the XIIIth century, and to reconstruct, at least in part, the structural thought and knowledge of the ancient builders.

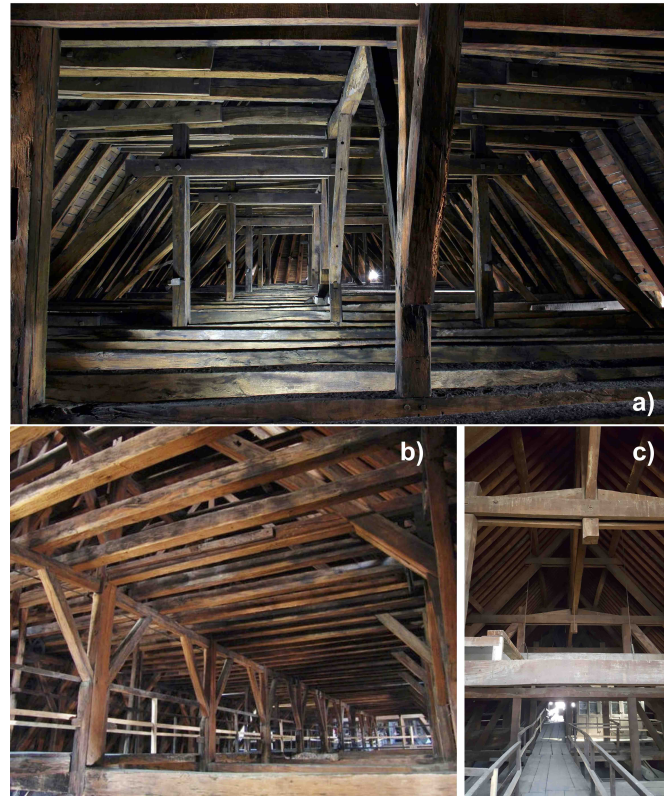
Figure 1: Views of the *combes*: a) in the choir (from Fromont and Trentesaux [2016]), b) in the nave (from Épaud [2019a]), c) in the transept (by the author).

The *charpente* was a very large structure: about 115.6 m long, 13 m wide, 9.75 m high for the nave and the choir. Though in Dubu [1854] it is said that the *charpente* was made with chestnut wood, it is certain that it was realized with the wood of oak trees. Scholars disagree about the quantity of trees employed for the structure: according to F. Épaud, who has deeply studied the timber structures of the Middle Ages, it was composed by the wood of about 1000 oaks, almost all of them with a diameter of  $\sim 25 \div 30$  cm and 12 m high, a small part with a diameter of  $\sim 50$  cm and 15 m high, corresponding to about 3 hectares of forest. In an interview, Corvol [2019], A. Corvol, an expert in forests, evaluates at 3000 to 5000 m<sup>3</sup> the volume of the *charpente*'s wood, corresponding to about 2000 oaks; other estimations give the value of 1300 oaks for 21 hectares of forest. The quantity of wood was, anyway, very important, so that the *charpente* was called *la forêt*, the forest: the visitor was immersed in an amazing very intricate set of wooden beams and struts, like in a sort of artificial forest crystallized during several centuries, Fig. 1.

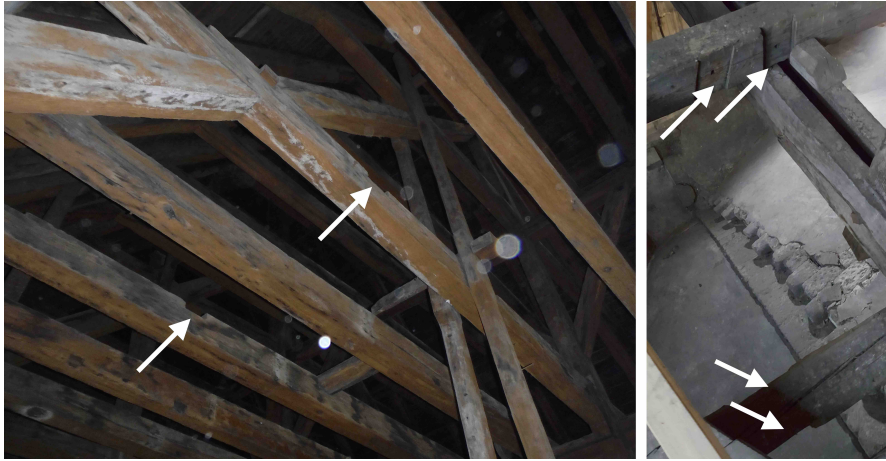
Figure 2: Notches indicating the reuse of ancient wooden beams (by the author).

The structures of the nave and choir used, at least in part, some timber beams of the more ancient, original roof of Notre-Dame, built around 1160-1170: several pieces of them, in fact, showed unused mortices or *mi-bois* notches in some parts of the *charpente* built after 1220, a clear sign of reuse, Aubert [1919], Fig. 2. The reconstruction of the *charpente* was the consequence of a set of changes made on the cathedral during its construction. In particular, the guttering

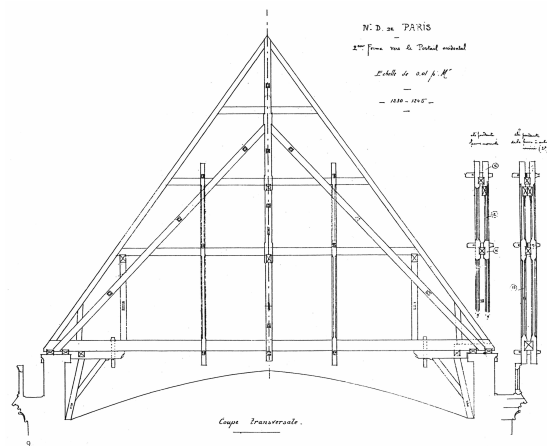
Figure 3: The survey of the second *ferme*, FN2, of the nave, according to Deneux [1927]; the *suspente* on the right side was not present, in reality.

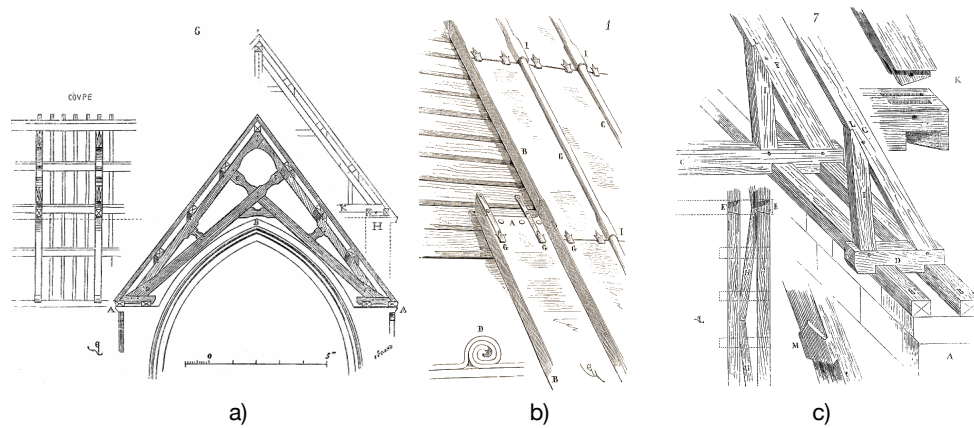
Figure 4: Structural schemes from [Viollet-le-Duc \[1854\]](#): a) scheme of a *ferme* without *entrait*; the *charpente* of  $\sim 1170$  was probably similar to this one; b) the system of lead tiles observed by Viollet-le-Duc on the roof of the cathedral of Chartres, before the fire of 1836 that destroyed entirely the *combles*; it is this system that he used to cover the roof of Notre-Dame of Paris after the restoration of the mid of the XIXth century; c) the system for the support of the *fermettes* (G), composed by *blochets* (D) and *sablières* (B), in a *charpente* with *chevrons formant ferme*.

The crucial architectural transformation of the cathedral operated after 1220 that with no doubts is directly linked to the change of the structural type of the *charpente* was the raise of the guttering wall, already mentioned above. This allowed the carpenters to use frames (*fermes* in French) with an *entrait*, i.e. a long tie-beam relying the bases of the frame's rafters (the *chevrons*, in French), which is the ideal device to absorb the horizontal component of the force in the rafters. In the previous roofing structure of  $\sim 1170$ , the vault exceeded in height the top of the guttering wall, so it was not possible to use *fermes* with *entrait*. We do not know how this older *charpente* was made, we can just imagine that it was something like that in Fig. 4 a). This type of solution

severely deform the *fermette*. The way invented by the Gothic carpenters is that of the *sablières* and *blochets*, see Fig. 4 c). Each *chevron* of a *fermette* has at its base a *blochet*, hosting the *chevron* and a *jambette*. The *blochet* is not directly placed on the top of the guttering wall, but it is linked to and supported by two longitudinal rods, the *sablières*. These two wooden beams are restrained by the *entraits* of two successive *chevrons maîtres*. In this way, the horizontal thrust at the base of each *fermette* is absorbed by the system of the *sablières*. These ones are hence solicited in bending and shear in the horizontal plane and transfer in this way the resultant of the horizontal thrust of the *fermettes* between two *chevrons maîtres* to the *entraits* of these last. The whole system hence does not apply any horizontal thrust on the top of the guttering wall. This is a fundamental fact of the *charpentes* with *chevrons formant ferme*: all the system was designed to transmit only vertical forces to the top of the guttering wall, while the horizontal forces engendered by the vertical loads, i.e. by the own weight of the structure, were self-equilibrated by the system composed by the *chevrons*, *blochets*, *sablières* and *entraits* of the main frames. Because the *charpente* is simply posed onto the guttering wall, the only mechanism able to absorb horizontal forces should be the friction between the wood of the *charpente* and the stone of the wall. We will see in Sect. 4.7 that actually this is not possible: not only friction cannot absorb the horizontal thrust of the Notre-Dame's *charpente*, but more importantly, such a situation could bring the guttering wall to a failure. In fact, the horizontal thrust applied to a high guttering wall could produce a rotation of the wall at its base, i.e. where it meets the vault, causing its collapse. It is likely that the builders of Notre-Dame were conscient of this danger, consequence of the elevation of the guttering wall, and adopted intentionally the system described above in order to create a structure not pushing horizontally on the wall's top.

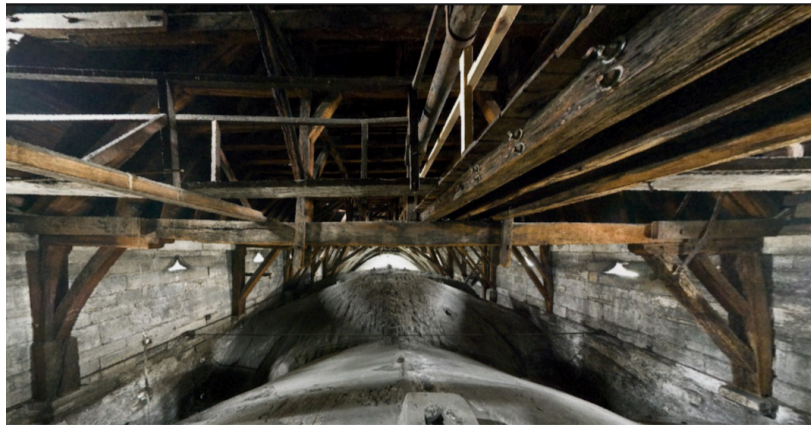
Figure 5: The *charpente* of the choir; the top of the guttering wall was, before  $\sim 1220$ , at the level of the corbels supporting the wall pieces and braces beneath the *fermes* (extracted from [Tallon \[2019\]](#)).

We have already mentioned that during the modifications started around 1220, the guttering wall was raised of  $\sim 2.70$  m above the keystone of the high vault, see Fig. 5, where it is apparent that the *entrains* of the *fermes* can now well pass above the vault, while this was impossible for the *charpente* of  $\sim 1170$ , as the top of the guttering wall was at that time at the level of the stone corbels well visible in the picture and serving as support for the lower part of the *fermes*.

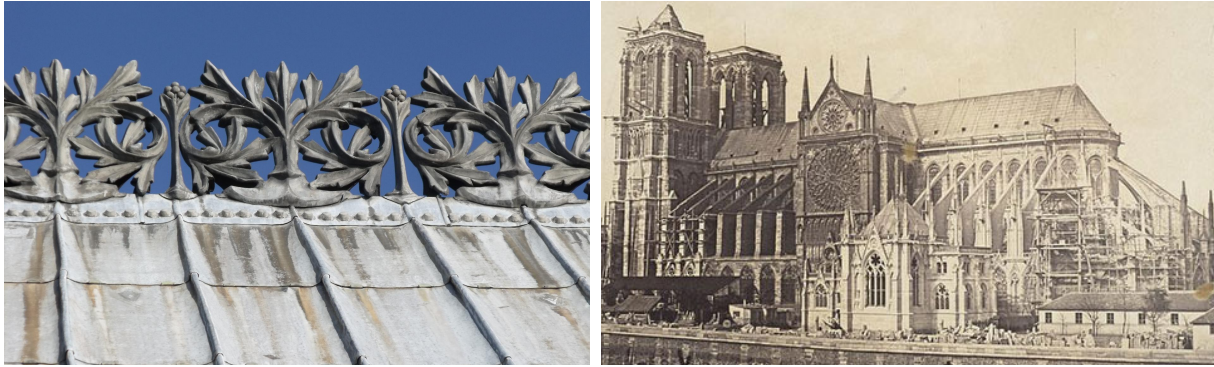
Figure 6: The lead frieze at the roof top and Notre-Dame before the restoration of Lassus and Viollet-le-Duc, without the frieze.

Originally, according to [Dubu \[1854\]](#), who wrote a history of Notre-Dame during the restoration works of Lassus and Viollet-le-Duc, the covering of the roof was made by 1236 lead plates, each one of the dimensions  $0.975 \times 3.248$  m and 5 mm thick, for a mass of 120 kg each, which gives a total mass of the lead covering of  $\sim 2060$  tons. This calculation is manifestly false: if the dimensions of a tile are correct, its mass should be of  $\sim 180$  kg, and the total mass of the covering of 221.15 tons, not far from the value normally given of 210 tons. However, this was not the lead covering melt by the fire of April 15th, 2019. In fact, in [Lassus and Viollet-le-Duc \[1843\]](#) it is specified that the Cardinal of Noailles proceeded to the restoration of the roof in 1726 and that the new mass of the lead covering was of 220240 pounds, i.e. about 99.9 tons. Evidently, the new lead tiles had a less thickness, presumably of  $\sim 2.25$  mm. Successively, during the restoration of Lassus and Viollet-le-Duc, the covering was made again, still with lead tiles, but now with a thickness of 2.82 mm, [Laboulaye \[1873\]](#); the tiles were welded together and fixed to the *charpente* with staples, Fig. 4 b). This was the lead covering melt by the fire of 2019. Its total mass can be estimated to  $\sim 135$  tons. Also, a lead frieze was put on the top of the roof, that did not exist before, Fig. 6.

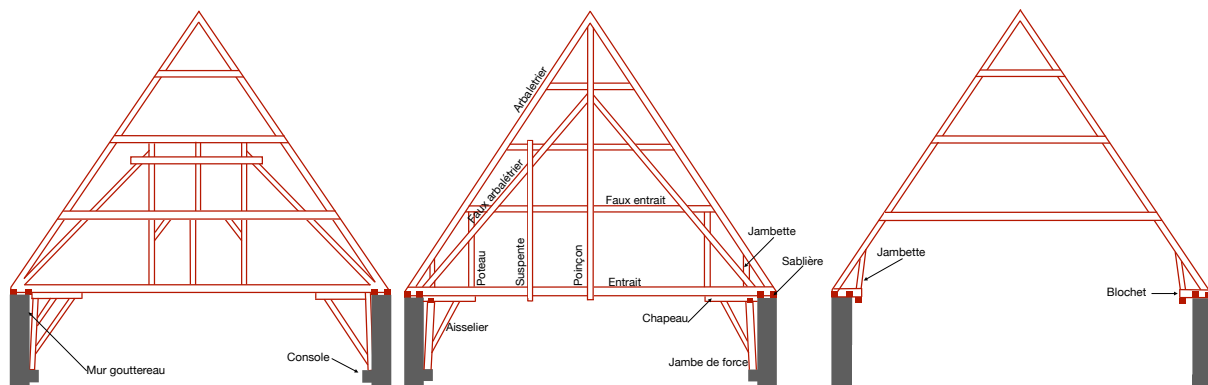
Figure 7: From left to right, scheme of a *chevron maître* of the choir, of the nave and of a *fermette*.

The *chevrons maîtres* of the choir and nave of Notre-Dame, as well as the model of a *fermette*, are shown in Fig. 7. In the same figure, the French names for the different pieces of the structure are also indicated, they will be used in the remainder of this paper. These schemes have been reconstructed using mainly Chevrier [1995] and Fromont and Trentesaux [2016]. These

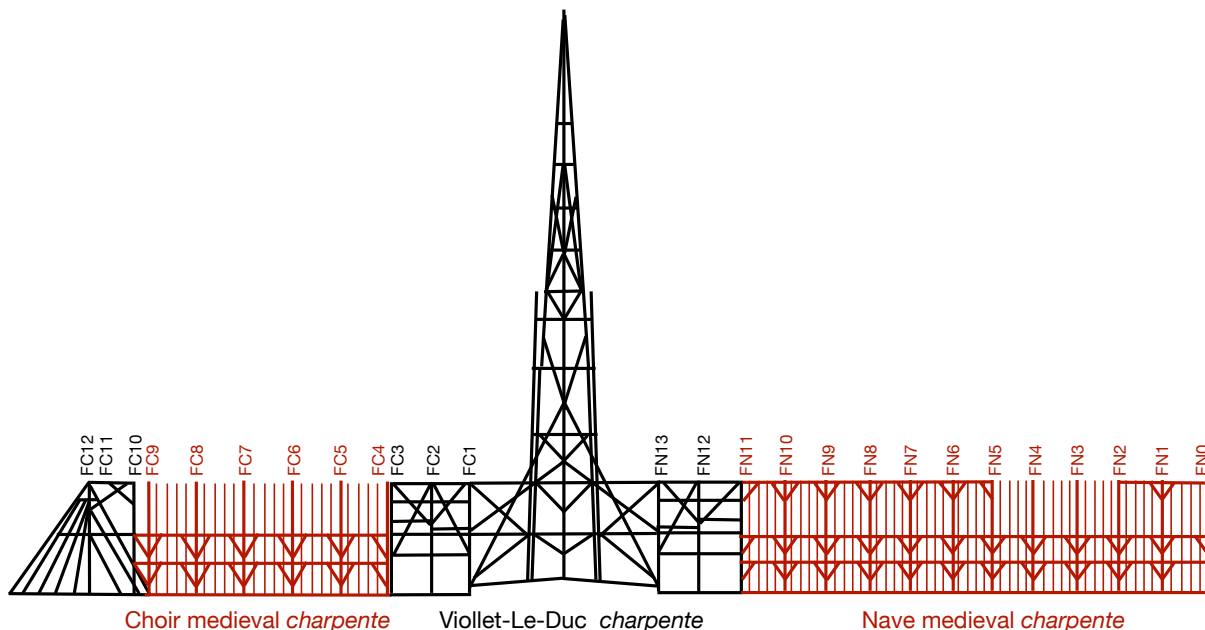
Figure 8: Longitudinal scheme of the *charpente*; the parts of the structure studied in this paper are in red; thick lines indicate the main frame and the longitudinal bracing system, while thin lines represent the secondary frames (scheme reconstructed from the survey in Fromont and Trentesaux [2016]).

The longitudinal scheme of the entire *combles* is presented in Fig. 8. The three parts of the *charpente* are clearly indicated as well as the notation of the *fermes principales*, as usually adopted. The longitudinal structure relying together the *fermes principales* and the *fermettes*, formed by *liernes* and *aisseliers* is schematically presented too. In this paper, only the parts of the *charpente* between *fermes* FC4 and FC9, for the choir, and between FN1 and FN11, for the nave, are studied. They correspond to the regular part of the medieval *charpente*, the rest being the part of the structure constituting the apse of the choir or that reconstructed by Lassus and Viollet-le-Duc during the XIXth century, and based upon a different structural scheme, that of *fermes, pannes et chevrons*, Bechmann [1981], Bernardi [2011]. Above the *chevrons* of the main or secondary *fermes*, there is a wooden decking, the *voligeage*, this last supporting the lead tiles, nailed on it, see Fig. 4 a).

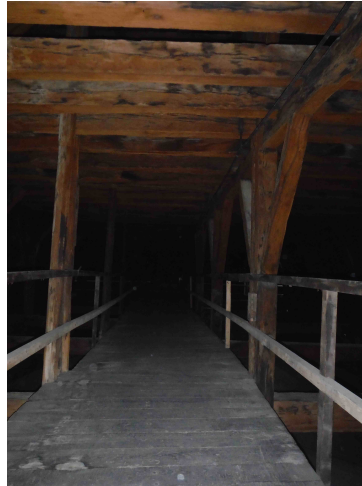
Figure 9: The catwalk; the *suspente* is the vertical tie on the left, while the *poignon* the one on the right, with its *aisseliers* (by the author).

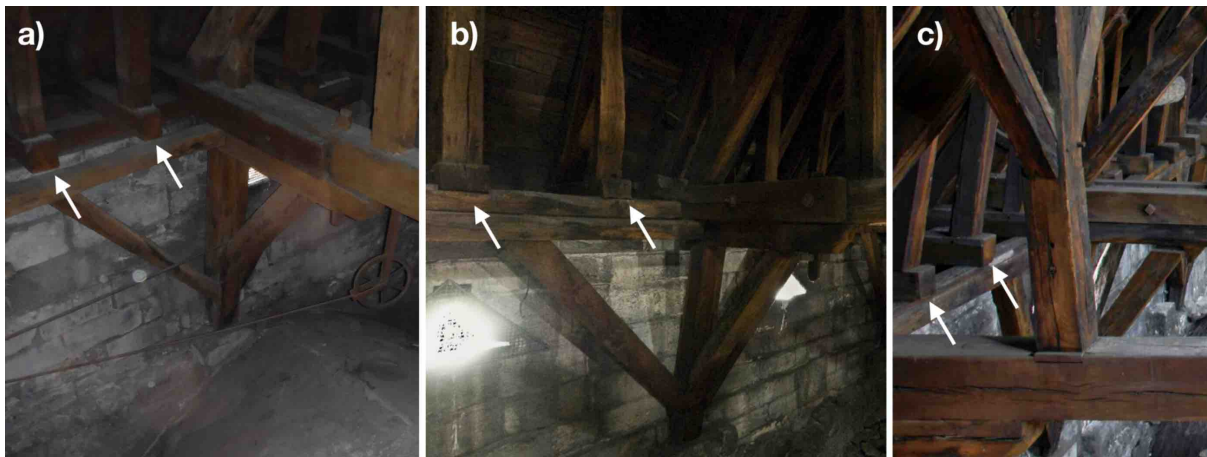
Figure 10: The detail of the contact between the *blochets* and the longitudinal tie, in the nave's *charpente*: a) the lack of contact for the part close to FN3, North side (by the author); b) the contact ensured by a thick piece in other parts of the *charpente* (extracted from Tallon [2019]); c) the direct contact close to FN6, South side (from Fromont and Trentesaux [2016]).

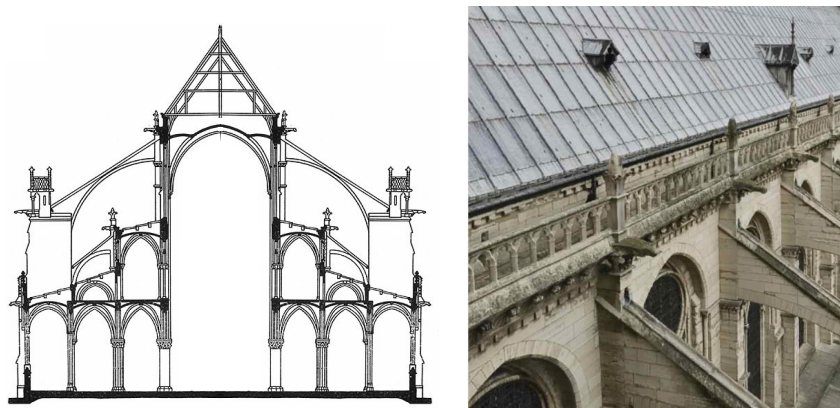
Figure 11: The vertical gap between the top of the flying-buttresses and that of the guttering wall.

The *charpente* of a Gothic cathedral was, normally, built before the construction of the high vault, see e.g. [Bechmann \[1981\]](#). During this phase, the *charpente* had also another role: to counterbalance the flying-buttresses thrust, ensuring the connection between the two sides of the clerestory before the construction of the vault. The device constituted by the *consoles* well assumed this structural role: the *entraits*, equipped with the two *consoles*, were able to balance and resist the inward thrust applied to the two opposite clerestory walls by the flying-buttresses on the North and South side of the cathedral. In particular, in Notre-Dame, after the raise of the guttering wall, the top of the flying-buttresses was too far below the *charpente* to assume such a kind of thrust balance without a device, the *consoles*, acting down below the *charpente*. The vertical gap between the *charpente* and the top of the flying-buttresses can be appreciated

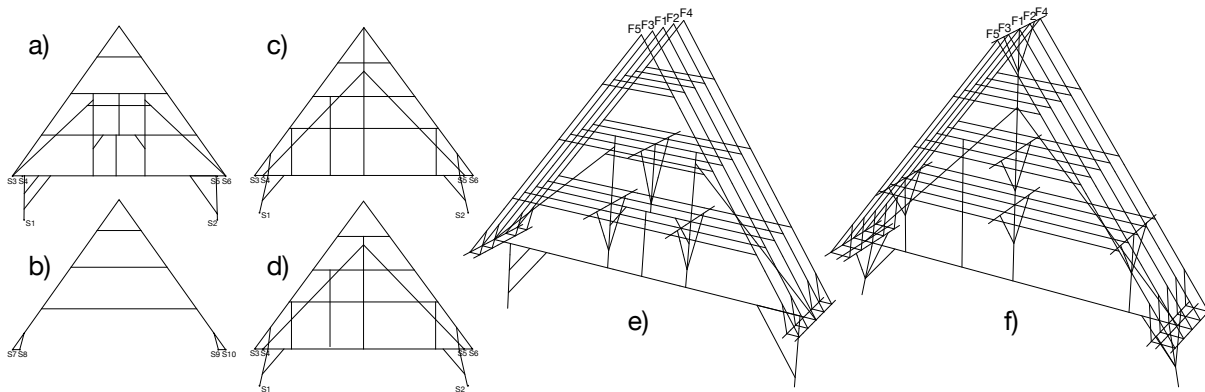
Figure 12: Schemes of the *combles*'s structure: a) *ferme principale* of the choir; b) a *fermette*; c) *fermes principales* FN1-FN2 and FN5-FN11 of the nave; d) *fermes principales* FN3-FN4 of the nave; e) the structural unit of the choir's *charpente*; f) the structural unit of the nave's *charpente*.

In the case of the nave, two different calculations are performed: one for the structural unit in Fig: 12 f), valid for FN1 to FN2 and for FN5 to FN11. The other one, for the structural units of FN3 and FN4, for which the model is slightly modified to account for some peculiarities, described above: the *suspente* is not linked to the *entrait*, the *poignon* is interrupted at the level of the third *faux entrait* and the tie connecting together the *consoles* is not linked to the *jambettes*, Fig. 12 d).

The distribution of the reaction forces for each support point, S1 to S6 for the main frame F1, S7 to S10 for the secondary frames F2, F3 and F4, F5, cf. Fig. 12, is detailed in Tab. 5 for all the *charpentes* and loading conditions ( $R_x$ : horizontal reaction;  $R_y$ : vertical reaction). The distribution of the reactions is almost symmetric between the South and North sides, though not exactly, due to the small asymmetries in the main frames structure. It is interesting to notice that not all the supports are active for the vertical load (condition OW): for the choir, the supports S7 and S10 of the *fermettes* are inactive, as well as S9 for F2 and F3 of the nave's *charpente* exception made for the part between FN3 to FN4. We can also observe that the vertical reactions in S1 and S2, i.e. at the level of the corbels supporting the *jambes*, is far less than that absorbed by nodes S3 to S6, on the guttering wall's top, for the choir's *charpente*, while it is higher in the nave, due to the different arrangement of the structure. This confirms that the system of wooden *consoles* is not determining in supporting the vertical loads, as already commented. For the loading condition OW+W, the situation is different: the presence of the *jambes* strongly affects the distribution of the reactions. The set of supporting nodes changes: in the choir, nodes S3 on the North side (the wind is simulated to blow from the South, where the cathedral is more exposed to the wind) are heavily charged, while nodes S4, S5, S8 and S10 are inactive. Nodes S6, S7 and S9 are also active, but with a reaction force far below that of S3. The node S1 is charged only horizontally, to entirely absorb the wind thrust, while S2 is charged in the vertical direction, as an effect of the roof's slope, see below. In the nave, due to the different

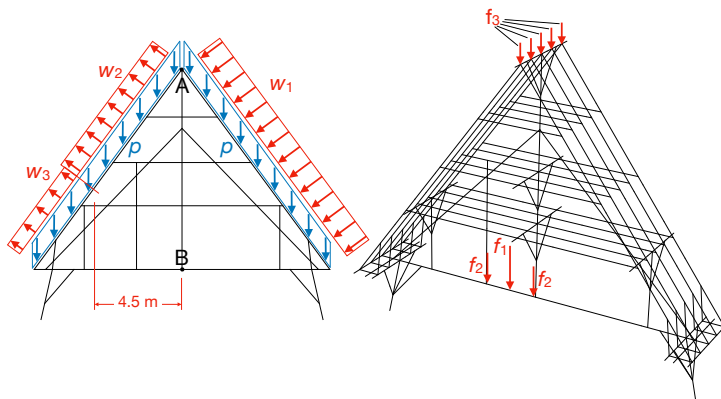
Figure 13: Scheme of the actions on the *charpente*;  $p$ : lead tiles and *voligeage* load;  $w_1, w_2, w_3$ : wind load;  $f_1, f_2$ : load of the catwalk;  $f_3$ : load of the frieze.

Two loading conditions have been considered: own weight and own weight plus the wind. For what concerns the own weight, two different cases have been analyzed: the original state (OS), i.e. the one before the changes occurred in 1726, and the final state (FS), that before the fire of April 15th, 2019. The differences between these two cases are due to the lead covering: tiles with a thickness of 5 mm for the OS, of 2.82 mm for the FS and the presence of the frieze, Fig. 6. The OS is analyzed to evaluate the structural situation of the original *charpente* as designed by the Gothic carpenters, while the FS is considered to have an assessment of the state of the *charpente* before its destruction. For what concerns the wind loads, the objective is just to evaluate what were the consequences on the *charpente* of an horizontal load. This analysis is a rather classical one: the wind action is modeled as a static load, orthogonal to the impinging surface, and distributed on the windward (overpressure) and leeward (suction) sides of the roof. The value of the wind load is calculated and distributed according to the European norm EUROCODE 1, CEN [2005]. The objective, however, is not to evaluate whether or not the *charpente* was safe according to such a standard, a meaningless objective for an ancient and now destroyed structure, but just to have a value of the wind action that is commonly accepted in the analysis of civil structures. The actions applied to the *charpente* are sketched in Fig. 13 and the values of the loads shown in Tab. 3.

To remark that the slope of the roof,  $\sim 55^\circ$ , ensures a stabilizing moment of the wind force distribution  $w_1$  on the windward side, Fig. 13, which explains the positive reaction in nodes S2, S6 and S9 of the choir and the high reaction at node S5 of the nave's *charpente*. Of course, we cannot affirm with certitude that the Gothics were conscious of this fact (the moment of  $w_1$  becomes an overturning one at a slope of  $60^\circ$ ), though the concept of moment of a force and its role in the equilibrium of a mechanical system was already roughly grasped in the Middle Ages, see Benvenuto [1981]. Nevertheless, the slope of the *combles* has at the same time a stabilizing effect for the wind actions and allows to decrease the bending of the *chevrons*, two real structural advantages. In Tab. 5 the resultant of the reactions is also indicated. This gives also an estimation of the global loads and weights; they are summarized in Tab. 6.

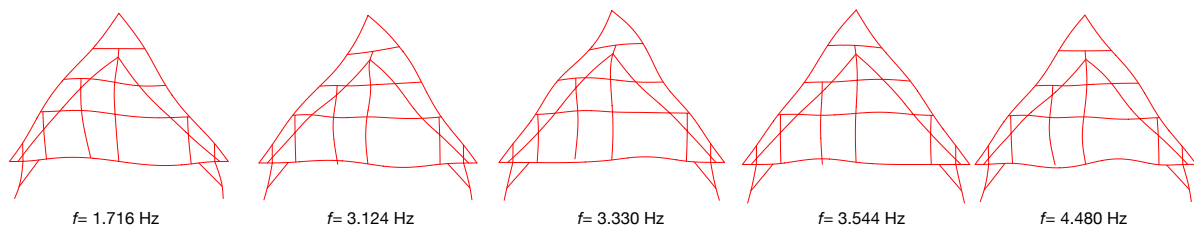
Figure 14: From left to right: the first five modal forms of FN3, CAST3M simulation.

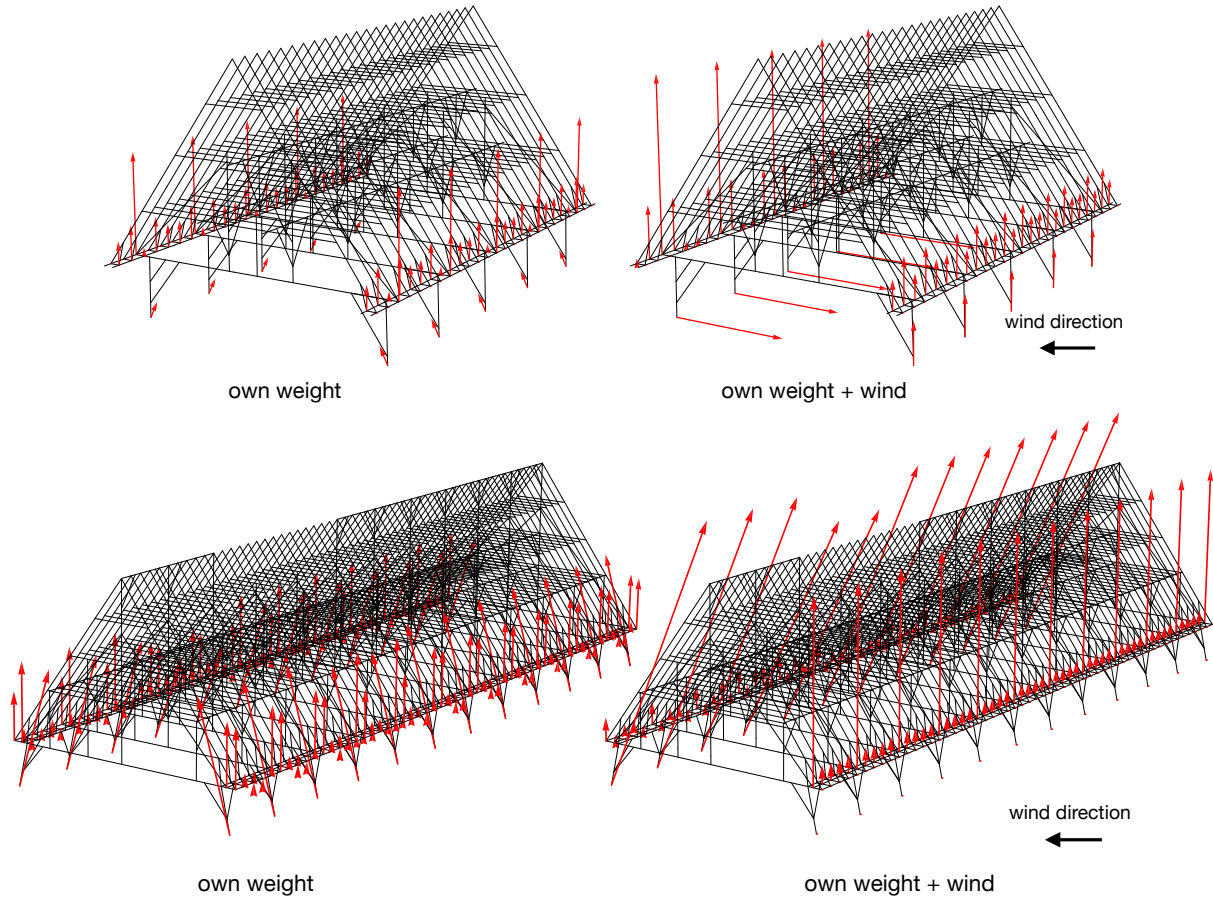
Figure 15: Distribution of the reaction forces in the original state; top, the choir's *charpente*, bottom the nave's one.

scheme, S2, S4, S6, S8 and S10 are inactive, while S1, S3, S5, S7 and S9 active. It is interesting to notice the high reaction at node S5, consequence of the structural scheme. The distribution of the reaction forces is depicted in Fig. 15, for the original state. Better than the data in Tab. 5, this two figures let see how the distribution of the reactions on the top of the guttering walls was far from being uniform. The main part of the load is transmitted by the *chevrons maîtres*, that play a fundamental role in the structural functioning of the *combles*.

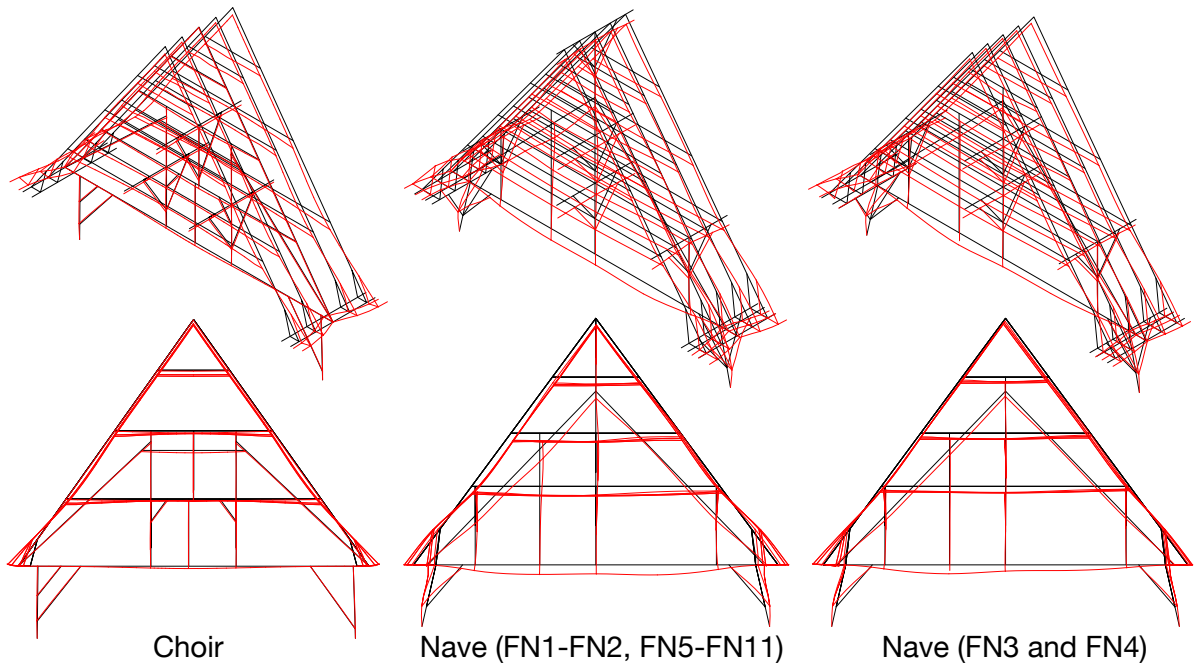
Figure 16: Deformation of the structural units of the *charpente*, in the original state, for the own weight (displacements magnified).

points A and B indicated in Fig. 13 are shown. The entity of the displacements is very small in all the cases.

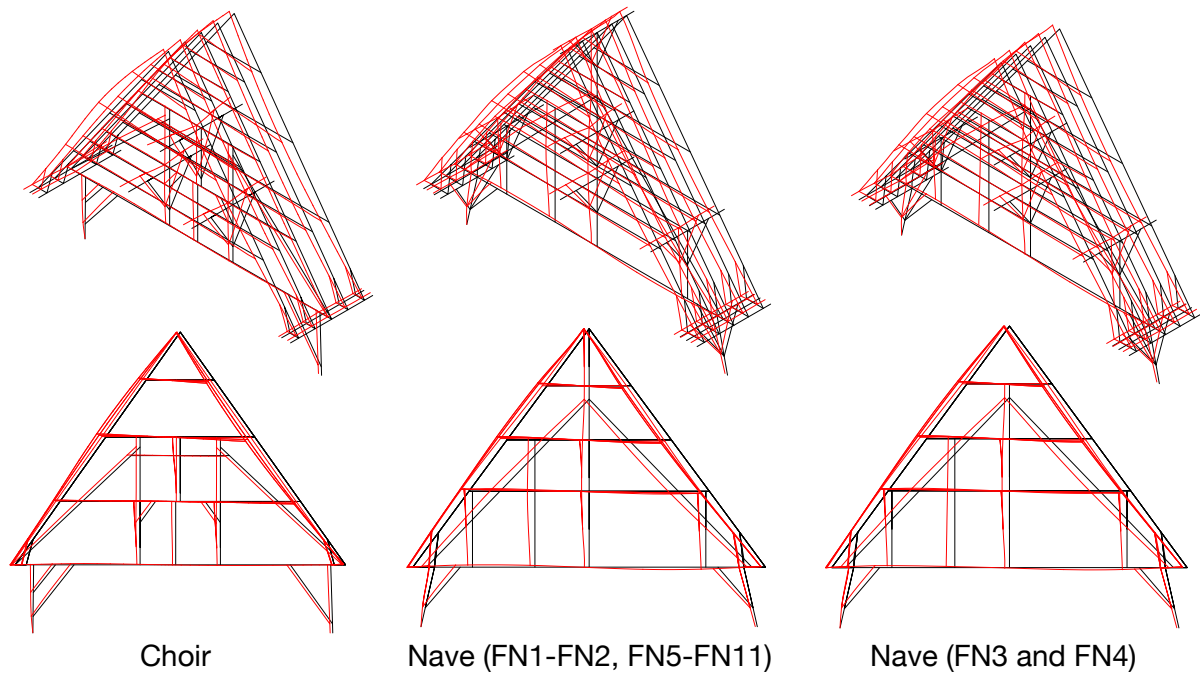
Figure 17: Deformation of the structural units of the *charpente*, in the original state, for the own weight and wind (displacements magnified).

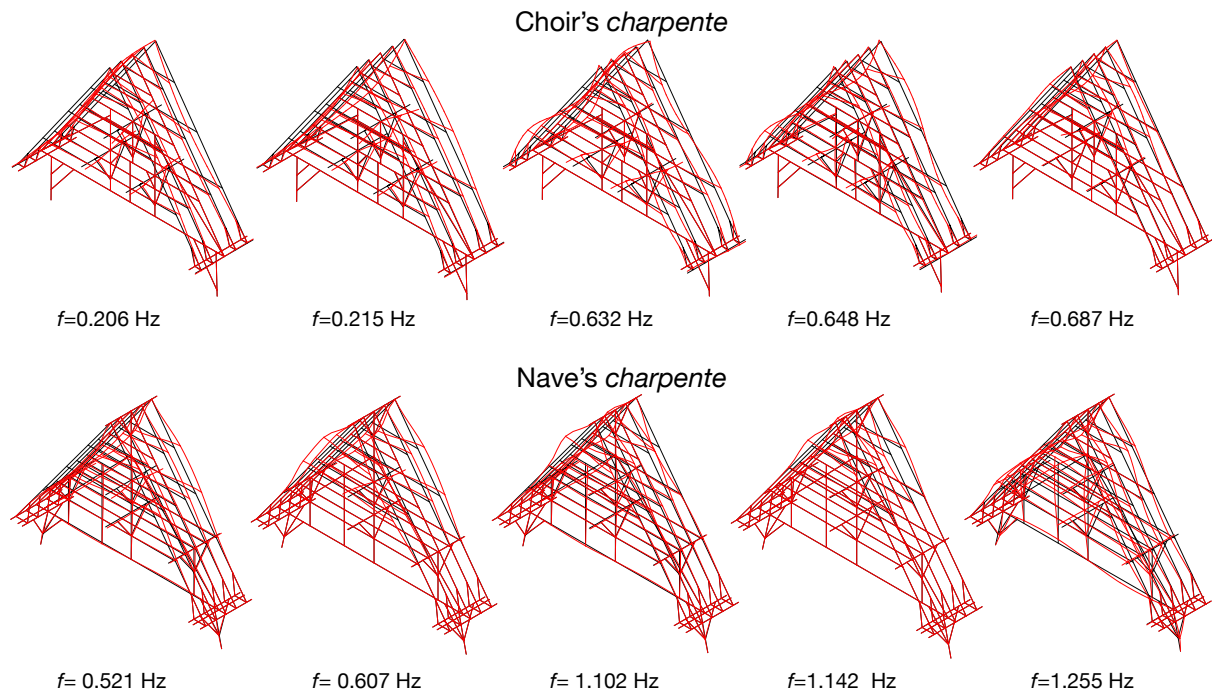
Figure 18: First five normal modes and corresponding vibration frequencies, original state.

Undoubtedly the solution of a *charpente* with *chevrons formant fermes* allowed the use of trunks of moderate diameter, easier to be found in the France of the Middle Ages, so realizing relatively light structures, though this seems more properly dictated by economical reasons than by statics. In fact, the dimensions used for the timber beams are largely sufficient to withstand the loads and a heavy load on the top of the clerestory walls could help in stabilizing the whole construction, knowing that the stress level in the stone of a Gothic cathedral is normally far from being critical, Heyman [1995]. Anyway, the change of the static scheme from the choir's *charpente* to the nave's one was certainly not dictated by economical reasons, because the mass of wood for unit length of longitudinal axis is greater for the nave. What clearly appears from a study of the two *charpentes* is that the nave's one is better designed and that this results in an increased stiffness of the wall structure. This is confirmed by a comparative modal analysis of the two *charpentes*: the structural unit of the nave has a fundamental frequency which is much higher than that of the choir, for about the same mass.
