# Temperature Accelerated Life Test and Failure Analysis on Upright Metamorphic Ga<sub>0.37</sub>In<sub>0.63</sub>P/Ga<sub>0.83</sub>In<sub>0.17</sub>As/Ge Triple Junction Solar Cells

A temperature accelerated life test on Upright Metamorphic Ga<sub>0.37</sub>In<sub>0.63</sub>P/Ga<sub>0.83</sub>In<sub>0.17</sub>As/Ge triple-junction solar cells has been carried out. The acceleration has been accomplished by subjecting the solar cells to temperatures (125, 145 and 165°C) significantly higher than the nominal working temperature inside a concentrator (90°C), while the nominal photo-current (500×) has been emulated by injecting current in darkness. The failure distributions have been fitted to an Arrhenius–Weibull model resulting in an activation energy of 1.39 eV. Accordingly, a 72 years warranty time for those solar cells for a place like Tucson (AZ, USA), was determined. After the ALT, an intense characterization campaign has been carried out in order to determine the failure origin. We have detected that temperature soak alone is enough to degrade the cell performance by increasing the leakage currents, the series resistance, and the recombination currents. When solar cells were

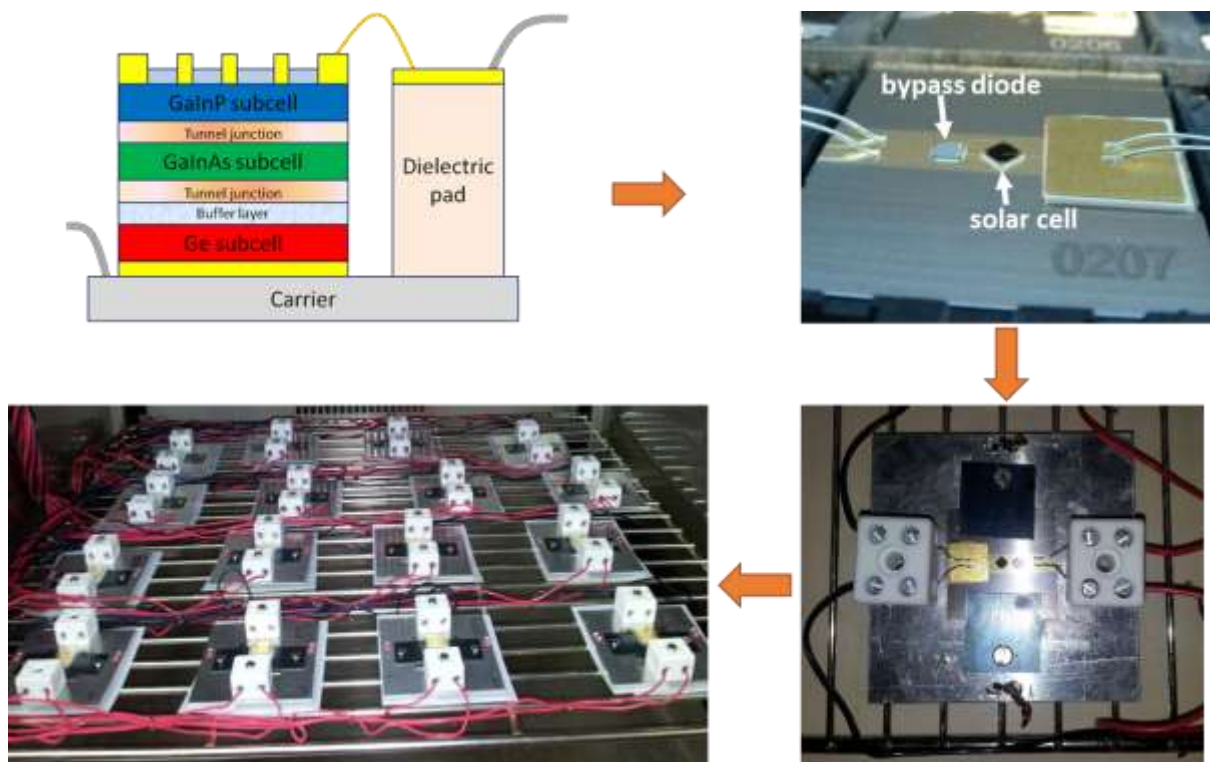
Figure 1. Schematics of the tested UMM CoC (top left), a picture of a CoC (top right), picture of the CoCs onto aluminum heatsinks with connectors (bottom right) and experimental setup of several CoCs inside one of the climatic chambers (bottom left). The bypass diodes such as those shown on the top right picture were disconnected from all the solar cells before the ALT

The CoCs with the UMM cells (see Figure 1 top left and right) were manufactured by Fraunhofer ISE (Germany) and were designed to be mounted inside a concentrator module using Fresnel lenses at  $500\times$  where the nominal working temperature is  $90^\circ\text{C}$  [8]. The maximum temperature the CoC can withstand is  $170^\circ\text{C}$  (limited by the solder stability). The CoCs were then sent to the Solar Energy Institute of the Universidad Politécnica de Madrid (IES-UPM, Spain) to carry out the pre-test characterization and the ALT. Additionally some characterization for the failure analysis was also carried out by the University of Málaga (UMA, Spain).

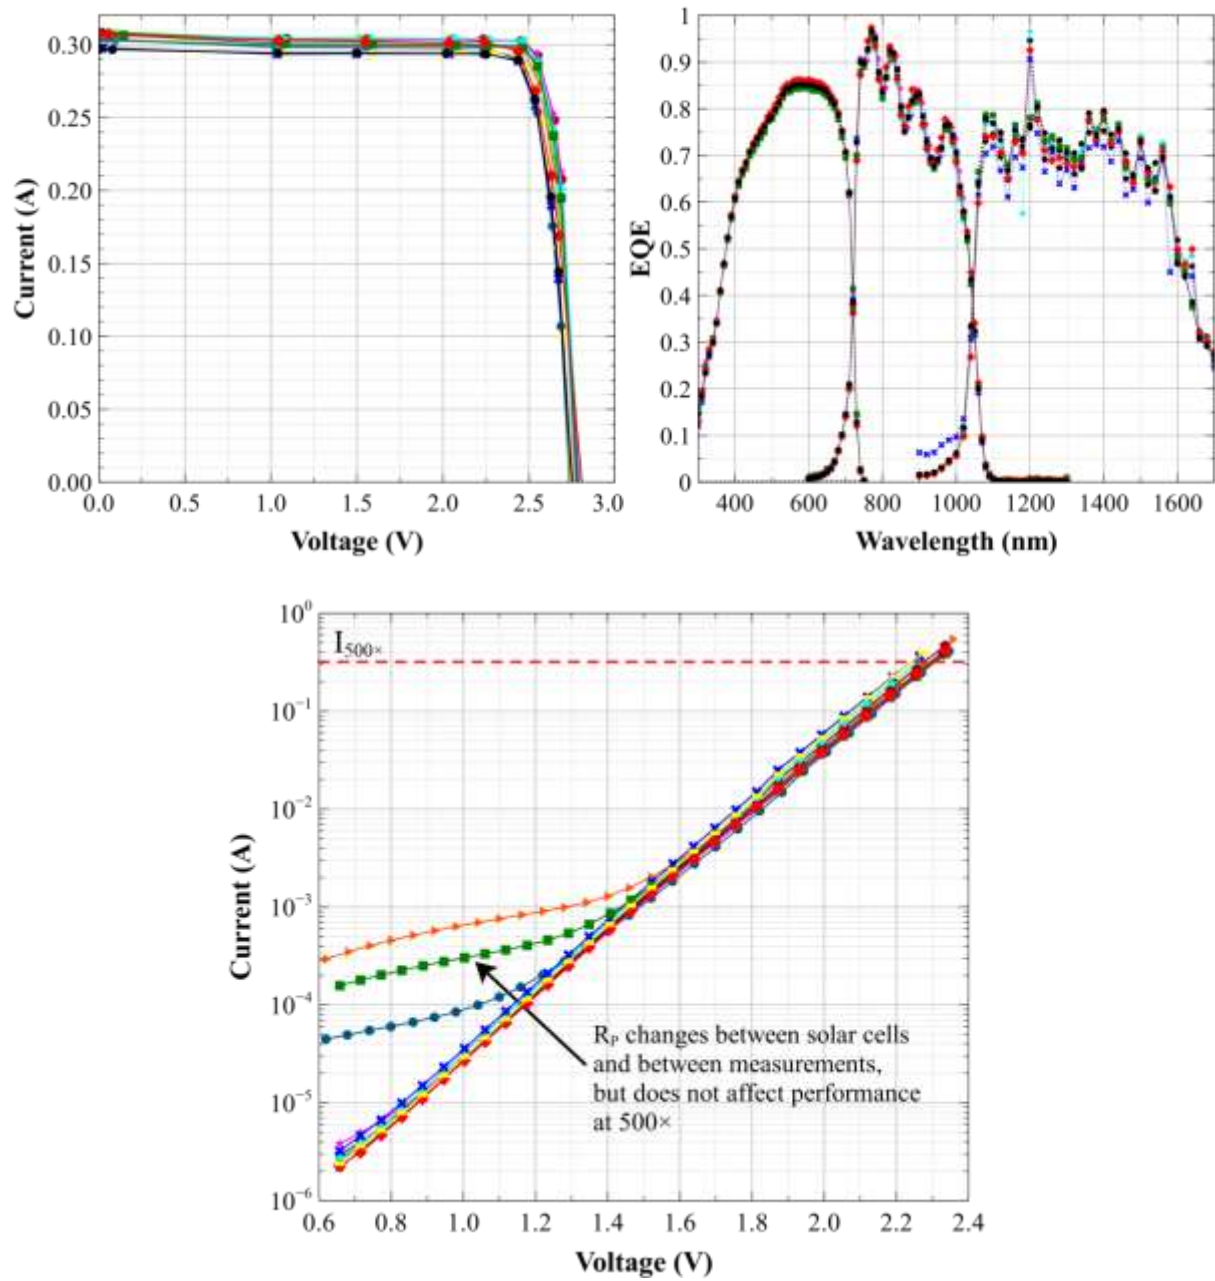
Figure 2. Illumination I-V curves at 500× (top left), EQE (top right), and dark I-V curves (bottom) of several solar cells before the ALT. A feature of these solar cells is that the shunt resistance changes with time (goes higher and lower), but it never gets low enough to affect performance at nominal working conditions.

The first step to carry out the ALT is to assess the performance of the devices before the degradation process. Forty-eight solar cells were carefully characterized by means of dark I-V curve,  $1\times$  and  $500\times$  illumination I-V curve, electroluminescence (EL) mapping, and external quantum efficiency (EQE). These measurements were used to quantify the degradation observed in the devices throughout the ALT and post-test analysis, and to support the failure analysis process. Figure 2 (top left) shows the illuminated I-V curves at  $500\times$  of the solar cells before the ALT. The dispersion for both short circuit current ( $I_{sc}$ ) and open circuit voltage ( $V_{oc}$ ) is less than 3% while the dispersion for the maximum power point ( $P_{MPP}$ ) is less than 5%. Figure 2 (top right) shows the EQE, and Figure 2 (bottom) shows the dark I-V curve for the solar cells before the ALT. Notice that the dark I-V curve of some cells exhibit a low shunt resistance ( $R_p$ ) at very low currents probably due to accidental processing differences among devices. This signature is far away from the operation point at  $500\times$  where the devices have to be tested for reliability purposes

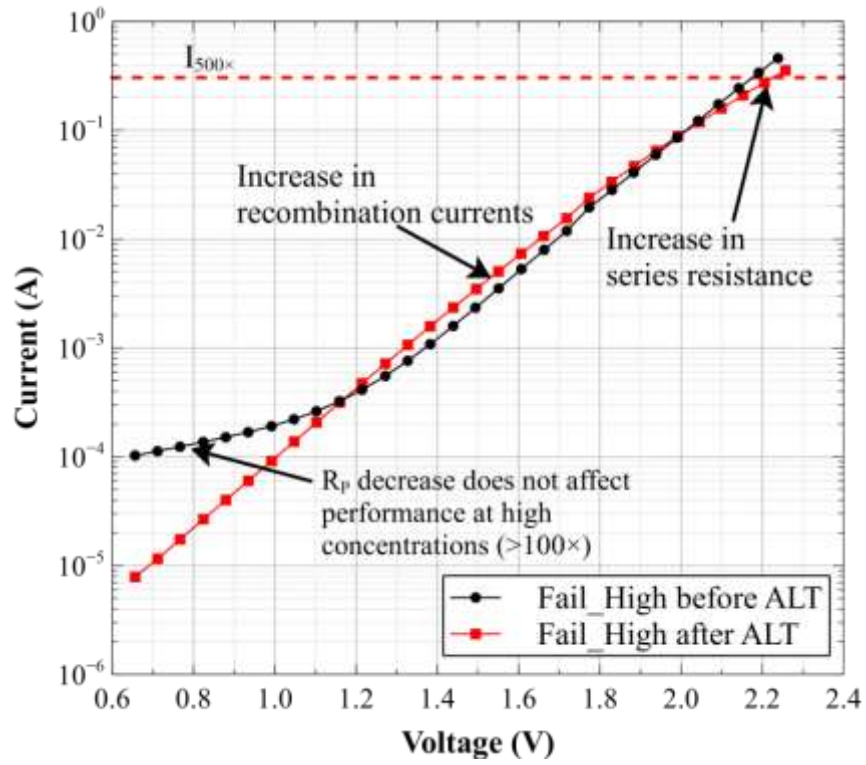
Figure 3. Typical dark I-V curve evolution of a degraded solar cell (“Fail\_High” of Table 1). Two main degradation mechanisms are observed: (1) an increase in recombination current and (2) an increase in series resistance. The shunt resistance improves/worsens between cycles without affecting the performance of the solar cell at 500×

The nomenclature used in Table 1 comes from changes observed in the dark I-V curves after the degradation tests. Figure 3 shows the typical evolution of a degraded solar cell (in this particular case, “Fail\_High” of Table 1) where the two main degradation processes are: (1) an increase in the recombination current, and (2) an increase of series resistance. Figure 3 also shows a shunt resistance variation which improves/worsens between cycles but without affecting the performance of the solar cell at 500×. Therefore, the shunt resistance variation is not relevant for the reliability analysis considering the nominal working conditions. Since two degradation mechanisms are observed, it is important to understand the time evolution of the dark I-V curve to analyze which degradation mechanism is dominating the solar cell performance. Figure 4 shows the evolution of the dark voltage at a current equivalent to the  $I_{mpp}$  for several “Fail\_High” solar cells. The first degradation process that appears is the

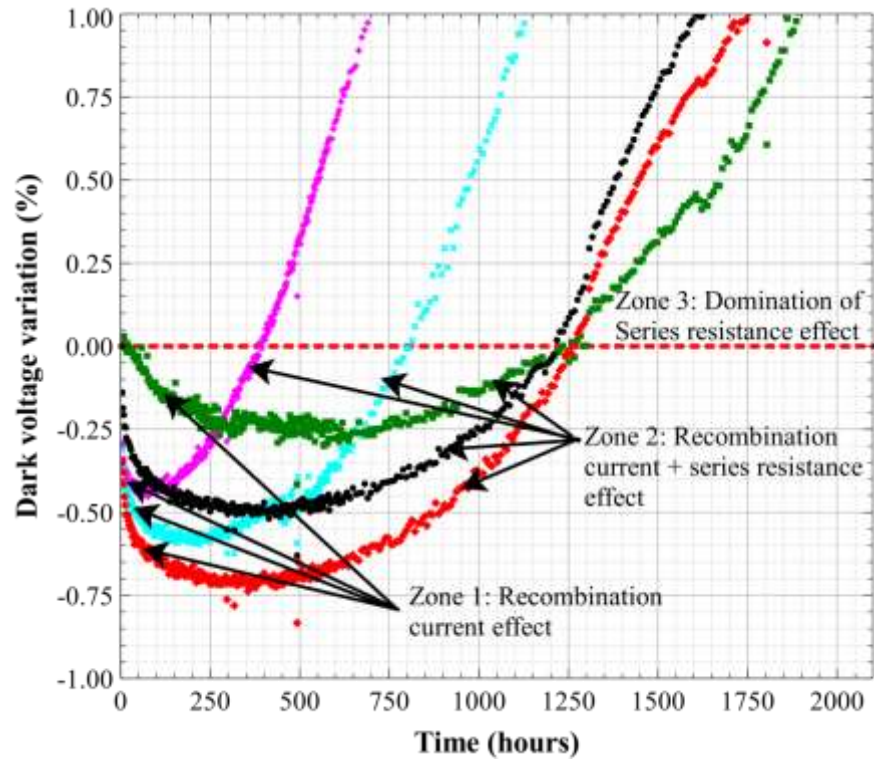
Figure 4. Evolution of the dark voltage at equivalent illumination operation conditions ( $I_{500\times}$  of Figure 4) as a function of test time for several “Fail\_High” solar cells. The time evolution shows that initially the solar cells exhibit a slight increase in recombination current (dark voltage decreases) while after some hundreds of hours the series resistance increase (dark voltage increases) dominates the degradation process. Different colors mean different devices

namely the “Deg\_High\_Rs” cell. In these cases, the solar cells were at zone 3 of Figure 4 on which series resistance dominates. However, the “Deg\_Low\_Rec” cells fall out of the red line of Figure 17 since those cells were at the zone 1 of Figure 4 where recombination current increase rules degradation while series resistance has not still appeared.

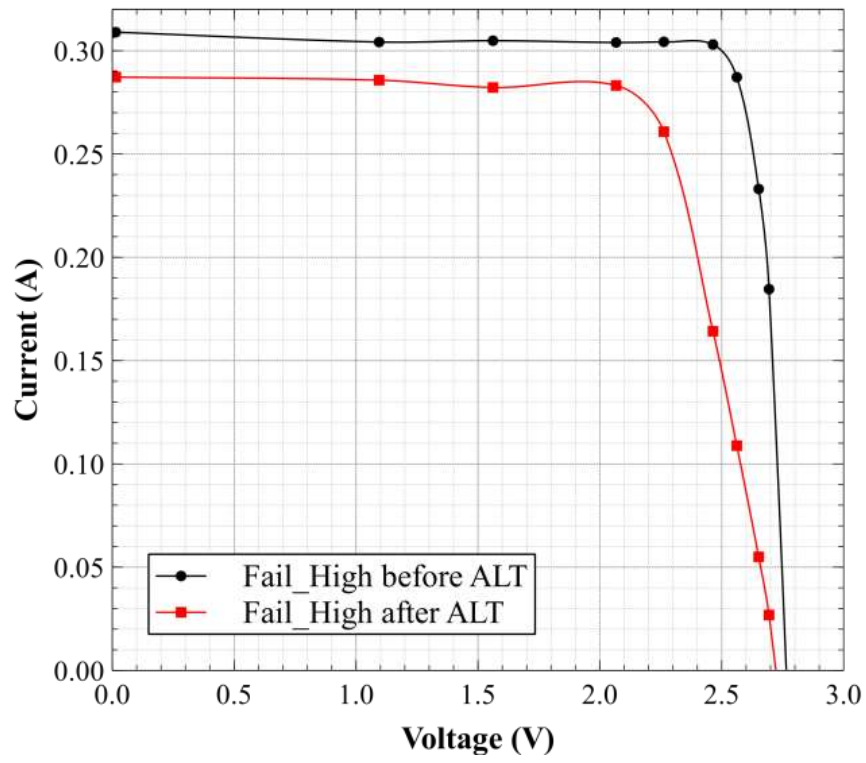
Figure 5. Comparison of illumination I-V curves at 500× before and after ALT for a solar cell degraded at 165°C.

The dark I-V curves provide a lot of information on the degradation of the solar cells, but they do not allow by themselves to determine when the solar cell has failed (notice that we have stated above the solar cell failure as the illumination power loss greater than 10% at 500×). Therefore, in order to connect the dark I-V curve evolution with the illumination power loss some solar cells were taken out of the climatic chambers during the ALT to quantify their degradation (see Table 1). Figure 5 shows the typical illumination I-V curves at 500× for a degraded cell at 165°C.

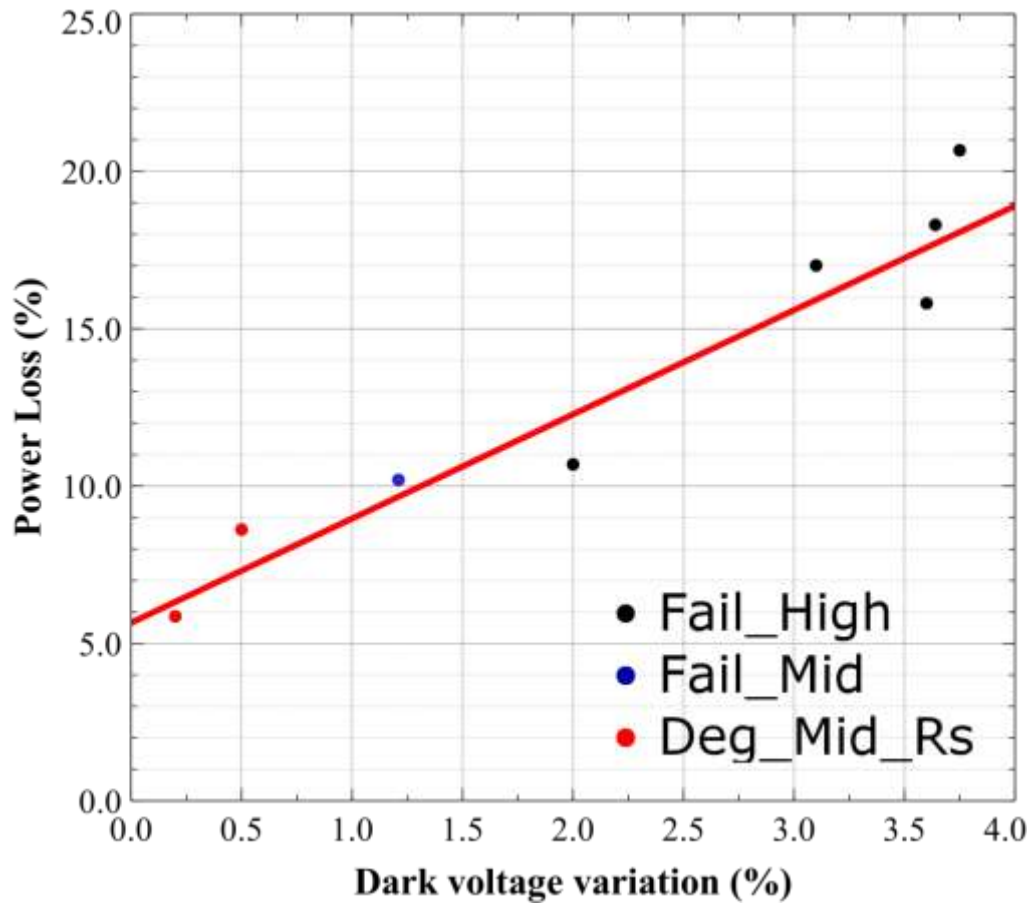
Figure 6. Experimental (black points) and average tendency (red line) illumination power loss at 500× vs. voltage variation in darkness (at the current equivalent to 500× illumination). Notice that at zero volts variation in darkness there is an illumination power loss of around 5% because of the increase in recombination current (decrease of dark voltage) although in terms of voltage variation is compensated by series resistance (increase of dark voltage) as can be seen in Fig. 4.

By combining dark and illumination I-V curves it is possible to correlate the power loss under illumination with the voltage variation in darkness. Figure 6 shows this correlation for several “Fail\_High”, “Fail\_Mid” and “Deg\_Mid\_Rs” solar cells when a dark voltage variation of  $1.2 \pm 0.2\%$  corresponds to a 10% illumination power loss (which is the failure criterion). This correlation was used to determine the moment on which a solar cell had failed. Accordingly, when a solar cell inside the climatic chamber had a dark voltage variation of 1.2% the total hours were recorded, and the solar cell was regarded as a failure. Additionally, the failed solar cell was disconnected from the current source and was taken out from the climatic chamber for characterization.

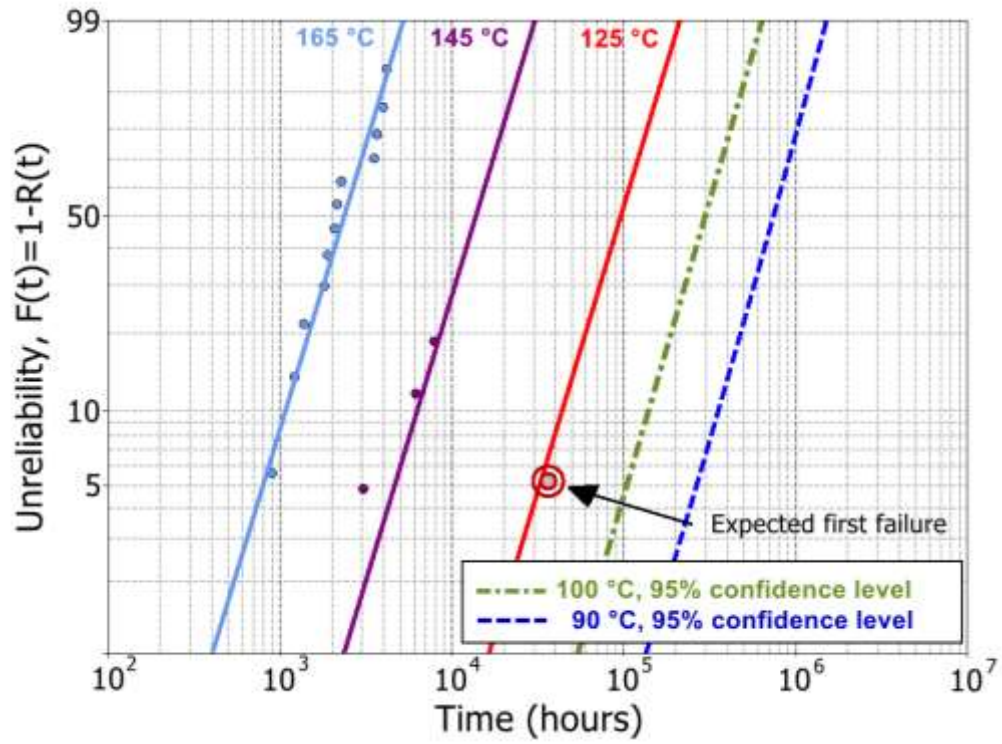
Figure 7. Unreliability vs. time plot for every stress temperature used in the ALT and extrapolated results at 90°C and 100°C with a 95% confidence level. The dark red target represents the time for the expected first failure in the 125 °C test (around 40,000 hours)

After 8,900 hours of test time (time for which the solar cells where under forward bias): a) all the solar cells on the 165 °C test had failed (the last failure at 165 °C happened after ~4,000 hours, see blue dots in Figure 7), b) three solar cells on the 145 °C test had failed also, and c) there were no failures on the 125 °C test. Using the statistical analysis (see Section 3) the probable time for the next failure on the 145 °C test was calculated, which resulted in around 1,500 additional hours of test time (approximately 3 additional months of testing, see Section 3), and the probable time for the first failure at 125 °C test resulted in around 40,000 hours (approximately 48 additional months of testing!) as shown in Figure 7. Continuing the test was impractical, so the test was stopped to start the reliability and failure analysis, whose results are shown in Section 3 and 4, respectively.

Figure 7 shows the Weibull failure probability plot for the three temperature ALTs together with the extrapolated results at 90 °C (nominal working temperature) with 95% confidence

The failure time data in the Weibull plot of Figure 7 shows that the model fitted by the maximum likelihood estimation (MLE) method reproduces the experimental data of the ALT with a very good fit.

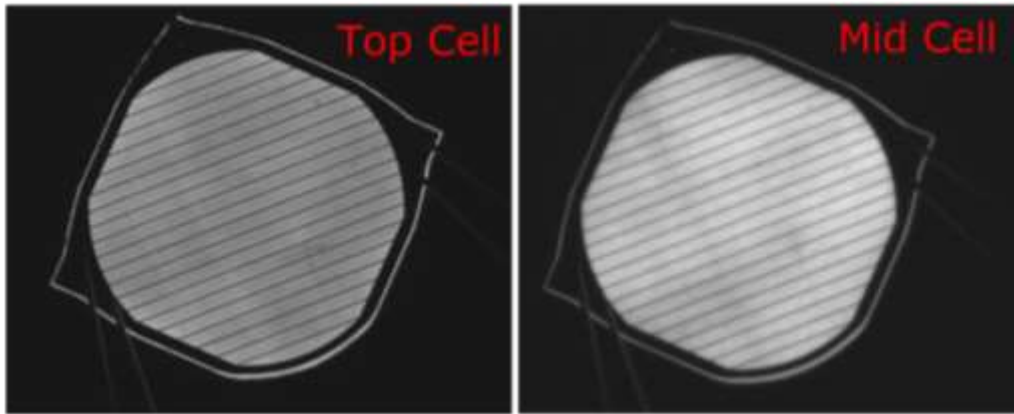
Figure 8. Typical EL maps of top and middle subcells before the ALT

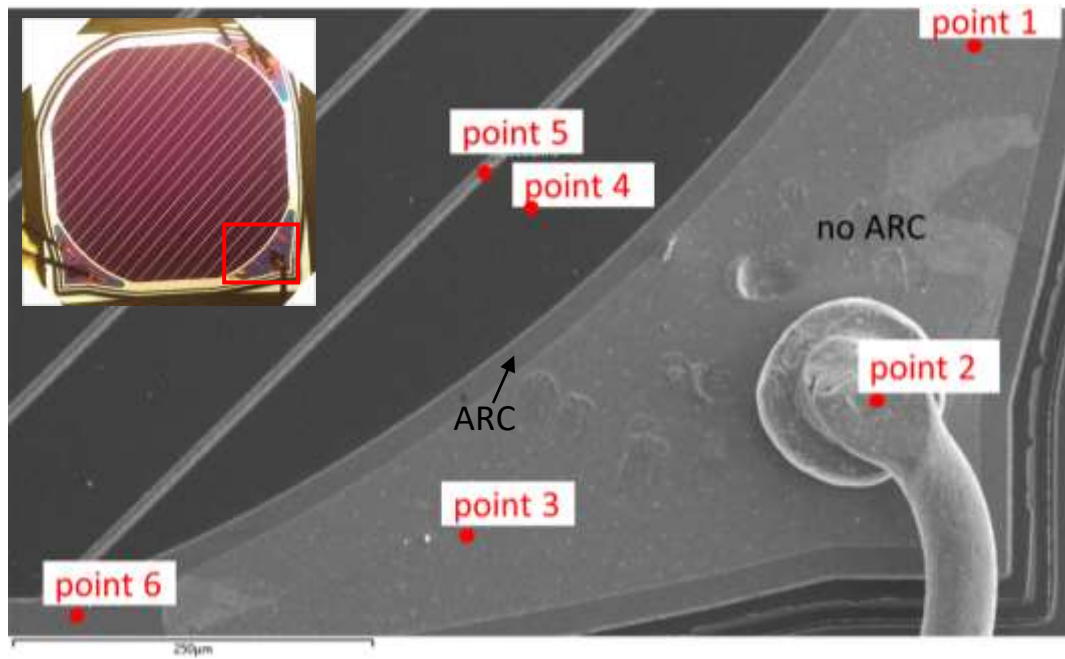
Figure 9. Planar view SEM image of the “Char\_Ref” solar cell surface, showing the points where EDX analysis has been performed. The clearest area of the busbar has no ARC while out of this region, ARC is deposited. The inset on the top left shows the region of the solar cell being analyzed.

The composition at the surface of the active area (point 4) is Al–Ga–In–P, suggesting an Al(Ga)InP window on the GaInP top subcell. The ARC, which covers the active area, the fingers (point 5) and the perimeter zone of the busbar surface (Point 6), is very probably made up of  $\text{TiO}_x/\text{AlO}_x$ . Points 1, 2 and 3 correspond to the metallic busbar not covered by the ARC, showing that the main constituents are Ag and Au. Analyses of metals covered by the ARC in points 5 (finger) and 6 (busbar) corroborate the composition of the metallization grid.

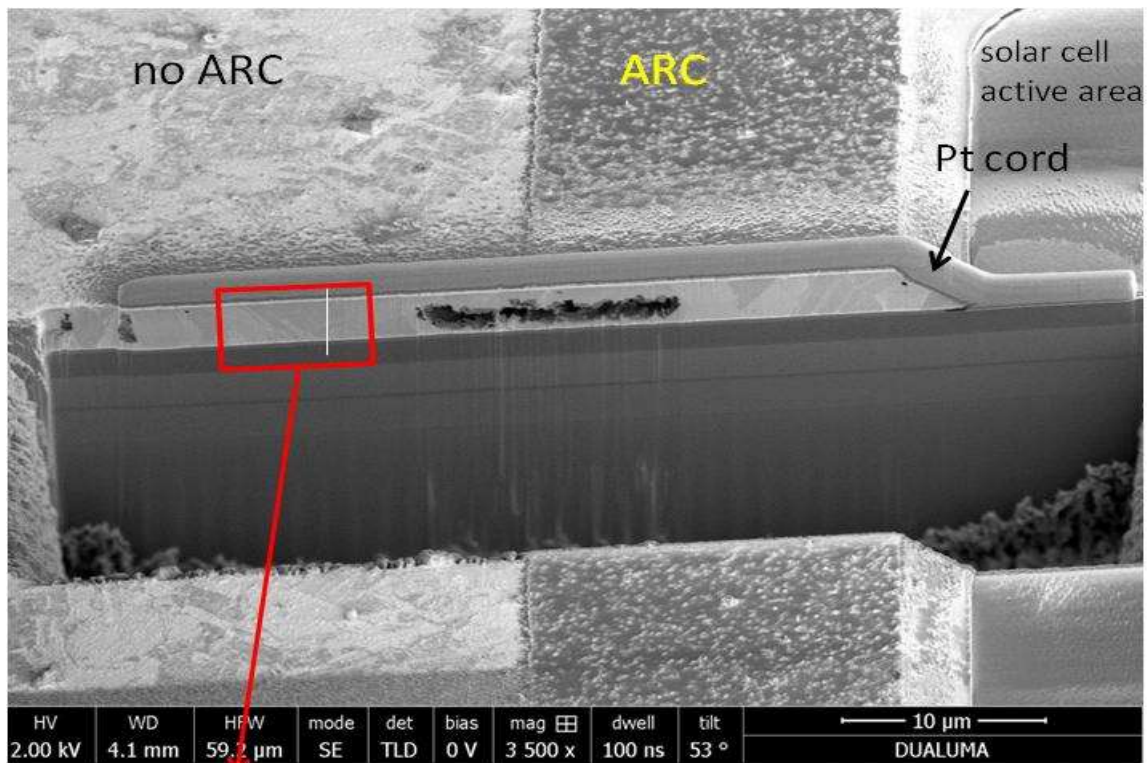
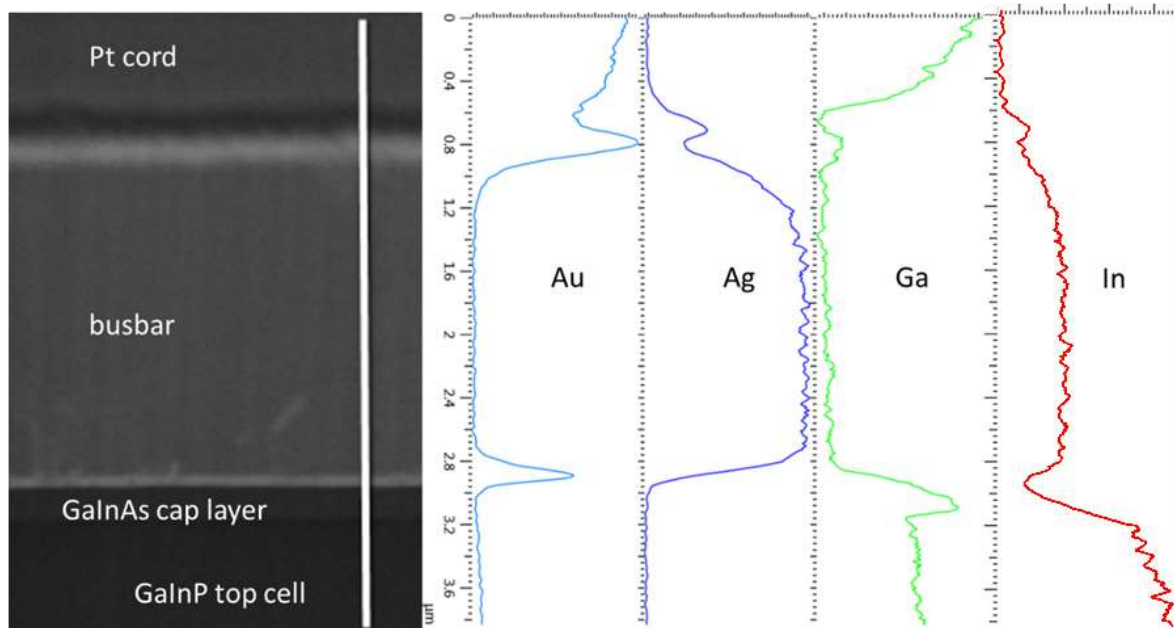
Figure 10. Top: SEM micrograph after FIB milling of the bus metallization cross-section of the “Char\_Ref” solar cell. Pt cord is deposited in order to protect sample surface during FIB. Bottom: (left) SEM micrograph of the busbar between the Pt cord and the Ga(In)As cap layer. White vertical line corresponds to the length scale on the right. (Right) Main element profiles along the analyzed length. Au, Ag, Ga and In signals have fake artifacts around 0.6-0.7 microns depth due to Pt signal. Ga implantation in the Pt cord due to FIB procedure is the cause of the Ga increase in the first half micron.

Some other mapping analyses have been done along finger sections. Metallization follows the same scheme as in the busbars. In some analysis, some non-uniform thickness cross sections have been revealed after FIB milling, where a void in Ag bulk can be observed. The existence of these metal voids together with the surface roughness (see Figure 10 top) would be compatible with an electroplated silver layer.

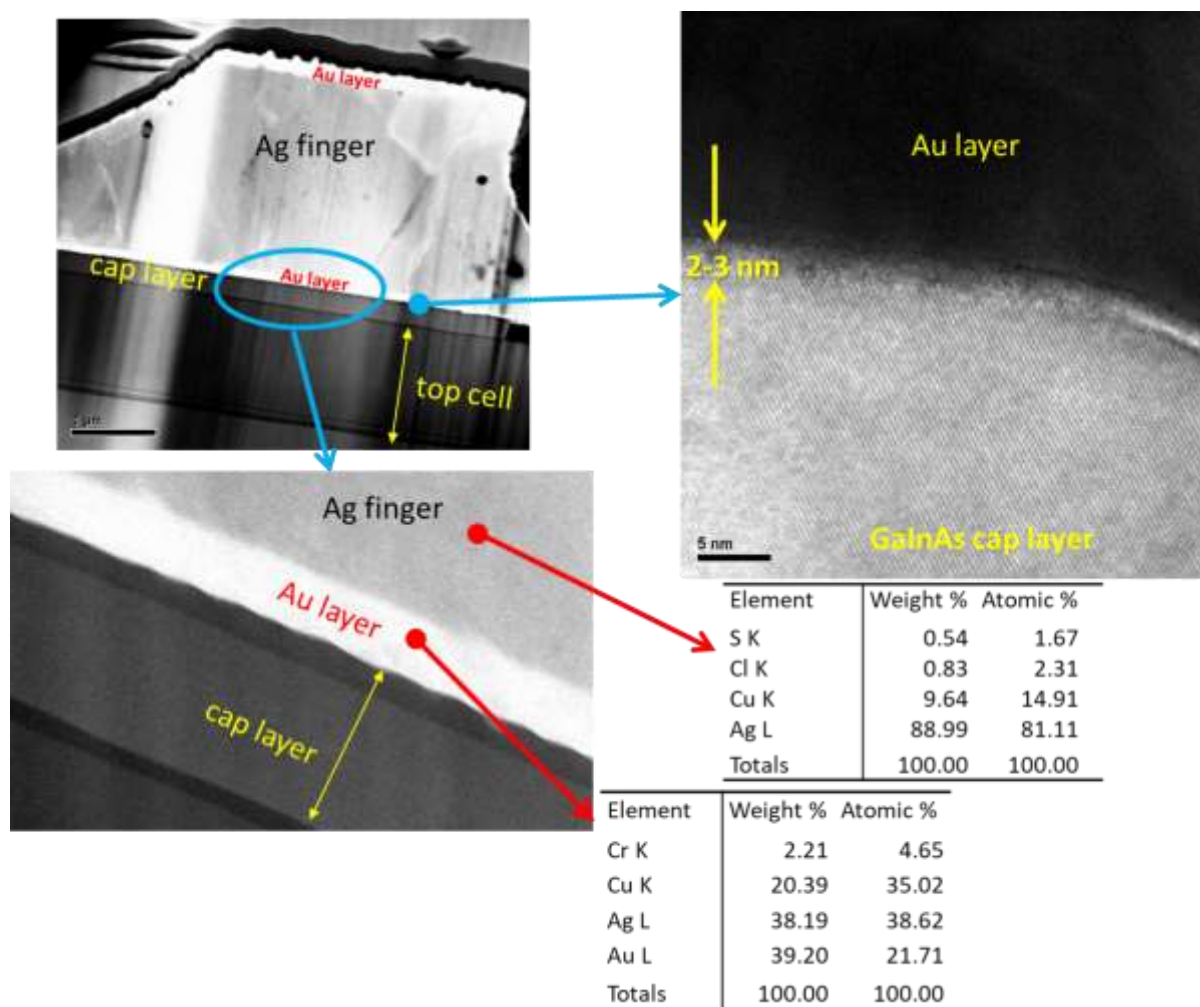
Figure 11. Cross-section view STEM image of a finger of the “Char\_Ref” solar cell (top left), showing the area where EDX analysis has been performed (bottom left). Copper presence in the EDX analysis derives from the sample holder. HRTEM of the Au/Ga(In)As interface (right)

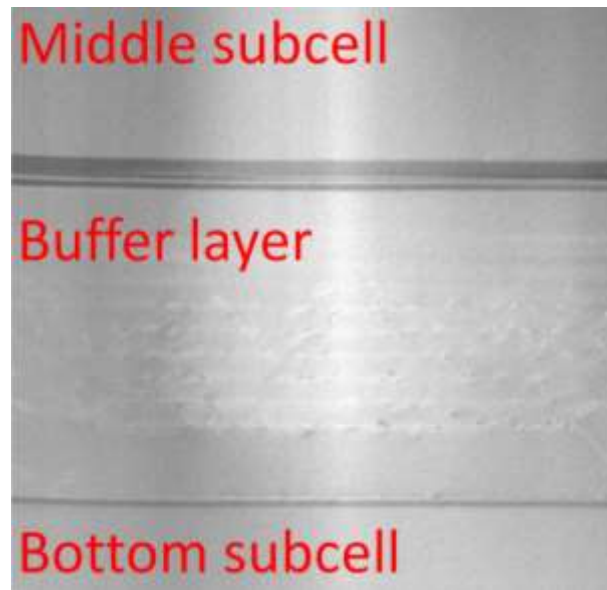
Figure 12. Cross-section view STEM image of the lower part of the semiconductor structure of a “Char\_Ref” solar cell, highlighting the buffer layer.

Another zone of interest to be characterized on UMM solar cells is the buffer layer between the bottom cell and middle cell (see figure 1) where defects could create or propagate under given stress conditions. Accordingly, STEM images were carried out on the buffer layer cross section and no defects were detected (see Figure 12).

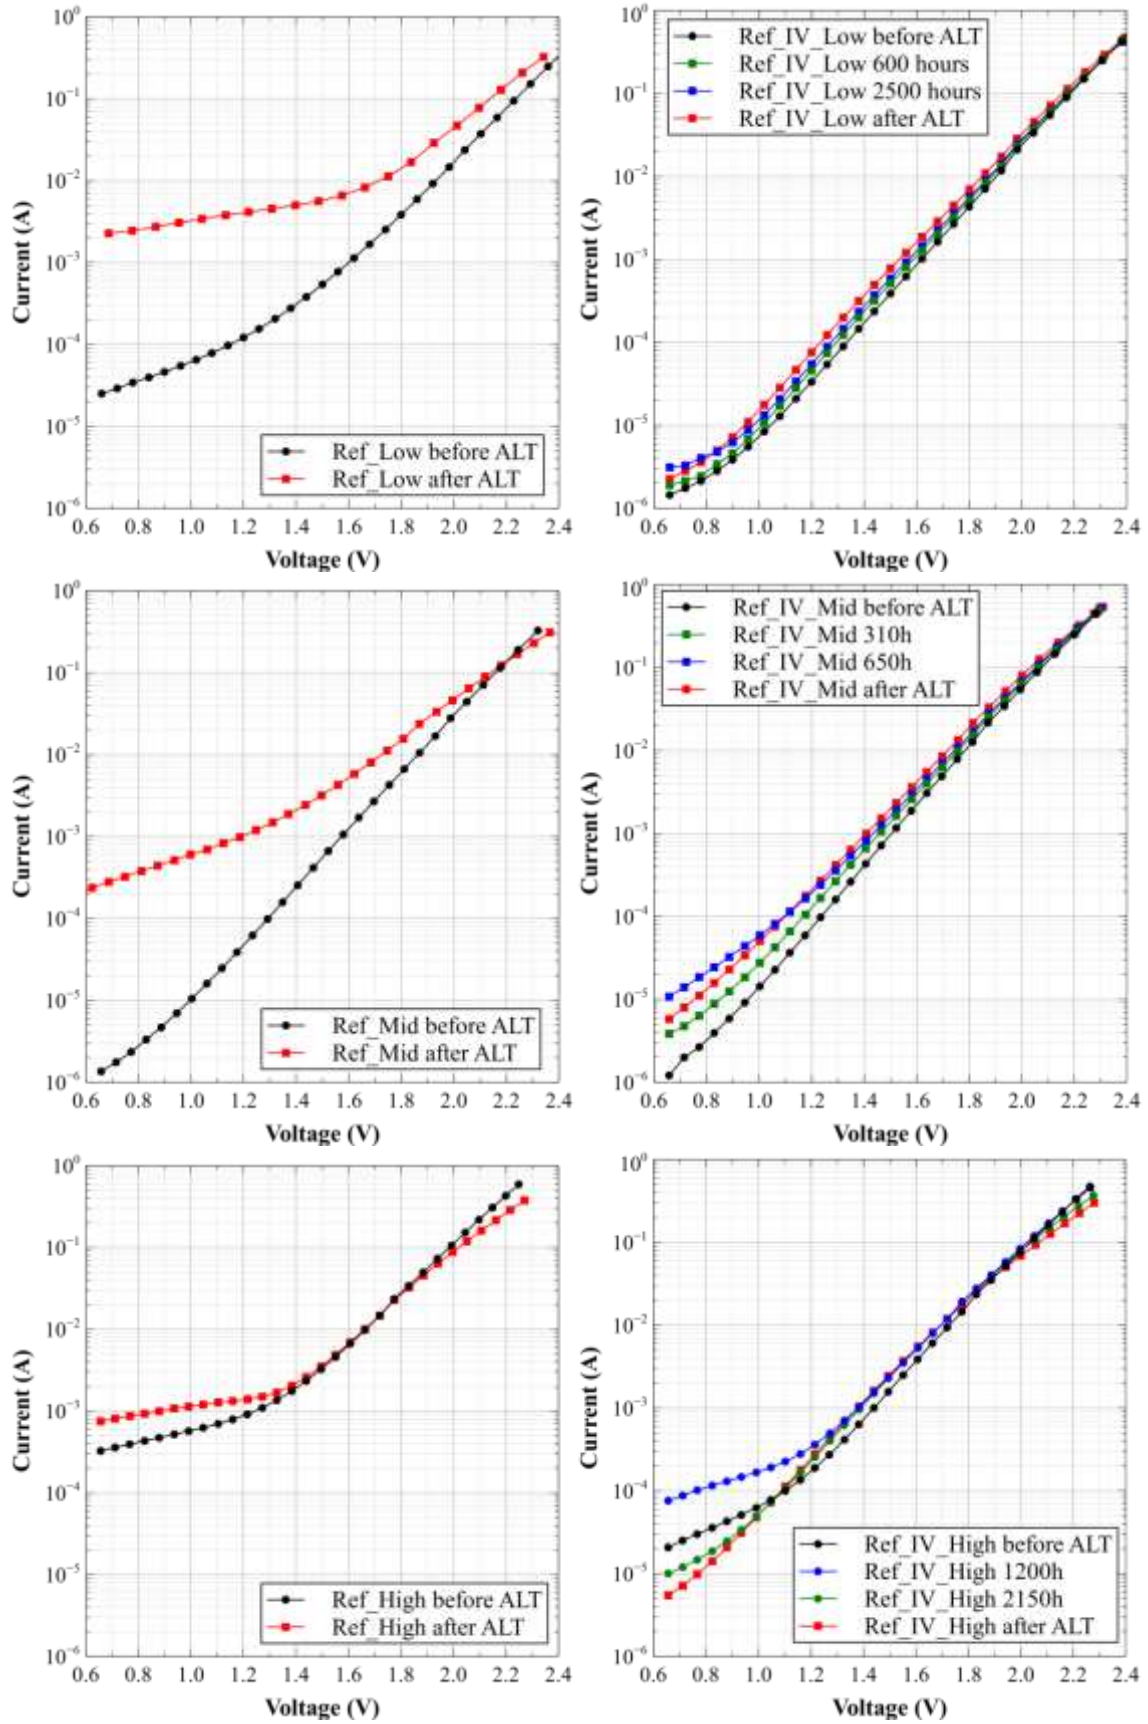
Figure 13. Comparison of the dark I-V curves of the reference solar cells (those without I-V measurements) before and after ALT (left). Evolution of the dark I-V curves for different times of the reference solar cells (those with I-V measurements) during ALT (right).

was only stressed by the temperature of the chamber, while the other cell was also stressed by temperature but its dark I-V curve was measured periodically (same periodicity as for the solar cells under current bias). The purpose of these reference solar cells is to observe if any failure mechanism is activated by temperature soak alone, or by a combination of temperature soak and the bias applied during the measurement of the I-V curves. Figure 13 shows the dark I-V curves of the reference solar cells.

The left column of Figure 13 shows that the solar cells with temperature soak alone (“Ref\_Low”, “Ref\_Mid” and “Ref\_High”) experience two effects: a) a decrease of the shunt resistance and b) a rise of series resistance which increases with temperature. This impact of the temperature was not observed in commercial lattice-matched GaInP/Ga(In)As/Ge triple junction solar cells [3]. An interesting feature is observed when comparing the left (temperature soak only) with the right column of Figure 13, where the time evolution of the dark I-V curve of solar cells stressed by temperature but with periodical measurement of their dark I-V curve is presented: the deleterious effect of series resistance caused by the temperature soak in “Ref\_IV\_Low” and “Ref\_IV\_Mid” is counterbalanced by the current injection when measuring the dark I-V curve. Just for the “Ref\_IV\_High” solar cell, current injection is not able to completely counteract its series resistance increase while the shunt resistance is even better at the end of the process (red dotted line) than that of the initial stage (black dotted line). Furthermore, an increase of recombination current with test time is found for the three cells “Ref\_IV\_Low”, “Ref\_IV\_Mid” and “Ref\_IV\_High”. The improvement of the shunt resistance could be related to the energy supplied by the current injection during the measurement process, that could reorder crystalline defects (such as in an annealing process), polarize vacancies, fill traps, etc. Therefore, the paths for current to leak substantially change due to current injection.

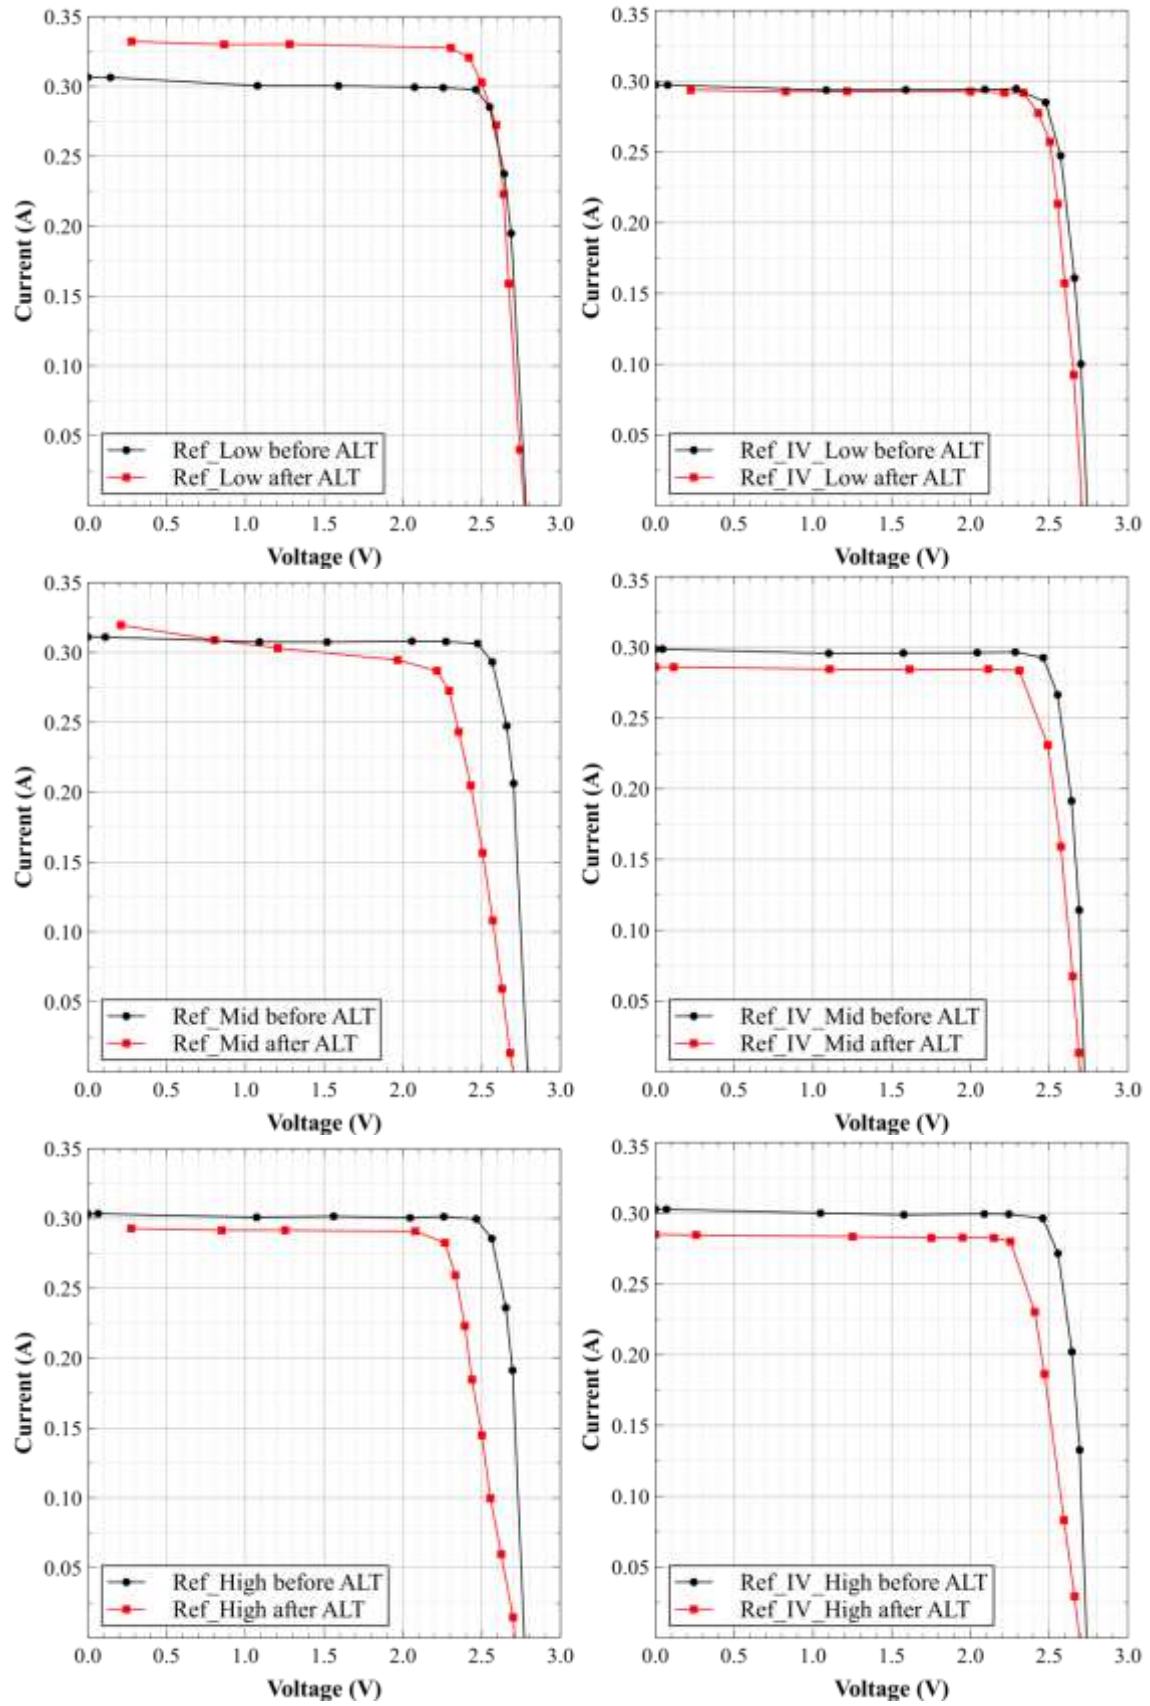
Figure 14. Comparison of the Illumination I-V curves at 500 $\times$  of the reference solar cells of Figure 13 before and after ALT.

Figure 14 shows the illumination I-V curve of the same reference cells of Figure 13. In the left column the effects of temperature on both series and shunt resistance shown in Figure 13 are confirmed under illumination. An interesting aspect is that of the short circuit current variation. For “Ref\_Low” and “Ref\_Mid” solar cells, an  $I_{sc}$  increase is detected which could be explained by the low shunt resistance observed in their dark I-V curves. This can be explained when the limiting subcell in the multijunction is shunted and then more current is allowed to flow through the solar cell as this subcell is under negative bias at  $I_{sc}$ . A more thorough explanation of this effect can be found elsewhere [20]. Since the “Ref\_Low” cell exhibits a very low shunt resistance an artificial  $I_{sc}$  increase comes up, while for the “Ref\_Mid” cell the shunt resistance is higher, thus resulting in the typical tilt of the illumination I-V curve. Regarding “Ref\_High” solar cell, which presents no shunt effect under illumination as expected from dark conditions, an  $I_{sc}$  decrease is detected. This  $I_{sc}$  reduction is confirmed in the right column of Figure 14 where no shunt current effect merges, as previously explained thanks to the beneficial effect of current injection.  $I_{sc}$  decrease is more intense with the soak temperature.

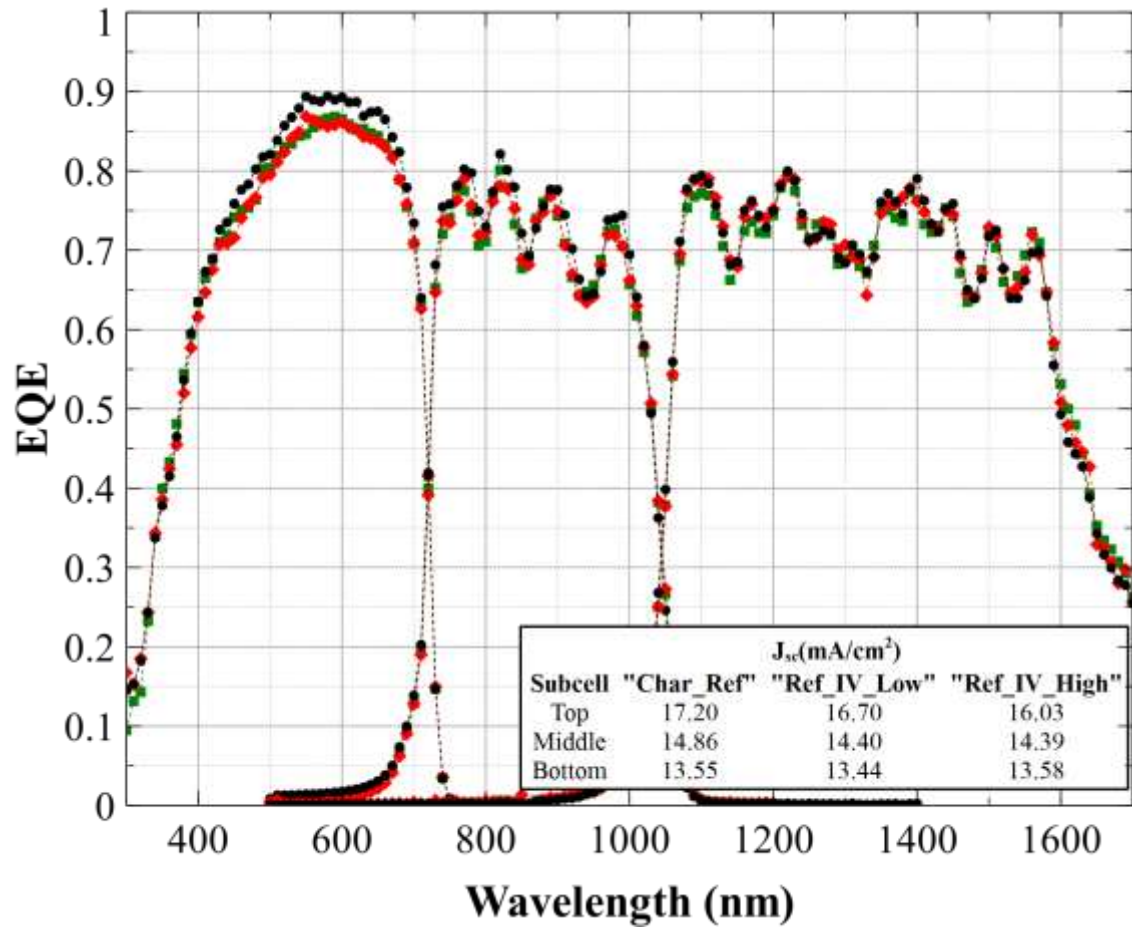
Figure 15. Comparison of the EQEs of “Char\_Ref” (black circles), “Ref\_IV\_Low” (red circles) and “Ref\_IV\_High” (green circles) solar cells. The bottom inset shows the calculated  $J_{sc}$  of each subcell under spectrum AM1.5d ASTM G173–03.

In order to know the origin of the  $I_{sc}$  reduction, we have measured the EQE of some cells. Figure 15 shows that “Ref\_IV\_Low” and “Ref\_IV\_High” cells exhibit degradation of their performance compared to the “Char\_Ref” cell. For both cells, the top GaInP subcell exhibits

the main degradation, followed by a very small degradation of middle Ga(In)As subcell. No significant degradation of the bottom subcell is detected.

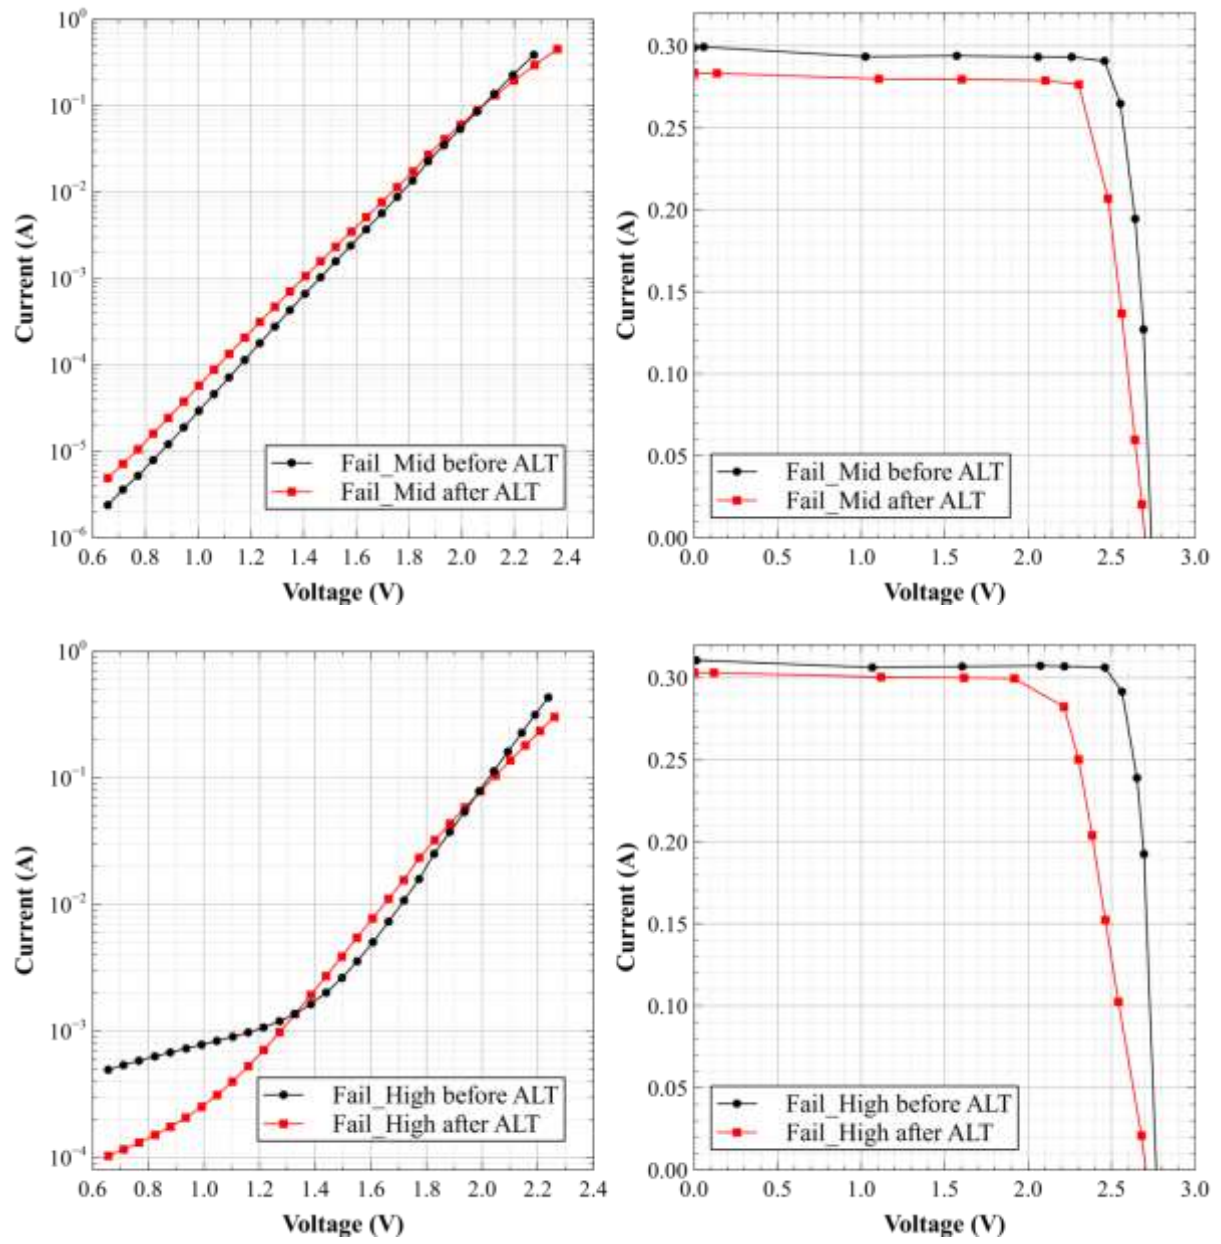
Figure 16. Dark I-V curves (left) and illumination I-V curves at 500 $\times$  of solar cells with current injection before and after ALT. Both solar cells exhibit a power loss greater than 10%.

This section describes the evolution of the solar cells that were subjected to both temperature and forward bias, thus emulating nominal working conditions. Figure 16 shows the dark I-V curves and 500× illumination I-V curves of two failed cells at medium and high temperatures, namely, “Fail\_Mid” and “Fail\_High” cells. No figure with a cell failed at low temperature is shown, since as we have stated in Section 2, the duration of the degradation test was not long enough to achieve failures at low temperature. Dark I-V curves clearly show: a) no effect of shunt resistance, b) increase of recombination current and c) increase of series resistance, thus confirming what described in Section 4.2 for the solar cells without current injection. Illumination I-V curves show: a) increase of series resistance affecting  $FF$ , b) decrease of  $I_{sc}$  and c) small drop of  $V_{oc}$ . Therefore, the increase in series resistance together with  $I_{sc}$  loss are the failure modes that dominate the aging process leading to the reliability values of Section 3 and Figure 7. Accordingly, we evaluate below the origin of these failure modes.
