# Temperature Accelerated Life Test and Failure Analysis on Upright Metamorphic Ga<sub>0.37</sub>In<sub>0.63</sub>P/Ga<sub>0.83</sub>In<sub>0.17</sub>As/Ge Triple Junction Solar Cells

A temperature accelerated life test on Upright Metamorphic Ga<sub>0.37</sub>In<sub>0.63</sub>P/Ga<sub>0.83</sub>In<sub>0.17</sub>As/Ge triple-junction solar cells has been carried out. The acceleration has been accomplished by subjecting the solar cells to temperatures (125, 145 and 165°C) significantly higher than the nominal working temperature inside a concentrator (90°C), while the nominal photo-current (500×) has been emulated by injecting current in darkness. The failure distributions have been fitted to an Arrhenius–Weibull model resulting in an activation energy of 1.39 eV. Accordingly, a 72 years warranty time for those solar cells for a place like Tucson (AZ, USA), was determined. After the ALT, an intense characterization campaign has been carried out in order to determine the failure origin. We have detected that temperature soak alone is enough to degrade the cell performance by increasing the leakage currents, the series resistance, and the recombination currents. When solar cells were

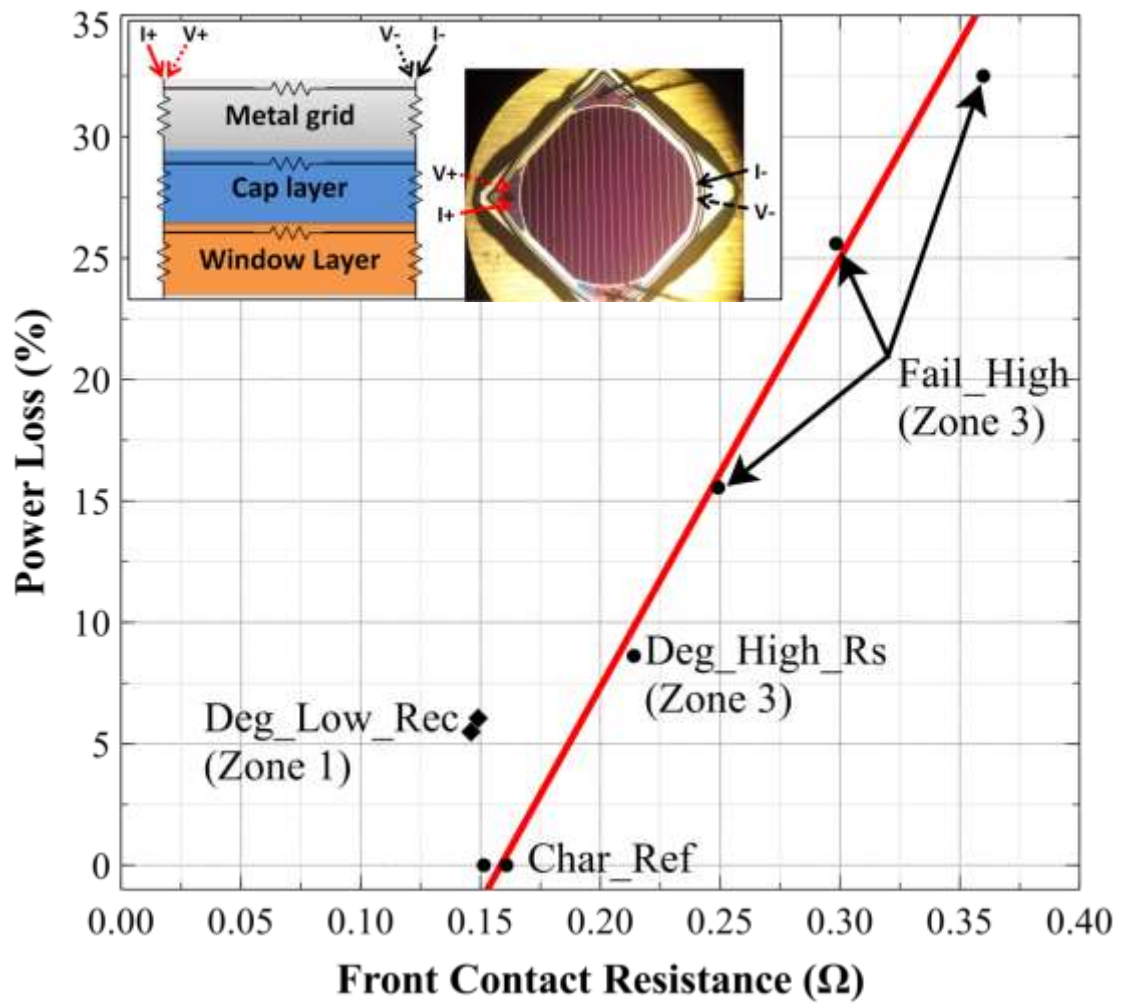
Figure 17. Illumination power loss vs. front contact resistance plot. Notice that front contact resistance measured includes the specific front contact resistance, grid resistance and lateral Ga(In)As cap layer resistance. Each dot represents a measured solar cell. The power loss was obtained comparing the light I-V curves at 500 $\times$  before and after ALT. See Figure 4 for the meaning of Zone 1 and Zone 3.

In order to find out the origin of the series resistance increase four wire measurements were carried out between two points of the busbar to obtain the front contact resistance of several failed solar cells and also of not tested (“Char\_Ref”, see Table 1) solar cell. Figure 17 shows the illumination power loss (at 500×) vs. front contact resistance in which the relationship between the power loss and the increase in grid resistance is linear with a coefficient of determination higher than 0.99 for all degraded solar cells in zone 3 (see Figure 4 for the meaning of the “zones”). All measurements produced similar results (i.e. linear relation between measured resistance and power loss) regardless of the points of the busbar chosen to measure the resistance in between. The linear relation between illumination power loss and front contact resistance suggests that failures are mainly caused by the degradation of the front contact. Figure 17 shows the interesting fact that not only the failed cells (power loss higher than 10%) follow this relationship but also the cell degraded but not still failed,

namely the “Deg\_High\_Rs” cell. In these cases, the solar cells were at zone 3 of Figure 4 on which series resistance dominates. However, the “Deg\_Low\_Rec” cells fall out of the red line of Figure 17 since those cells were at the zone 1 of Figure 4 where recombination current increase rules degradation while series resistance has not still appeared.

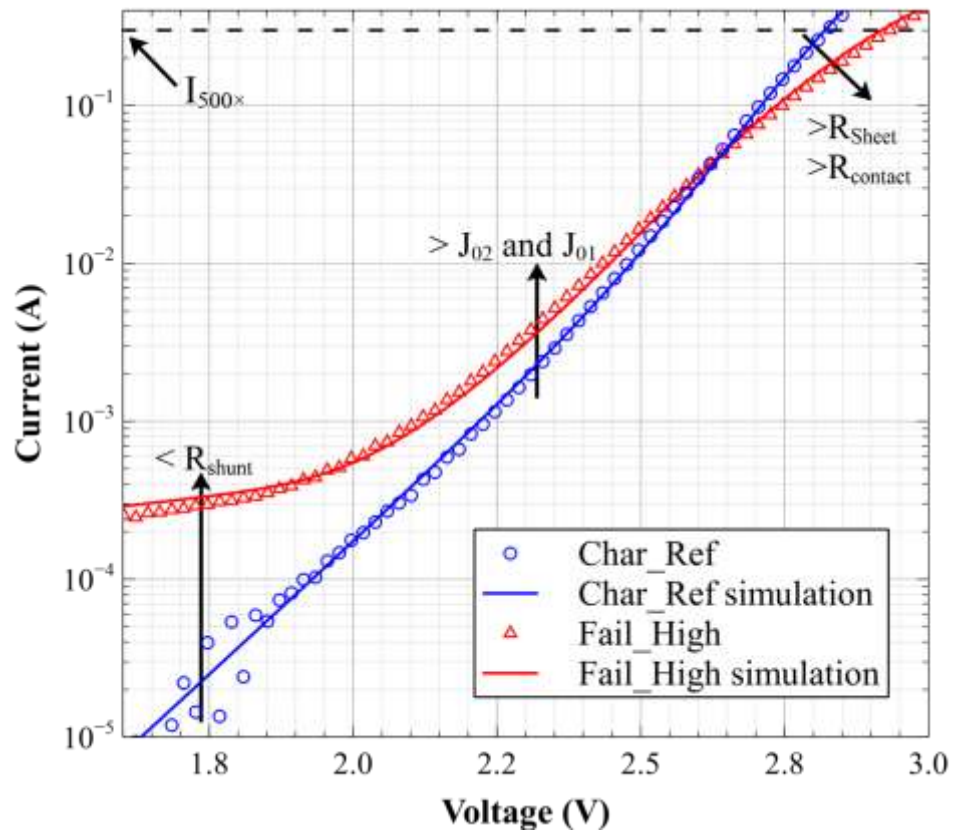
Figure 18. Experimental and fitted dark I-V curves of a non-degraded at all “Char Ref” and a failed “Fail High” solar cell. The fitting parameters used are presented in Table 3.

Figure 18 shows that the “Char Ref” simulation fits very well the experimental curve. Regarding the “Fail High” solar cell simulation, a very good fit was achieved by both reducing the shunt resistance and increasing 1.5 times the  $J_{01T}$ ,  $J_{01M}$ ,  $J_{01B}$ ,  $J_{02T}$ ,  $J_{02M}$  values (see Table 3). But, when trying to simulate the series resistance effect of the “Fail High” cell by only increasing the value of the metal sheet resistance ( $2.65 \cdot 10^{-2} \rightarrow 5.3 \cdot 10^{-2} \Omega/\square$ ) resulted in an almost negligible impact on the dark I-V curve (not shown in Figure 18 for the sake of simplicity). Therefore, the specific front contact resistance was increased until the “Fail High” simulated curve fits the experimental one, which happened for a specific front contact resistance around  $3.5 \cdot 10^{-3} \Omega \cdot \text{cm}^2$  (i.e. much higher than the typical values around  $5 \cdot 10^{-4} - 10^{-5} \Omega \cdot \text{cm}^2$  of the non-degraded one).

cell (red curve of Figure 18) could also be achieved by using different values of some components of the front series resistance. For example, we have found that by increasing only the metal sheet resistance around 40 times ( $2.65 \cdot 10^{-2} \Omega/\square \rightarrow 1 \Omega/\square$ ), a good fit of the red curve is also achieved. However, if a value of  $1 \Omega/\square$  is used for the metal sheet resistance, the simulated EL pattern of Figure 19 bottom is achieved. This pattern is significantly different from the experimental one (Figure 19 top right) discarding a failure dominated by a degraded metal sheet resistance. This last simulated pattern results from the fact that the solar cell only has bond wires at the right and left sides of the busbar, producing further areas darker as increasing the metal sheet resistance in contrast with the “symmetrical rounded” experimental pattern. Consequently, we can conclude that a degradation of both the specific contact resistance and the metal sheet resistance is taking place, so we want to know the origin of both degradations (although the metal sheet resistance has an almost negligible influence on the solar cell degradation).

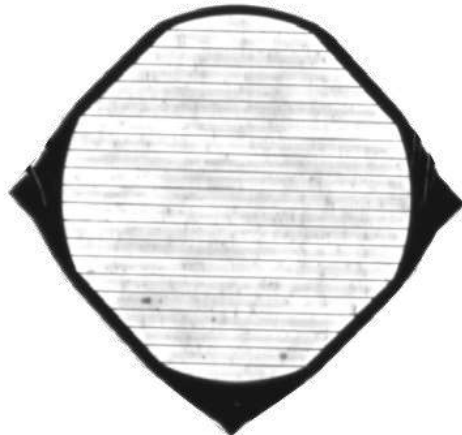
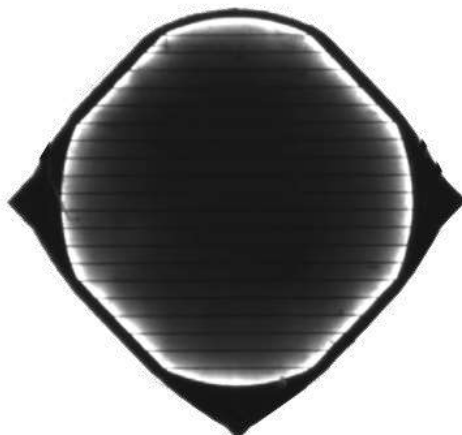
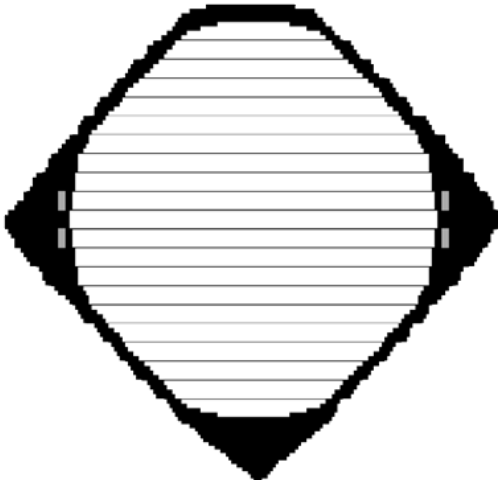
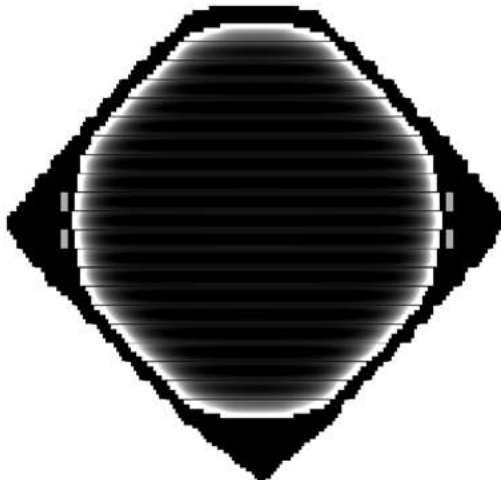
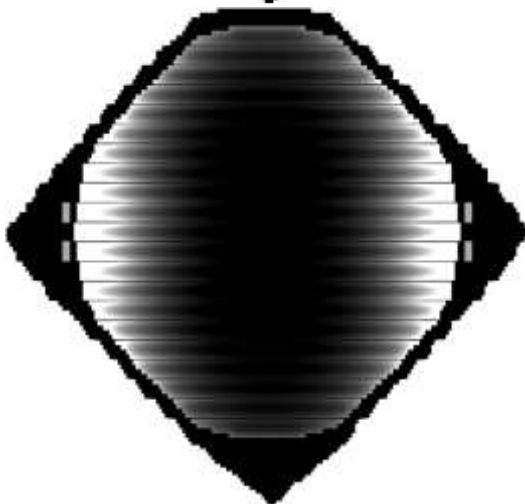
Figure 19. Top: Experimental EL of the GaInP top subcell. Left: “Char\_Ref” solar cell. Right: “Fail High” solar cell. Center: Simulations by using the parameters of Table 3. Bottom right: Simulated EL of the GaInP top subcell of the “Fail High” solar cell using a metal sheet resistance of  $1 \Omega/\square$  and a specific front contact resistance of  $10^{-5} \Omega \cdot \text{cm}^2$  which fit the red curve of Figure 18. In center and bottom figures, small grey rectangles at the left and right part of the busbar emulate the wire bonding connections. Their grey color has no meaning relating EL just to highlight them from the black color of the busbar.

In order to give physical support to these simulations, EL analysis of the same two cells was carried out. Firstly, we measured the GaInP top subcell EL of both cells (Figure 19 top) and after that, we simulated the EL patterns of both cells with our 3D model (Figure 19 middle). As it can be seen, there is a very good fit between the experimental and simulated EL patterns when the parameters of Table 3 are used (including the estimated value of the specific contact resistance of  $3.5 \cdot 10^{-3} \Omega \cdot \text{cm}^2$ ). It can be argued that a very good fit of the “Fail High” solar

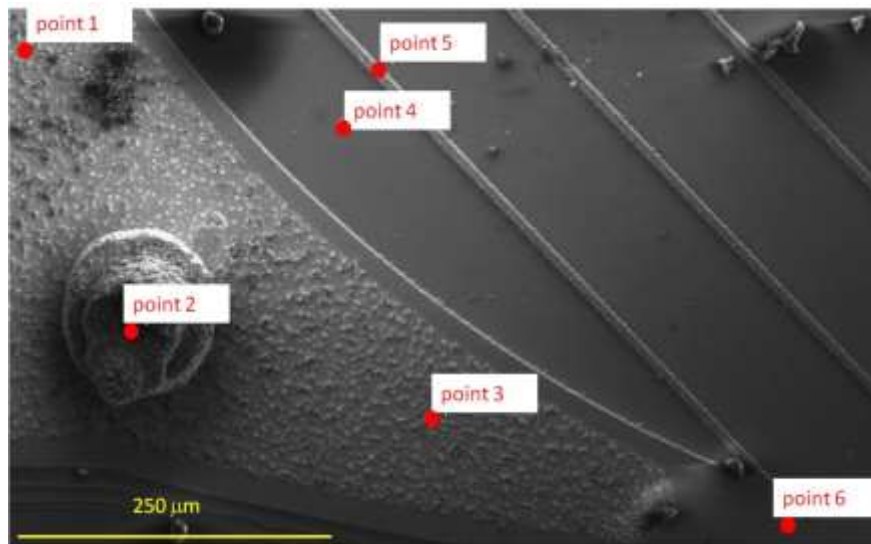
Figure 20. Planar view SEM image of the “Fail\_High” solar cell surface, showing the points where EDX analysis has been performed.

In order to know the origin of the front metal grid degradation, solar cells have been examined in the same way as described in section 4.1. In this case, metallization grid of the “Fail High” solar cell, both in busbar and fingers, shows a blistered surface (Figure 20), in contrast with the smooth surface seen in the “Char\_Ref” solar cell (Figure 9). EDX analysis was carried out in several points and the compositional analysis from the spectra can be seen in Table 4.

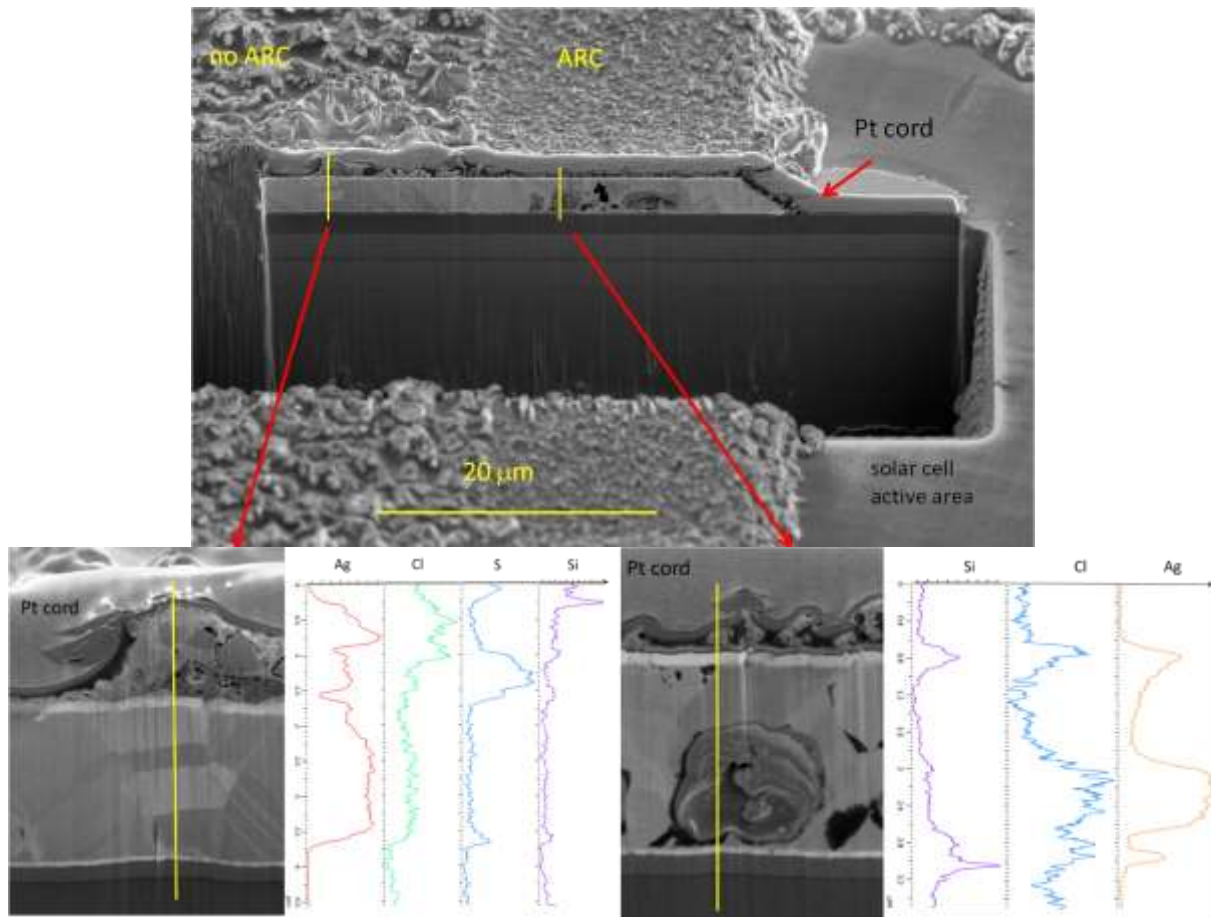
Figure 21. Top: SEM micrograph after FIB milling of the “Fail\_High” solar cell busbar metallization cross-section. Pt cord is deposited in order to protect the sample surface during FIB. Bottom: (left) SEM micrograph and line EDX analysis of the busbar cross-section in the area without ARC; (right) SEM micrograph and line EDX analysis of the busbar cross-section in the area covered with ARC. Profiles of the main elements along the analyzed length (notice that there are different scale spans for each element). Yellow vertical lines correspond to the length scale on the element profiles.

Some remarkable differences should be pointed out when comparing Table 4 with Table 2 of the “Char\_Ref” solar cell, which accounts for the situation before degradation (section 4.1). Again, points 1, 2, 3 in Table 4 were taken in the metallic area not covered by the ARC, while 4, 5, 6 correspond to the active area, a finger and a part of the busbar covered by the ARC, respectively. The amount of C on the surface has increased a lot in this failed cell. The presence of a new element, namely, Si, is now evident in all the analysed points. Its origin is probably related to its evaporation from the thermal paste used to join the Solar cell to the aluminium base plate (see Figure 1). Chlorine, which was also detected in the “Char Ref” cells, is only absent in the solar cell active surface (point 4) while S is only present in the busbar surface not covered by ARC. In summary, silicon is almost everywhere while both chlorine and sulphur are in the metal grid. Chlorine is at any grid point of the metal grid while sulphur is only in the uncovered grid (exposed to ambient conditions). The roughness increase of the metallization surface is more evident in the cross-section picture (Figure 21 top). A remarkable fact is that in the busbar area uncovered with ARC, the roughness is higher than at the covered parts including fingers. In Figure 21 bottom left, the roughness increase is visible in the form of small granules, whose composition seems to be an Ag-Cl and Ag-S mixture. Their sizes are in the order of microns. ARC seems to slow down the formation of these granules. This is probably due to the barrier effect that the ARC plays on top of the metallization, preventing the metallization constituents moving towards the top surface, where they can interact with air during the ALT. As a consequence of the movement of the metal grid constituents towards the surface, an increase in the void density of the front metal grid has been detected in several cross-section images taken at different busbar and finger zones. Some of these voids appear now partially filled (Figure 21 bottom right). The

EDX analysis of these stuffing voids shows a huge contamination of chlorine together with a silver depletion around the void. It should be reminded that the presence of Cl and S was already detected in the “Char\_Ref” cells of Section 4.1 but the difference is that now Cl and S have moved and concentrated in several regions where they form compounds of silver that poison the electric performance of the front metal grid. All these effects can explain the two times reduction of the front contact resistance of the cells subjected to temperature and current injection degradation.

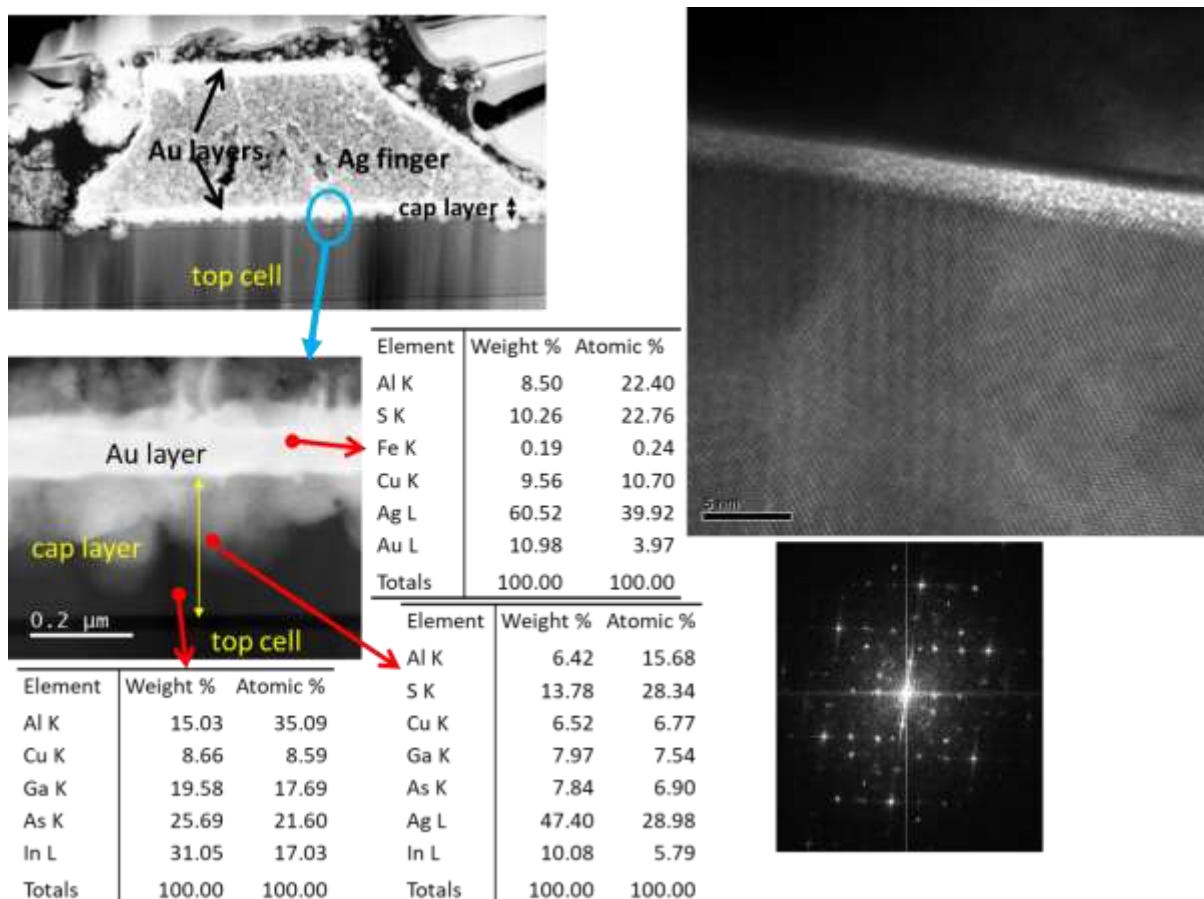
Figure 22. Cross-section view STEM image of a finger of the “Fail\_High” solar cell (top left), showing the area (cyan circle) where EDX analysis has been performed (bottom left). Copper and iron presence in the EDX analysis derive from the sample holder (left). HRTEM of the Au/Ga(In)As cap layer interface (top right). Fast Fourier Transform of Ga(In)As the cap layer (bottom right).

Now we are going to analyse the origin of the specific contact resistance increase (see Table 3). Figure 22 (top left) shows a clear evolution of the metal finger cross section of a “Fail\_High” solar cell when compared with that of “Char-Ref” cell (see Figure 11). Now the interfaces between metals and also between metals and cap layer are not abrupt but very diffused (Figure 22 top left). Besides, the EDX analysis of gold layer shows sulphur and silver contamination (Figure 22 bottom left). Additionally, there are intrusions of gold, sulphur and silver in the Ga(In)As cap layer which modify the properties of the specific front contact resistance. A deeper insight by HRTEM image of the Ga(In)As cap layer and the metallization interface (Figure 22 top right), shows a deterioration of the semiconductor layer crystalline quality, which gives rise to the different contrast fringes observed in the HRTEM image. The FFT image (Figure 22 bottom right) confirms this point, showing extra spots disturbing the cubic symmetry of the Ga(In)As layer. Therefore, we can conclude that the Au/Ga(In)As cap layer interface is much degraded in the “Fail\_High” cell and consequently, the specific front contact resistance exhibits a high increase.
