In orbit performance of UVIT over the 5 years

Over the last 5 years, UVIT has completed observations of more than 500 proposals with ~ 800 unique pointings. In addition, regular planned monitoring observations have been made and from their analysis various key parameters related to in orbit performance of UVIT have been quantified. The sensitivities of the UV channels have remained steady indicating no effect of potential molecular contamination confirming the adequacy of all the protocols implemented for avoiding contamination. The quality of the PSF through the years confirms adequacy of thermal control measures. The early calibrations obtained during the Performance Verification (PV) phase have been further revised for more subtle effects. These include flat fields and detector distortions with greater precision. The operations of UVIT have also evolved through in orbit experience, e.g. tweaking of operational sequencing, protocol for recovery from bright object detection (BOD) shutdowns, parameters for BOD thresholds, etc. Finally, some effects of charged particle hits on electronics led to optimised strategy for regular resetting. The Near-UV channel was lost in one of such o

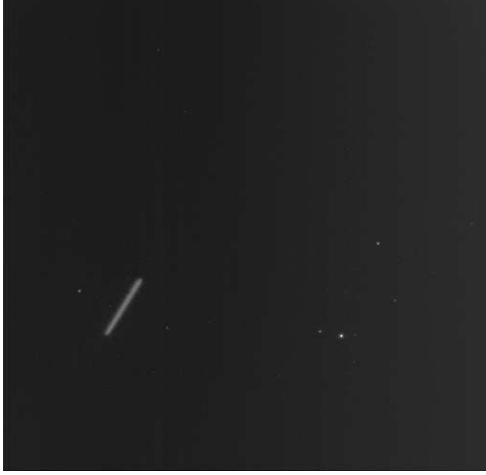
Figure 1. An example of Bright Object Detect (BOD) trigger due to appearance of an unanticipated non-celestial object in UVIT’s field of view. One image frame in VIS band is displayed. The bright streak (near the bottom left corner) caused this BOD trigger.

In spite of these knowledge base, an accidental BOD operation awaited the UVIT team on first light of VIS channel ! It resulted from an erroneous choice of settings for the High Voltages - the set corresponding to Photon Counting mode was configured while attempting to image in Integration mode. This oversight was corrected swiftly. Very soon another BOD trigger occurred due to a star in a field thought to be safe, indicating error in estimation of 'signal per photon' from the ground calibration. The observed signal in orbit was higher, needing adjustment of the trigger threshold. Tweaking of all detector related parameters to optimal values were completed within days of the first light. The selection of the band whose clock would be used as ideal Master Clock, i.e. in effect the clock for all the three bands, as well as a consistency sequence of their configuration for imaging were achieved shortly. This sequence being rather critical, its reliable implementation was achieved by embedding these details in well designed Macros for operations. The initial ramping up of high voltages was enforced for every change of filter.

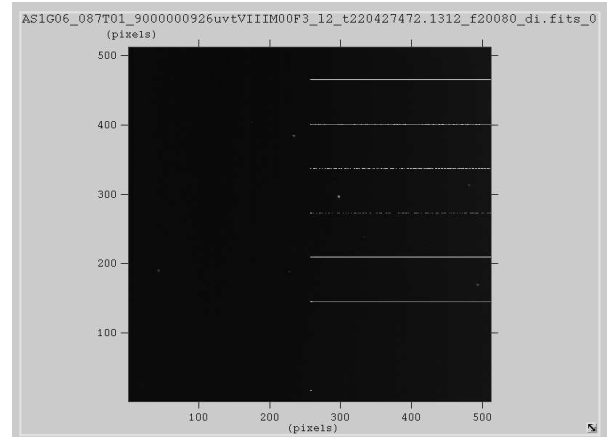
Figure 2. Example of artifacts appearing in VIS band images. The horizontal stripes occur possibly due to effects of charged particle hits and they disappear after a power reset.

An anomaly noticed rather early on (within months of in orbit operations) was appearance of stripes in the raw image frames of VIS band (see Fig. 2). These were diagnosed to be effects due to charged particle hits and complete recovery could be achieved by powering OFF the VIS electronics. Since the processing pipeline on ground was agile enough to ignore such artifacts and generate final products unaffected, the mitigation action was not carried out till the situation demanded powering OFF. At a later phase, when such stripes in VIS appeared more often, along with some additional

artifacts in UV bands too, a monthly schedule was drawn up to normalize (power OFF) all the 3 bands FUV, NUV & VIS.

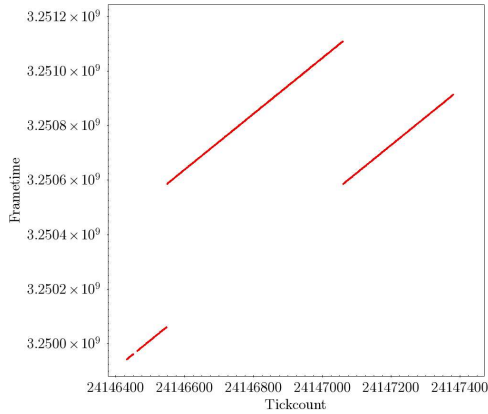
Figure 3. Example of an artifact due to a stuck bit in the Master Clock. The time stamped on individual frames (‘Frametime’), are plotted against the elapsed time (‘Tickcount’). The fixed amount of jumps at each discontinuity indicates the 20 th bit of the ‘Frametime’ to be stuck at zero.

More recently (since \sim December 2018), some other types of artifacts due to radiation hits were discovered, which could be recovered. However, their recovery required power RESET. These artifacts were : (a) frozen 20th bit of VIS clock which is the selected Master for all bands (see Fig. 3), (b) certain frozen bits of all X-centroids for photon events, etc. Initially, on encountering (a), plans and

procedures were set up for change over of the Master Clock from VIS band to FUV band – thereby avoiding issuance of any RESET (in view of the loss of NUV band). This involved re-programming all command tables corresponding to ‘Imaging Parameters’ for each band. The uploading of these tables to the relevant spacecraft sub-system involved certain new activities. After a review by ISRO experts, this course of action was not found to be advisable. In the mean time, (b) was encountered which forced the use of RESETs which eventually mitigated both these issues. Most recently (October 2020), all bits corresponding to fractional part of the Y-centroid were stuck (see Fig. 4). All instances of appearance of such artifacts (other than periodic appearance of stripes in VIS image frames) and subsequent recovery from them are presented chronologically in Table 1.

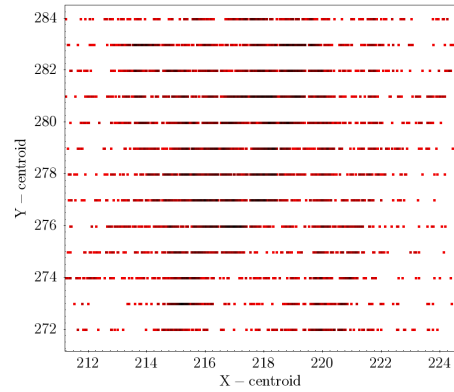
Figure 4. Example of multiple bits of the centroid coordinates (along Y-axis) of every photon event to be stuck to zero. The points in the plot correspond to individual photons. The systematic gaps in the values of Y-centroid indicate several successive least significant bits (corresponding to the fractional part) are affected.

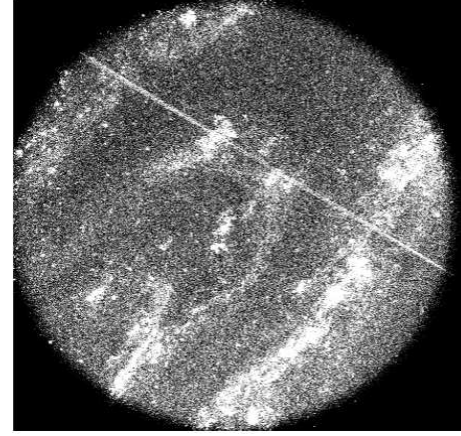
Figure 5. An unexplained feature (streak) observed in images in all 3 bands of UVIT for certain targets. As an example, image of the galaxy M31 in NUV band is displayed. The orientations of the streaks with reference to mountings of FUV / NUV / VIS detectors imply that they could be caused by some structure within the telescope tube.

Example of an observed artifact is a bright

“streak” due to some very bright object within a few degrees of the telescope axis (though outside UVIT’s 28 arc-min field of view). Such streaks have been observed in VIS as well as NUV images. The orientation of the streaks in these images imply a direction fixed to the telescope tube, once the relative angle between the axes of the detectors is taken into account. Such streaks have been observed while observing the targets : M 31, PKS 1510-089 & Crab. One example is presented in Fig. 5 which is an NUV image of M 31.

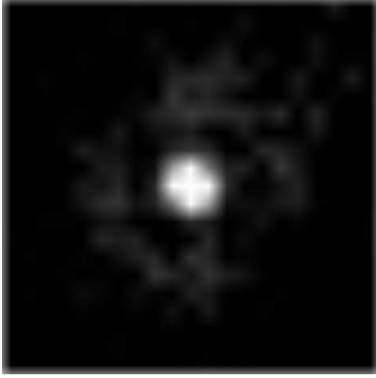
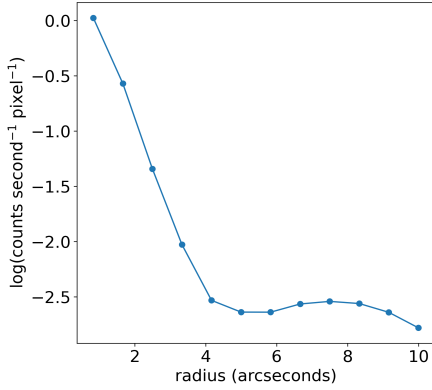
Figure 6. Effect of saturation is illustrated in the NUV band image of a bright star in the cluster NGC 188 (size : 28'' × 28''). The valley encircling the central peak is due to saturation effect of photon counting mode. The radial profile displays the local dip quantitatively.

Another artifact presented here relates to the effects due to saturation in photon counting mode of imaging. A deep valley encircling the central peak is observed for a bright star in the star cluster

NGC 188 imaged in NUV, which is displayed in Fig. 6. The accompanying plot of the radial profile quantifies this dip.

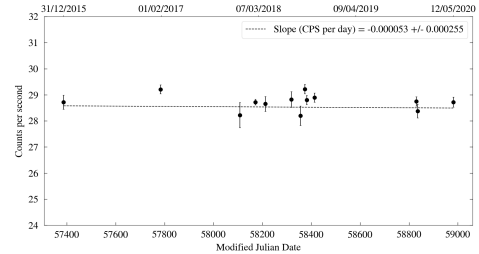
Figure 7. The sensitivity of the FUV band over its operations covering earliest operations till May 2020 has remained unchanged. The plot shows count rates from monitoring of a secondary calibrator, WOCS-5885, – a star in the cluster NGC 188. The rms scatter is $\sim 1\%$ over 1600 days.

The result from monitoring the sensitivity of the FUV band over the entire mission including recent observations is presented in Fig. 7, which shows no detectable change in the count rate for a secondary calibrator star, WOCS-5885, in the cluster NGC 188 (Subramaniam et al., 2016a). The stability of sensitivities over long duration has vindicated the care taken over the years on ground towards control of molecularcontamination, viz., choice of materials, operations in clean room, cleaning protocols, pre-assembly baking, purging of the optical cavity of UVIT with pure N2 gas. In addition, the in orbit protocols followed : long in orbit wait for degassing before opening the doors as well as avoiding direct sun light falling on telescope

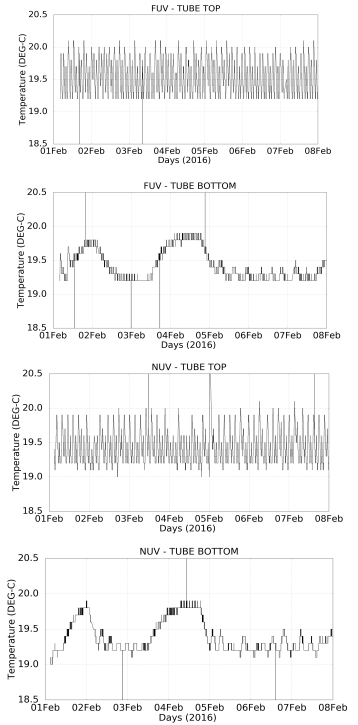
Figure 8. Example of typical variation of temperature of the two UVIT Telescopes (FUV and NUV/VIS) at respective Tube Top (TT) & Tube Bottom (TB) over one week.

tubes during spacecraft maneuvers also helped. The stability of the PSF is ensured by adequate on board thermal control through the mission. The temperatures of critical elements, viz., telescope tubes and detectors (measured over \sim a week) responsible for the observed stability in sensitivity as well as PSF size are displayed in Fig. 8 & Fig. 9 respectively. The temperature of the tubes is stable within ± 0.5 C, which translates to a geometrical blurring in the image by < 0.1 arc-sec rms, implying a change from ~ 0.5 arc-sec to < 0.51 arc-sec rms for the PSF. The temperature of detector (Star250 imager) is stable to within ± 1 C.

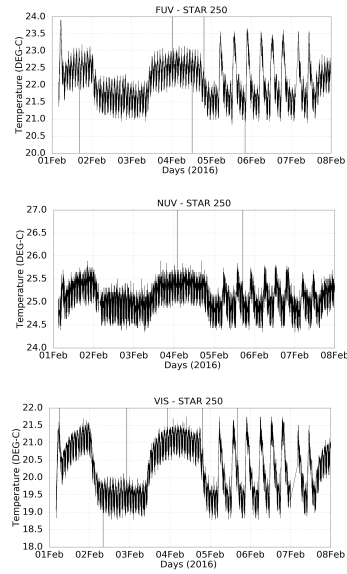
Figure 9. Example of typical variation of temperature of the 3 Detectors (FUV, NUV, VIS) in UVIT over one week. The temperature is measured on the Camera Proximity Unit housing the image Intensifier and the CMOS sensor STAR 250.

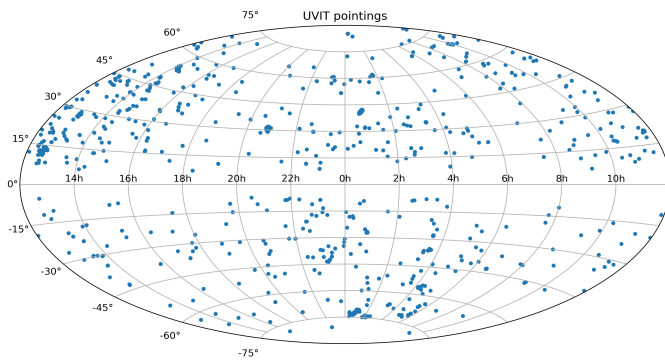
Figure 10. A plot showing distribution on sky of the astronomical targets observed by the UVIT (total ~ 800 unique pointings).

targets observed with UVIT is displayed in Fig. 10, which includes about 800 unique pointings. A large number of important astronomical results have already appeared in journals with high impact (possibly many more are in the process). All scientific payloads of AstroSat including UVIT, had a baseline design life of 5 years, which has already been achieved. While it is a pity that the NUV band was lost at the mid-point of this life, due to radiation damage of some critical electronic components, the FUV & VIS bands continue to serve the users. It is hoped that these two bands will last many years in future. Although HST allows extremely sensitive imaging in the FUV (STIS, FUV-MAMA; $25'' \times 25''$), UVIT currently provides the unique opportunity for wide field imaging with $28'$ dia field.
