# Machine Learning and Thermography Applied to the Detection and Classification of Cracks in Building

Angela Busheska<sup>1</sup>, Nara Almeida<sup>2</sup>, Nicholas Sabella<sup>1</sup>, Eudes de A. Rocha<sup>3</sup>

<sup>1</sup> Lafayette College, <sup>2</sup> University of Washington - Tacoma, <sup>3</sup> University de Pernambuco

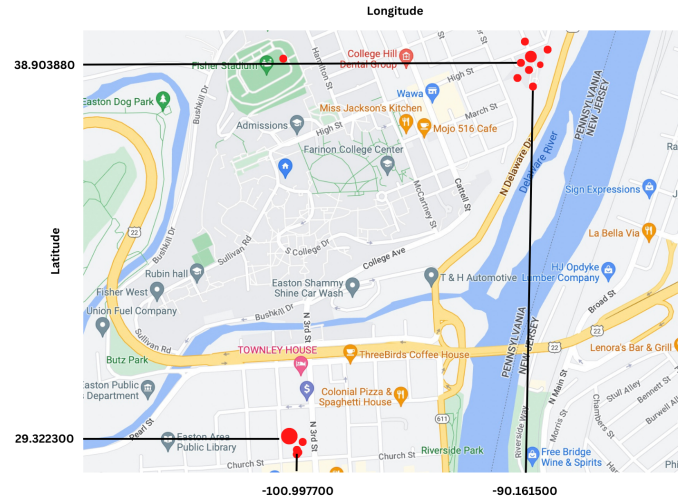
**Figure 1: Data Collection Area**

All the data was acquired in Easton, Pennsylvania (marked as the red dots in Figure 2). Two buildings, the McKelvy House and the Laundry Building were used extensively to build the data set due to their structure and the presence of cracks. The buildings were chosen due to their age and structure which contained cracks.

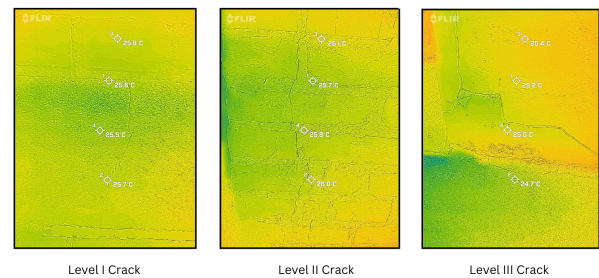
**Figure 2: Data Examples of FLIR MSX Pictures**

All the FLIR MSX thermal images were evaluated using the camera's software, so the three different levels of cracks could be identified. Further image treatments were performed on some FLIR MSX images for addition and reduction of noises, improved quality, or enhanced accuracy of the model, using MatLab.

First, infrared thermographic tests were performed on cracks of random buildings located in Easton, Pennsylvania from June to August of 2022, always right after sunrise time. During these tests, we used HTI HT-18 (220 x 160 pixels) and FLIR One Pro (160 x 120 pixels) cameras to take pictures of each specific crack. The idea was to have MSX images, obtained from the FLIR One Pro, and conventional and thermal images, taken with the HTI HT-18, so all these images could be included in the ML model, and their accuracy levels could be tested and compared.

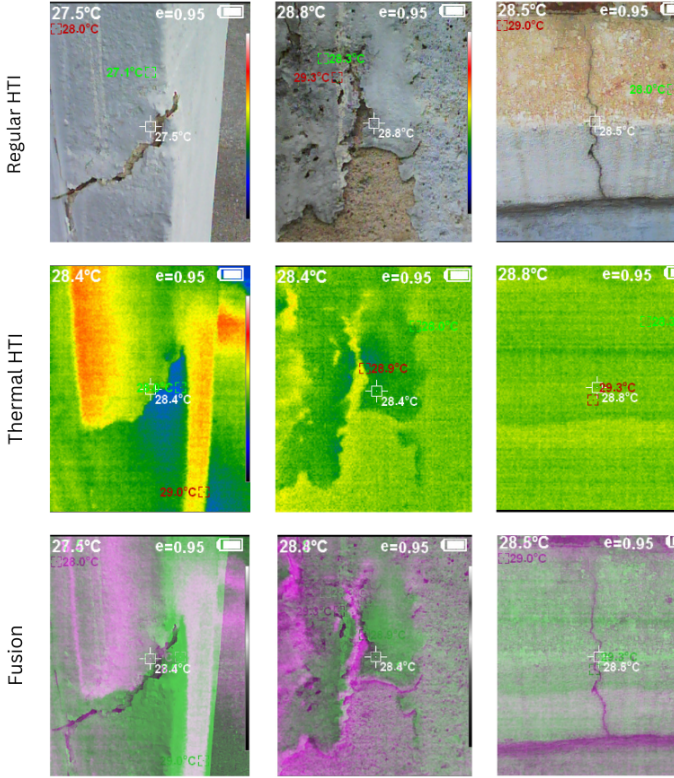
**Figure 3: Data Examples of HTI - Fusion Pictures**

Also utilizing MatLab, conventional and thermal images captured using the HTI HT-18 camera were fused, by applying a specific function that used a 50% transparency filter in the thermal images, superposing it on top of the conventional

images of the same crack. To avoid any potential distraction of training the model, all pictures were resized to 1080 x 1440 pixels with three channels for RGB (Red, Green and Blue). To ensure the highest level of clarity, on selected pictures it was necessary to remove noise and further sharpen the image. Such noise includes a blurry image or unnecessary objects present in the background.
