Influence of microstructure on mass loss caused by acoustic and hydrodynamic cavitation

Abstract. The proposed study investigates the damage mechanisms of martensitic stainless steel X3CrNiMo13-4 exposed to cavitation using two complementary experimental apparatus: ultrasonic horn (MUCEF) and hydrodynamic tunnel (PREVERO). Cavitation testing has been carried out on two different metallurgical states: QT780 and QT900 corresponding to coarse and fine microstructure respectively. Acoustic cavitation erosion tests have been performed on the MUCEF equipment inspired from the ASTM G32 standards but specially designed to be installed inside X-Ray tomographs. The ultrasonic horn operates at 20 kHz and the tested specimen is located at 500 μm from the horn tip. Hydrodynamic cavitation erosion tests were conducted with classic experimental conditions of PREVERO device: a cavitation number of 0.87 corresponding to a flow velocity of 90 $\text{m}\cdot\text{s}^{-1}$ and an upstream pressure of 40 bars. For acoustic cavitation, mass loss has been identified as dependent of the microstructure while for hydrodynamic cavitation the mass loss is identical whatever the microstructure size.

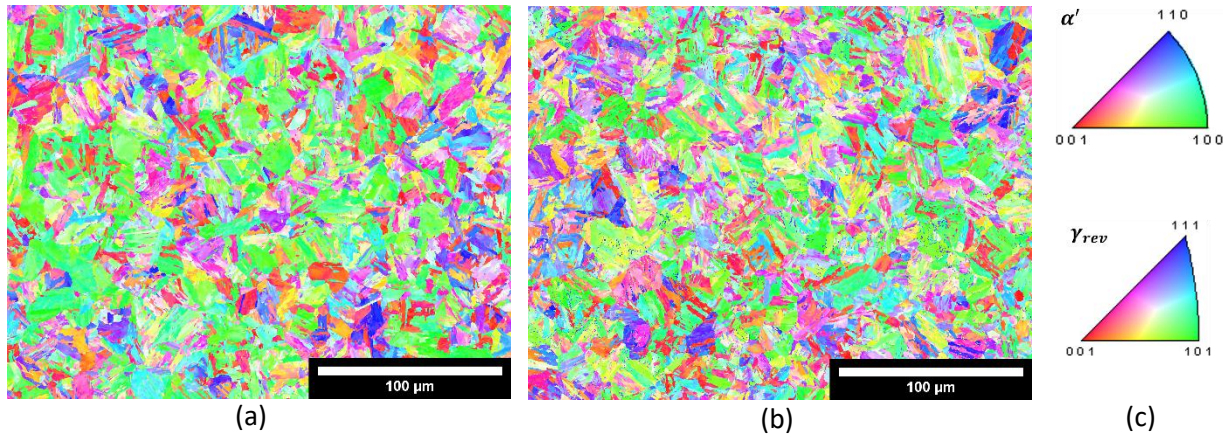
Figure 1: Electron backscatter diffraction (EBSD) orientation maps for grade (a) QT780 and (b) QT900 of X3CrNiMo13-4 martensitic stainless steel. (c) Inverse pole figures.

In the present study, the low-carbon martensitic stainless steel X3CrNiMo13-4 was used as the tested material. The two metallurgical states QT780 and QT900, corresponding respectively to coarse and fine microstructure, have been studied. Both grades were austenitised at 1100 °C and quenched. The differences in the two grades QT780 and QT900 lays in the tempered sequence, 600 °C for 2*4 h and 540 °C for 4 h respectively. The resulting materials are composed of a α' martensitic matrix with lamellar reversed austenite, γ_{rev} and residual delta ferrite, δFe . Presence and proportion of these phases were confirmed using XRD analysis. Due to the different tempering conditions, the percentage of reversed austenite in each grade is different: respectively 11.9 vol.% and 2.7 vol.% for QT780 and QT900 grades. The reversed austenite can transform to martensite when submitted to plastic deformation: this is known as the transformation-induced plasticity (TRIP) effect. This transformation is associated to a volumetric expansion, which produces compressive forces that delay crack initiation and propagation. The low-carbon X3CrNiMo13-4 is hence widely used for water turbine manufacturing due to its high mechanical strength and high corrosion resistance. Figure 1(a) and Figure 1(b) show the orientations maps for the grades QT780 and QT900 respectively at the initial state with the martensitic matrix α' and reversed austenite lamellas γ_{rev} . These observations using EBSD technique reveal that the QT780 grade is coarser than the QT900 grade.

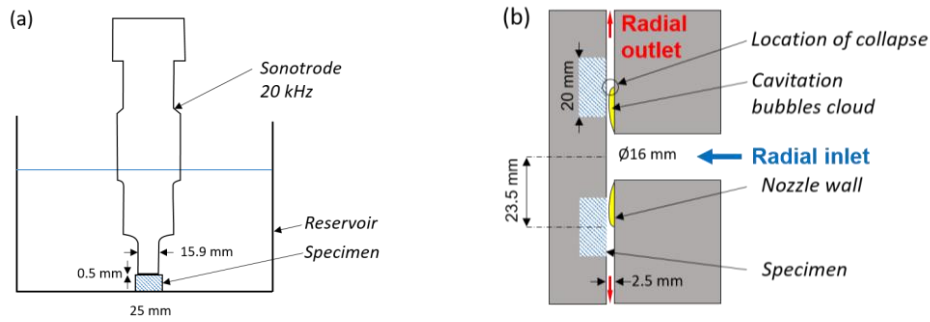
Figure 2: (a) MUCEF device used for generating acoustic cavitation. Specimen is located at 0.5 mm from the sonotrode (indirect method). (b) Cross section view of PREVERO device used for generating hydrodynamic cavitation. A constant cavitation number σ of 0.789 has been used for experiments.

For testing material, two experimental devices were used for generating acoustic and hydrodynamic cavitation. For MUCEF device, a sonotrode vibrating at 20 kHz with a peak-to-peak amplitude of 50 μm was used for generating acoustic cavitation. The distance of 500 μm between the specimen and tip was measured using x100 optical camera (Dino-Lite AM4815ZTL, Taiwan) and adjusted using a micrometric motorized stage (OWIS LTM120, Germany). This in-house setup, using indirect method and inspired from the ASTM G32 standard, is depicted in Figure 2(a).

Hydrodynamic cavitation testing was performed using the famous 40 bars flow tunnel called PREVERO located at LEGI laboratory. Water was accelerated using a centrifugal pump rotated by an 80 kW electric engine. Tap water was pressurized using nitrogen gas on the free surface of a water tank. As shown in Figure 2(b) on a cross section view, specimen were located at 2.5 mm from the nozzle wall where the velocity is approximately equal to 90 $\text{m}\cdot\text{s}^{-1}$ leading to the formation of cavitation bubble clouds. Hydrodynamic cavitation erosion tests were conducted at a constant cavitation number $\sigma = 0.870 \pm 0.001$.

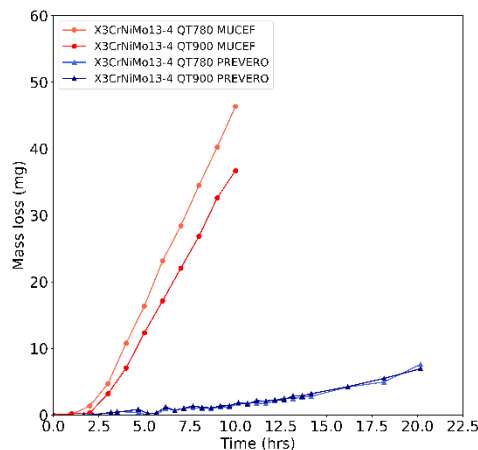
Figure 3: Mass loss as a function of exposure time in acoustic (MUCEF) and hydrodynamic cavitation (PREVERO) for the QT780 and QT900 grades.

Figure 3 shows the mass loss as a function of the exposure time to cavitation for both grades QT780 (coarse microstructure) and QT900 (fine microstructure) for acoustic and hydrodynamic cavitation. For each measurement point, the specimen were dried carefully and then weighted using an analytical balance. Incubation time, defined as the exposure time required to observe first mass loss, is greater for hydrodynamic cavitation than acoustic cavitation. The incubation times are respectively 1 h and 2 h for the grades QT780 and QT900 for acoustic cavitation while it is approximately 5 h for both grades for hydrodynamic cavitation. For hydrodynamic cavitation, the type of microstructure has no effect on the incubation time and both mass loss curves are identical. According to MUCEF experiments, the mass loss measured for the coarser microstructure (QT780) is more important than for the finer (QT900). This is consistent with the ranking of the ultimate strengths of these two grades. It is concluded that the mass loss curves depend on the microstructure only for acoustic cavitation whereas hydrodynamic cavitation could not distinguish the behaviour of the two grades. This difference of material response according to the type of cavitation could be attributed to the size of the bubble. It has been previously shown that hydrodynamic cavitation erosion creates large pits (20-250 μm) at a small pitting rate and, conversely, acoustic cavitation erosion creates small pits (5-30 μm) at a high pitting rate (5). Bubbles size generated by acoustic cavitation is thus closer to the characteristics size of the microstructure while the collapse of hydrodynamic cavitation bubbles does not differentiate the grains.
