Pavement Fatigue Crack Detection and Severity Classification Based on Convolutional Neural Network

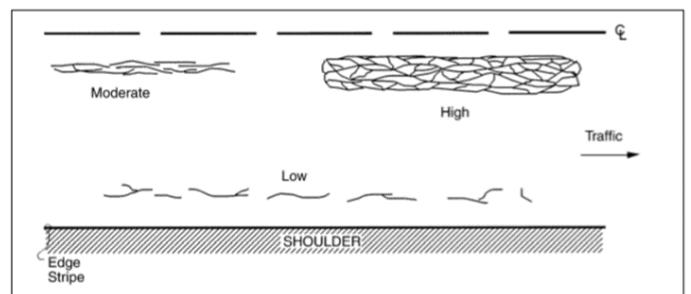
Fig. 2. Fatigue Cracking Severity Levels for Asphalt Concrete Pavements.

Upon completion, the image library contained images of all types of cracking with varying levels of severity as defined by the LTPP Distress Identification Manual (John S. Miller and William Y. Bellinger). The ground-truth of cracks on all images were classified with three round supervision by the data preparation team. An inspection by experts was conducted to ensure the accuracy of human classification and labeling. 2892 images from the library were chosen at random to be used in the training and subsequent testing of the model. More specifically, the training dataset consisted of 2024 images and the testing dataset consisted of 868 images.

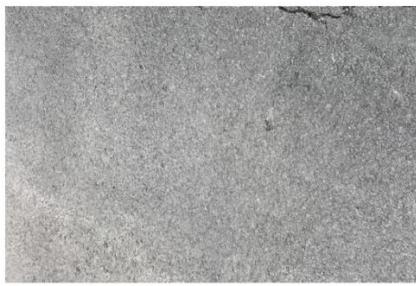
Fig. 3. Pavement surface without cracking (top) and with cracking (bottom).

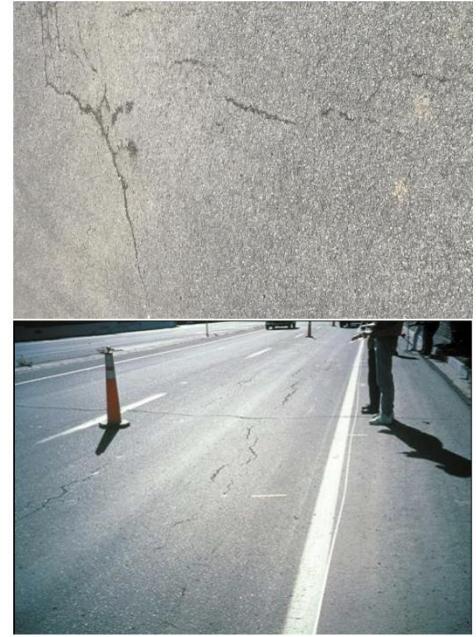
Fig. 4. Low Severity Fatigue Cracking.

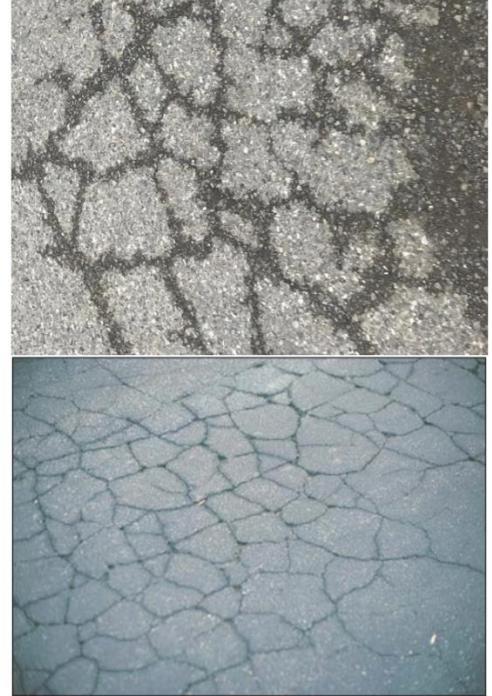
Fig. 5. High Severity Fatigue Cracking.

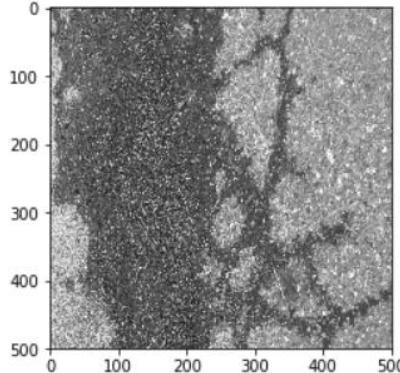
Fig. 6. An example of resized gray-value training image.

As Fig. 6 shows, the distress severity level information remains readily recognizable in the downsized training image. Since the computer identifies the presence of cracks by individual pixel shade, the gray-value image is sufficient for the computer to train and learn. After image preprocessing was completed, labeling was completed to ensure training accuracy.

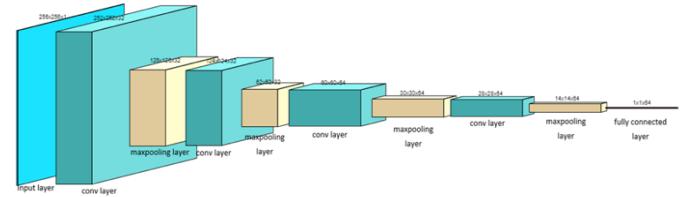
Fig. 7. Architecture of proposed CNN for crack detection and mark-crack classification.

As illustrated in Fig. 7, the CNN proposed in this study consists of four convolutional layers with ReLU and four, 2x2 max-pooling layers. The kernel size of four convolutional layers are 32x5x5, 32x3x3, 64x3x3, and 64x3x3, respectively. Two fully connected layers follow the convolutional layers. A cross-entropy loss function is also employed to calculate the performance of a training quality of a classification model.

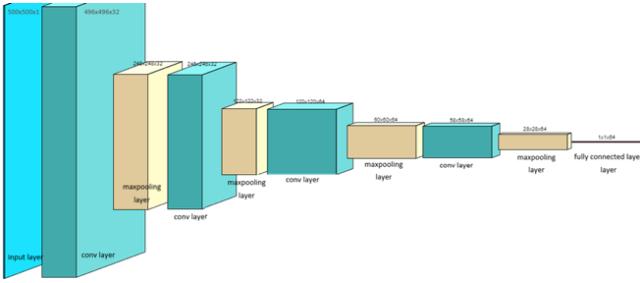
As shown in Fig. 8, each convolutional layer is followed by a maxpooling layer to subsample the feature map. The first convolutional layer has 32 kernels, which corresponds to the depth of the convolutional layer and also to the amount of feature maps. The filter size of the first convolutional layer is 5x5, and the padding type is set as valid. The input image will be calculated and transferred to a feature map of size 496.

Fig. 8. Architecture of proposed CNN for crack detection and mark-crack classification.

The feature map size is calculated by the following output size shrinks by filter size – 1. Next, the output is passed through the maxpooling layer, the size of the maxpooling filter is 2x2 and the stride is 2. This process is for down sampling the feature map.

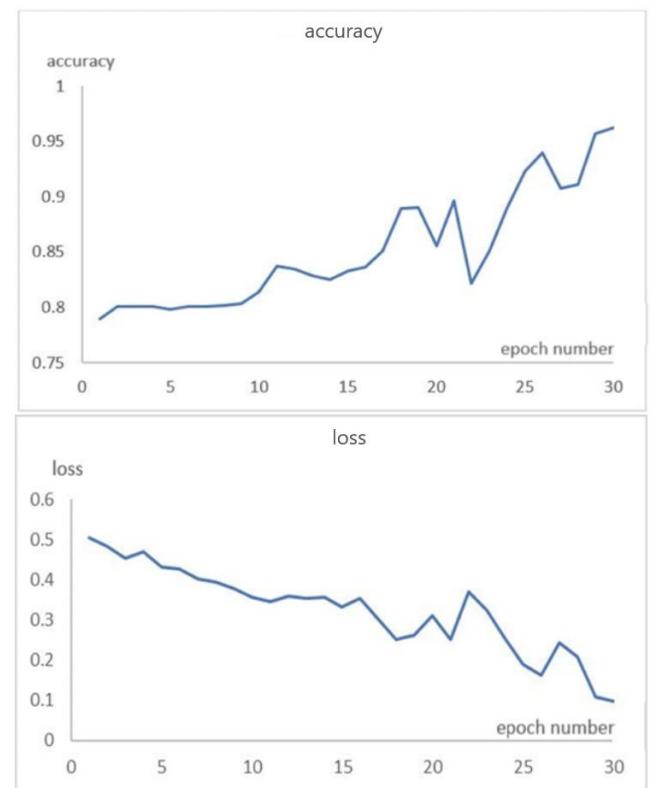
Fig. 9 shows the training results of the proposed CNN model performance on the crack detecting function. The objective of the training was to enable the model to classify the pavement surface images into two categories: non-cracked pavement surface or pavement surface with fatigue cracking present. The results show the loss of the training process is approaching zero while the accuracy of the classification model increased from 79.03% to 96.24% before and after training. As there may exist a small number of human errors during the labeling step, the accuracy is ideal for pavement surface fatigue cracking identification.

Fig. 9. Accuracy and loss on training data for crack detection.

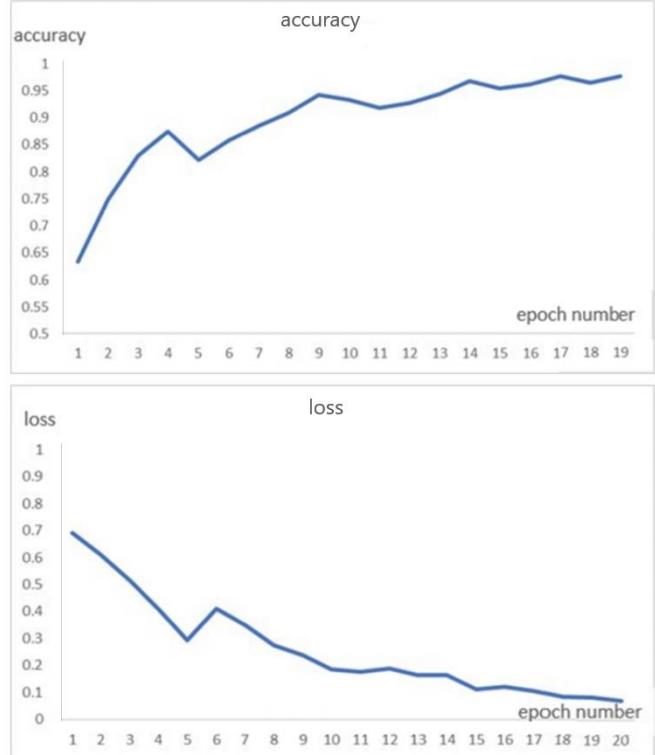
Fig.10. Accuracy on training data for mark/crack classification.

As Fig.10 shows, there are 20 epochs for the training process instead of 30 as initially developed. While the model was being trained, it was noticed that the accuracy trend began to decrease, and the loss trend began to increase after the 20th epoch. The

method employed to prevent a decrease in accuracy is known early stopping. Early stopping is a method by which the performance of the model on the test set is monitored during training. The training process is then stopped at the moment that the performance of the model on the test set begins to decrease, so as to avoid the problem of over-fitting caused by continued training. Thus, the training of the model was stopped at the 20th epoch to avoid over-fitting error. To further avoid over-fitting problems, the training image dataset is enlarged at the early steps. The dataset built at the first stage contains 500 hundred images in total. The accuracy of the first attempts is around 0.3 and the validation accuracy is 0. The other effort to overcome over-fitting problem was adding cross-validation before training the model which allows the test set as a truly unseen dataset.

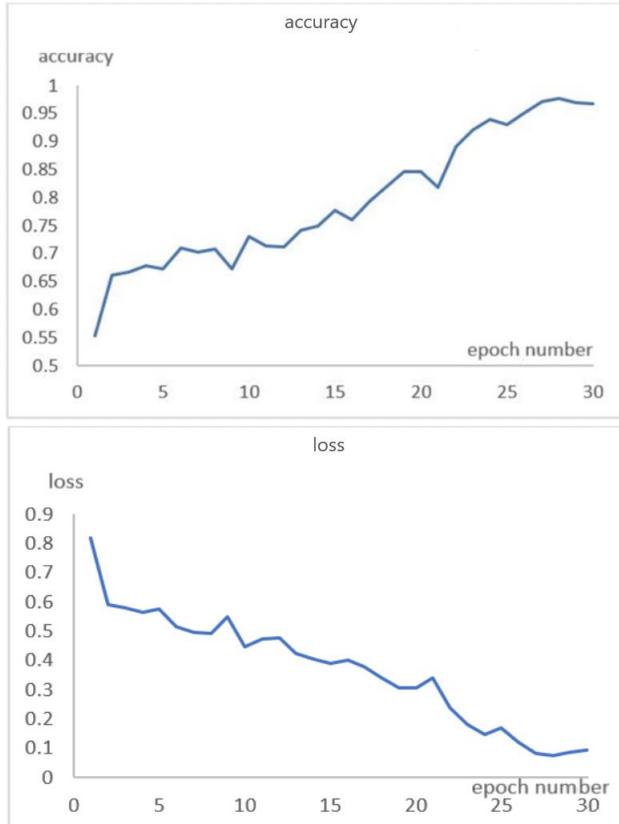
Fig. 11. Accuracy on training data for crack severity classification.

Fig. 11 shows the training results of the proposed CNN model when trained for the crack severity classification function. The results show the loss of the training process is approaching zero while the accuracy of the classification model increased from 55% (which is almost random) to 96.74%. Considering the reality that there may exist some level of human error during the labeling step, the accuracy is ideal for pavement surface fatigue cracking severity level classification.

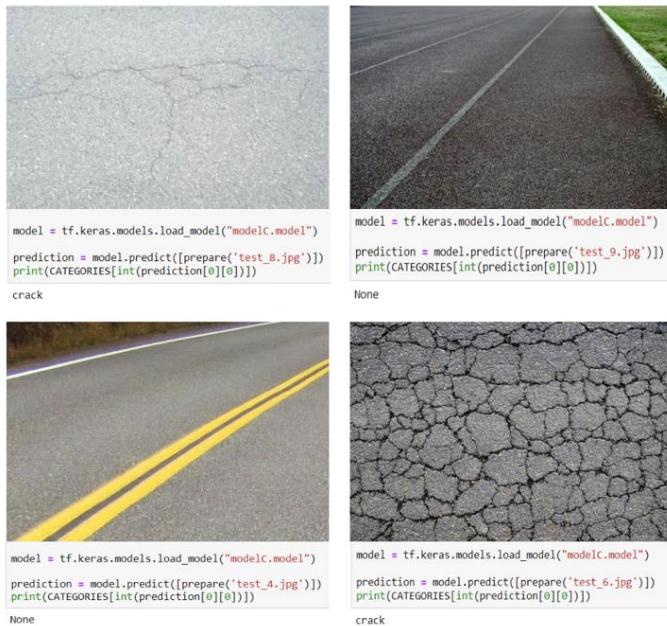
Fig. 12 illustrates examples of the results of the proposed model’s predictions of crack presence in prepared test images (test_4, test_9, test_6 and test_8). The prediction results correctly match crack presence classification completed by humans. The prediction accuracies of crack and non-crack images are 46 out of 50 and 48 out of 50, respectively. The overall accuracy of crack image classification from the test dataset is 94%.

Fig. 12. Crack and Non-Crack Image Classification.

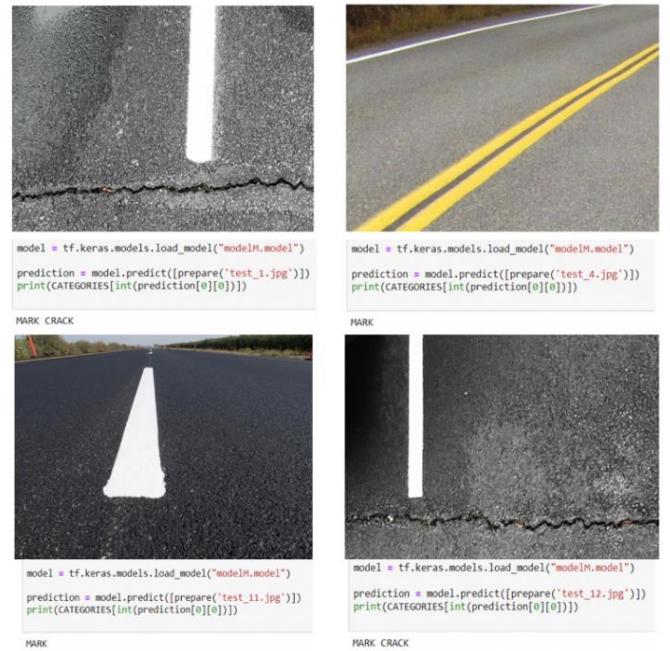
The second test that the proposed model completed was for the classification of the presence of pavement marks and cracking. The purpose of this classification test was to assess whether the presence of pavement marks affect the model’s ability to recognize cracking. Fig.13 shows the classification results of test_1, test_4, test_10 and test_11. The prediction accuracy of mark and crack classification is 49 out 50 and 46 out of 50, respectively. The overall prediction accuracy is 95%.

Fig. 13. Mark and Crack Classification Results.

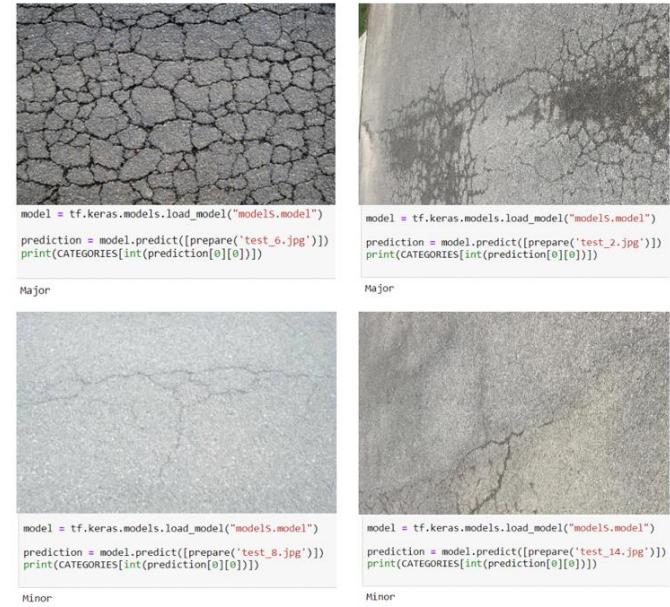
Fig. 14 shows the classification of different crack severity levels. The output categories are no cracking, moderate severity cracking, and high severity cracking, and in the code, these categories are represented as none, minor, and major, respectively. The prediction accuracy of non-crack, moderate severity crack and high severity crack is 48 out of 50, 42 out of 50, and 46 out of 50 respectively. The overall prediction accuracy of crack severity is 90.67%. Table 3 provides a summary of training and prediction

Fig. 14. Examples of Crack Severity Classification Results.
