University of Ferrara
Physics and Earth Sciences Department
Ph.D. Course in Physics
Cycle XXXVII
Coordinator Prof. PAOLO LENISA

**Construction, Commissioning, and Installation
of the Cylindrical GEM Inner Tracker
of the BESIII Experiment**

Year 2021/2024

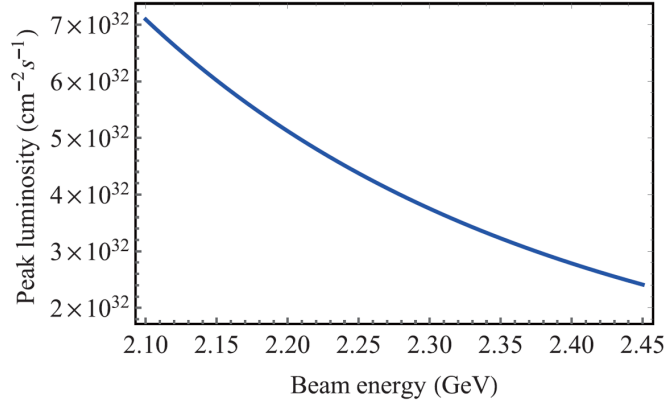
Figure 1.1: Estimated peak luminosity above 2.1 GeV [2].

In 2019 a campaign of hardware upgrades was carried out to bring the beam energy to 2.45 GeV. Above 1.89 GeV, the luminosity decreases as shown in figure 1.1 due to limitations in the power of the RF cavities and increasing difficulties in controlling the beam bunches. Because of this, proposed machine upgrades aim not only to expand the energy range even further to 2.5 GeV, and to 0.9 GeV towards lower energies, but also to increase the luminosity to cope with the losses. While crab-waist schemes

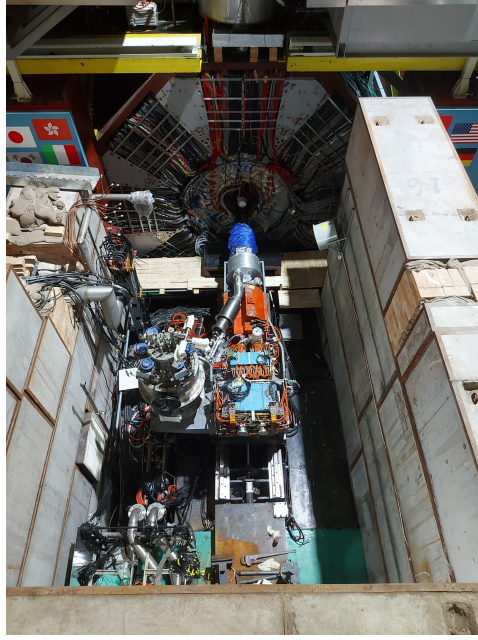
Figure 1.2: The eastern superconducting interaction magnet, before its removal, extracted to free the access to BESIII's innermost subdetectors.

The SIMs are mounted on moving trolleys, so that they can be extracted to access the innermost BESIII subdetectors, as shown in figure 1.2. For the installation of the Cylindrical GEM Inner Tracker (CGEM-IT), the eastern magnet was temporarily removed, to make space for the installation tooling. The western SIM was also extracted but it was kept in place on its rails.

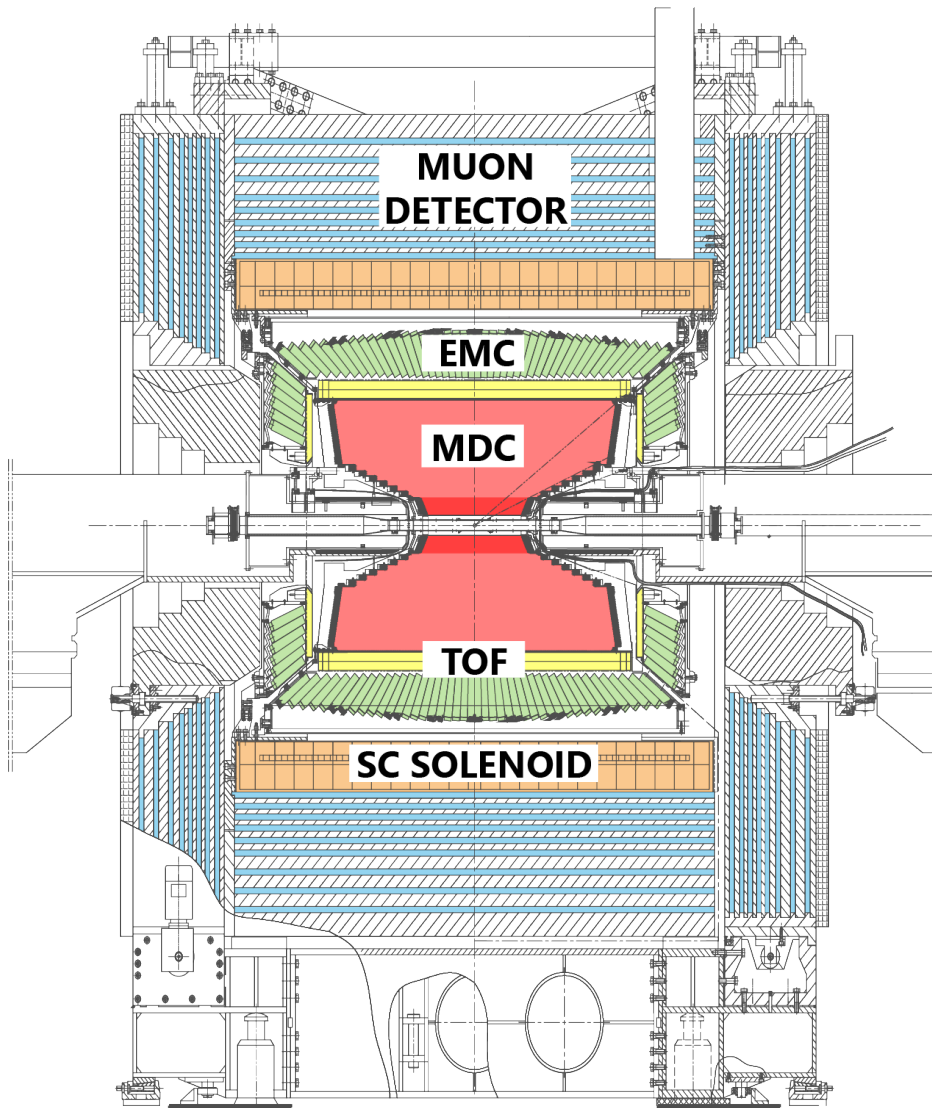
Figure 1.3: Cross-sectional view of the BESIII experiment.

In BESIII the collisions are symmetric and so is the layout of the detector, consisting of a barrel and two identical endcaps, which manages to achieve a 93% coverage of the whole solid angle. The spectrometer, in figure 1.3, comprises 5 main subsystems: the multilayer drift chamber (MDC), the time of flight (TOF) system, the electromagnetic calorimeter (EMC), the superconducting solenoid magnet (SSM), and the muon counter (MUC). A detailed description of the BESIII subsystems can be found in reference [3].

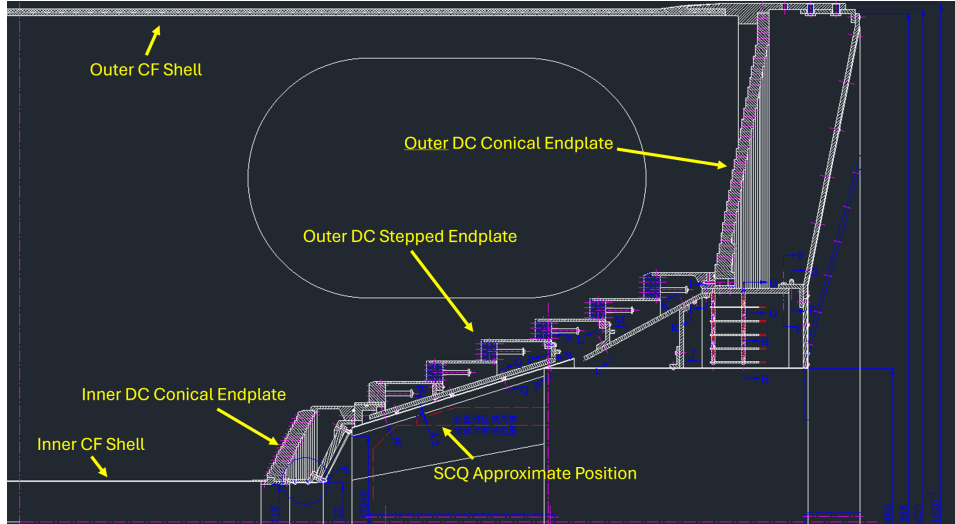
Figure 1.4: Cross-sectional view of the MDC's mechanical support structures.

The inner chamber has conical endplates, while the outer chamber has an inner stepped part and an outer conical one, with the stepped sections providing the necessary space for the insertion of the interaction quadrupoles. All endplates are machined from high strength aluminum alloy, while the cylindrical shells that separate them, bearing the axial load of the MDC's many wires, are made of carbon fiber composites. The outer shell of the MDC is 11.5 mm thick, while the inner shell is 1.2 mm thick. The cross-sectional view in figure 1.4 shows how the mechanical structures of BESIII's MDC fit together and the approximate position of the quadrupole when fully inserted.

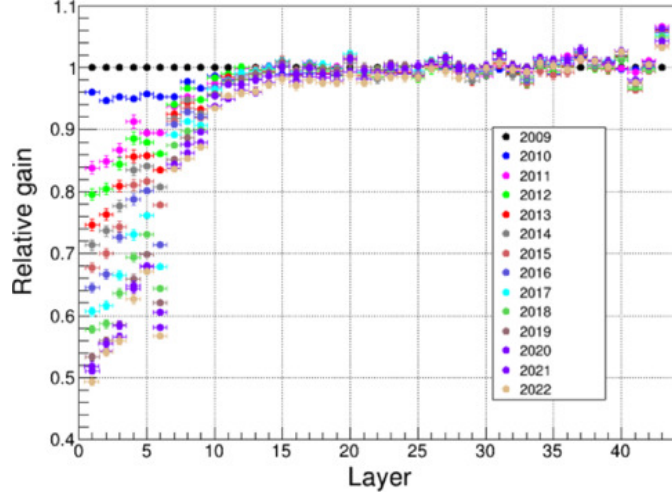
Figure 1.5: Relative gain loss of the MDC layers since commissioning [15].

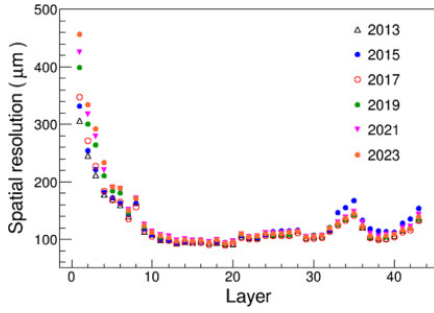
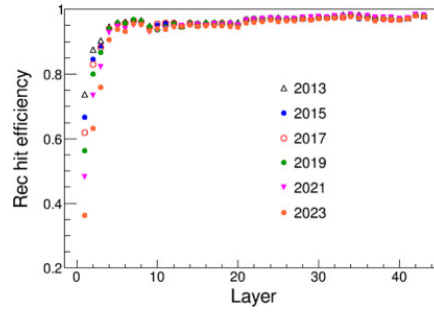
(a) Spatial resolution

(b) Hit reconstruction efficiency

Figure 1.6: Yearly variation of the MDC's spatial resolution and hit reconstruction efficiency per layer [15].

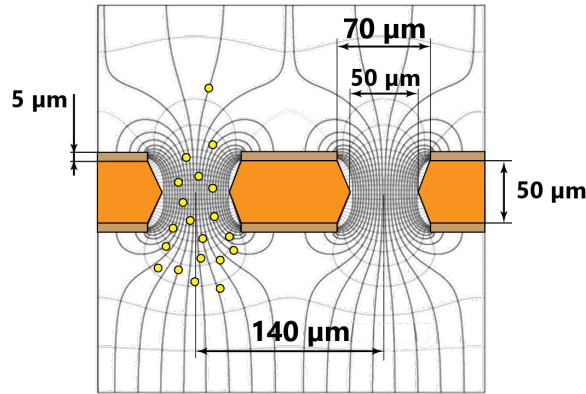
Figure 1.7: Cross sectional drawing of a GEM foil.

Gas Electron Multiplier (GEM) is a Micropattern Gaseous Detector (MPGD) first introduced by Fabio Sauli in 1997 [16]. GEM foils are produced by etching a dense matrix of holes on a $50\text{ }\mu\text{m}$ thick polyimide foil plated by a $5\text{ }\mu\text{m}$ thin copper layer on both faces. The holes, obtained through photolithography and chemical etching, have a biconical cross section, with a diameter of $70\text{ }\mu\text{m}$ at the two copper surfaces and $50\text{ }\mu\text{m}$ in the narrowest point of the polyimide bulk. The pitch of the holes' matrix in the standard fabrication pattern is $140\text{ }\mu\text{m}$, but foils' parameters can be optimized for specific applications. A cross-sectional drawing of a GEM foil and its holes' structure is provided in figure 1.7.

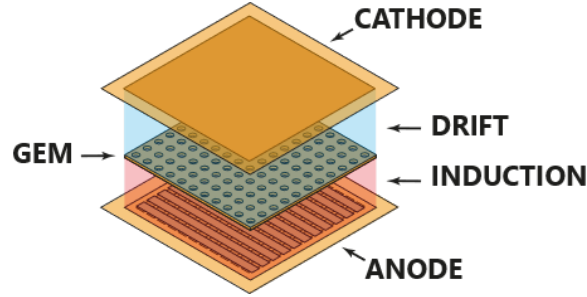
Figure 1.8: Simple example of a single GEM detector with two-dimensional strip readout.

By applying a voltage of the order of a few hundreds of volts to the two faces of a GEM foil, an electric field of the order of 10 kV/cm can be generated inside the holes. The simplest example of GEM detector consists of a cathode, a GEM foil, and a patterned readout anode, stacked and separated by gaps of a few millimeters as shown in figure 1.8. The electrodes's stack is immersed in a gas mixture, which include an easily ionizable noble gas

By applying appropriate cascading voltages to the electrodes, three main regions are established. The gap between the cathode and the GEM identifies the drift region, permeated by the drift field. The multiplication region is distributed within the many holes of the GEM foil and houses the strongest electric fields in the system. Finally, the gap that separates the foil from the anodic readout circuit identifies the induction region, where the induction field resides.

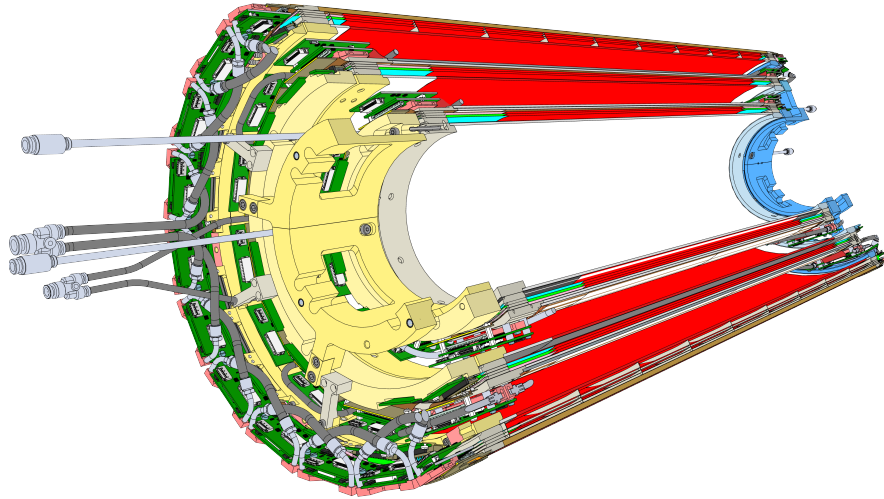
Figure 1.9: Cross-section of the CGEM-IT's CAD model.

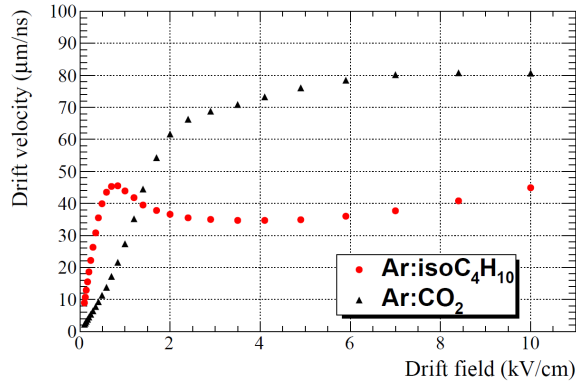
Figure 1.10: Drift velocity as a function of the electric field in a 1T magnetic field from Garfield simulations [19].

The chosen operating mixture for the CGEM-IT is $\text{Ar}:\text{iC}_4\text{H}_{10}$ in 90:10 proportions. This choice of gases provides a good balance between the performance of charge centroid and μTPC reconstruction and yields, on average, larger clusters when compared with $\text{Ar}:\text{CO}_2$ (70:30). The relatively slow drift velocity, as shown in figure 1.10, boosts the precision of the μTPC algorithms used in the reconstruction of inclined tracks [18].

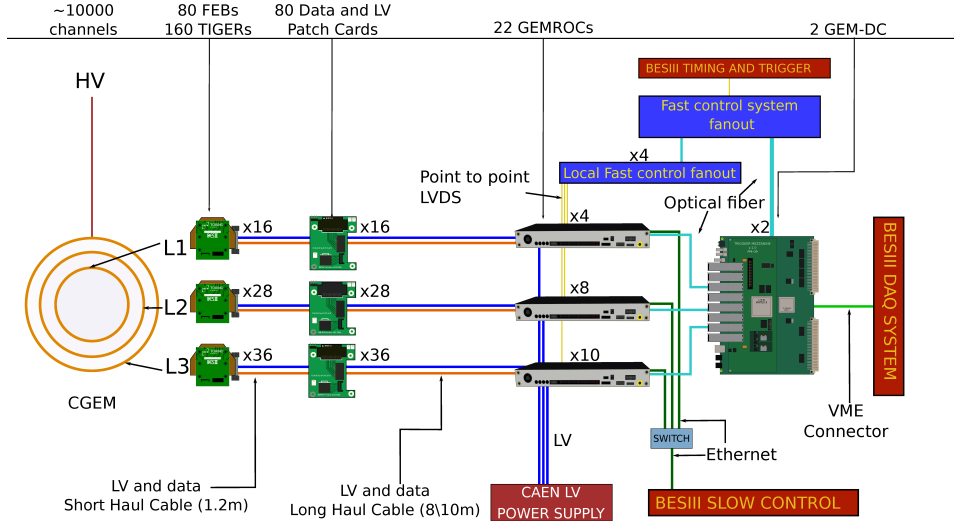
Figure 1.11: Complete Layout of the CGEM-IT readout chain [20]. The schematic shows a configuration employing the minimum possible number of GEMROCs, the chosen readout scheme currently uses 22 GEMROCs overall to ensure symmetry of the two endcaps.

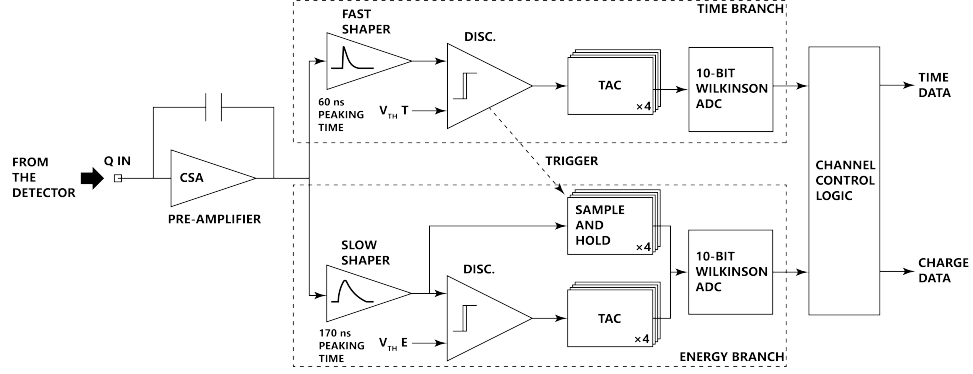
Figure 1.12: Simplified architecture of one of TIGER's channels.

TIGER [21] is capable of performing simultaneous charge and time measurements on each of its 64 channels. A simplified scheme of one of these channels is provided in figure 1.12 while a summary of the chip's performance can be found in table 1.4. The signal induced on the strips is amplified by a charge sensitive amplifier (CSA), split, and fed to two branches, optimized for time (T-branch) and charge (E-branch) measurements. The T-branch has a fast shaper with a 60 ns peaking time, to minimize the ef-

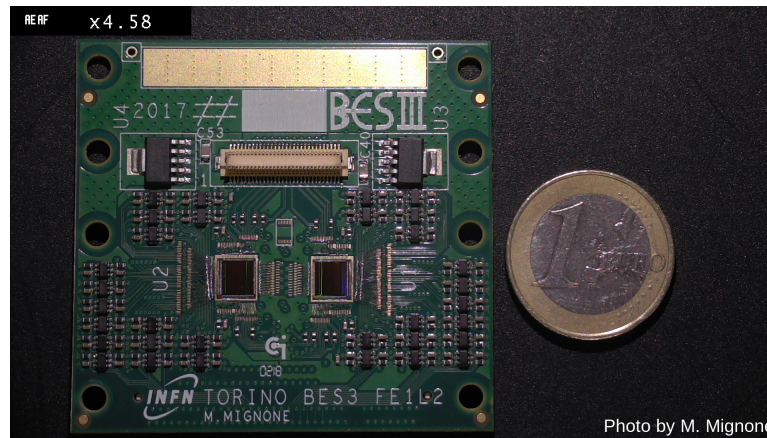
Figure 1.13: Photograph of one of Layer 2's front-end boards.

TIGERs are mounted in pairs on the detector's front-end boards (FEBs), as shown in figure 1.13. Layer 3's FEBs have a more compact design with respect to the ones of layers 1 and 2, due to the very limited clearance that separates the outer diameter of the detector and the walls of the cavity. On each FEB is mounted a copper heat sink, inside of which flows demineralized water. Active cooling is necessary to dissipate the 12.5 mW of heating power generated by each TIGER channel in the confined space of BESIII's IP.

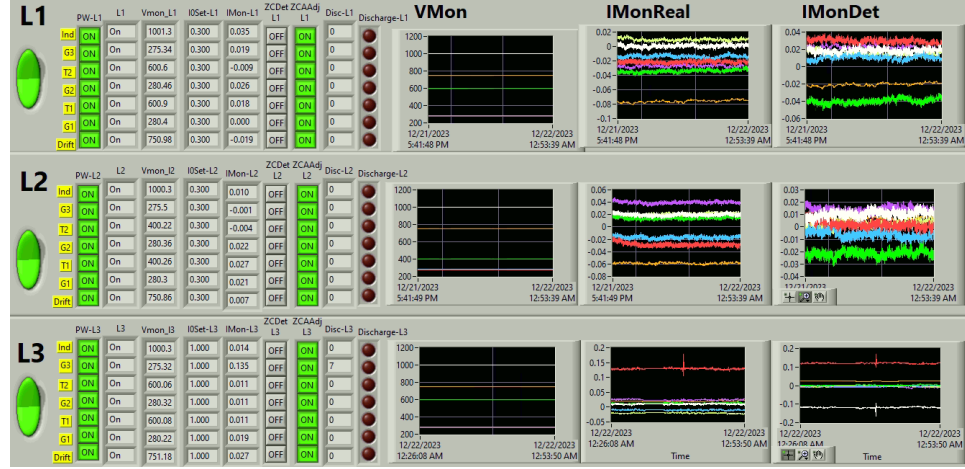
Figure 2.1: Control and monitoring interface of the HV power supply system used for the commissioning. The IMonReal parameter indicates the factory-calibrated reading of the absolute current circulating on each channel. IMonDet instead represents the current circulating in the individual meshes formed by two adjacent electrodes.

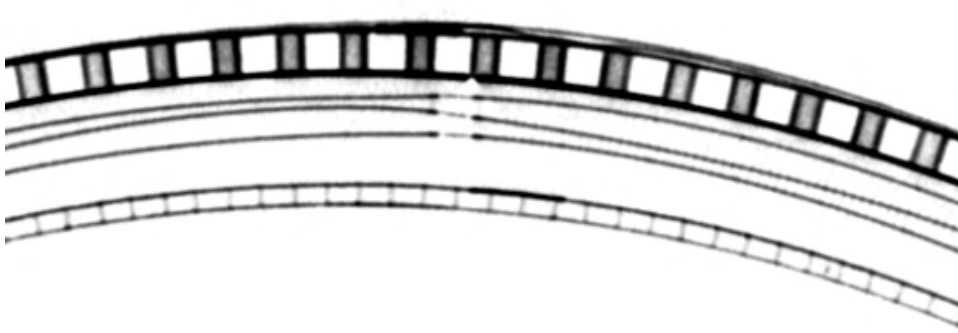
Figure 2.2: Detail of a cross-sectional slice of Layer 3 showing extensive misplacement of the electrodes.

The mapping of the problematic sectors was not sufficient to identify the cause of the issues affecting Layer 3. A more direct approach was then pursued through the use of X-ray imaging. A campaign of computed tomography (CT) scans was conducted at TEC Eurolab SRL, a company specialized in industrial testing located in Campogalliano, Italy. The industrial CT scan machine available within the facility has a resolution of roughly 300 μm , allowing to collect very clear pictures of the internal configuration of the detector, an example of which can be observed in figure 2.2. From the raw pictures it was immediately clear that the electrodes were not cylindrical and that their deformation was not local but extended to the whole detector.

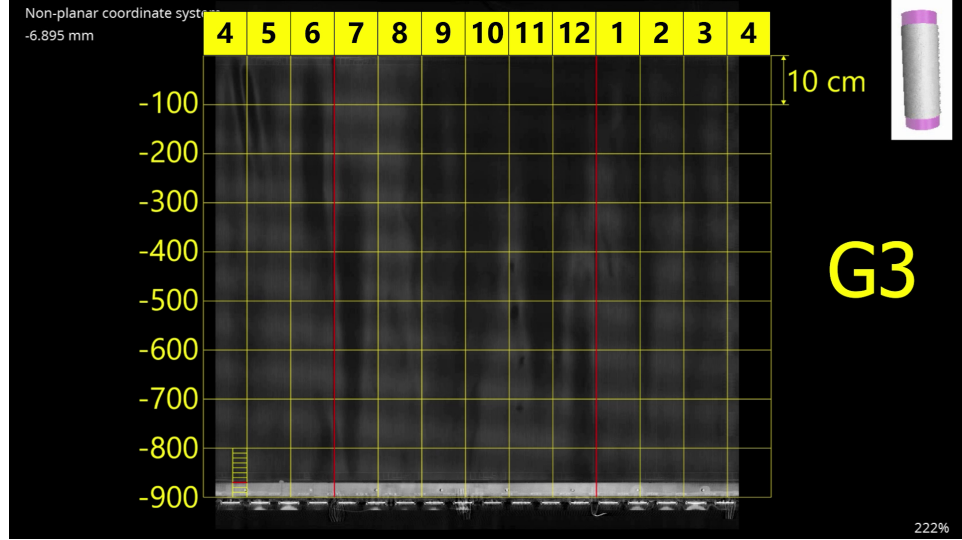
Figure 2.3: X-ray image of Layer 3's GEM 3. The slices are stitched together and digitally elaborated to "unroll" the foil. A grid is superimposed to locate defects within macro-sectors. The numbers at the top correspond to the macro-sector number, while the two red lines indicate the overlaps between the two foils.

From the 3D reconstruction it is possible to obtain images such as the one shown in figure 2.3, where the GEM foils are digitally "unrolled" to precisely locate defects. While some striping, due to imperfect alignment between the real axis of the detector and the one used for unrolling, is to be expected, some of the more evident inhomogeneities are indication of structural collapse of the electrodes and matched well with the mapped malfunctioning sectors. Other smaller bumps and creases are also highlighted in such view. Other views, like the one in figure 2.4, allow to roughly measure the magnitude of the deformation by superimposing a proportional grid. The position of the anode and the cathode, together with their nominal distance of 11 mm can be used as reference.

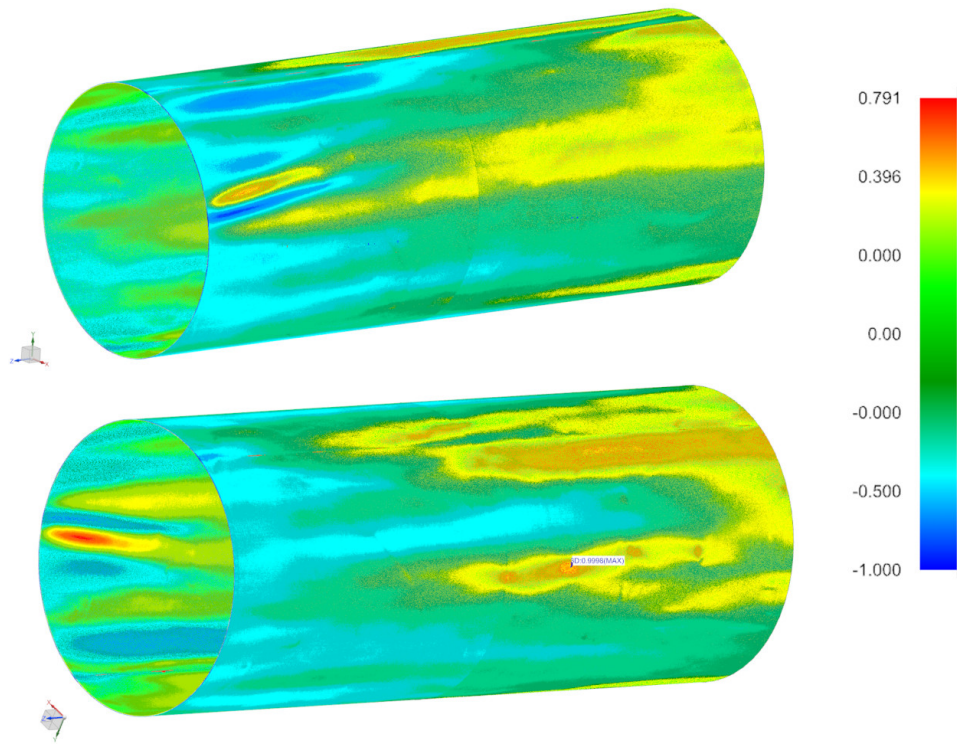
Figure 2.5: Deviation of the CT scan reconstruction of GEM 3 with respect to a nominal cylindrical surface. The alternating pattern of ridges and valleys is compatible with buckling lobes. The unit of the color grading scale is mm.

Further elaboration of the images allows to extract a 3D model of each GEM foil, which can then be compared with a nominal cylindrical surface to measure the deviation. This was done using the reverse engineering module of the Siemens NX suite, to obtain images as the one shown in figure 2.5. The striping already observed in the unrolled images is now clearly visualized as an alternating pattern of peaks and valleys. This kind of deformation is typical of a phenomenon called buckling, to which thin walled cylindrical shells, with unfavorable ratios of radius to overall length, are particularly prone. Buckling occurs suddenly at the reaching of a critical load, which depends on the geometry and material of the structure under stress. FEM simulations of the CGEM-IT layers were carried out, setting provisional values for their critical load: 8.7 g for Layer 1, 4.0 g for Layer 2, and 2.5 g for Layer 3, where g is the standard acceleration of gravity.

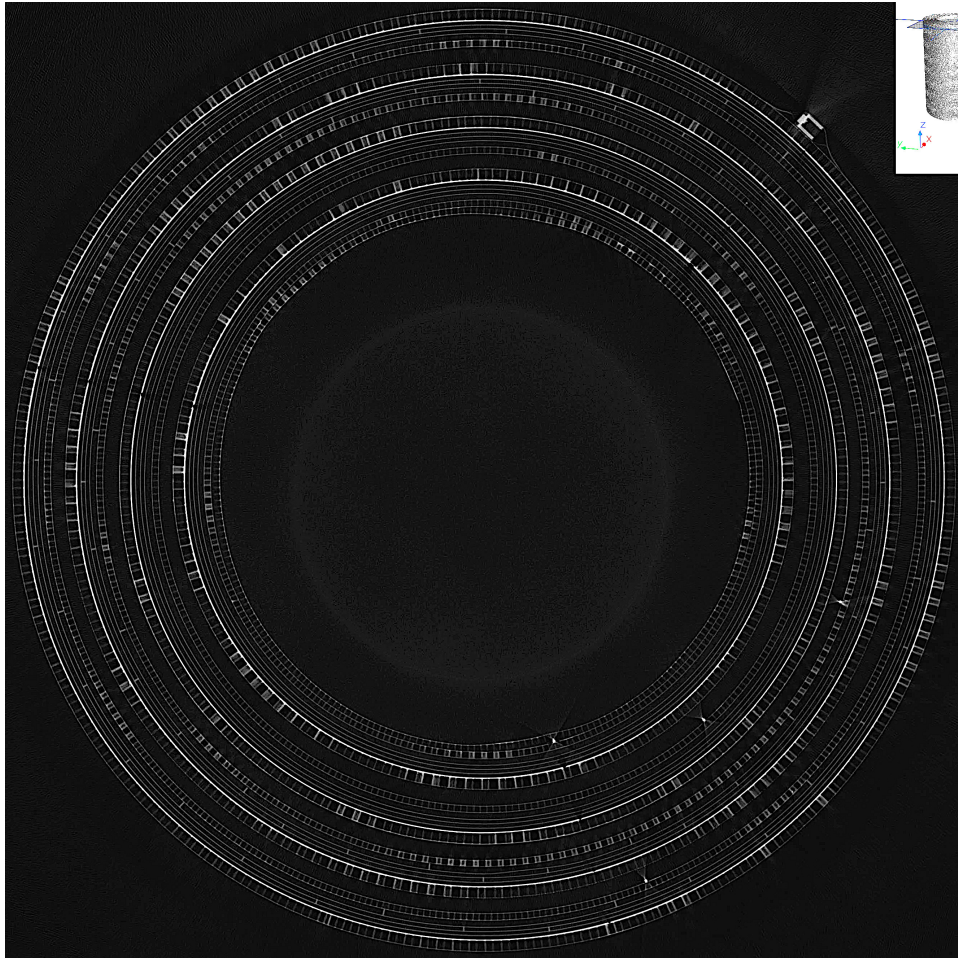
Figure 2.6: Cross section of the KLOE2-IT. The gaps separating the electrodes appear evenly spaced in all four layers. The axial rods of the PEEK spacer grids can be observed in the two outermost layers.

The KLOE2-IT was subjected to a CT scan similar to the one performed on Layer 3, to verify the absence of buckling-induced deformation of its electrodes. The pictures collected showed some localized defects, traceable back to accidents happened during assembly, but no signs of buckling, as shown by figure 2.6.

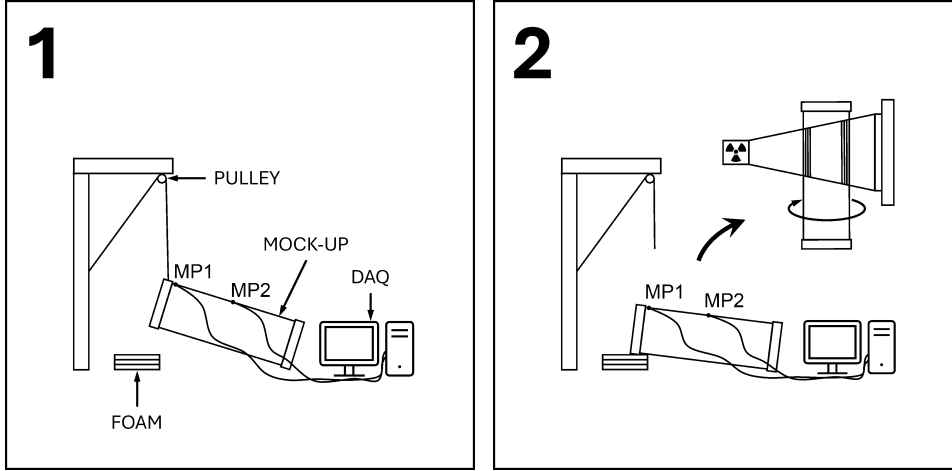
Figure 2.7: Schematic representation of the test. MP1 and MP2 represent the location of the accelerometric sensors installed on the mock-up.

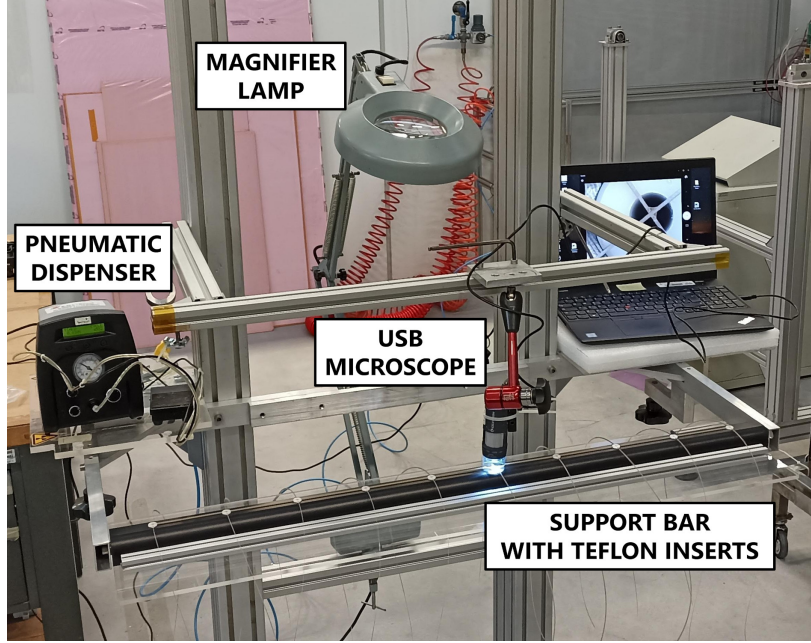
Figure 2.8: Machine used for the assembly of the PEEK grids for the mock-up of Layer 3.

The machine used to assemble the mock-up was the same used to assemble all CGEM layers, temporarily commissioned for the occasion at LNF. The Vertical Insertion Machine (VIM) is a custom CNC machine, which was originally built for the assembly of the KLOE2-IT and later refurbished for the construction of the CGEM-IT. The VIM will be described thoroughly in chapter 3, since its upgrade played an important role in making the split construction of Layer 3 possible. During the assembly of the mock-up, defects present on the electrodes, either pre-existing or arisen during the construction process, were once again mapped and noted down to inform the analysis of the CT scan images. Poor alignment of the VIM and the lack of dimensional fidelity of the 3D printed rings, leading to almost no clearance during the insertion of the electrodes, greatly complicated the mock-up assembly. From its removal from the assembly machine to the end of the drop test the mock-up was kept under constant acceleration monitoring by means of a custom accelerometric measurement system developed for the test.

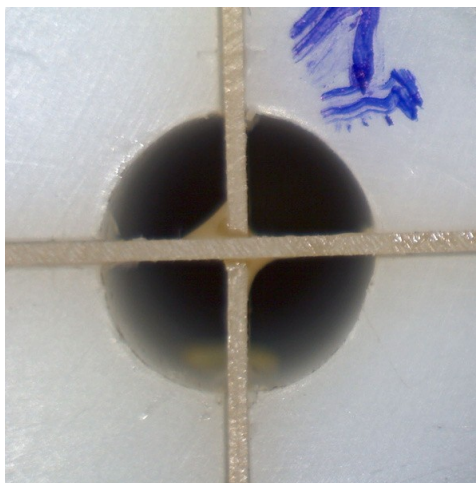
Figure 2.9: Glued grid joint photographed through the microscope.

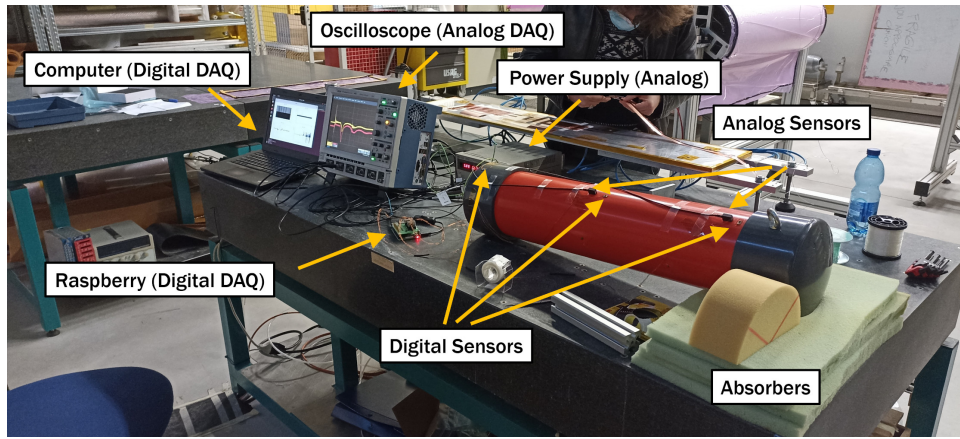
Figure 2.10: Simple setup for the preliminary characterization of the accelerometers and the test of their DAQ system.

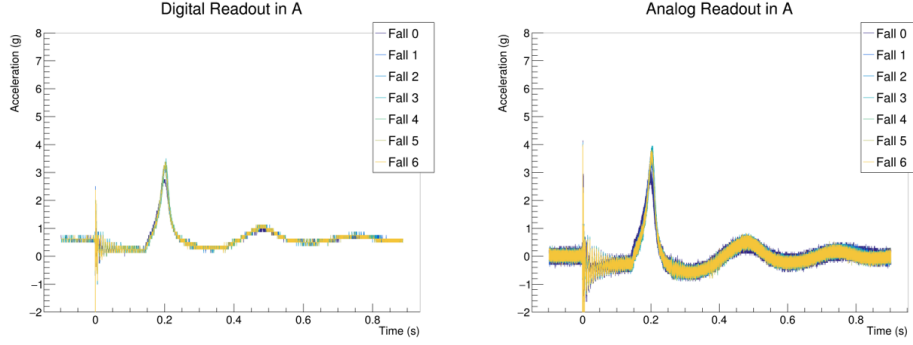
(a) Readings from the digital sensor positioned in the middle of the pipe. (b) Readings from the analog sensor positioned in the middle of the pipe.

A few examples of the spectra generated in the test falls can be found in figure 2.11. The release of the nylon wire holding the pipe suspended produces a quick acceleration spike. The echo of the release can still be observed in the form of a high frequency oscillation until the pipe contacts the absorbers. The first impact with the pile of absorbing foam generates a wide impact peak, where most of the energy accrued in the fall is dissipated and experienced as load by the falling object. The impact peak is followed by low frequency and gradually dampening bumps, due to the object bouncing on the absorbers. The analog sensors measure 0 g at rest, since they cannot measure the stationary gravitational load, while the digital ones registered a value different from 1 g due to a calibration error. A scaling factor was later applied so to fix this issue but the correction still did not fully resolve the discrepancy between the digital and the analog sensors, with the latter always registering slightly larger impacts. The more conservative measurements provided by the analog sensors were chosen to determine the load

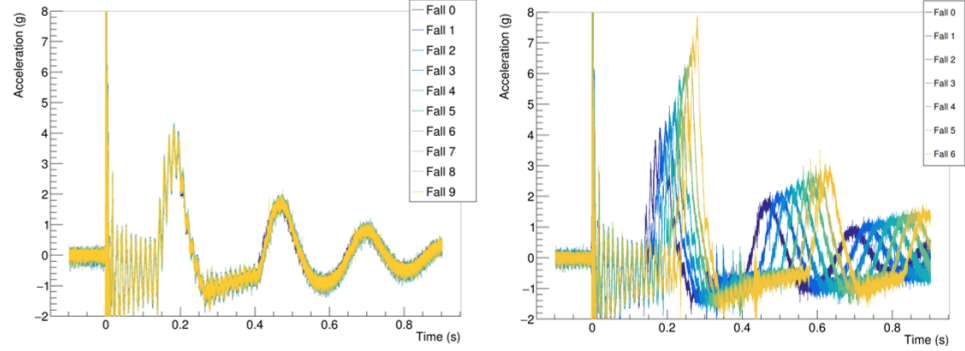
(a) Repeatability study performed by having the assembly take several falls at the same height.

(b) Waveforms obtained in falls from different heights. The height of the fall was defined as the distance between the top-most absorber and the closest point of impact on the assembly. This parameter was varied between 0 and 18 cm, in 3 cm steps.

The two plots of figure 2.11 show that this preliminary setup already granted a very good degree of repeatability to the test falls. The plastic pipe was later substituted with an anode and GEM 3 assembly, discarded in the previous construction of layer 3. This assembly is much more representative of the detector's elastic and inertial behavior, and provides an exposed GEM electrode to relate internal and external stresses. Two of the light digital accelerometers were applied directly to the floating GEM, in the middle of the foil and near the point of impact, while the outer composite structure was instrumented in the same way the plastic pipe was. The suspension structure was later upgraded to provide evenly spaced positions for the quick release mechanism, so to study the amplitude of falls from different heights. Figure 2.12a shows the measurement's repeatability holding true despite the change of falling object, while figure 2.12b hints at an almost linear dependency between the force of the impact and the height of the falls. The plots show a secondary high-frequency oscillation superimposed to the main one previously described. This is likely due to the presence of a resonating internal structure, since it appeared when switching from the pipe to the anode and GEM 3 assembly. Measurements collected by the sensors positioned on the GEM and on the outer shell near the impact point show little difference. In the middle, the acceleration recorded on the GEM was always slightly larger than the one measured on the outer shell. The small difference of about 0.2 g could either be due to the weight of the accelerometer altering the inertial behavior of the foil or to a small amplifying effect due to the material's elasticity. Either way, the effect is too small to be relevant for the

purposes of the test, and the more conservative measurements collected on the outer shell were adopted in the determination of the critical load.

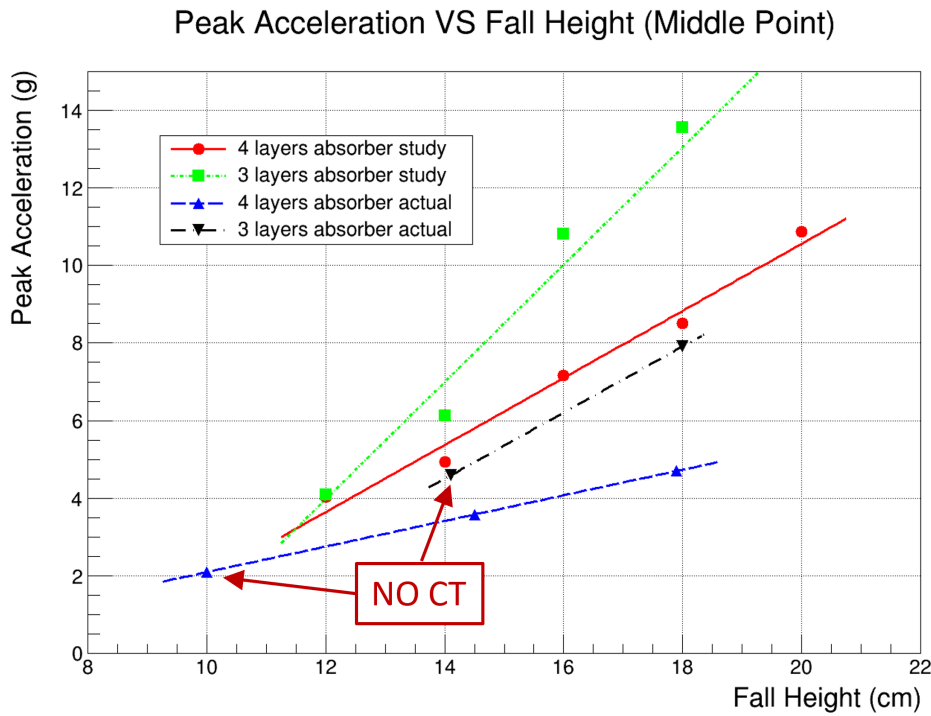
Figure 2.13: Comparison between the preliminary studies conducted on the anode and GEM 3 assembly (study) and the mock-up falls (actual). When switching between 4 and 3 layers of absorber material, to increase the maximum load achievable, an equally strong fall in the two configurations was taken, without performing a CT scan, to ensure the validity of the model and the scaling factor held true when switching between the two curves.

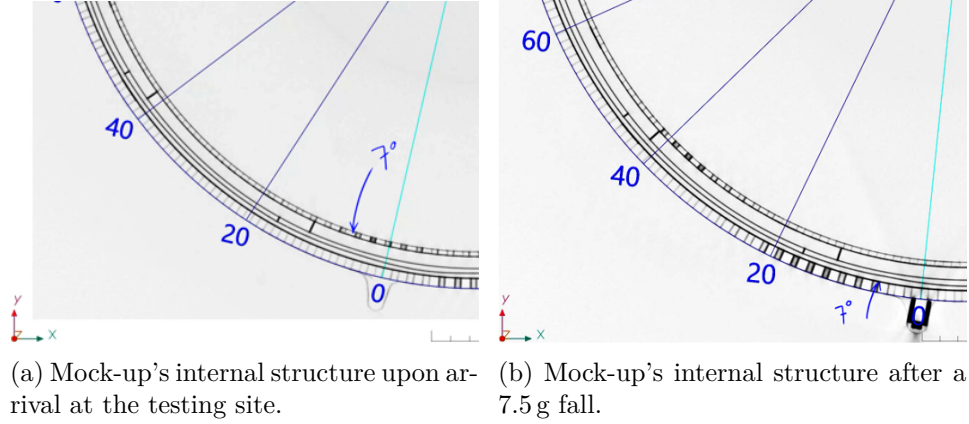
Figure 2.14: Comparison between X-ray CT scan images of the mock-up collected upon arrival at the testing site and after suffering a 7.5 g fall.

mock-up at the testing site and after the 7.5 g fall. No relevant change is observed in the internal structure between the two scans. The electrodes remain evenly spaced and show no sign of damage, aside for the known preexisting defects. Moreover, despite the grid detaching and going out of position due to friction during the assembly, as shown in figure 2.15, the damage was contained, localized, and unaffected by the falls.

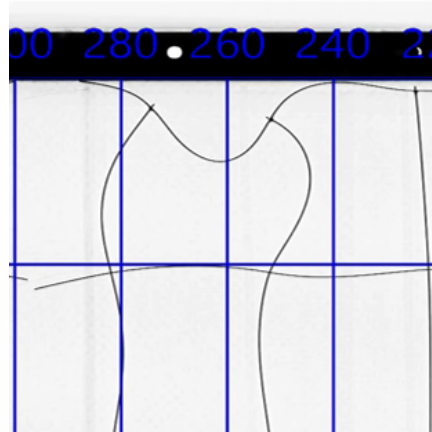
Figure 2.15: Portion of the grid that came loose and went out of position during assembly

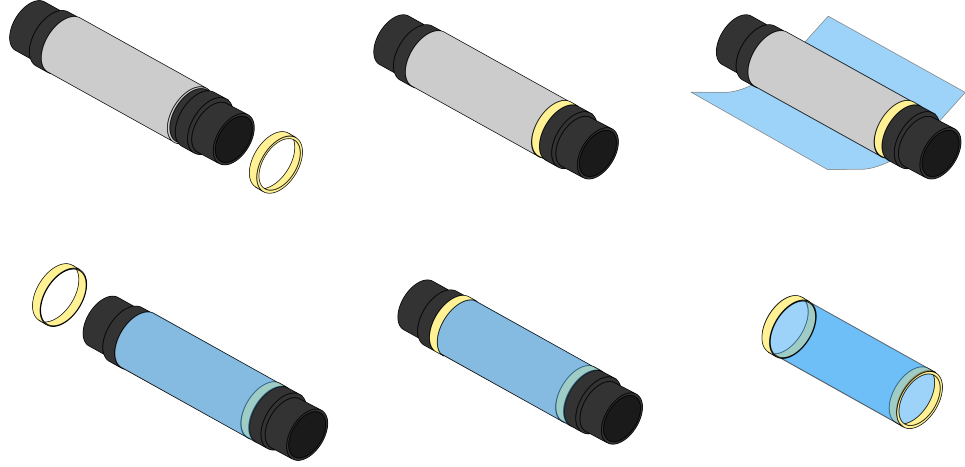
Figure 3.1: The general idea at the basis of the construction of cylindrical electrodes: foils are wrapped around a mandrel and glued to structural rings at the two ends.

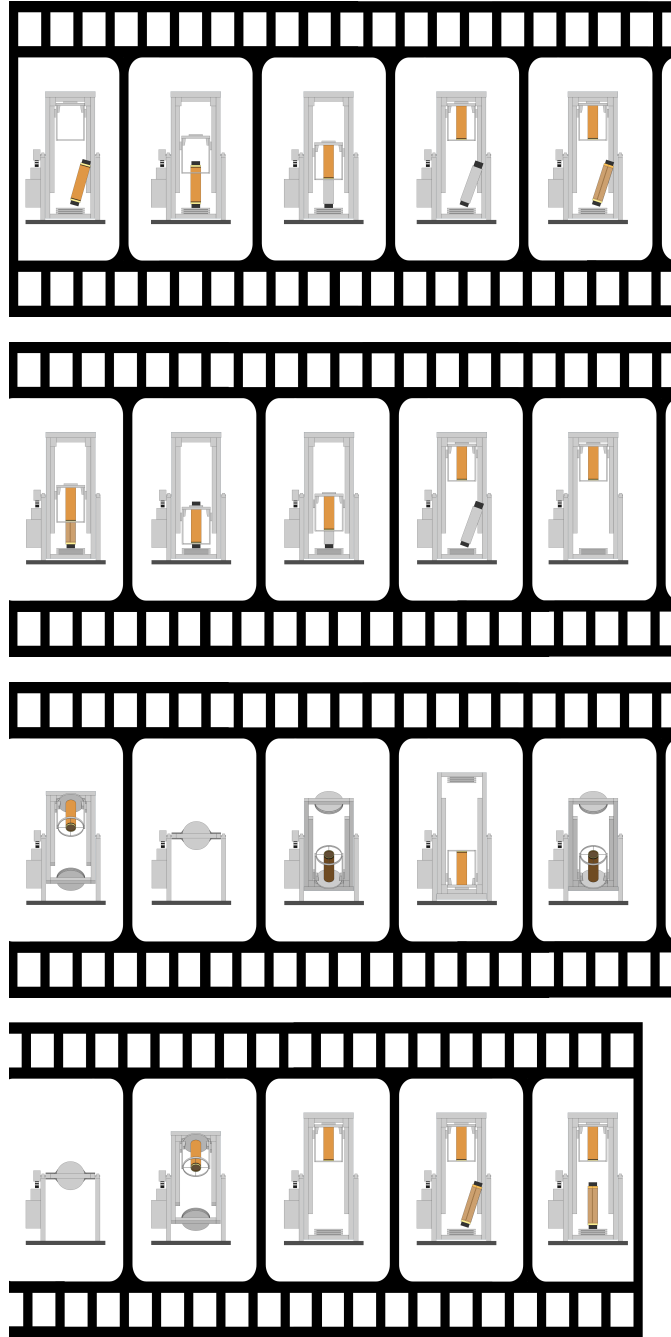
Figure 3.2: Schematic representation of the assembly procedure of CGEM electrodes. This sequence only shows the beginning of the assembly, stopping right before the insertion of the second GEM electrode. All remaining steps necessary to fully assemble the detector follow a similar concept.

The assembly of the electrodes, schematically represented in the sequence of figure 3.2, is performed vertically using a custom CNC machine called VIM. The first step in this process is the extraction of the largest electrode, the anode, from its mandrel (frames 1 to 4). Then, the next electrode, GEM 3, replaces the empty mandrel and is inserted into the anode (frames 5 to 7). The top rings of the two electrodes are glued together and, once the glue has cured, GEM 3 is also extracted from its mandrel (frames 8 to 10). The machine is then rotated 180° to glue the rings at the opposite end (frames 11 to 14). After the machine is brought back to the original position (frames 15-18), the entire process is repeated until all five electrodes are glued together. Both endcaps are finally sealed with epoxy resin to ensure gas tightness, marking the end of the CGEM layer's construction.

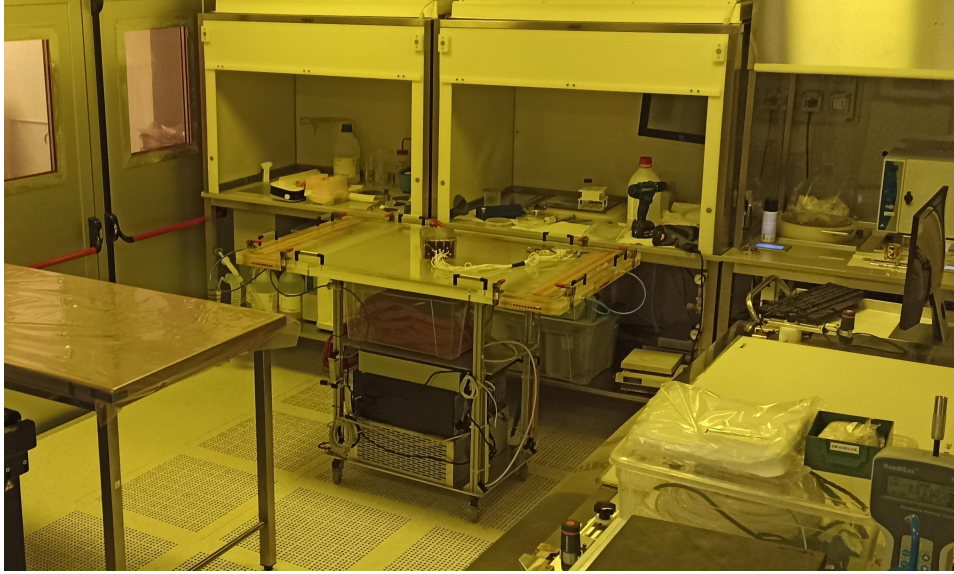
Figure 3.3: The HV test setup used in the quality control of Layer 3's GEM foils. The setup was compacted on a single wheeled table to avoid crowding the smaller cleanroom space available in Ferrara.

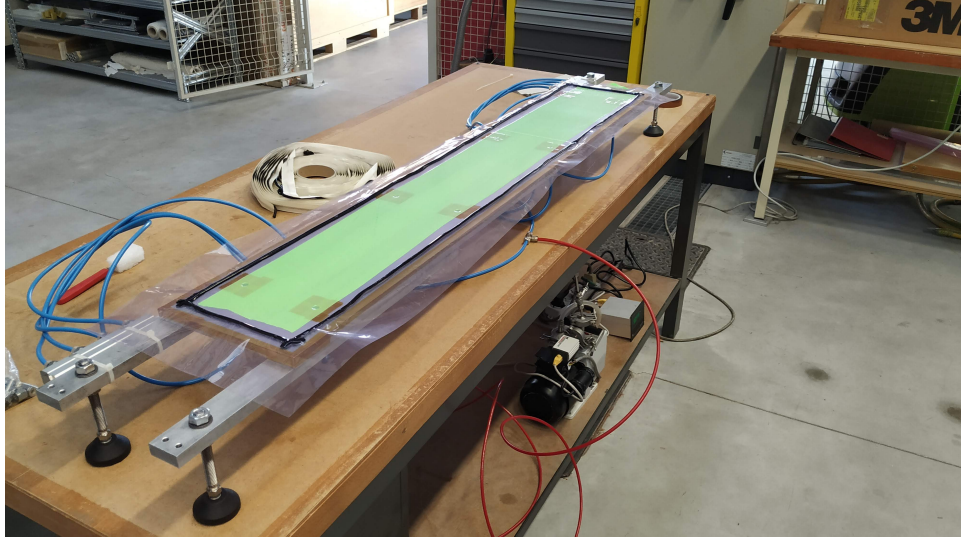
Figure 3.4: The small vacuum table used to practice the gluing of the narrow GEM overlaps.

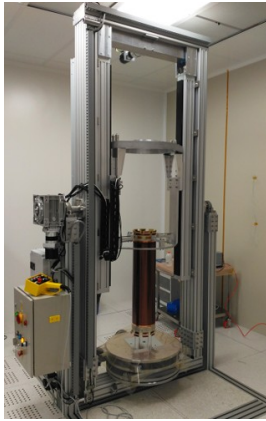
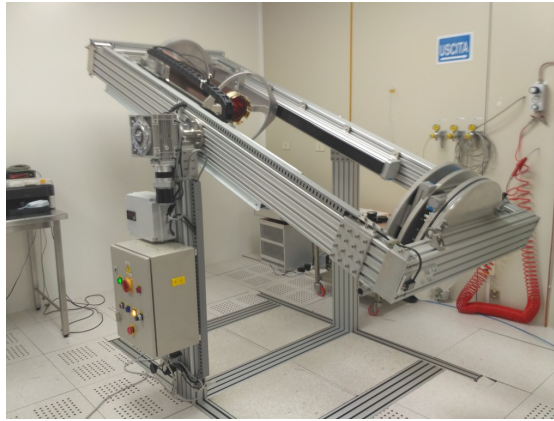
(a) The VIM in its standard, upright position

(b) The VIM, mid rotation

Figure 3.5: Two photographs of the VIM, showing its two main degrees of freedom, the vertical movement of the trolley and the rotation of the main frame.

The VIM was designed and built for the construction of the KLOE2-IT, and later modified to adapt to the slightly longer CGEM-IT. Bosch profiles were adopted for the framing, commercial electric motors and motorized linear guides control the movements, and custom machined flanges are used to interface with the detector. Figure 3.5 shows the VIM in its standard upright position and mid rotation. The two principal degrees of freedom of the machine are showcased in the photographs: the vertical movement of its rail-mounted trolley and the rotation of the main rectangular frame. The base of the machine consists of a rectangular frame, bolted to the floor, and two vertical struts, which support the main rotating structure. This large rectangular frame has an adjustable base at the bottom, for housing the mandrels, and a moving trolley at the top, used for inserting and extracting the electrodes.

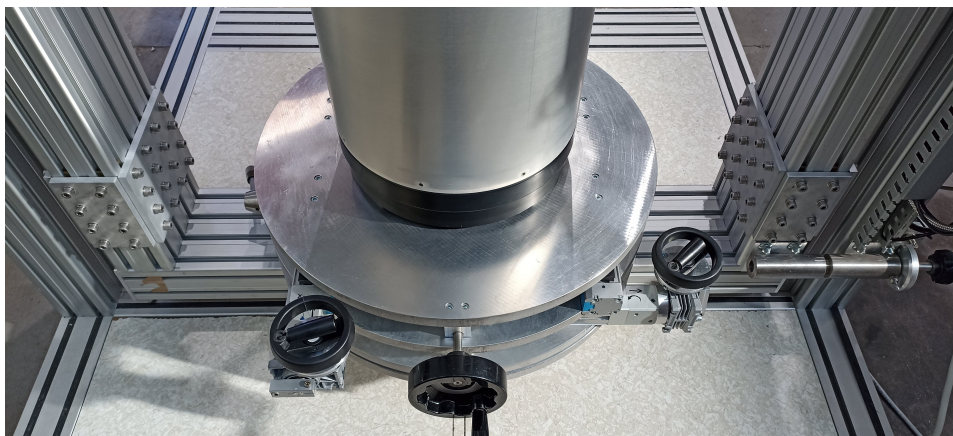
Figure 3.6: The base of the VIM showing the stacked plates it is made of and the adjustment wheels.

The base of the machine, in figure 3.6, consists of four circular aluminum plates, stacked and connected by adjustable elements that grant the base its degrees of freedom: movement in the horizontal plane and tilt with respect to the main frame. At the center of the base lies a self-centering chuck, which is used to keep the mandrel steady by holding onto a pin affixed to its bottom-facing three-spoke flange.

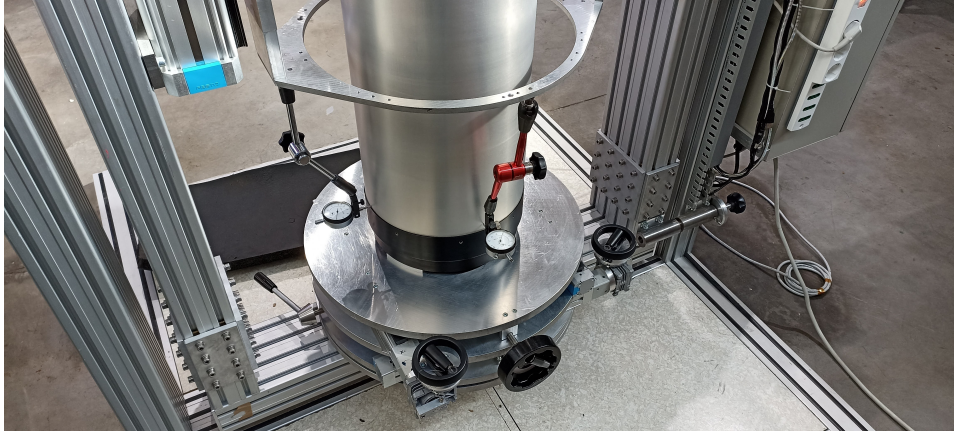
Figure 3.7: Positioning of the dial gauges for the alignment of the VIM.

To assess the centering, the trolley had to be lowered until its top flange was level with the top end of the mandrel, so that the clearance separating the two could be measured with a caliper. The clearance in the two horizontal directions could then be equalized by acting on the control wheels at the base to move the mandrel with respect to the flange. This second part of the alignment procedure could be affected by large measurement errors, due to improper caliper placement, and was complicated by the absence of a direct feedback on the adjustments performed through the control wheels.

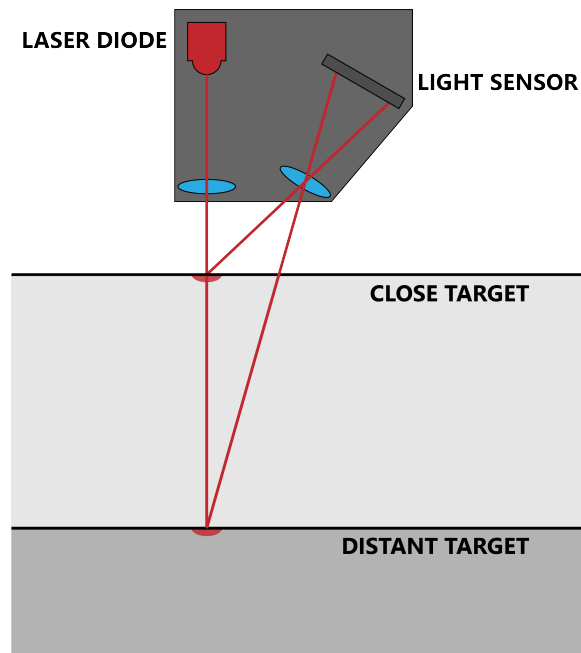
Figure 3.8: Functioning principle of a laser triangulation sensor. The light sensor is angled with respect to the emitter so that the distance can be determined by the position of the reflected light impinging on the sensor.

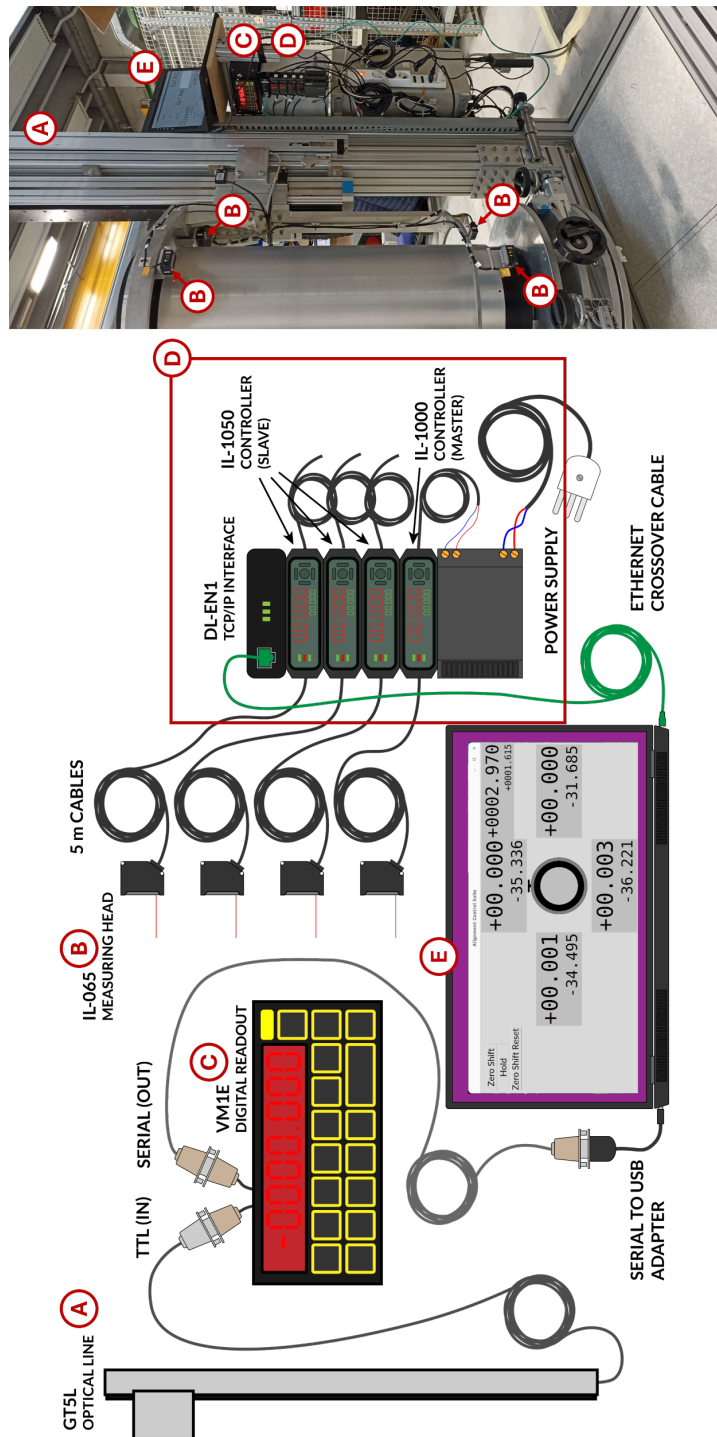
Figure 3.9: Diagram of the laser alignment system and position of its main components on the VIM
