University of Ferrara
Physics and Earth Sciences Department
Ph.D. Course in Physics
Cycle XXXVII
Coordinator Prof. PAOLO LENISA

**Construction, Commissioning, and Installation
of the Cylindrical GEM Inner Tracker
of the BESIII Experiment**

Year 2021/2024

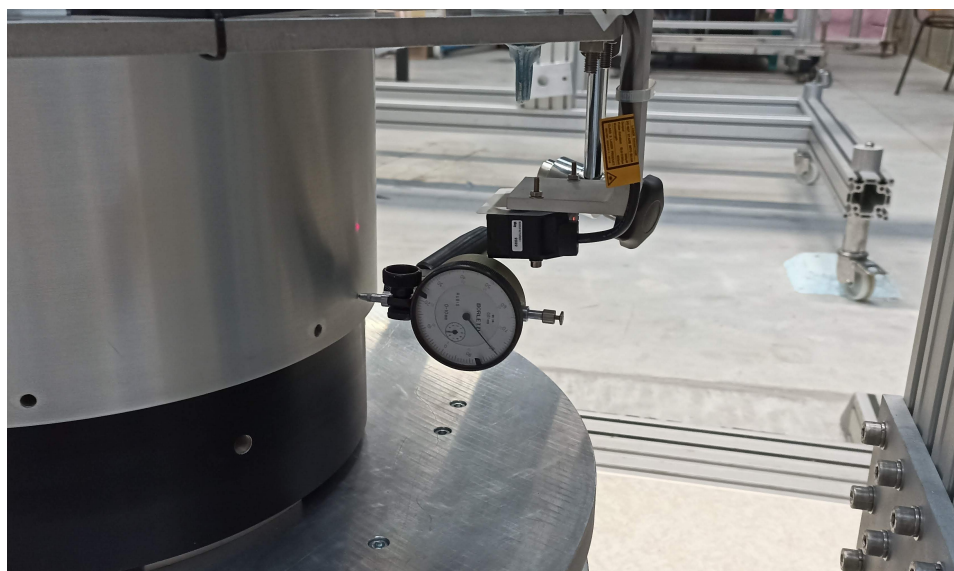
Figure 3.10: Mounting of the dial gauges for their use in the preliminary comparative studies

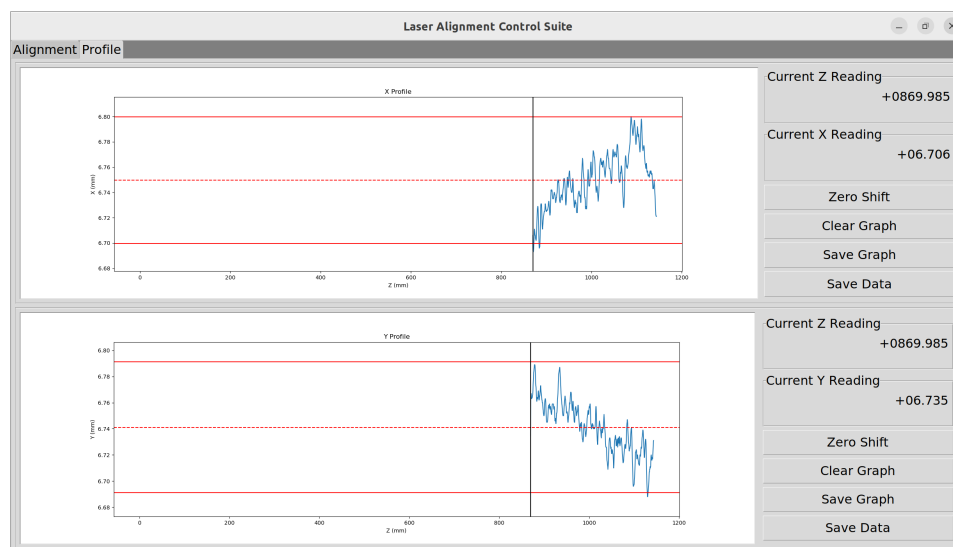
Figure 3.11: Screenshot of an early version of the alignment interface, displaying unexpected fluctuations of the readings when scanning the Teflon surface. In this build, the monitor always displayed the full range of the profile and populated it according to the movement of the trolley, the position of which is represented by the black vertical line in the plots.

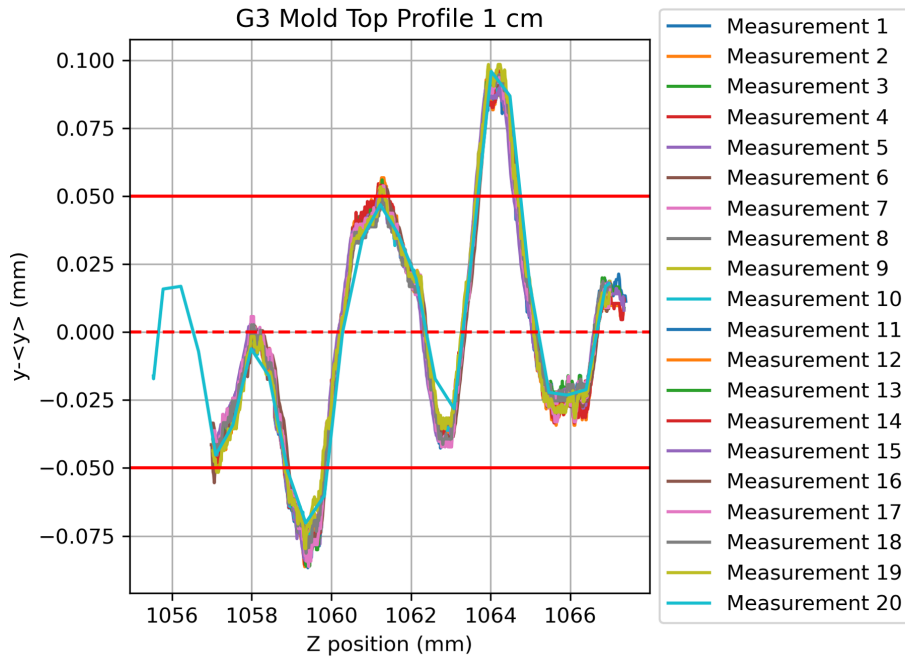
Figure 3.12: Repeatability study of the laser sensors' readings.

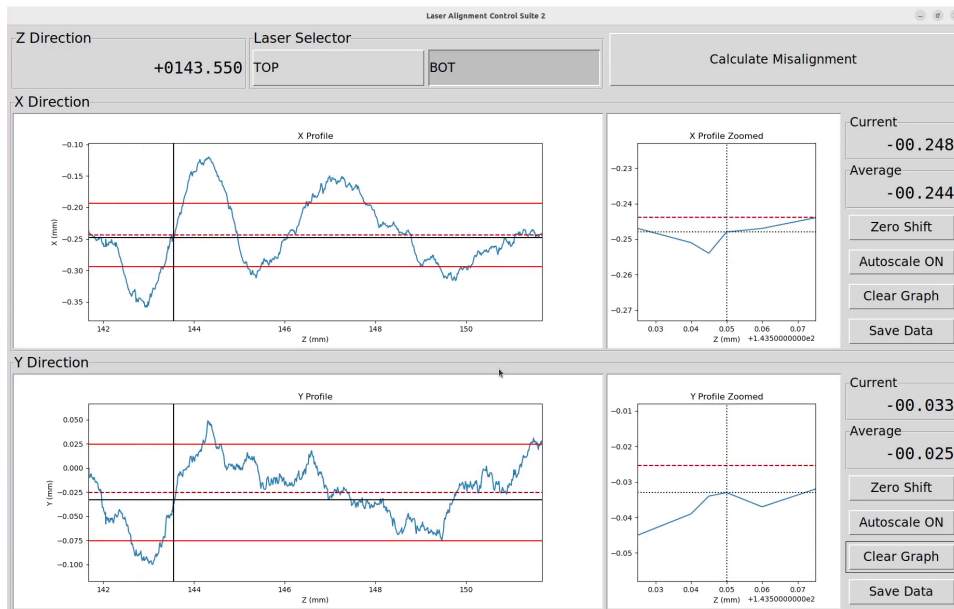
Figure 3.13: Screenshot of the final version of the alignment interface. A function to automatically scale the plots was added to display effectively both small scans and the full profile of the mandrels. Zoomed-in views facilitate precise trolley positioning for zeroing and performing the adjustments.

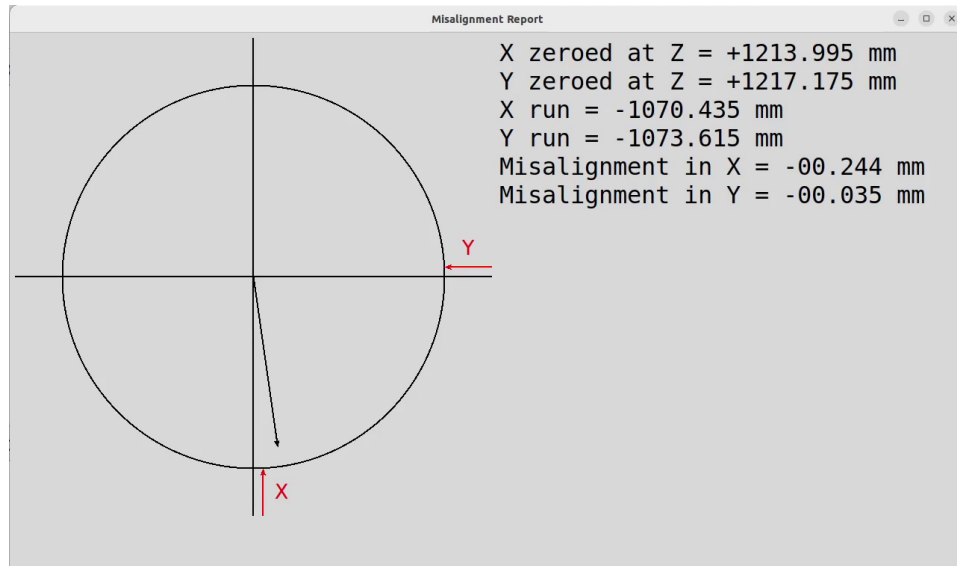
Figure 3.14: Screenshot of the misalignment report window of the interface.

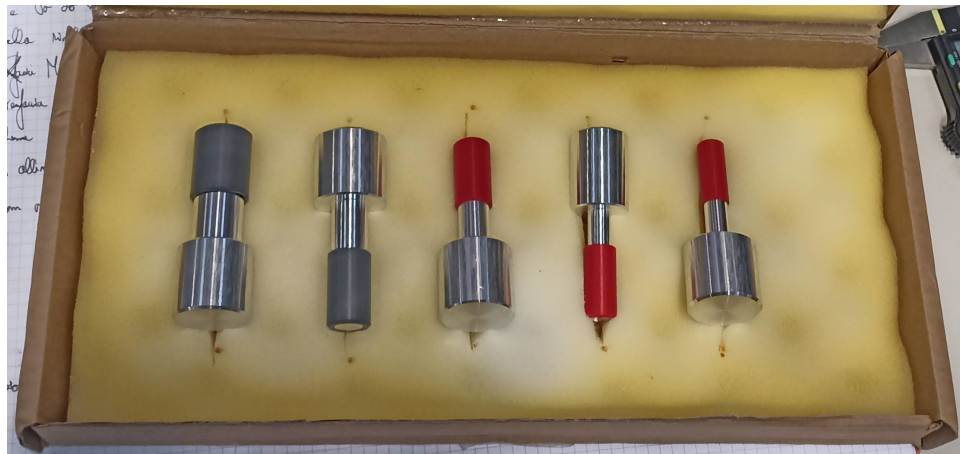
Figure 3.15: Custom set of precision gauge pins, precisely turned to match the nominal clearance between the trolley's top flange and each mandrel's top end.

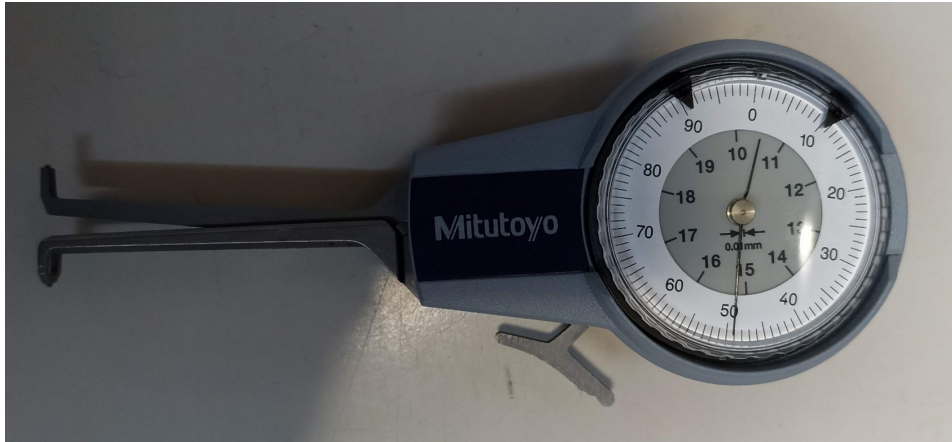
Figure 3.16: The internal dial gauge procured for improving the centering procedure.

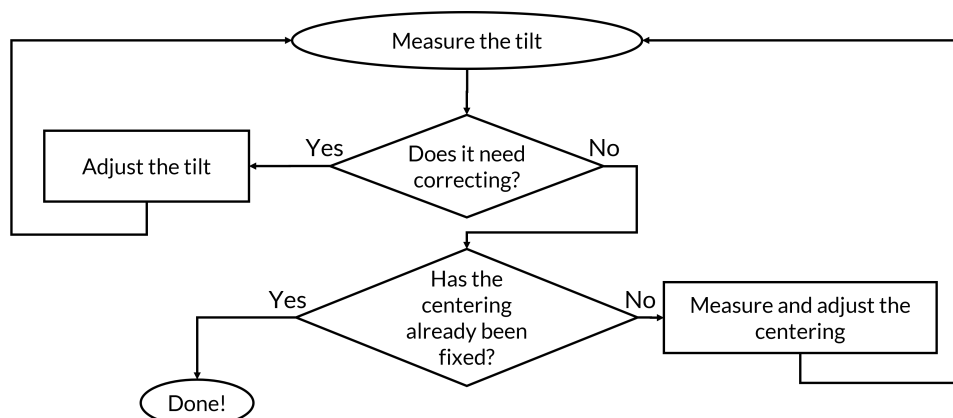
Figure 3.17: Flowchart summarizing the iterative alignment procedure.

The correlation of tilt and centering required yet another change of approach with respect to what had been done in the past. Tilt and centering have to be progressively adjusted and re-checked until both can be brought simultaneously within tolerance, as shown in the flow diagram of figure 3.17. Such iterative procedure requires the trolley to move up and down along its full run many times, increasing the overall duration of a full alignment.

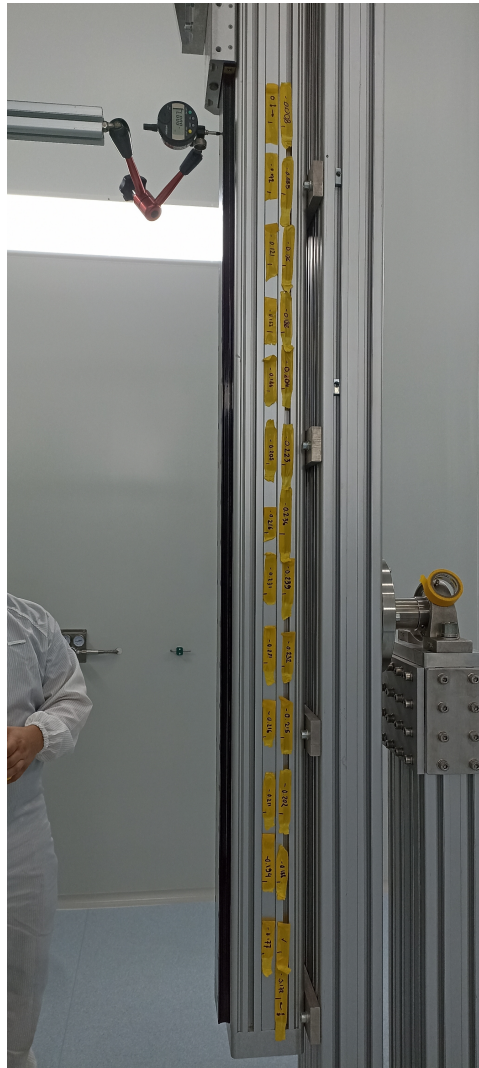
Figure 3.18: Rails' parallelism checks performed during the commissioning of the VIM in Beijing.

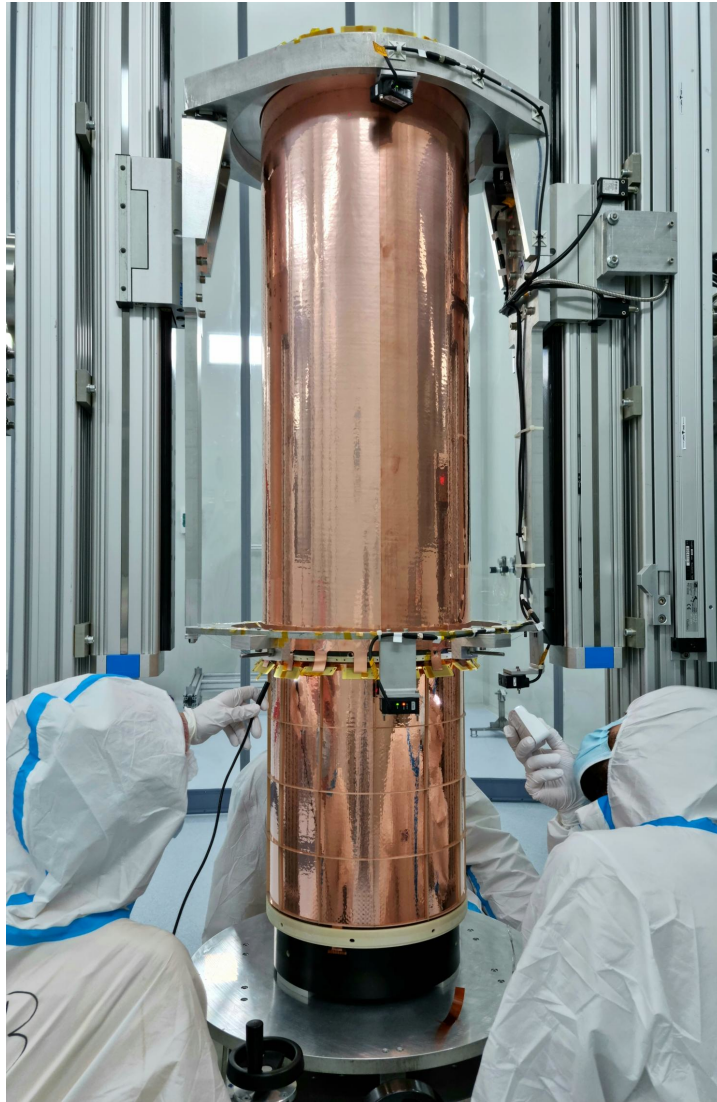
Figure 3.19: Photo taken during the insertion of the cathode into the other assembled electrodes.

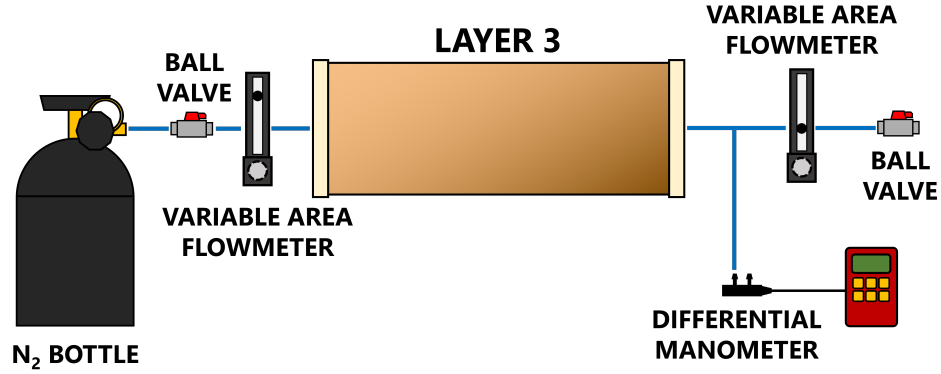
Figure 4.1: Gas circuit used for measuring gas leakage rate.

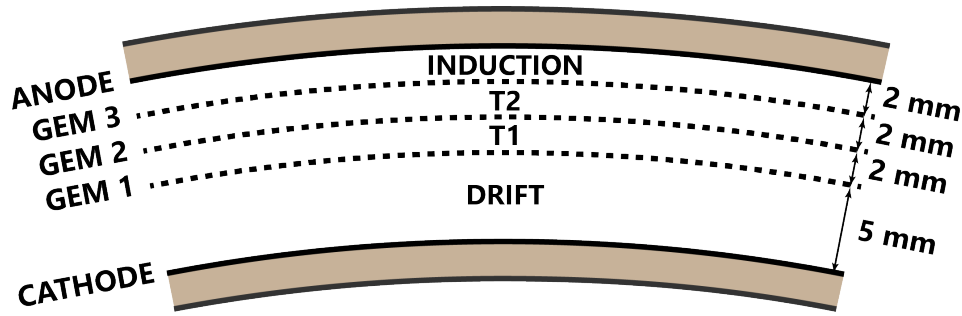
Figure 4.2: Schematic drawing showing the arrangement of fields inside the detector, the electrodes involved in their establishment, and the size of the gap they inhabit.

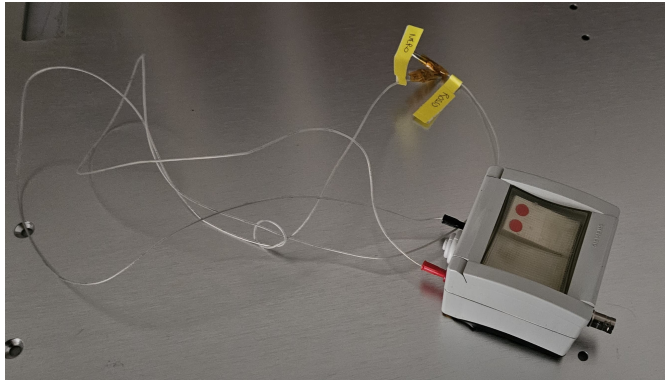
Figure 4.3: Repurposed domestic power switch used for the electrical cleaning of pathological GEM sectors

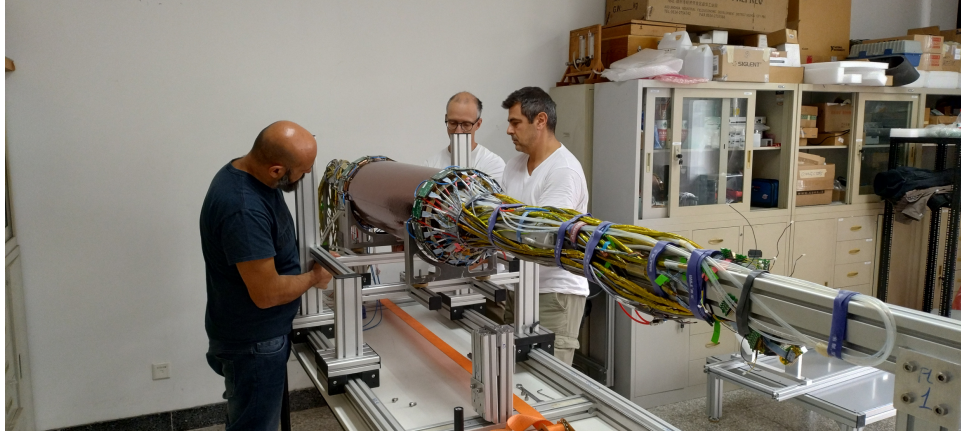
Figure 4.4: Custom machine used for the assembly of the three layers

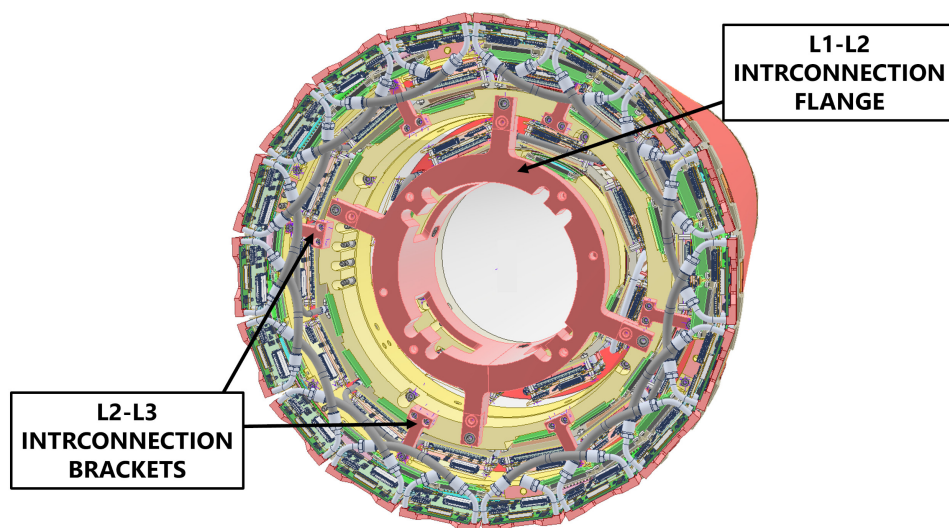
(a) The flange connecting Layer 2 to Layer 1 is segmented to allow the passage of the former around the latter during assembly. The number of interconnection brackets differ between the two sides.

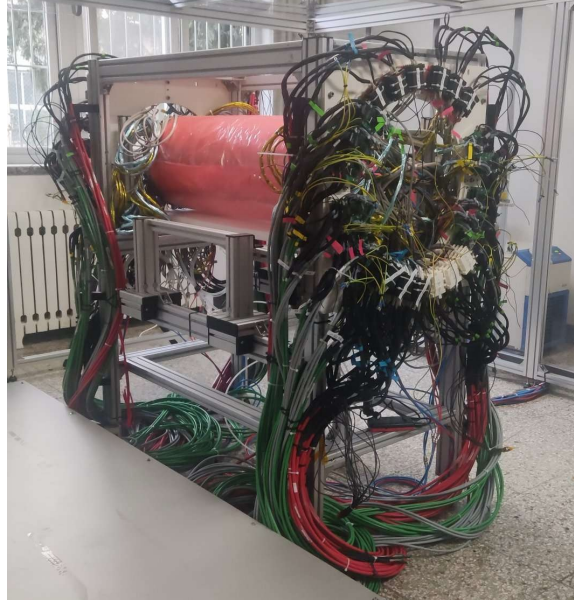
Figure 4.6: The CGEM-IT fully cabled inside the testing station for the acquisition of cosmic ray data.

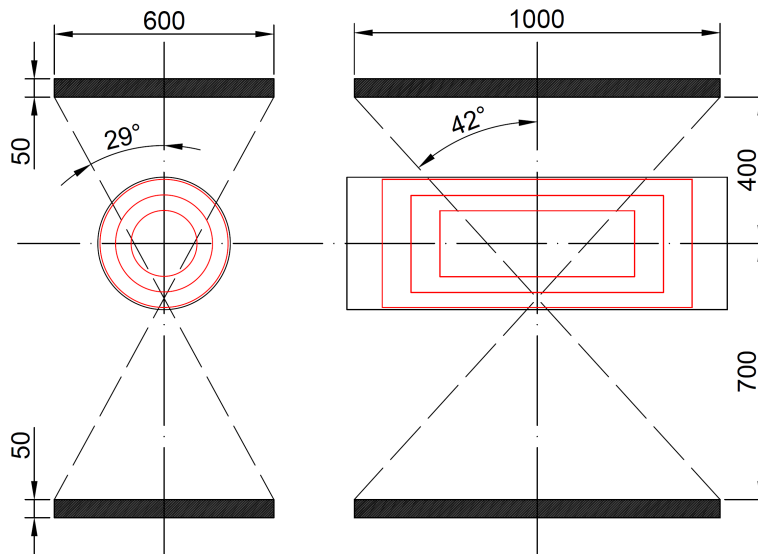
Figure 4.7: Relevant geometries of the testing station for the determination of the solid angle acceptance. All units are in mm. The shapes in red represent the active surfaces of the three anodes in the system, while the black rectangles are the plastic scintillators. The maximum angles of acceptance in the two directions, assuming perfect alignment, are indicated in the two views.

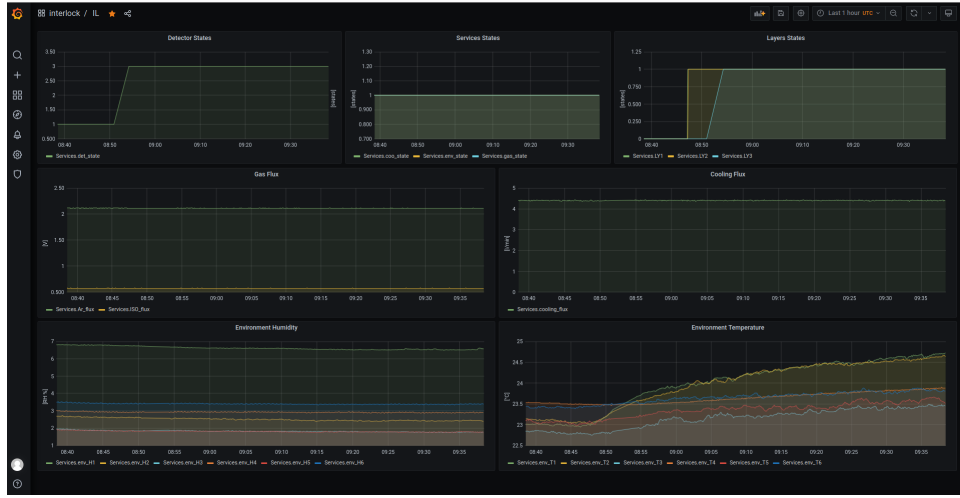
Figure 4.8: Online dashboard of the interlock system showing relevant environmental parameters and the status of ancillary services.

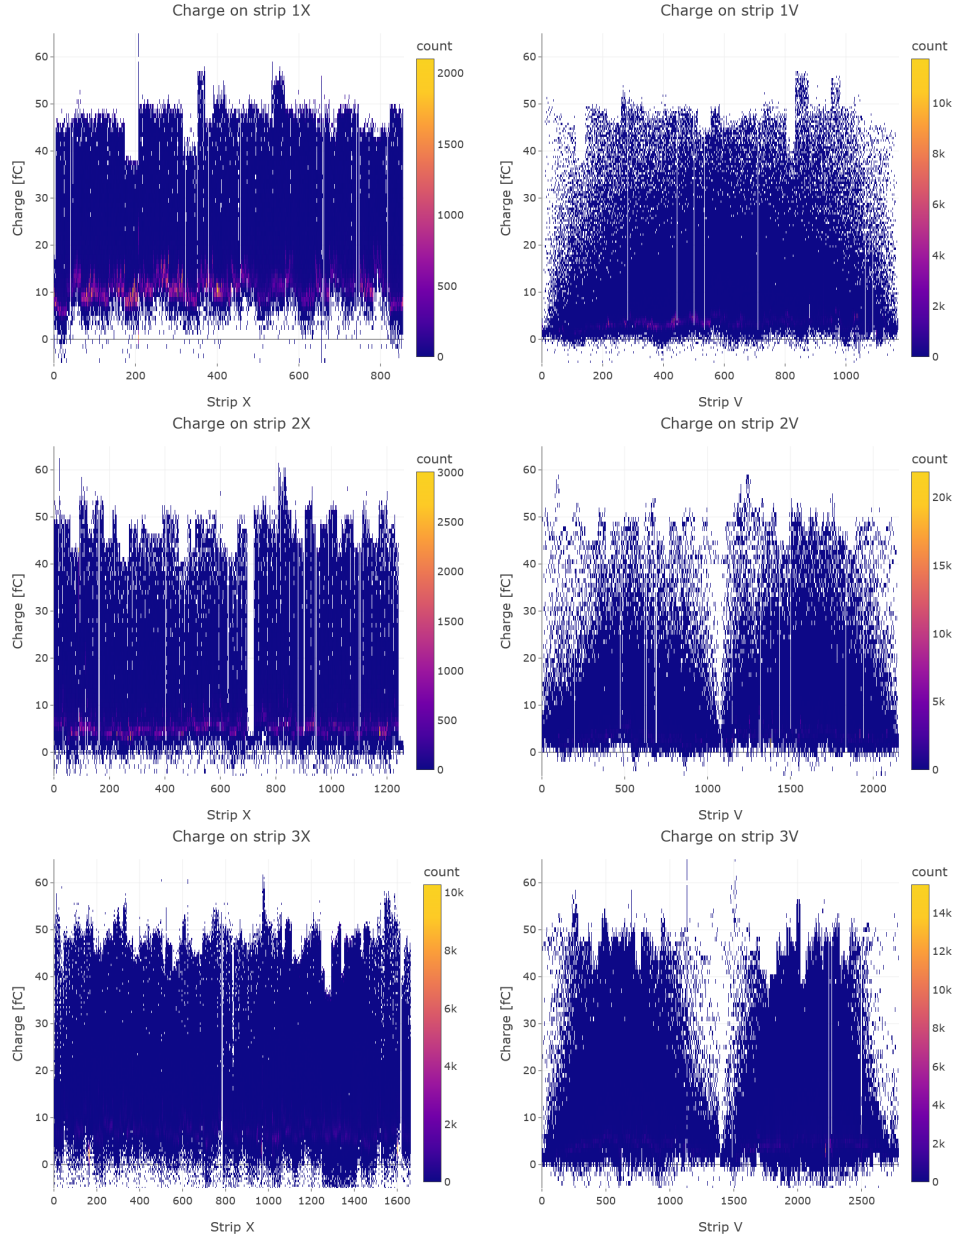
Figure 4.9: Charge of all hits collected during a typical run for both views of all three layers.

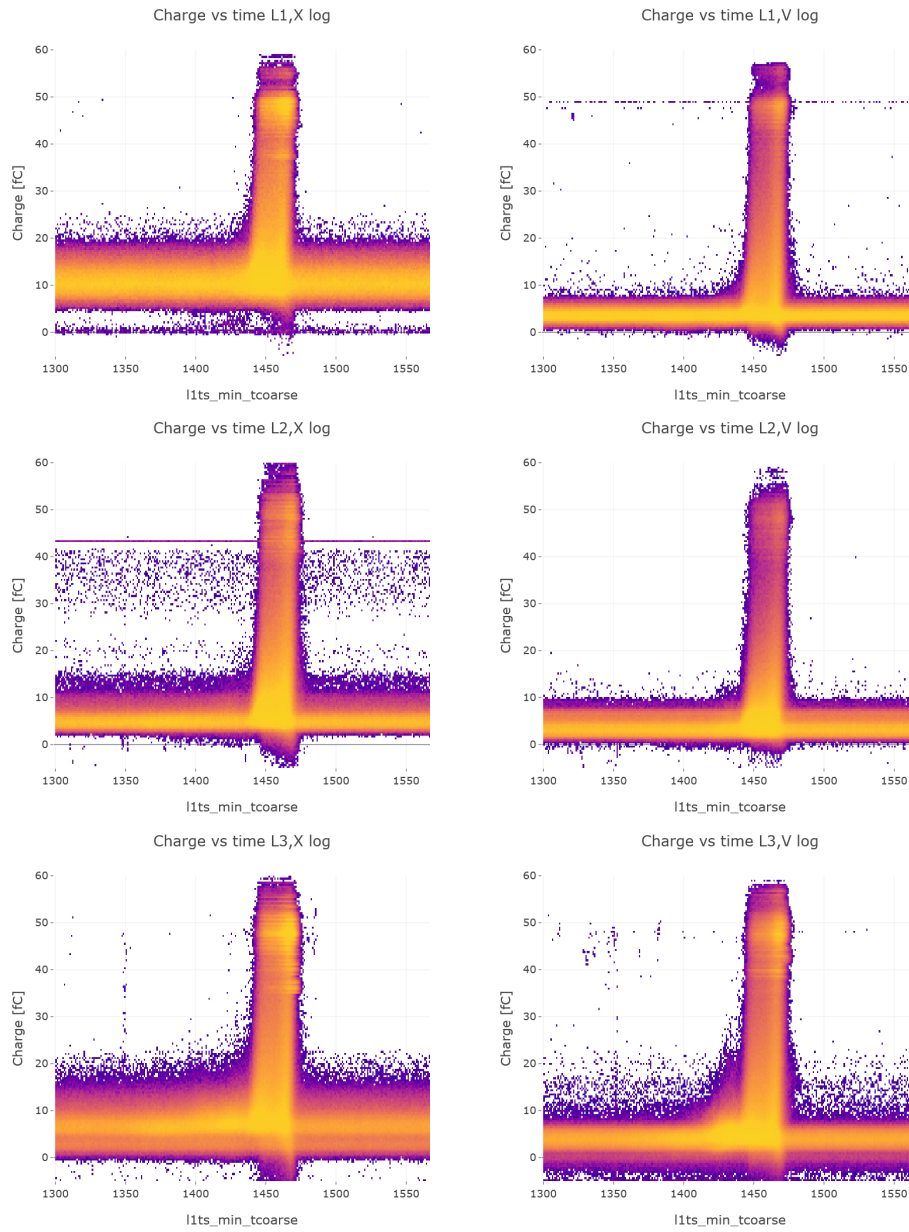
Figure 4.10: Two-dimensional histograms displaying the time-charge distribution of hits. Signal concentrates in a narrow band, while noise is uniformly distributed

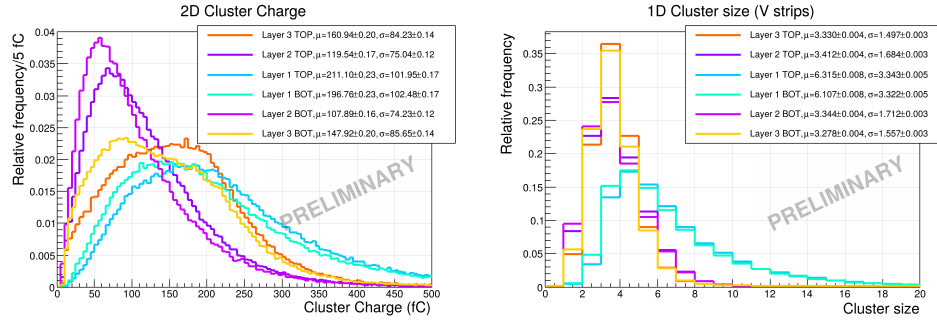
(a) Integrated charge of two-dimensional signal clusters. (b) Distribution of the hit multiplicity in the stereo view for clusters selected as signal.

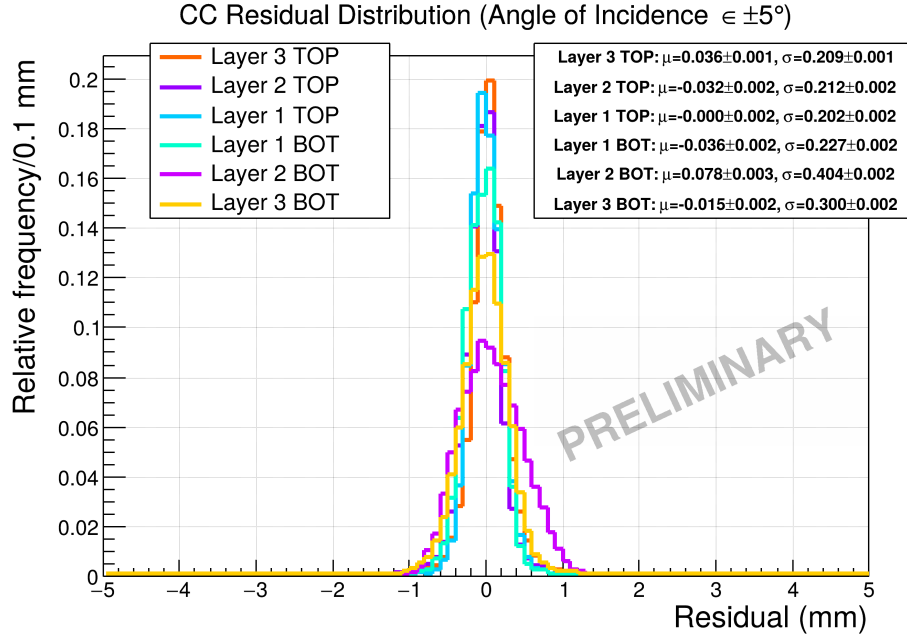
Figure 4.12: Distribution of the residuals calculated from positions reconstructed with the CC algorithm. Only tracks with angles of incidence within 5° from the perpendicular are included in the study.

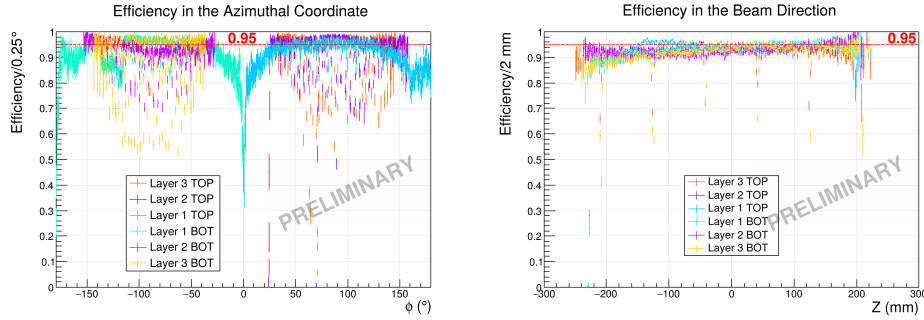
(a) Efficiency in the azimuthal coordinate. The origin is located on the horizontal plane passing through the overlaps of the foils and corresponds with the southern direction for the nominal position of the detector in BESIII.

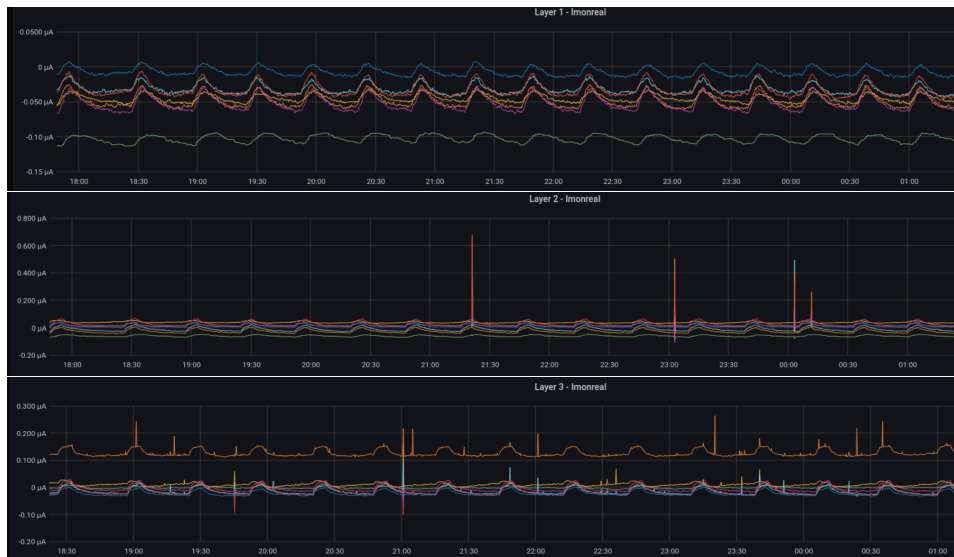
Figure 4.14: Operating currents for the three layers during a seven hours long data taking run.

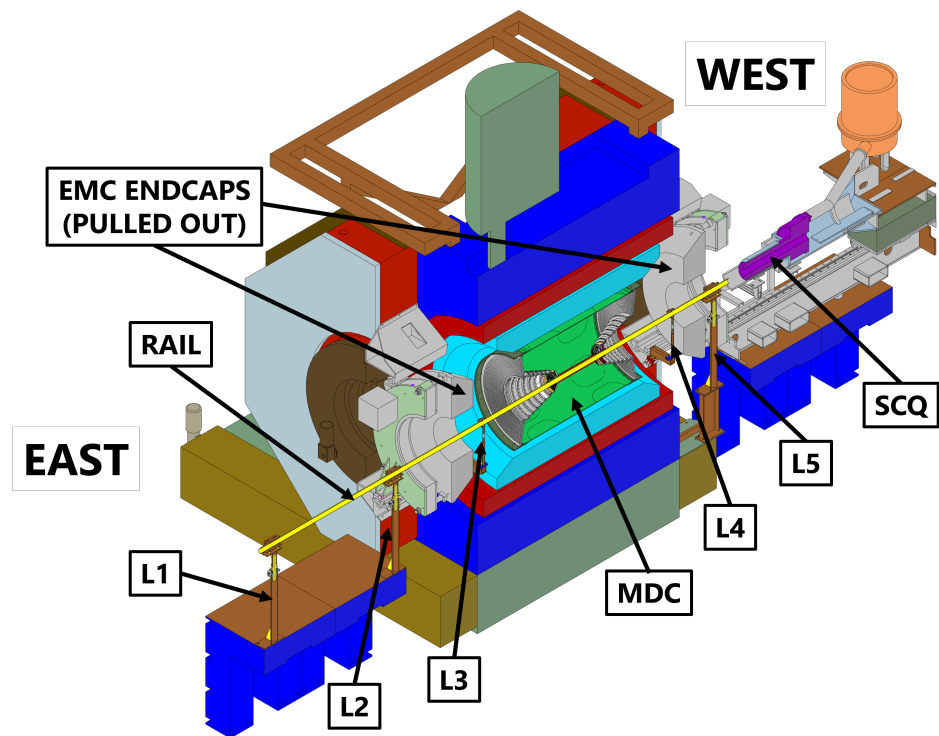
Figure 5.1: The installation setup according to the 2017 documentation.

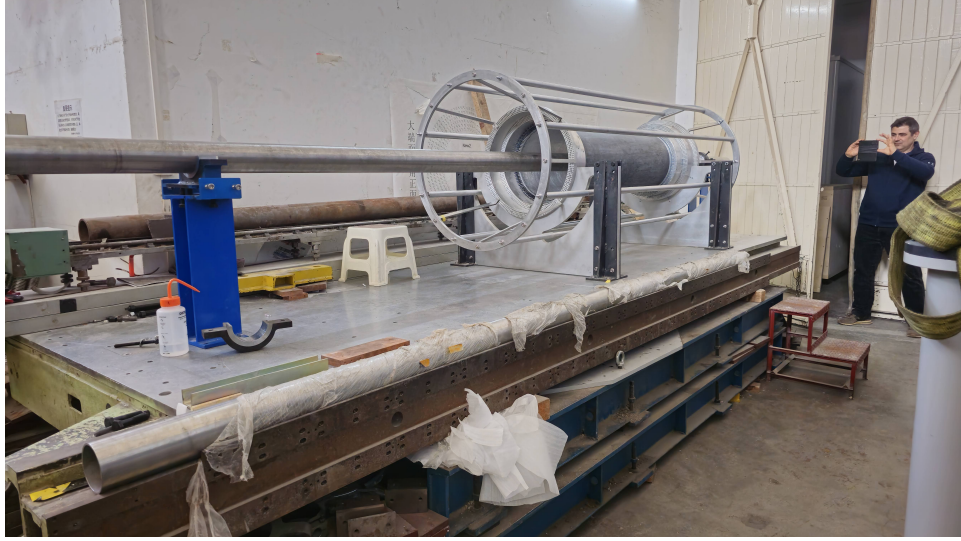
Figure 5.2: The setup used in the first insertion test

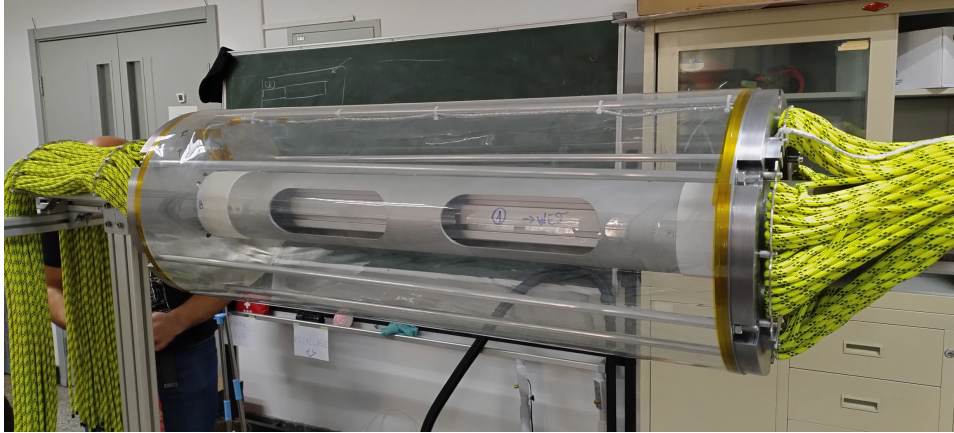
Figure 5.3: Mock-up of the CGEM-IT used in the first insertion test resting on the first version of the insertion trolley.

A mock-up of the CGEM-IT, in figure 5.3, was manufactured for the test. Its design was meant to provide slightly pejorative conditions for what

concerns all the critical aspects for the insertion: diameter, weight, and clutter of the cables. Steel flanges at the extremities replicate the mounting points for anchoring the detector and its maximum outer diameter. The combined weight of the flanges, approximately 50 kg, matches a conservative estimate for the detector and all its short haul cables. Rope segments secured to the flanges simulate the occupancy of the cables. Their length is equal to the longest cables, their diameter matches the cable's thickest sections, and their overall number is slightly in excess. Spacers are used to replicate the overall length of the detector, by maintaining the correct distance between the flanges. These were kept intentionally feeble to make the mock-up fragile against bending and torsion. A Mylar sheet wrapped around the flanges and pulled taut with Kapton tape provides a reference surface to check for contacts with the cavity and other signs of damage. The same MEMS accelerometers used in the drop test, mounted on the inside of each flange, continuously monitored inertial stresses during the test.

The mock-up was built on top of the actual insertion trolley, which had been freed from the assembly machine after the detector was moved to the testing station for collecting cosmic ray data. This first version of the trolley consists of three sections of aluminum pipe joined by two shorter Teflon parts. The aluminum sections have cutouts to reduce the overall weight of the trolley and, consequently, the deflection of the rail. The two Teflon junctions, together with inserts of the same material on the external aluminum sections, ensure the trolley can slide smoothly on the rail and favor its extraction once the detector has been fixed to the outer chamber. Crown-shaped cable holders allow to neatly arrange the cables on the exterior of

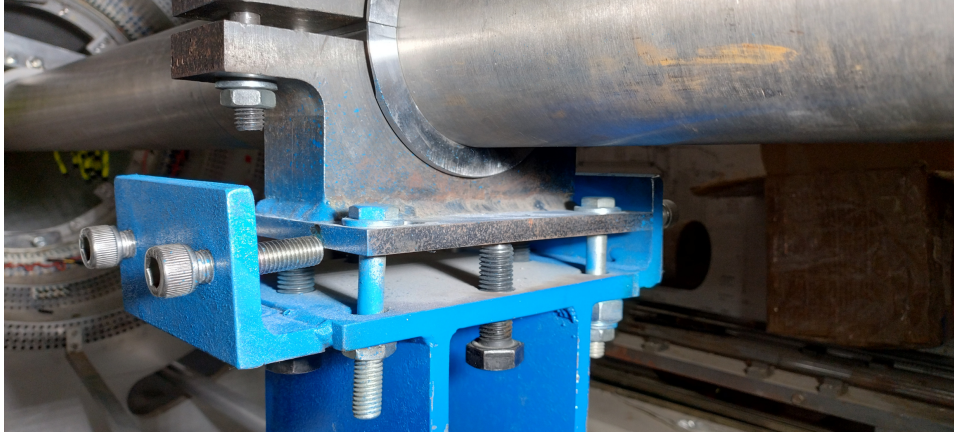
Figure 5.4: Adjustment mechanism of the makeshift support legs used for the first insertion test.

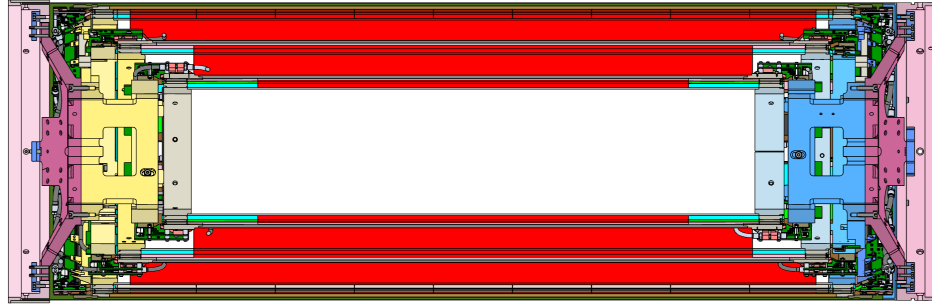
(a) Lateral cross-section.

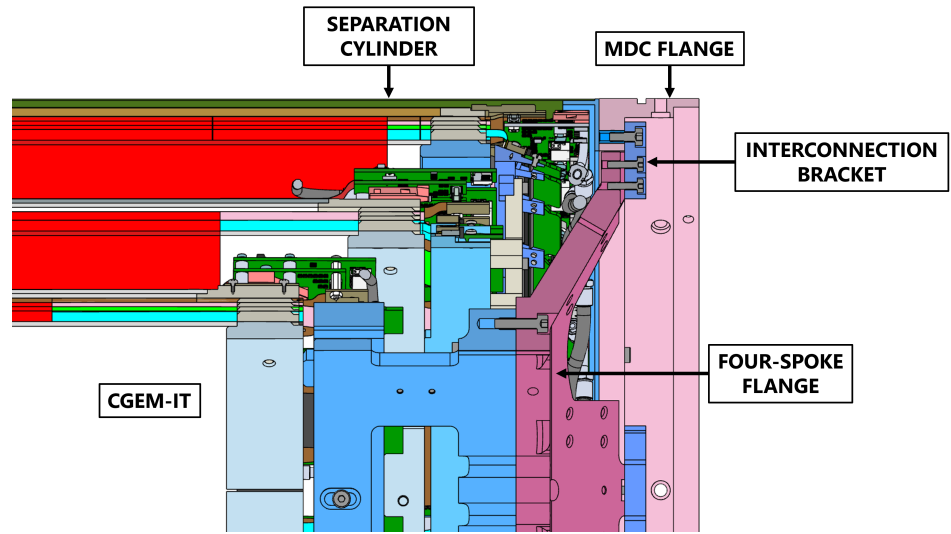
(b) Detail of the west side fixing solution.

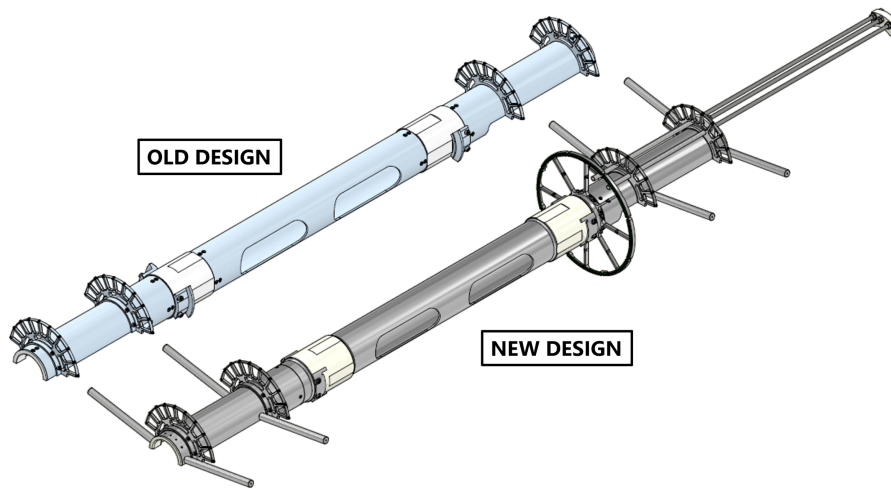
(a) 3D models of the two trolleys side by side.

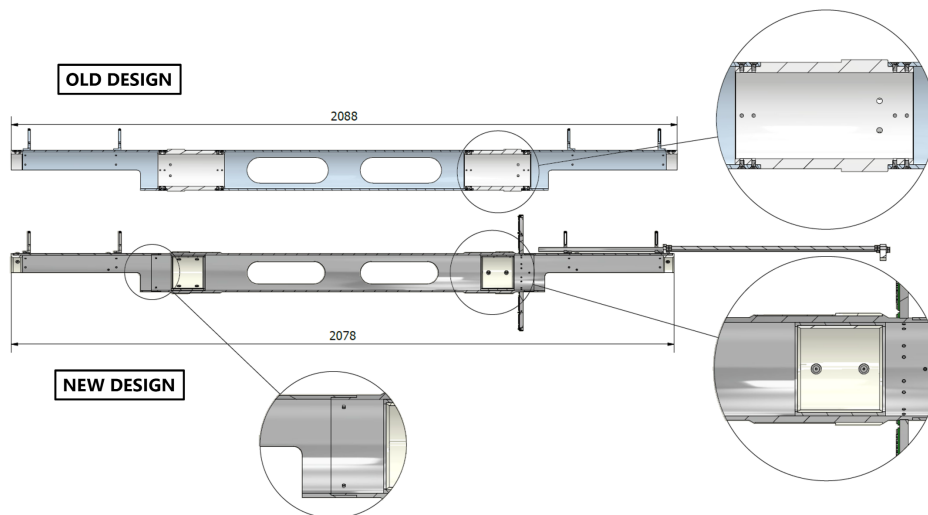
(b) Cross sectional view of both designs

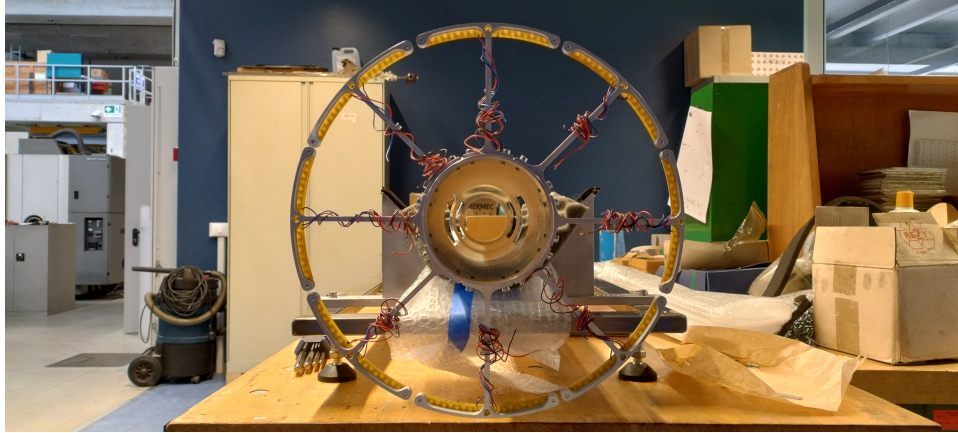
Figure 5.7: The new trolley's guard ring, fully assembled on the central pipe for performing the quality control measurements.

The remaking of the trolley also provided an opportunity to address the difficulties encountered in evaluating the clearance with respect to the cavity. A reference guard ring, in figure 5.7, was designed to serve several purposes at the same time. Positioned in front of the detector, it would be the first thing to contact the walls of the cavity in case of misalignment, therefore shielding the delicate electronics of Layer 3 from the impact. Equipped with an array of led diodes, it would also provide a distributed source of light to help evaluate clearance at both sides without having to rely on the external spotlights. The team operating on the west side could also benefit from the regular shape of the ring as a reference to determine the detector's position. Finally, it could provide mounting points for the installation of an array of simple contact sensors to identify the contact's direction in case the optical evaluation would have still proven difficult.

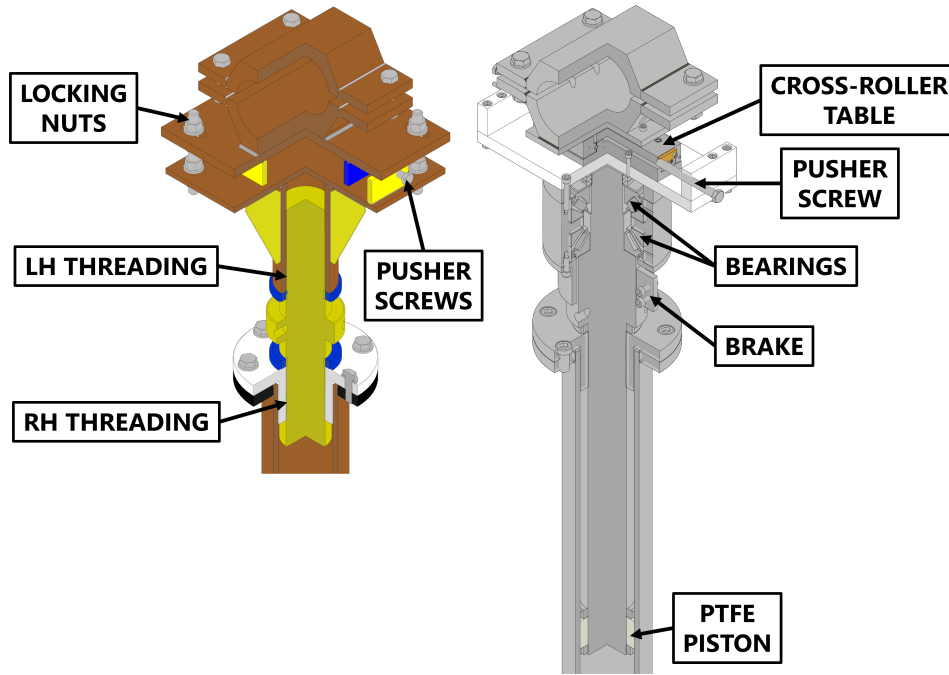
Figure 5.8: Comparison between the old leg's design, on the left, and the new one, on the right.

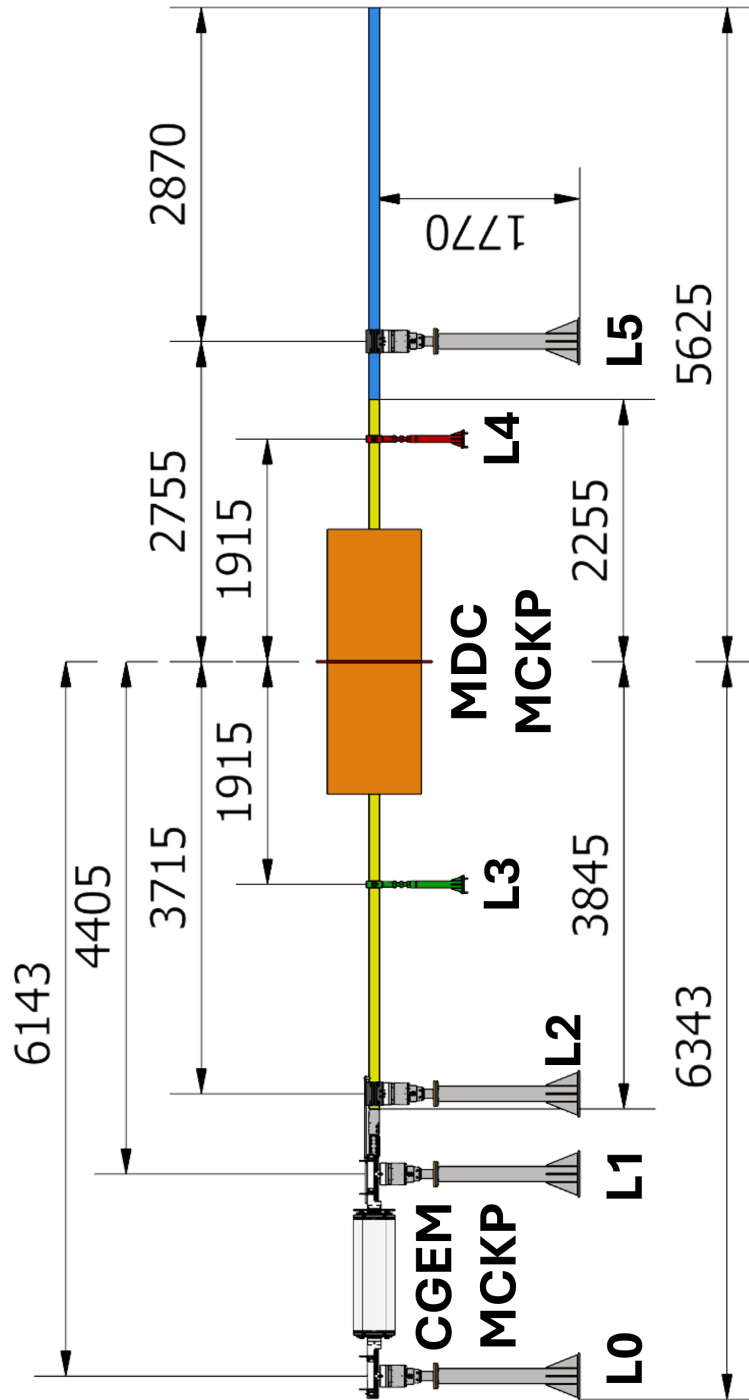
Figure 5.9: Drawing depicting the setup used for the second insertion test. All units are in mm.

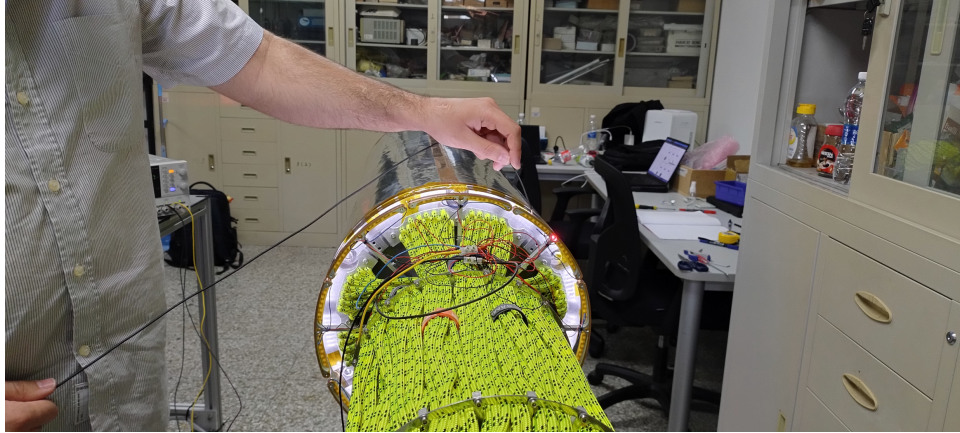
Figure 5.10: Photograph of the contact sensor array being tested. Individual sensitive surfaces are grounded to check the connections.

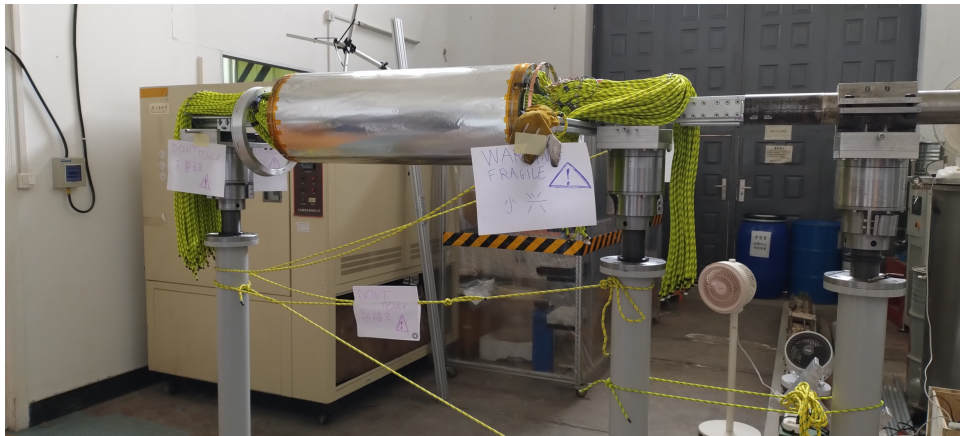
Figure 5.11: The aluminum profile supporting the trolley, fully aligned and coupled with the rail.

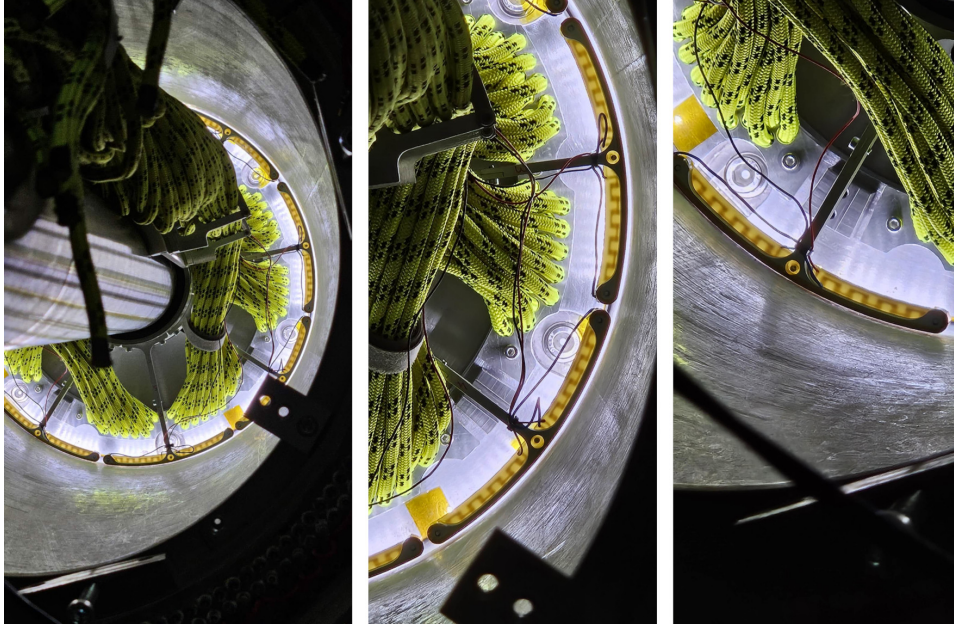
Figure 5.12: Photos, taken during the insertion phase of the second test, showing how the guard ring helps evaluate clearance and position of the detector with respect to the cavity.

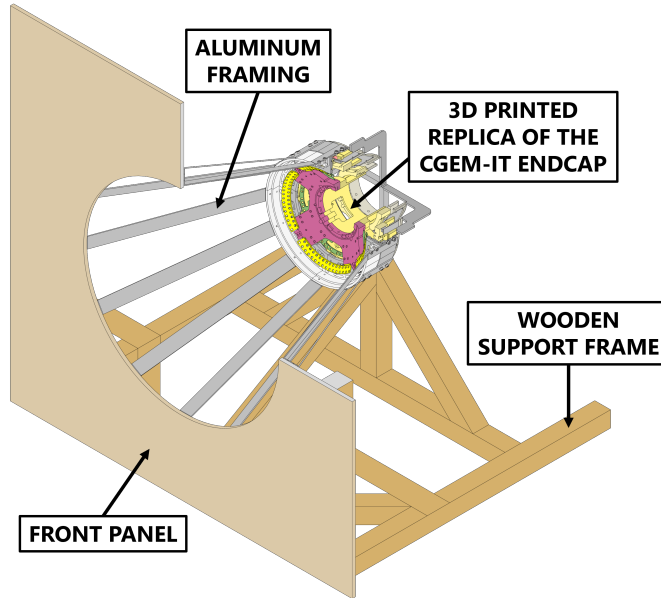
Figure 5.13: 3D model of the mock-up used to study the cabling schemes.

Figure 5.13 shows the CAD model of the mock-up constructed for studying the cable schemes. The design in this case was intended to be inexpensive and quick to build. The CGEM-IT's endcap and MDC's flange were replicated by gluing together several 3D printed parts, some of which were salvaged from previous setups. Rope segments of different colors, lengths, and sections, glued to the endcap, simulate the different types of SH cables. These analogs are labeled according to their position, and match the corresponding cables on the detector. A wooden panel with a large central hole provides a support to staple full-scale drawings depicting the position of the

removed preamplifier boards. A conical aluminum frame connects the panel and the 3D printed endcap, replicating the shape of the MDC's cone, while a wooden one is used to support everything and provide a stable base.

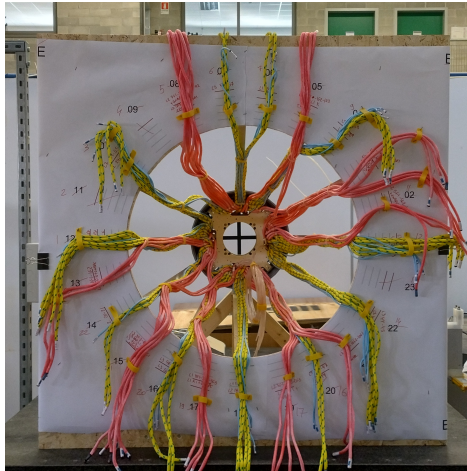
(a) West side.

Figure 5.15: An example of the schematics used to inform the fixing of the cables onto their holders. This schematic contains a complete set of the cabling information and can therefore be used as a map to locate issues when debugging the connections.

end product of the tests was the validation of cabling schematics as those shown in figure 5.15 and 5.16. These were designed to collect in a concise way all the information necessary to fix the cables and route them to the patch cards.
