University of Ferrara
Physics and Earth Sciences Department
Ph.D. Course in Physics
Cycle XXXVII
Coordinator Prof. PAOLO LENISA

**Construction, Commissioning, and Installation
of the Cylindrical GEM Inner Tracker
of the BESIII Experiment**

Year 2021/2024

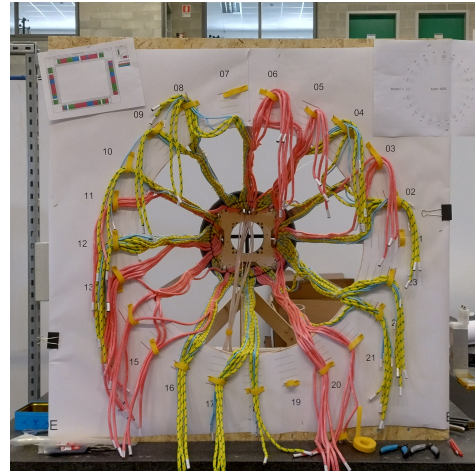
(b) East side.

Figure 5.14: Results of the test of the cabling schemes for both sides of the detector.

The last two criteria required to arrange and fix the cables on their holders according to the position of the towers of arrival. The mock-up could be converted to represent either side by flipping the 3D printed endcap 180° and adding or removing a few cables. Several iterations were necessary before satisfactory solutions could be found for both sides, and figure 5.14 showed the result of their testing conducted on the mockup. The

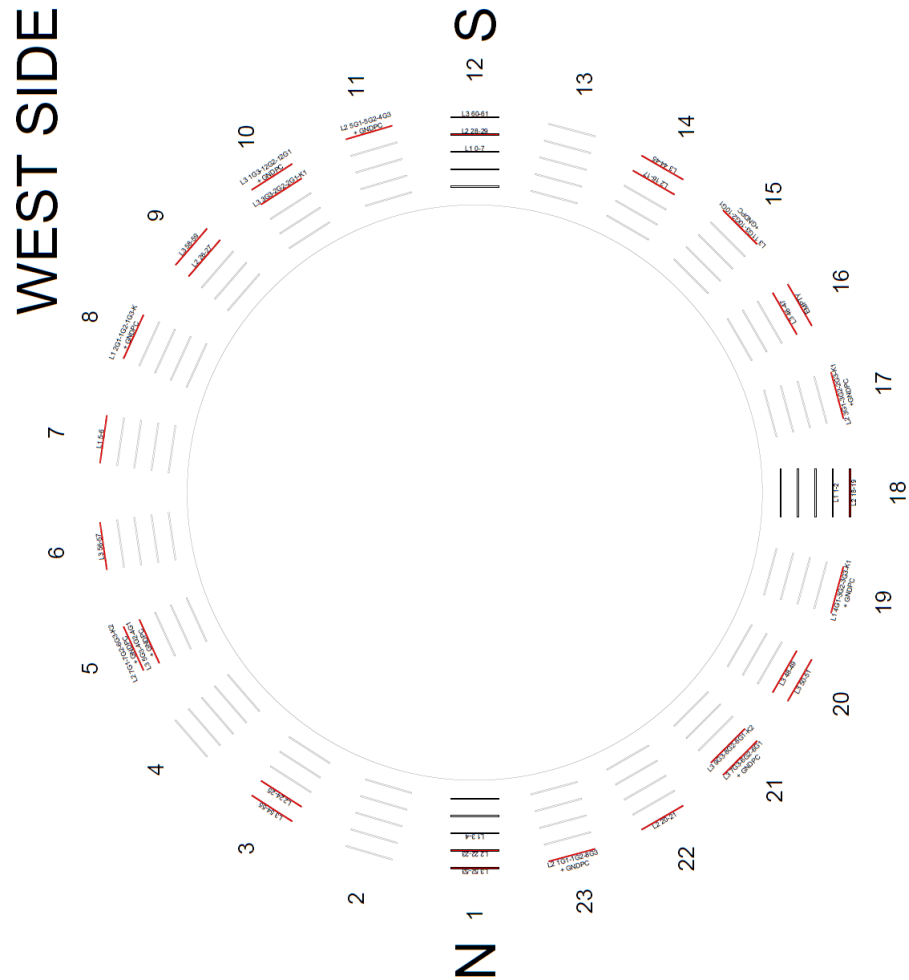
Figure 5.16: Schematic used to easily locate the tower of destination of SH cables. These schematics, divided in half and printed in A0 format, were stapled to the front panel of the mock-up to represent the location of the slots where patch cards could be installed on the apparatus

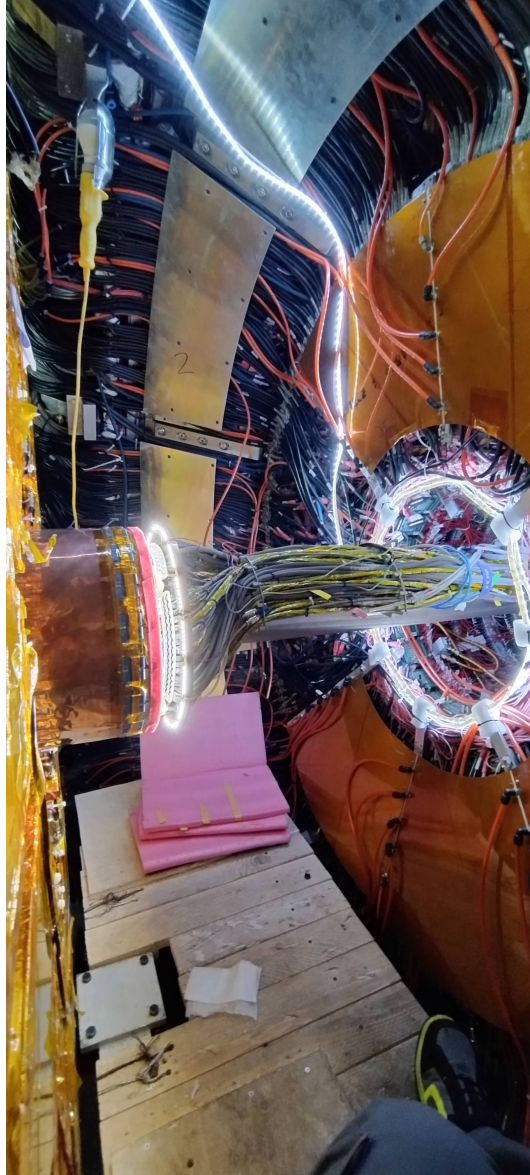
Figure 5.17: The narrow cavity separating the endcaps of the EMC and the endplates of the MDC, where most of the operations took place. The photograph was taken as the detector approached the MDC at the beginning of the insertion.

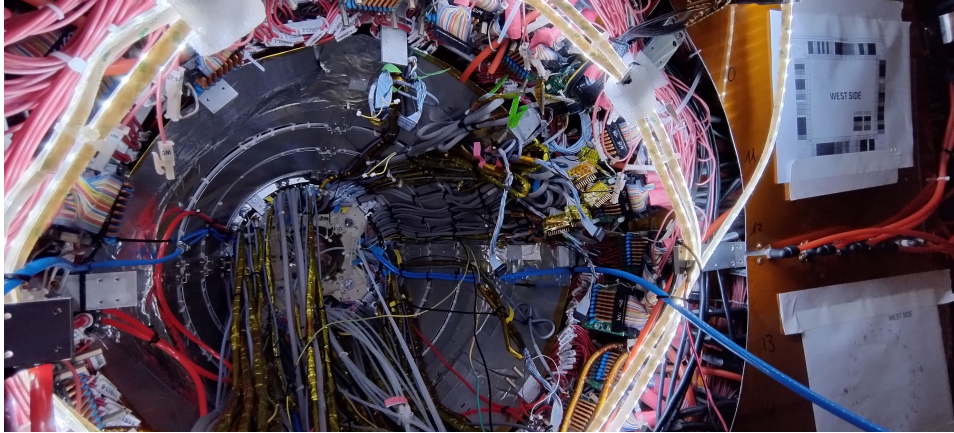
Figure 5.18: Routing of the cable within the MDC's cone. Cables are kept parallel and flat against the shielding closer to the inner tracker, where the clearance is narrower, while excess length is collected near the destination towers.

The routing of the cables within the shielded cone of the MDC was by far the most time consuming operation. The schematics proved invaluable in minimizing improvisation and mistakes that could have led to long delays. The extra length of the cables was collected near their destination towers, as shown in figure 5.18, where more space is available below the EM shielding. The conduits where the MDC's cables reside could not be accessed, so the cables of the CGEM-IT had to exit the spectrometer along the beam pipe. A lot of planning was involved in making sure that the cables wouldn't get entangled, but their presence still made accessing the endcaps increasingly difficult as more and more cables were added, as shown in figure 5.19.

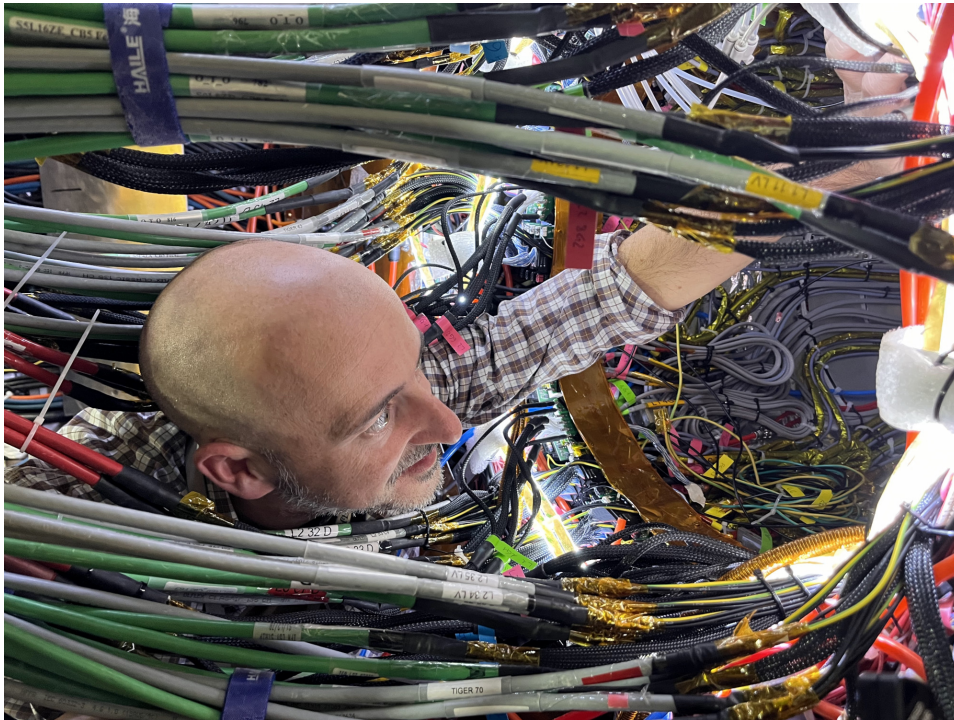
Figure 5.19: Photograph depicting the difficulty of conducting operations inside the cone as the long haul cables progressively restricted the available space.

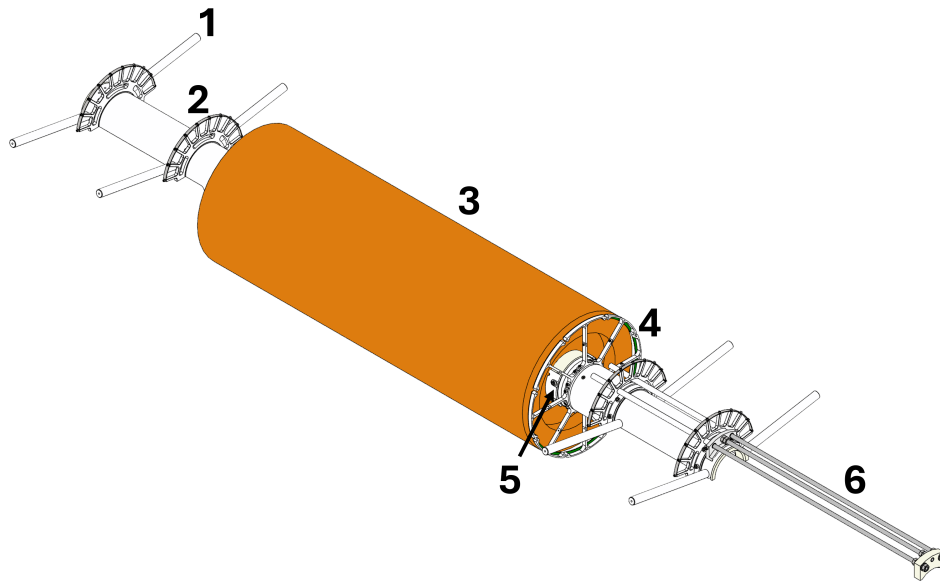
Figure B.1: Volume occupied by the CGEM-IT on the insertion trolley. The numbers refer to different parts of the trolley:

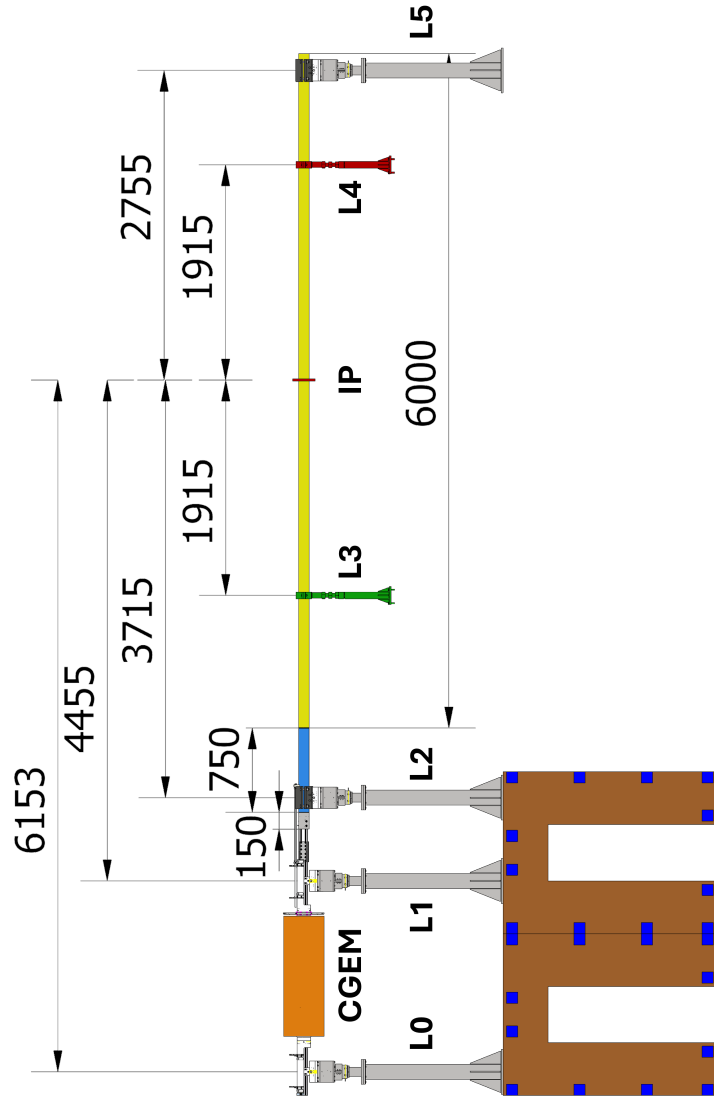
Figure B.2: Layout of the insertion equipment in the BESIII experiment hall. All dimensions are in millimeters.

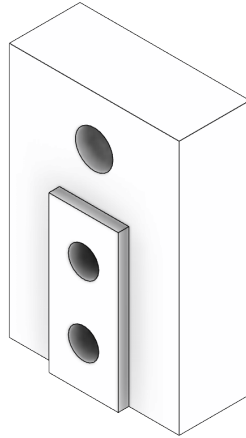
Figure B.3: Reference interconnection bracket. The other interconnection brackets lack the relief on the side facing the detector

Additional information: The reference interconnection bracket (fig. B.3) distinguishes itself from the other interconnection brackets due to the presence of a relief on the side facing the MDC.

1. ☐ Fix the reference interconnection bracket and a regular interconnection bracket to the positioning tool (fig. B.4) using four M5x16 bolts.
2. ☐ With the help of the positioning tool, fix the two brackets to the west flange using two M5x16 bolts. Make sure that the reference bracket is located at the bottom right (south) corner.
3. ☐ Remove the positioning tool by unscrewing the four M5 bolts that connect it to the brackets.
4. ☐ Repeat the three previous points to fix the two remaining brackets to the west flange.

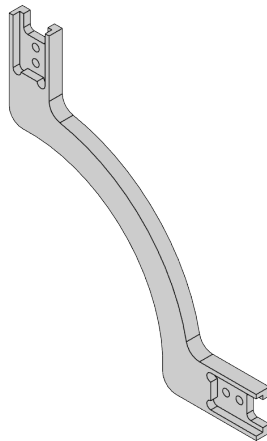
Figure B.4: Positioning tool.

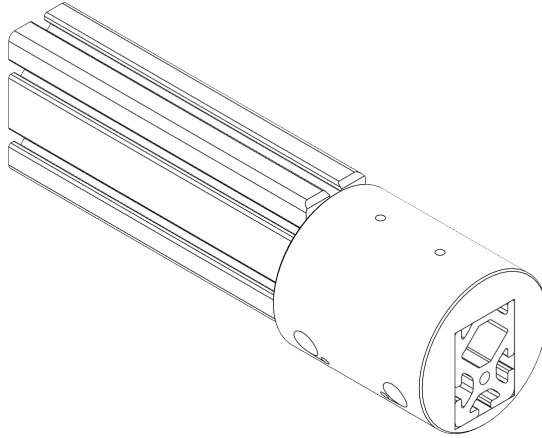
Figure B.7: Coupling implement.

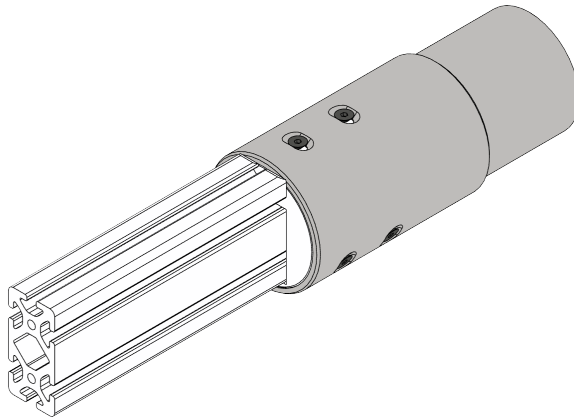
Figure B.8: The coupling implement bolted to the slotted rail extension. The slotted rail extension is welded to the rail (not in picture).
