A Novel Approach for Fault Detection and Failure Analysis of CMOS Copper Metal Stacks

Abstract—For the Inner Tracking System 3 (ITS3) upgrade, the ALICE experiment at CERN requires monolithic active pixel sensors of dimensions up to 97 mm × 266 mm, occupying a large fraction of a 300 mm wafer. To manufacture such a wafer-scale device, larger than the single design reticle size, stitching is employed. The MOOnolithic StIched Sensor (MOSS) is a prototype silicon pixel sensor of 14 mm × 259 mm size with the primary goal of understanding the stitching technique and yield. Given the large size, high yield is paramount for the ITS3 sensors, and an in-depth yield characterization was performed on these MOSS sensors. In a collaborative effort, the foundry adapted the metal stack to the requirements of the project, but recurrent fault signatures were discovered with various frequencies across all 20 wafers tested, and correlated through dedicated measurements and analyses. Following these findings, the foundry implemented a mitigation strategy to avoid the issue in the future. This article does not describe process details but concentrates on the measurements and analysis method.

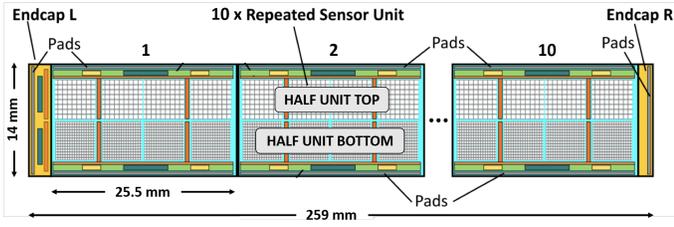
Fig. 1: Schematic structure of the MOSS sensor.

The MOSS chip is shown in Fig. 1. Ten identical repeated sensor units (RSU) are stitched together on the same die, creating one monolithic sensor with the left and right endcaps completing the design structure. Each RSU comprises 4 pixel matrices in the top Half Unit (HU), and 4 pixel matrices in the bottom HU, with each 256 × 256 pixels and 320 × 320 pixels per matrix, respectively [6]. For the future ITS3 sensors, the chips will be read out and powered exclusively from the left and right endcaps. In the MOSS design, each of the 20 HUs is interfaced via an individual set of wire bond pads along the long edges of the chip, featuring independent power domains. This design granularity allows the characterization and operation of sub-structures of the MOSS sensor in case of faults on other parts of the chip. There are 8 power nets for each HU. Using custom-developed tools and procedures, the sensor is mounted on a purely passive testing PCB. In total, 2192 wire bonds electrically interconnect the chip to the PCB. Four high-density connectors, each with 560 pins, allow for connecting to 5 HUs each. A fifth connector on the left edge of the test PCB is wired to the left endcap structure of the MOSS

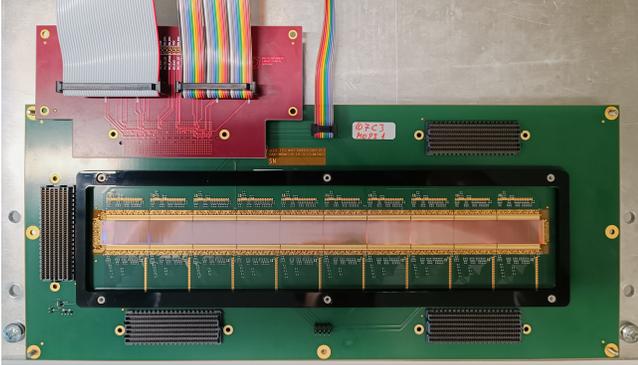
Fig. 2: MOSS sensor (center) mounted on the testing PCB (green), with the protective cover removed. A breakout board (red) in impedance measurement configuration is connected to the top left high-density connector. The dimensions of the testing PCB are 150 mm \times 350 mm.

sensor, used for testing the stitched communication bus. It is not used for powering and testing individual HUs. A breakout board (see Fig. 2) gives access to the 8 power nets for each HU. Table I describes the naming and associated functional domain of the power nets. The Backbone domain spans the full length of the MOSS sensor, crossing the stitching boundaries between each RSU.

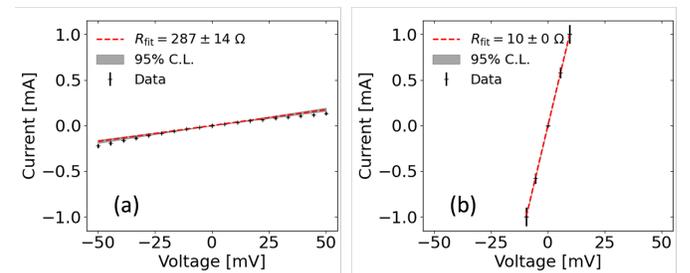
Fig. 3: Power net pair succeeding (a), and classified as short (b) in the impedance measurement.

unit. The channel multiplexer enables the automatic setting of all $\binom{8}{2} = 28$ power net pair combinations for each of the 5 HUs connected via a single breakout board. For every combination, a voltage is applied in steps of 5 mV from 0 to -50 mV and 0 to $+50$ mV. In this voltage range, transistor and diode structures do not become highly conductive. The current is measured, and the voltage ramp is stopped if the current exceeds 1 mA. A linear fit is performed to approximate the resistance between the nets under test from Ohm’s law $U = R \cdot I$. Errors are estimated from the fluctuating laboratory temperature, and lead wire resistances. From the distribution of all measured resistances, an empirical global cut is made at 30Ω at the minimum between the first tail and the following rise in the distribution. For a lower resistance value, the power net pair is deemed to have a short. Fig. 3a and Fig. 3b show two examples of net pair measurements classified as ‘ok’ and ‘short’, respectively.

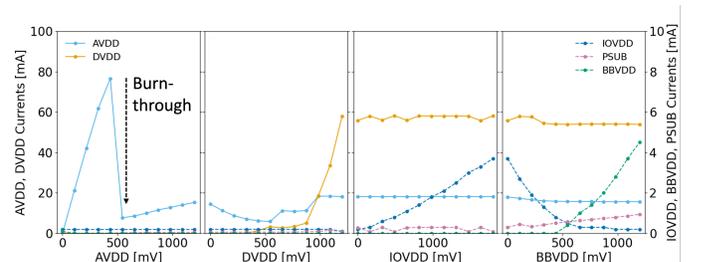
Fig. 4: Example of power ramp turn-on curves. The plot on the left shows a burn-through during the ramp-up of the AVDD power net. After the burn-through, the turn-on curves follow the standard behavior of a MOSS chip. The legend entries correspond to the power domains in Table I.

In the power ramping stage, the turn-on current curves provide information on ohmic turn-on behavior and burn-through events, and a thermal camera is used to locate faults via heat signatures. Each power net is brought to nominal voltage individually for each HU. The chip-specific power-up sequence is shown for one HU in Fig. 4. Here, the first power net (AVDD) is ramped up in steps of 100 mV, while the remaining power nets are held at 0 V. Currents on all power nets are measured. In this example, a steep, ohmic turn-on, corresponding to a short, is observed during ramp-up of the AVDD net. The sharp drop in current indicates a

so-called ‘burn-through’ of the short – visible with a thermal camera as a disappearing hotspot as discussed below – and the turn-on curve again follows the expected shape. After reaching nominal voltage, the AVDD net is kept powered on, and the DVDD power net is ramped up. This pattern is repeated until all power nets are at nominal voltage. If the currents on any of the power nets exceed an individual current limit, the power ramp is stopped. Because the powering setup does not allow configuration of the chip by writing to multiple registers, the currents in the powered-on state vary. The typical ranges are given in Table II for reference at PSUB = 0 V.

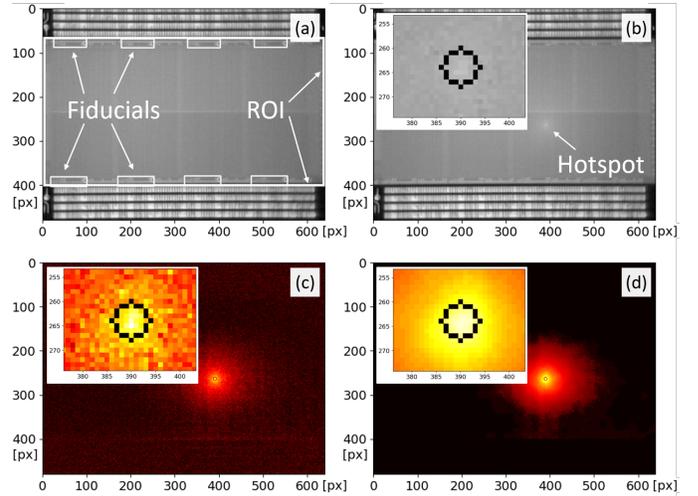
Fig. 5: Thermal camera image analysis steps. (a) The HU under test prior to powering with marked fiducials and ROI. (b) The hotspot candidate image. (c) The difference between (a) and (b). (d) The final denoised image used to extract the hotspot location. Insets in (b), (c), (d) illustrate the extracted location. The black circle has a radius of 5 pixels, centered on the hotspot location.

- 1) One image I_0 is taken before powering up the chip. Eight fiducial structures on the chip are located (see Fig. 5a), and an affine transformation matrix is estimated by a least squares fit of the fiducial positions and the target positions of the global MOSS sensor design coordinate system. A Region Of Interest (ROI) cut is made on the active chip area, excluding the PCB structures.

- 2) Hotspots are identified by following algorithm: For each of the n images I acquired during the power ramp (for a completed ramp $n \simeq 520$ at a typical imaging frequency of 6.67 Hz), a difference image is computed between the initial (non-powered) image I_0 and image I . The ROI cut, an empirical threshold (setting pixels below to 0), and a median blur operation (reducing salt-and-pepper noise) are applied to each difference image, creating n new images I_{ROI} . From each new image I_{ROI} , the average \bar{I}_{ROI} is calculated, and subtracted from the average value of a 5×5 pixel mask $\bar{M}_{5 \times 5}(x, y, I_{ROI})$ which is scanned over the same new image. Looping over all n images the same way, the image which maximizes the difference between the full ROI average and the 5×5 pixel mask average is taken as a candidate I_{cand} (see Fig. 5b) for further hotspot analysis:

- 3) The simple difference image between the initial image (Fig. 5a) and the selected hotspot candidate I_{cand} (Fig. 5b) is shown in Fig. 5c. After a non-local means denoising step is applied to the corresponding image I_{ROI} (improving localisation accuracy, see Fig. 5d), the hotspot locations are extracted as the enclosed contour

maximum (or center of gravity), and manually confirmed. The extracted hotspot location is indicated as a black circle in the insets of Fig. 5. The transformation determined in step 1) is applied to the selection, and the hotspot coordinates are stored.

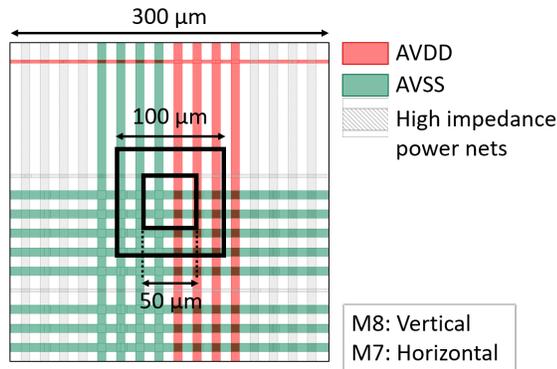
Fig. 6: Detail of the MOSS power grid, overlaid with the best case ($50\ \mu\text{m} \times 50\ \mu\text{m}$) and average case ($100\ \mu\text{m} \times 100\ \mu\text{m}$) resolution windows of the thermal camera. The AVDD and AVSS nets, exhibiting a short, are highlighted in color.

To determine failure-relevant design features, hotspot locations are correlated with the metal stack from the chip design and power nets from the impedance measurement. For a single hotspot and single net pair classified as short, an unambiguous correlation is made. An example overlay of the best case ($50 \mu\text{m} \times 50 \mu\text{m}$) and average ($100 \mu\text{m} \times 100 \mu\text{m}$) resolution windows, with the two power nets exhibiting a short highlighted in red and green, is shown in Fig. 6. Only the uppermost copper layers of the chip metal stack (M7, M8) are shown in the Figure. An M7 and M8 metal presence, as well as the presence of affected power nets within the best and average case resolution windows, is extracted from the analysis.

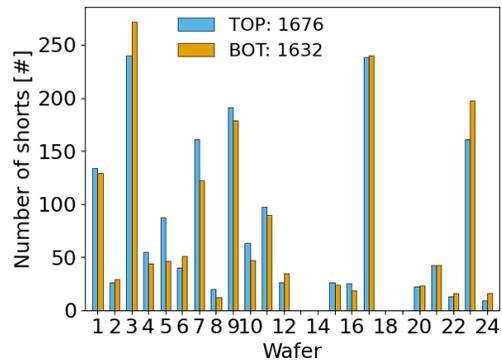
Fig. 7: Shorts per wafer, split into the top and bottom half of the MOSS sensors. A strong wafer-to-wafer fluctuation is observed. Wafers 13, 14, 18, 19 were physically damaged and could not be tested.

Fig 7. Strong fluctuations between wafers are observed, with an even split in the number of shorts between the top and bottom halves of the chip.

- 1) Wafer-to-wafer fluctuations. Large statistical variations in the number of shorts, of up to a factor of 10, were observed between different wafers with hotspots in varying locations (see Fig. 7).
- 2) Integration density independence. A comparable number of shorts are observed in the top and bottom halves of

From the chip design, we also extract the total layout areas compatible with Hypothesis A, and observe an even area split between the top (49.8%) and bottom (50.2%) halves of the chip. This matches the integration density independence, observed in Fig. 7 as an even split of shorts in the top and bottom halves of the chips.

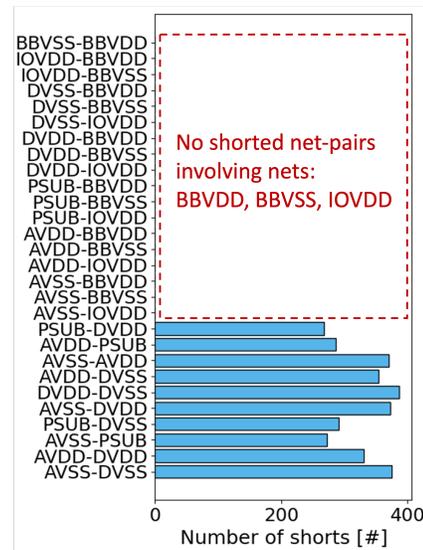
Fig. 8: Shorts for all 28 net pair combinations. No shorts are observed measuring BBVDD, BBVSS, IOVDD nets.

Shorts only occur in net combinations of nets AVDD, DVDD, AVSS, DVSS, PSUB as shown in Fig. 8. There is no favored net combination. No shorts are observed in net combinations involving BBVDD, BBVSS, IOVDD. Hence, only $\binom{5}{2} = 10$ out of 28 power net combinations exhibit shorts.

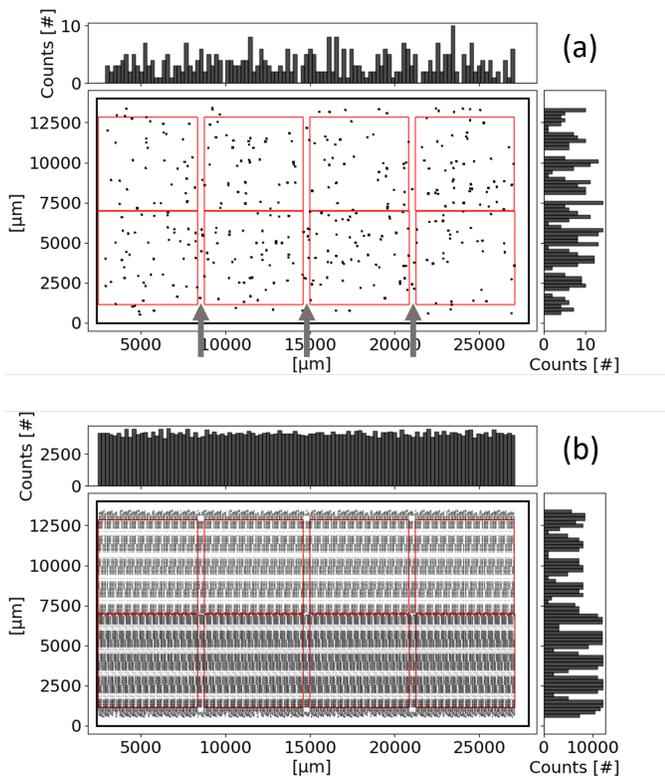
Fig. 9: Measured hotspot locations (a), and areas with M7 and M8 present simultaneously (b). The arrows in (a) indicate the vertical gaps between pixel matrices (red squares) where only M7 and M8 metals are routed.

The distribution of a set of identified hotspots is mapped onto one RSU in chip coordinates as shown in Fig. 9a. Shorts are seemingly distributed without a distinct pattern. It is observed that shorts occur in regions between pixel matrices (indicated by arrows). Only the top two copper metals – M7 and M8 – are present in these regions.

From the chip design, regions with the presence of both M7 and M8 are extracted and shown in Fig. 9b. Here, these locations are shown for one RSU.

- 3) Shorts are also observed in the gaps with only M7 and M8 present in between pixel matrix areas (see arrows in Fig. 9a). During inspections of fault locations with a microscope, no optical evidence was found of shorts involving the presence of one metal only – now referred to as Hypothesis B.
- 4) The metal stack composition (both thickness and dielectric) for layers M7 and M8 is different from the remaining metal stack.
- 5) The fault locations extracted with the thermal camera match regions in the chip with specific features involving both M7 and M8 metals.
- 6) No shorts are observed for 3 out of 8 power nets (BBVDD, BBVSS, IOVDD). M7–M8 metal features differ for these power nets compared to the rest of the power grid.

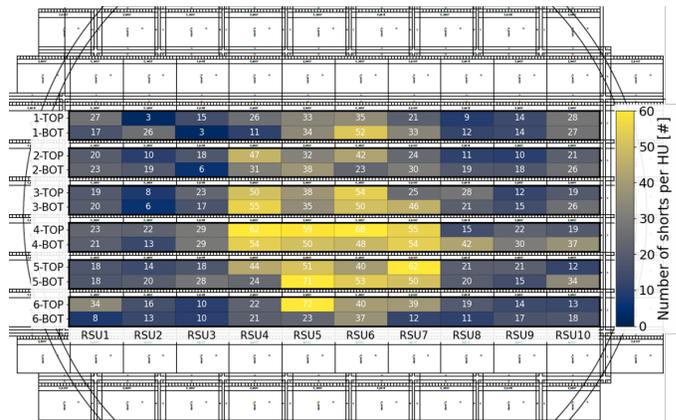
Fig. 10: Distribution of number of shorts per HU on wafer level. Each double row represents the position of one MOSS sensor on the wafer, with 20 HUs per chip. A distinct central gradient is visible. This effect is attributed to the type of failure observed and is compatible with high-temperature and rotationally symmetric processing steps during fabrication.

The wafer-level distribution of the number of shorts per HU across the 20 wafers measured is given in Fig. 10 (see Supplementary Material and [8]), with a higher number of shorts observed in the center of the wafers.

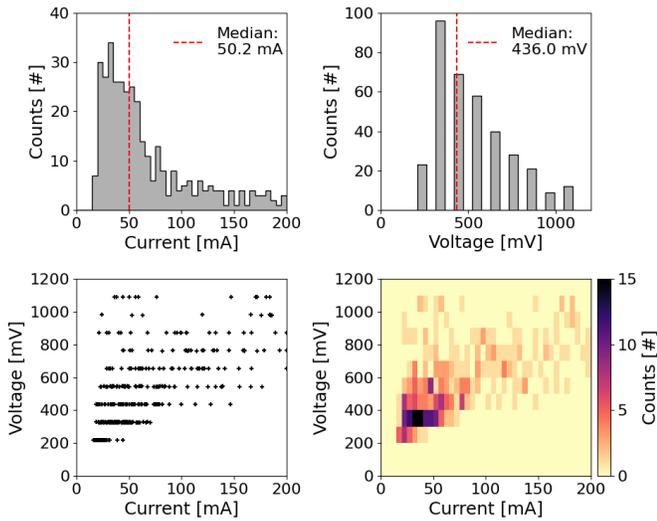
Fig. 11: Distribution of burn-through currents and voltages. The discrete voltage steps correspond to the chosen steps during chip power ramp-up.

and voltages is shown in Fig. 11 (see Supplementary Material). It is important to note that these currents are moderate (see also Table II) and do not pose any danger to the chip power supply network. In the remaining cases, the short remains, as an increase in current potentially burning through the short would only be possible by increasing the supply voltage above a safe level.

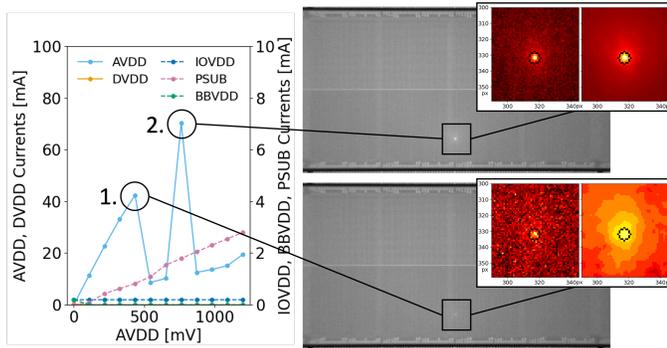
Fig. 12: Example of a double burn-through: The short disappears temporarily (first peak), before burning through permanently (second peak). The same hotspot location is identified for both peaks, and magnified figures are overlaid showing the non-denised and denoised analysis step for each peak. The local temperature change during the first burn-through appears to cause deformation in the metal stack, resulting in the short reconnecting. Only after the second burn-through does the impedance change from low to high and stay stable. The increase in PSUB current is within specification.
