# Investigation and Mitigation of a Prominent Off-Axis Stray Light Path in Rubin Observatory Commissioning

**Keywords:** Rubin Observatory, stray light, commissioning, wide-field telescopes

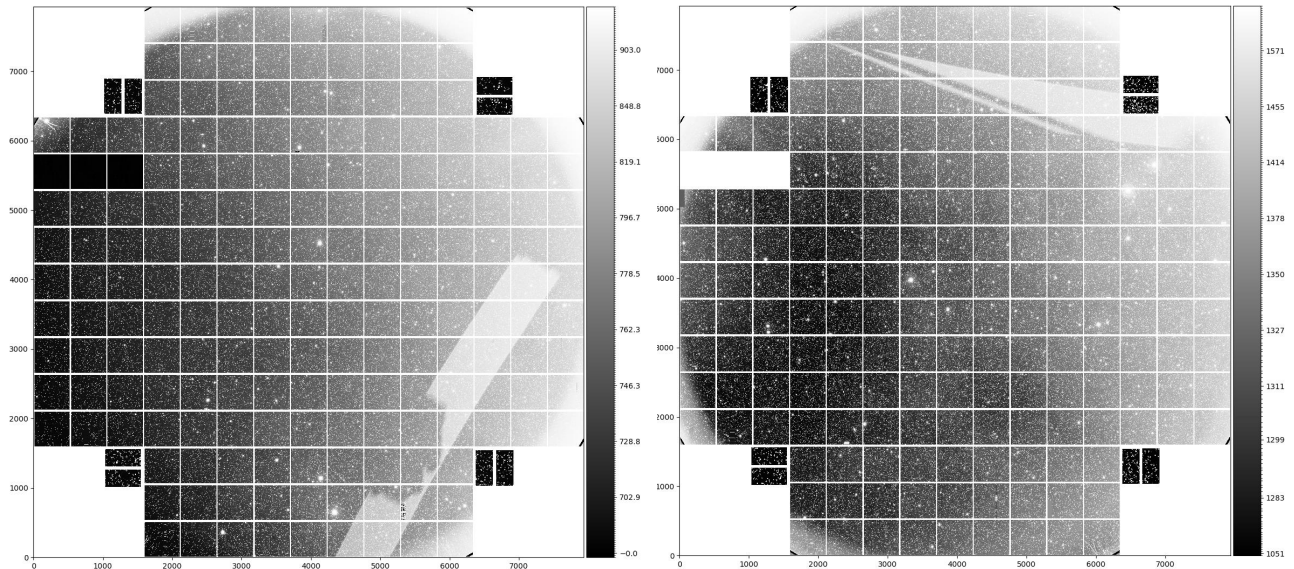
Figure 1: Examples of stray light features associated with the “scratched tape” stray light path in LSSTCam images from Rubin commissioning. These examples originate from  $\alpha$  Cen ( $V \sim -0.29$  mag), which is located  $\sim 21$  deg off-axis and illuminates the primary mirror (M1) through a gap between the mid-level and center-section light baffles. (Left) Prototypical “scratched tape” morphology (visit = 2025050500421; 15 s exposure in  $r$ -band). (Right) Prototypical “sail” morphology coming from a similar light path (visit = 2025051900402; 30 s exposure in  $i$ -band). The difference in morphology comes from physical obscurations on the TMA (see Figure 2).

science validation, and early operations made it possible for astronomical sources located  $\sim 20$  deg off-axis to illuminate the primary mirror (M1) and have their light reflected directly into LSSTCam—i.e., bypassing the secondary and tertiary mirrors (M2 and M3, respectively). The result is a sharp, several-degree-long, rectilinear feature with surface brightness that has been measured to be  $\sim 20\%$  of the dark-sky background in bluer bands when sourced by bright stars (Figure 1). The scratched tape feature manifests in a variety of morphologies, brightnesses, and prominences, and several morphologically similar artifacts (e.g., the “pillow”, “muddy shoe”, etc.; [3]) are suspected to be associated with the same light path. In this document, we use the term “scratched tape” to collectively refer to all features that arise from the same off-axis stray light path. Figure 1 shows two common morphologies of the scratched tape feature sourced by the bright star system  $\alpha$  Centauri ( $\alpha$  Cen;  $V \sim -0.29$  mag [6])\* when it was located  $\sim 21$  deg off-axis from the telescope boresight.

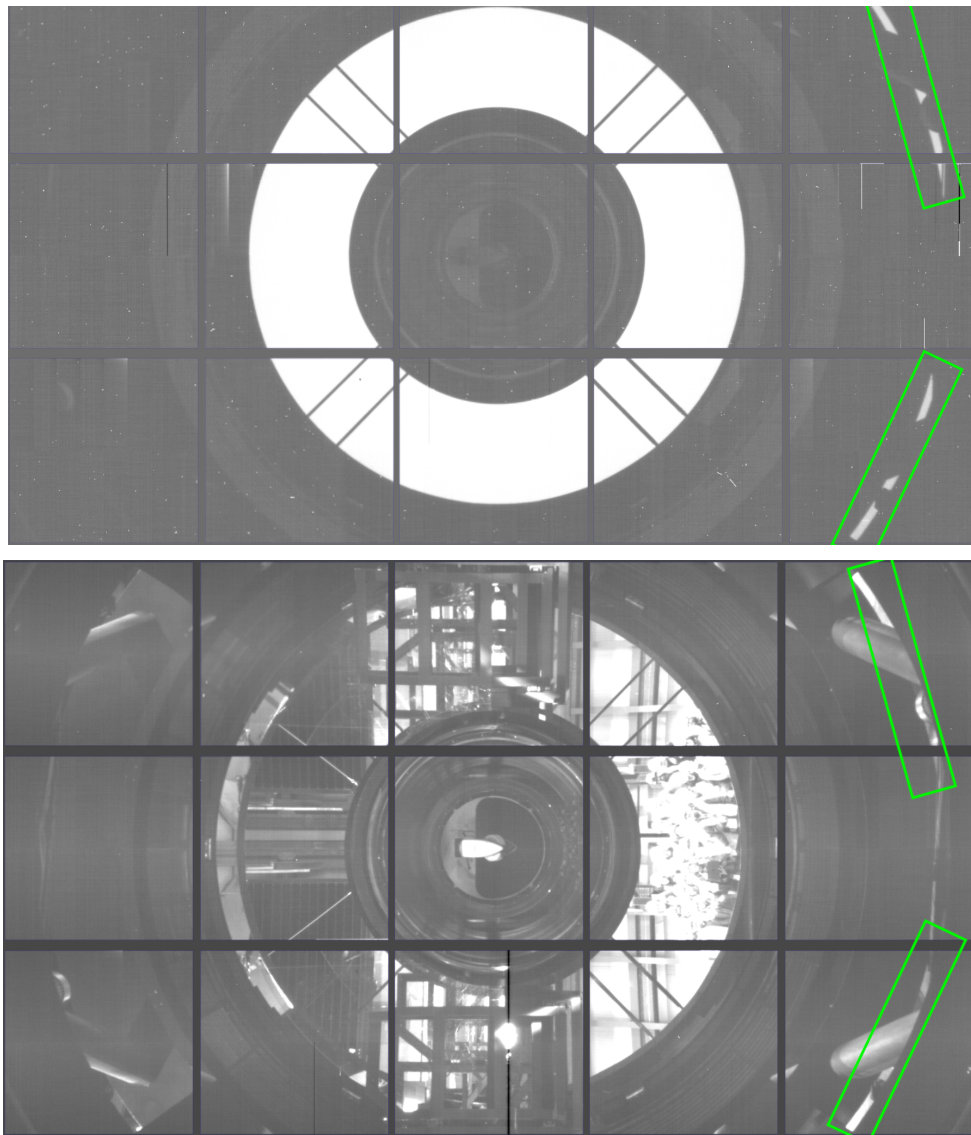
Figure 2: Images taken with the pinhole filter showing the gap between the mid-level and center-section light baffles that is responsible for the scratched tape feature (green rectangles). (Top) Twilight flat (visit = 2025070100103; 120 s exposure) showing scratched-tape-like morphology at large incident angles. (Bottom) In-dome image at higher illumination level (visit = 2025070200040; 1 s exposure) showing the scratched tape path in the context of the TMA geometry.

After demonstrating the ability to reproduce the scratched tape feature on-sky, emphasis was placed on understanding the light path that allowed a bright star located  $>20$  deg off-axis to impact LSSTCam images. Investigation of images taken with the pinhole filter during twilight in early May 2025 proved extremely useful (Figure 2). The pinhole filter is an opaque mask with a configurable number of small pinholes that can be inserted directly into the LSSTCam filter changer to produce an image of the telescope pupil, including the mechanical structures that surround the system clear aperture. We identified a direct connection between the appearance of the scratched-tape features observed on-sky and the light patterns revealed by the pinhole images. Morphologically similar bright features were observed at large angles from the central pinhole in twilight

images. Additional pinhole observations were executed in July 2025, including both on-sky twilight images and illuminated in-dome images. Investigation of these images identified the stray light path as a gap between the mid-level and center-section light baffles (Figures 2 and 3). The existence of this gap was experimentally verified by directed illumination with the collimated beam projector [8, 9, 10] at large off-axis angles on 3 September 2025. In addition, models of the telescope and optical system with the **batoid** ray-tracing software [11] and Ansys **Zemax OpticStudio**<sup>®</sup> (**Zemax**) [12] were able to reproduce this stray light path to the sky (Figure 3).

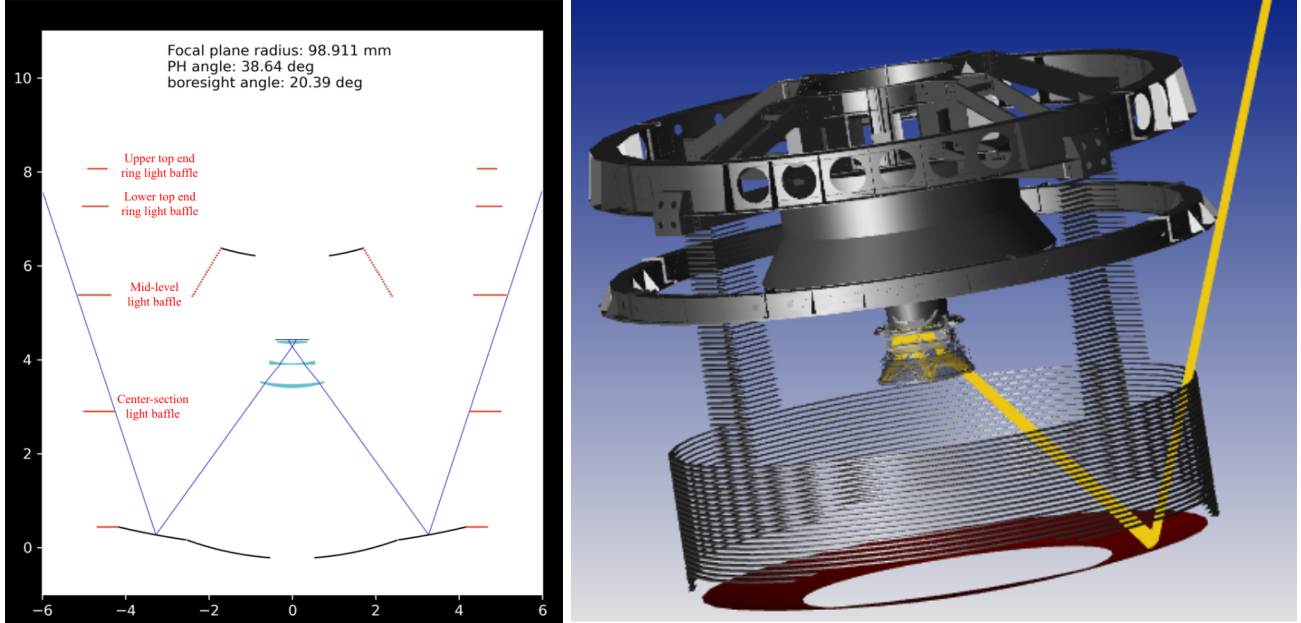
Figure 3: Ray tracing models showing the scratched tape light path between the mid-level and center-section light baffles. (Left) The **batoid** model showing a ray passing through the scratched tape gap and into the center pinhole. The projected radius on the focal plane (98.911 mm) corresponds to the position of the scratched tape seen in pinhole twilight flats. Baffles (red lines) are labeled following the nomenclature of TMA engineering drawings [7]. (Right) A **Zemax** model showing the scratched tape light path with a more complete model of the TMA and LSSTCam. **Zemax** modeling indicated that it is possible for photons to reach the detectors for off-axis angles of  $19.8 < \theta < 26$  deg due to secondary bounces off surfaces within the camera.

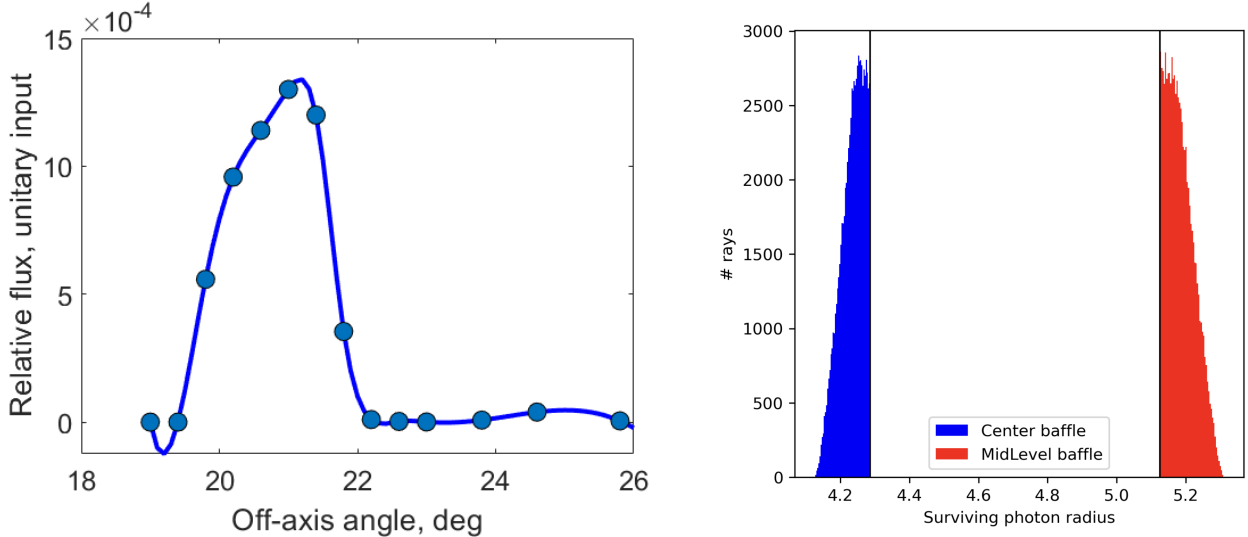
Figure 4: (Left) Ray-tracing simulations with `Zemax` show the relative flux on the LSSTCam focal plane via the scratched tape light path for a unitary flux injected into the telescope pupil. The relative flux reaching the LSSTCam focal plane peaks at  $\sim 10^{-3}$  and falls to  $\sim 10^{-6}$  at off-axis angles  $\gtrsim 22$  deg. (Right) Ray-tracing simulations run with `batoid` show the distribution of  $\sim 2 \times 10^7$  photons fired in the direction of the scratched tape gap between the mid-level and center-section light baffles. The simulation tracks the rays that survive the trip through the baffles, reflect off M1, enter LSSTCam, and reach the detectors. The radial distribution of the surviving rays at the heights of the mid-level baffle and the center-section baffle are shown in red and blue, respectively. This study showed that the mid-level baffle would need to be extended outward by 185 mm to block all surviving rays. However, these simulations used the TMA design dimensions [7] and do not account for the 10 mm uncertainty on the as-built TMA.

Note that these surface brightness estimates were assembled from observations collected over several nights when the scratched tape feature could be associated with  $\alpha$  Cen. The reported standard deviation includes variations in the observing conditions, differences in the precise location of  $\alpha$  Cen with respect to the gap between the mid-level and center-section light baffles, and the exact geometry of the scratched tape feature on the focal plane. Furthermore, while the wavelength dependence of the scratched tape in this analysis is expected to follow the spectral energy distribution of  $\alpha$  Cen, this has not been explicitly verified. Despite these caveats, this analysis suggests that the scratched tape feature originating from bright stars can contribute a flux per pixel that is comparable to  $\sim 20\%$  of the nominal dark-sky background in the bluer bands [13]. Furthermore, we find that the total integrated flux of the scratched tape feature is  $\sim 1.3 \times 10^{-3}$  of the flux expected from direct on-axis illumination by  $\alpha$  Cen, which roughly agrees with the relative flux predicted by the `Zemax` model (Figure 4).

the camera (e.g., the L2 holder pads, auto-changer, etc.) to reach the focal plane. However, the flux of these reflections is suppressed by a factor of  $\sim 10^{-3}$  relative to the scratched tape itself (Figure 4). Given the tolerances on all large TMA components ( $\sim 10$  mm) and allowing for some margin of error, the recommended width of the mid-level baffle extension was 220 mm.

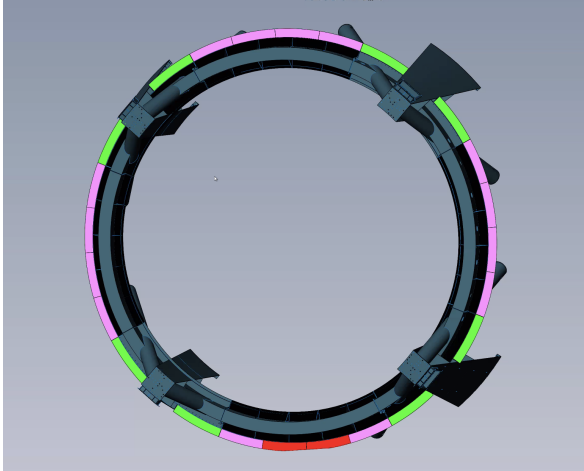
Figure 5: Drawing of the 220 mm outward extension to the mid-level light baffle to block the scratched tape light path. The mid-level baffle extension is composed of 24 panels that were installed incrementally (colored green, pink, and red).

The ray tracing studies described in Section 3 indicated that the scratched tape light path could be effectively mitigated by extending the mid-level light baffle outward (Figure 5). This mitigation strategy has no impact on the clear aperture of the telescope. Ray-tracing simulation with `batoid` modeled the paths of  $\sim 2 \times 10^7$  photons fired in the direction of the scratched tape gap between the mid-level and center-section light baffles. This simulation tracked rays that survived the trip through the baffles, reflected off M1, entered LSSTCam, and reached the detectors. It was found that extending the mid-level baffle outward by 185 mm would block all simulated photons from reaching the detectors. However, these simulations used the design dimensions of the TMA [7], did not account for uncertainty on the positions/dimensions of the as-built TMA, and did not account for reflections off components inside the camera. Further modeling with `Zemax` showed that an extension of 200 mm would effectively block the primary scratched tape component out to  $\sim 23$  deg. A small fraction of photons originating with off-axis angles  $> 23$  deg can enter the camera and reflect off components internal to

The mechanical design of the mid-level baffle extension was performed at NOIRLab. Consideration was given to a lightweight modular design that would allow installation to be staged during regular daytime engineering to avoid interrupting the observing schedule. The baffle extension comprises 24 panels, each measuring  $120\text{ cm} \times 27\text{ cm}$ , allowing for 5 cm of radial overlap with the existing mid-level baffle (Figure 5). The baffle extension panels were fabricated from 2-mm-thick low-carbon steel and painted with low-reflectivity Aeroglaze Z306. These panels were attached to the mid-level baffle using self-tapping screws that were fixed in place with silicone sealant. Small overlap panels ( $22\text{ cm} \times 5\text{ cm}$ ) were attached to the extension panels to prevent gaps between the panels.

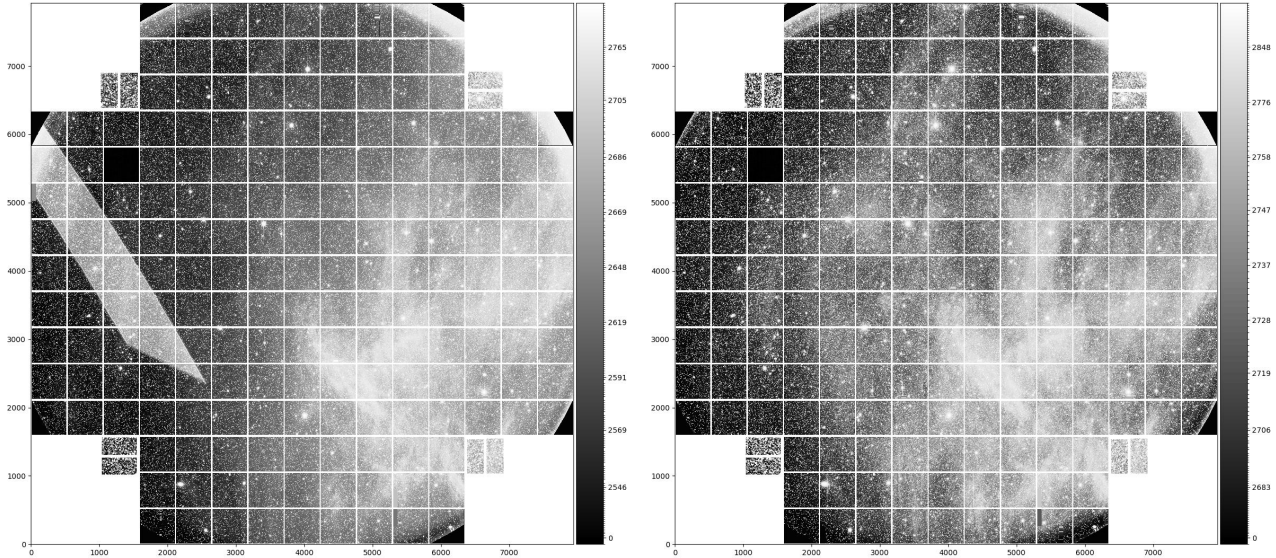
Figure 6: Mitigation of the prominent scratched tape stray light feature by the mid-level light baffle extension. (Left) Stray light originating from  $\alpha$  Cen located  $\sim 21$  degrees off-axis prior to the installation of the mid-level baffle extension (visit = 2026021600550; 30 s exposure in  $i$ -band). (Right) Stray light is not present in an exposure taken after installation of the mid-level baffle extension (visit = 2026031200669; 30 s exposure in  $i$ -band). The relative position of  $\alpha$  Cen is similar to the image on the left.

The effectiveness of the mid-level baffle extension was validated with dedicated on-sky tests and with opportunistic on-sky data taking. Dedicated pre-observations on 16 February 2026 placed  $\alpha$  Cen in different radial and azimuthal positions in the scratched tape gap. Subsets of these observations were then repeated on 19 February 2026 (after the  $-Y$  extension was installed), 26 February 2026 (after the outer  $+Y$  panels were installed), 6 March 2026 (after the  $+Y$  panels were completed), and 12 March 2026 (after several corner overlap panels were installed). These tests demonstrated that the scratched tape light path had been blocked (Figure 6). A small residual feature (referred to as the “smudge”) was observed until 19 March 2026. This smudge has not been observed since additional corner overlap panels were installed. Figure 7 shows the relative occurrence rate of the

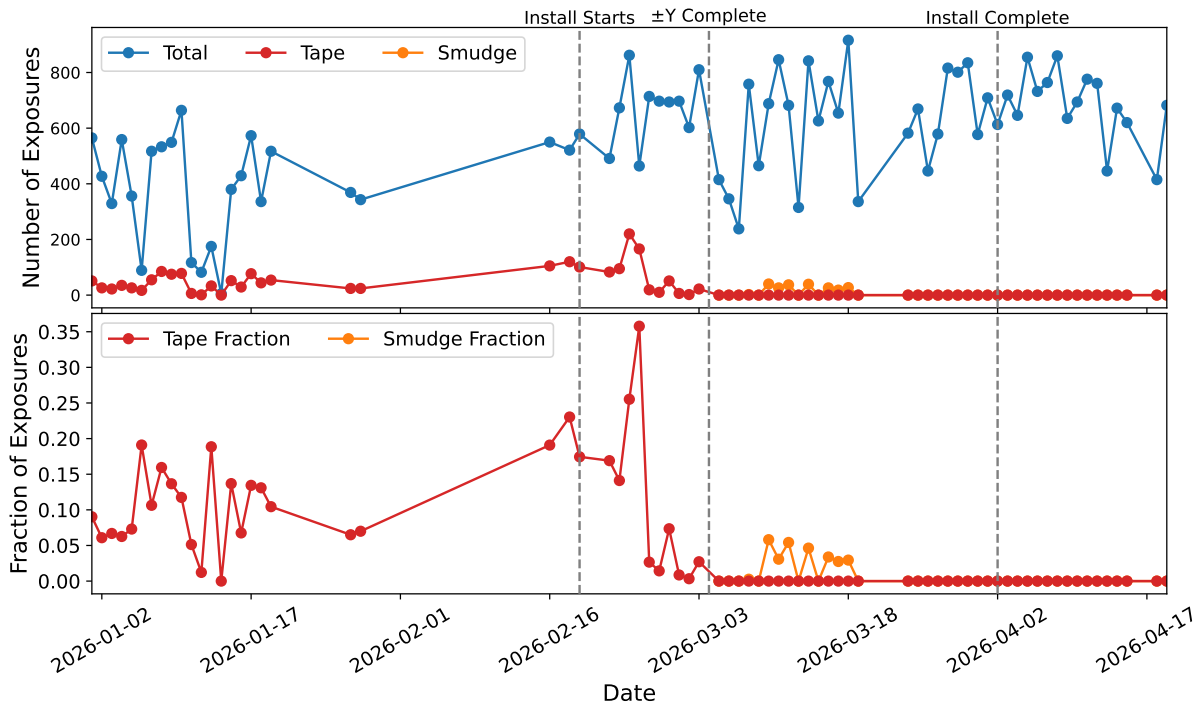
Figure 7: Installation of the mid-level light baffle extension effectively removed the scratched tape stray light feature. A small, residual feature (known as the “smudge”) appeared briefly, and was attributed to a remaining gap between the extension panels. This feature has not been observed since installation was completed.

scratched tape and smudge before, during, and after the installation of the mid-level baffle extension. Anecdotally, the muddy shoe and pillow stray light artifacts have also been observed less frequently since the installation of the mid-level baffle extension. However, these features occur much less frequently than the scratched tape feature and require additional observations to fully characterize.
