LIFETIME TESTING 700 MHZ RF WINDOWS FOR THE ACCELERATOR PRODUCTION OF TRITIUM PROGRAM

K. A. Cummings, M. D. Borrego, J. DeBaca, J. S. Harrison, M. B. Rodriguez, D. M. Roybal,
W. T. Roybal, S. C. Ruggles, P. A. Torrez, LANL, Los Alamos, NM 87545, USA
G. D. White, Marconi Applied Technologies, Chelmsford, England

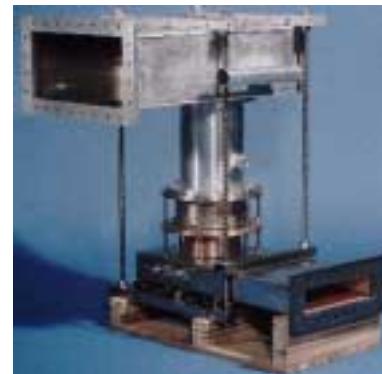
The windows are a coaxial geometry using an AL995 alumina ceramic. As shown in Figure 1, the window assembly consists of 1/2 WR 1150 waveguide on the vacuum side, a T-Bar transition into the coaxial region of the alumina ceramic, and another T-Bar to transition to full height WR 1500 waveguide on the air side. The configuration shown in Figure 1 is referred to as a right handed configuration. The air side waveguide may be rotated 180 degrees around the axis of the coax to yield a

left handed configuration. Both the right handed and the left handed configurations are used to feed power to the CCDTL on the APT accelerator. The vacuum side waveguide is copper plated stainless steel. The inner and outer coax is copper and the air side waveguide is aluminum.

The windows are cooled with 40 CFM of air cooling and 2 GPM of water cooling. The air inlet is on the air side T bar. The air then flows through the T bar on the air side, down the inner conductor, and then exits the inner conductor through a series of exit holes and flows across the alumina ceramic. The air exits the coaxial region through a series of exit holes on the outer conductor and is vented to the ambient environment. The water circuit cools the vacuum side T bar region and the vacuum waveguide.

Figure: 1 EEV 700 MHz RF Window

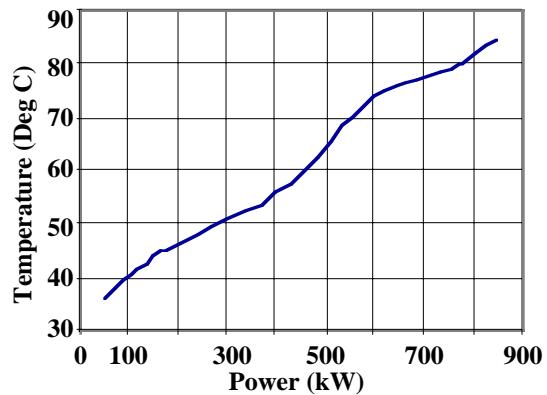
Figure 2. Steady State Temperature vs. Power

The steady state temperatures of the outer coaxial surface at various power levels are shown in Figure 2. These temperatures are on windows that did not show any arcing, glowing or heating problems. During the high power acceptance testing the temperatures of the windows are compared to this data as a tool to indicate any problems.

The variations in the coaxial surface temperature, air out temperature, amount of arcing, and vacuum pressure are examined over time. As shown in Figure 3, the coaxial surface temperature is plotted at various power levels during each month for serial numbers 12 and 13. As expected from Figure 2, the average temperature increases with the average power, however, there is no correlation of temperature, either increasing or decreasing with time. Figure 4 shows no correlation between the air out temperature and test time; however, the noticeable increase in the air out temperature with power can be easily seen. The vacuum pressure remained very constant throughout the testing and there were no significant number of arcs.

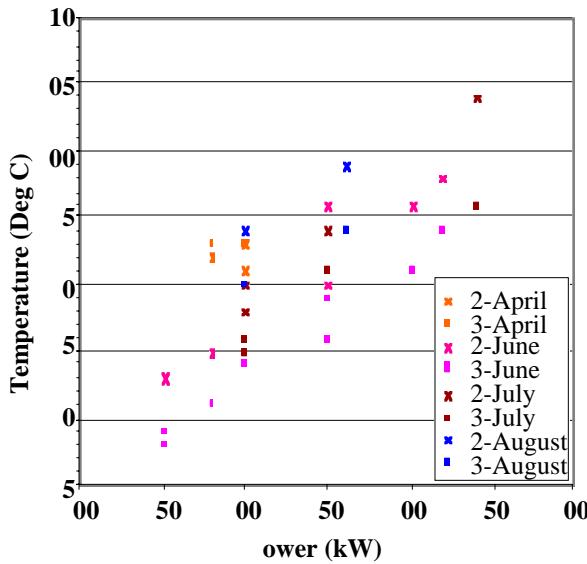
Figure: 3 Average Coaxial Surface Temperatures

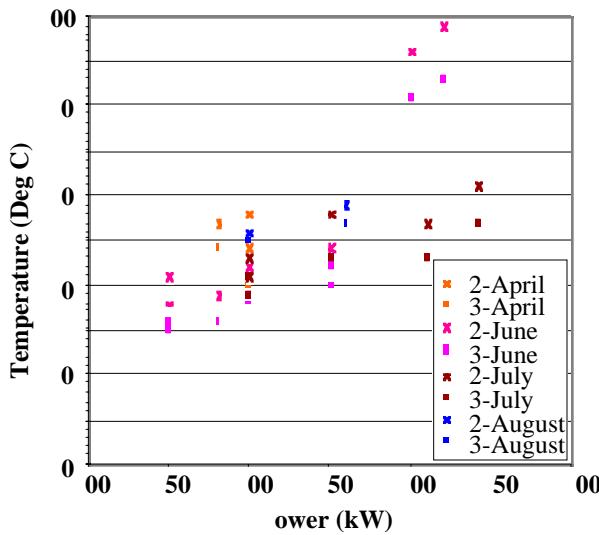
Figure: 4 Average Air Out Temperatures
